# STRUCTURAL REPORT

Barn at  
Green Farm  
Shorne

Job 16462

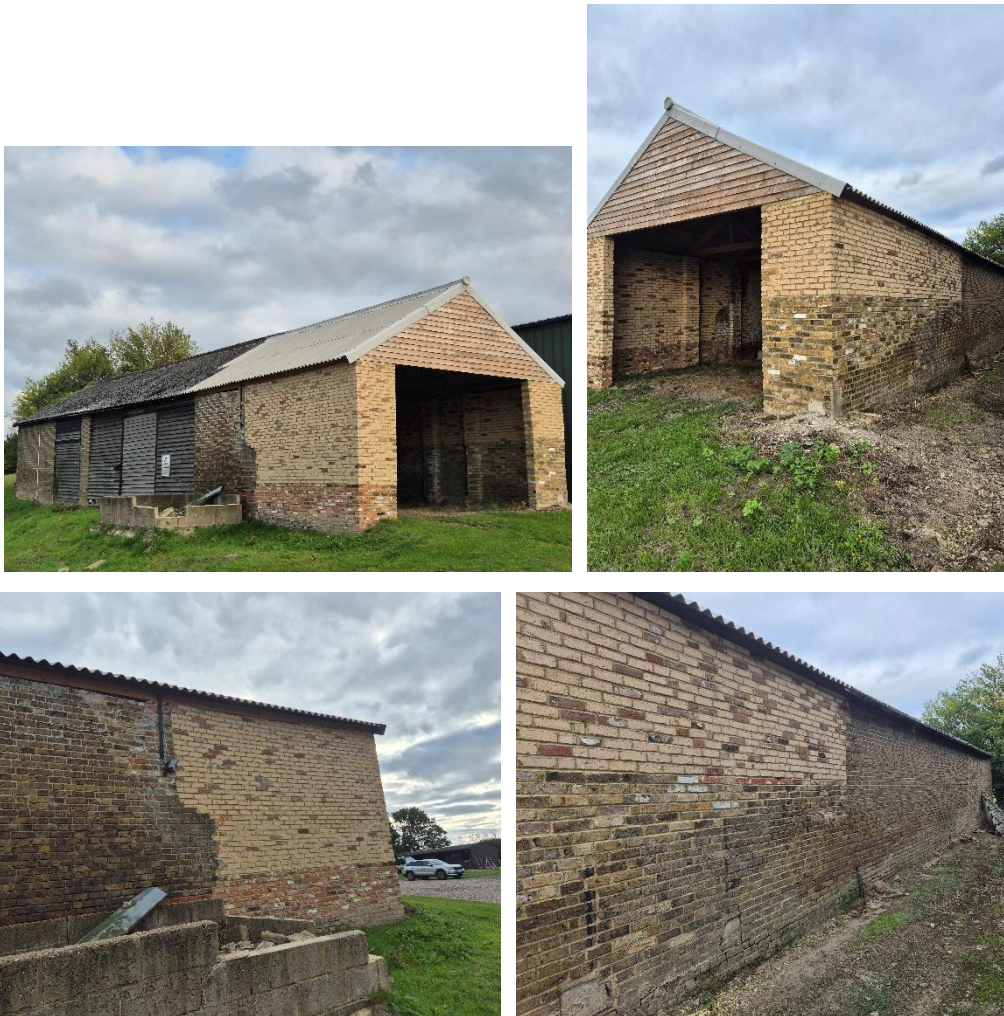
2.1 We are informed by the client that the original parts of the barn are in the order of 200 years old. The front section was blown down in storms at the end of the 1980s and was rebuilt. This area is clearly distinguishable as being of newer brickwork.

*Figure 1: Photographs showing the rebuilt section of the barn*

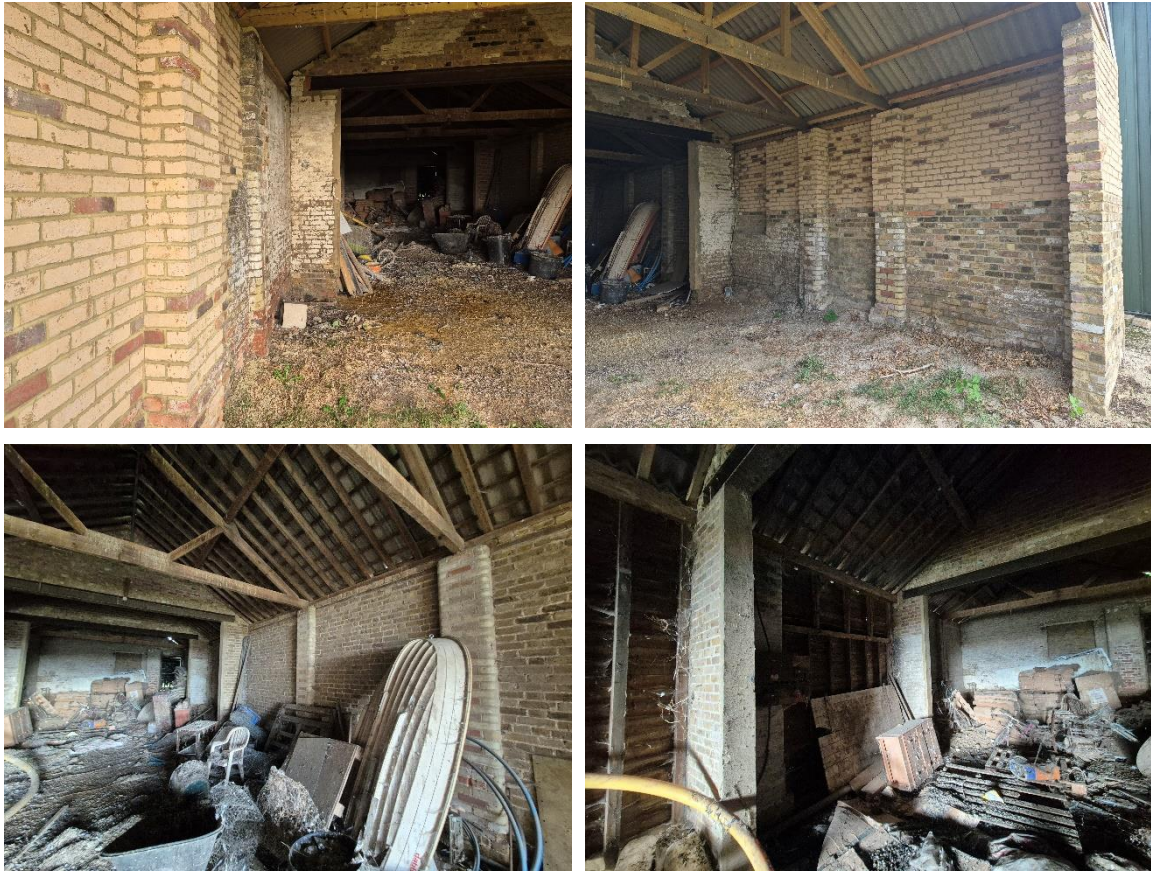
2.2 The barn itself is a single-storey, brick-built structure in rectangular planform approximately 6.8m x 25m. The walls are solid brickwork approximately 3.5m in height to eaves with regular buttresses and piers along the length of the flank walls, which divide the building into 4 “bays”.

*Figure 2: Photographs showing the buttresses and pier walls within the barn*

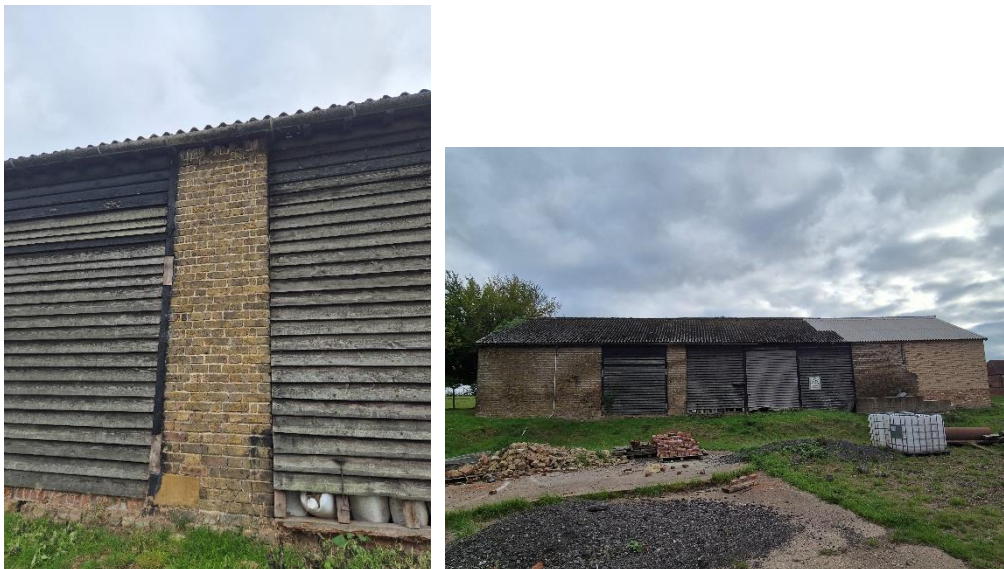
2.3 Two full-height openings are noted, currently infilled with timber frame to the North Elevation of the 2<sup>nd</sup> and 3<sup>rd</sup> bays.

*Figure 3: Timber infill panels in the North Elevation*

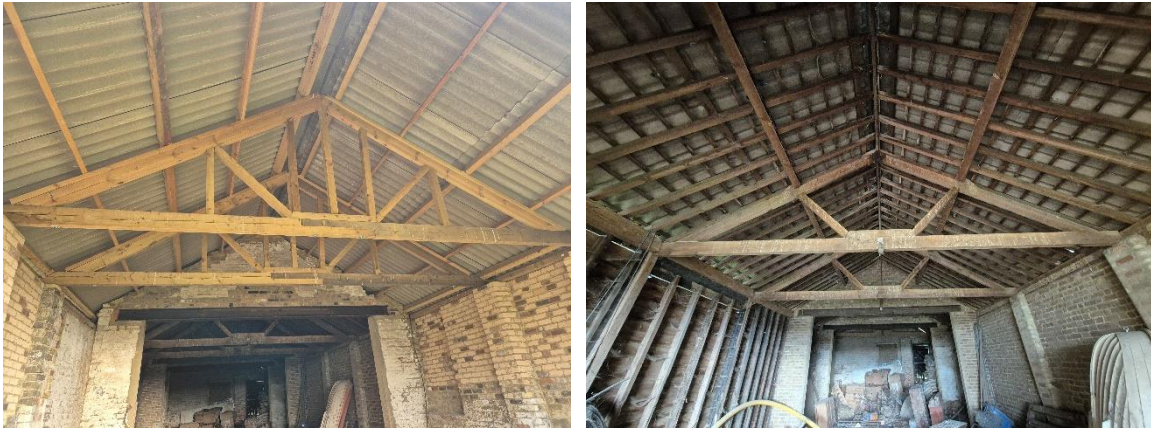
2.7 The roof covering is corrugated roofing panels off timber purlins which are supported off timber trusses. Three of the trusses appear to be original, or are at least significantly older than the two trusses closest to the entrance which were installed in the late 1980's. The newer trusses are poorly made and should be replaced whereas the original trusses are more conventionally formed.

*Figure 5: Modern trusses (left) original trusses (right)*

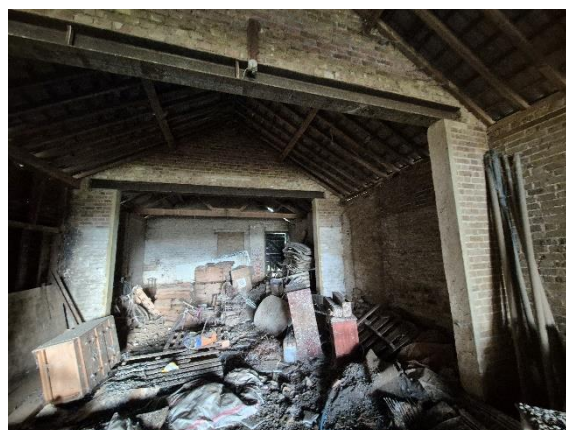
2.8 Where the barn is divided into bays, 203 x 203 UC / RSJ steel beams have been installed supporting 9" gable brickwork over the openings. Aside from some superficial rust these appear to be in good order and are of an appropriate member for their span.

*Figure 6: Beam in situ supporting gable brickwork between bays*

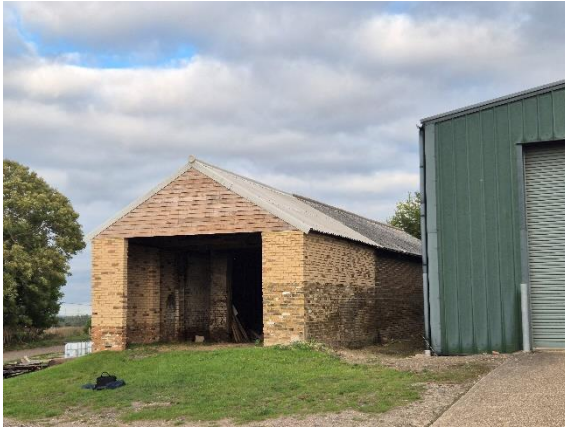
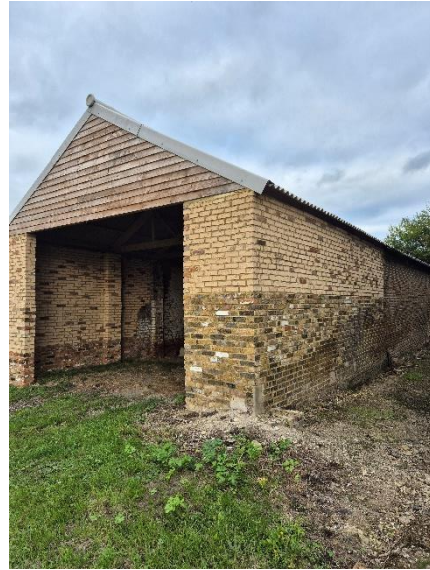
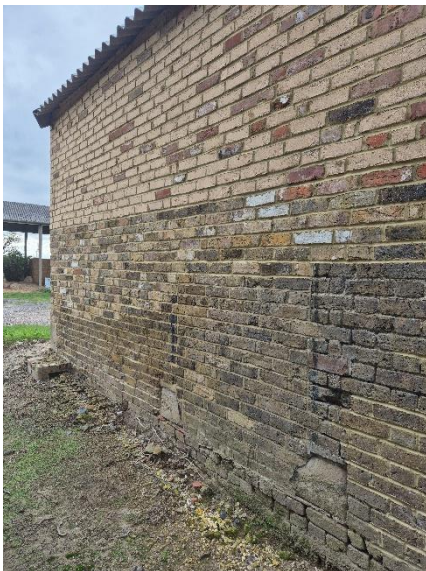
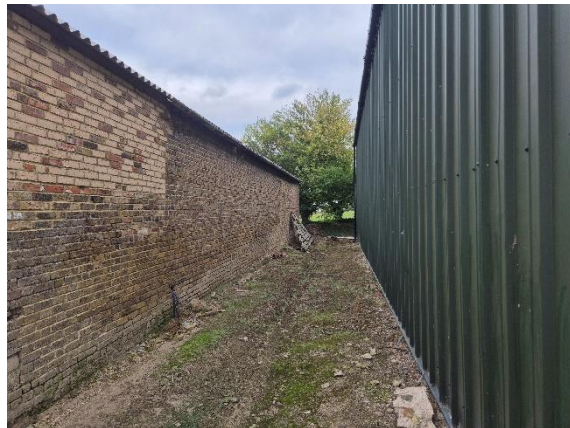
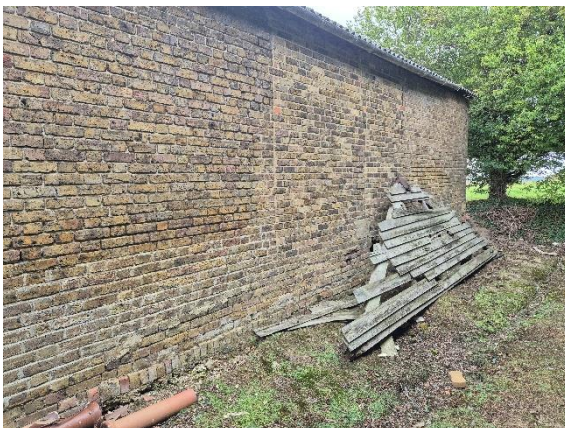
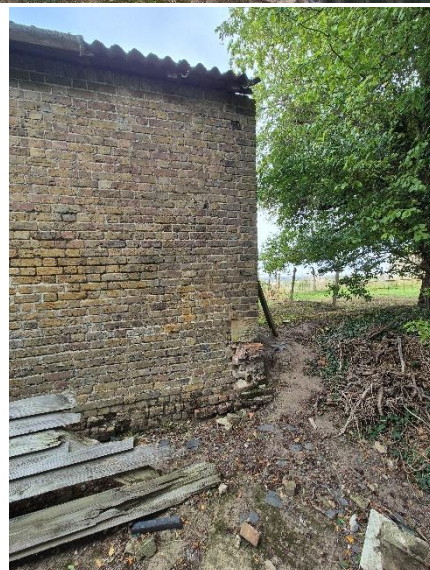
*Figure 7: Photographs of the Barn exterior (West elevation, South Elevation, East elevation, North elevation)*
