**STRUCTURAL ASSESSMENT  
OF  
BRIMSOLE FARM  
MEOPHAM**

**CLIENT:** MR THOMPSON

**AGENT:** OPEN ARCHITECTURE

**DATE:** FEB 2023

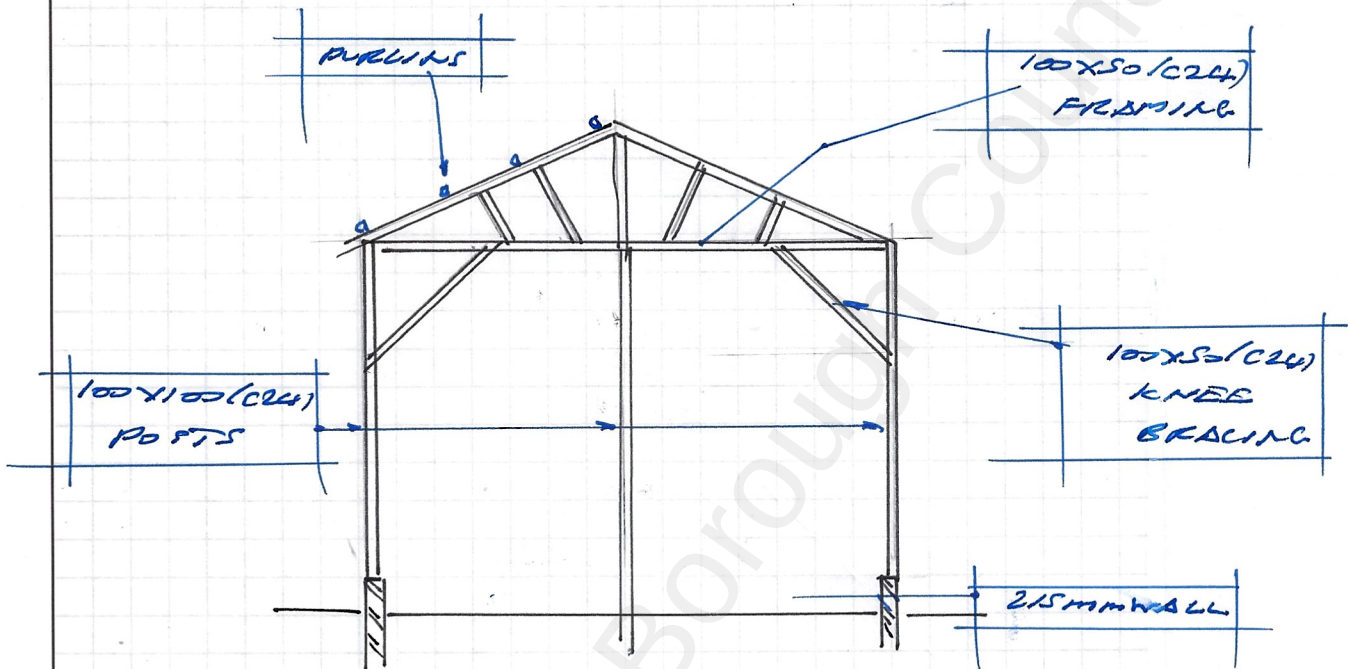
MAIN TRUSSES ON  
GRIDS 2-6

On grids 2-6 inclusive main frames are provided comprising 100 x 100 timber columns on grids A and B with triangulated trusses to the roof zone integrated with knee bracing to achieve frame action. On the centreline (grids A/B) there are central 100 x 100 timber posts providing mid-span support (see attached). From preliminary analysis the frame/truss is of acceptable strength to carry the existing load but it is recommended that some upgrading work is carried out in the future to enable the proposed increase in roof load to be accommodated. On grids 5 and 6 the central post support on grid A/B is missing and should be reinstated.

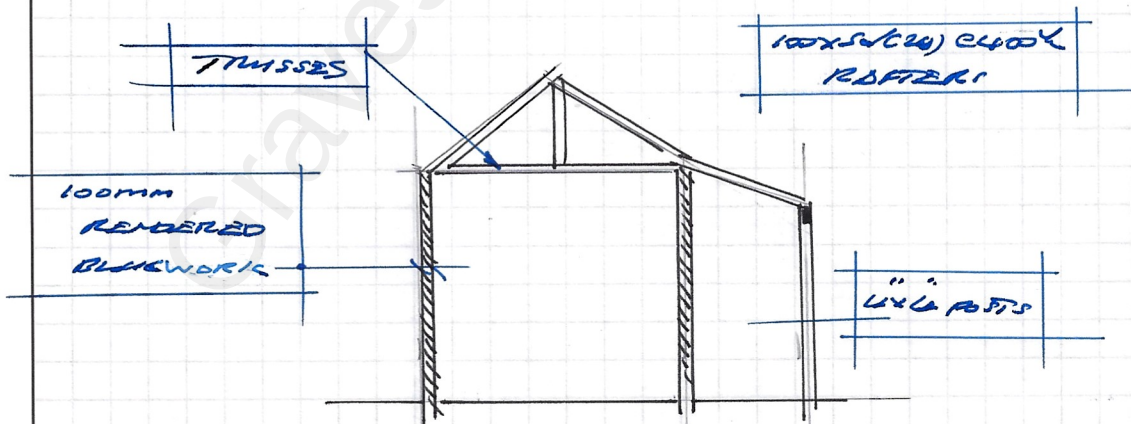
BUILDING GRID B-C

Between grids B-C a single-storey blockwork enclosure is present with a timber framed roof structure covered in corrugated fibre cement sheeting. The 100mm x 50mm timber framing and small catslide to the front elevation is in good order and requires little attention. The concrete slab can be reused in any conversion works but the walls will require upgrading to meet modern building regulation requirements. Existing foundations will require inspection in due course.
