Project Name: Bailiffs House Barn, Camer Park,  
Camer Road, Meopham DA13 0XT

Structural Heritage Assessment Report

Date: April 2022

Project Number: A8542

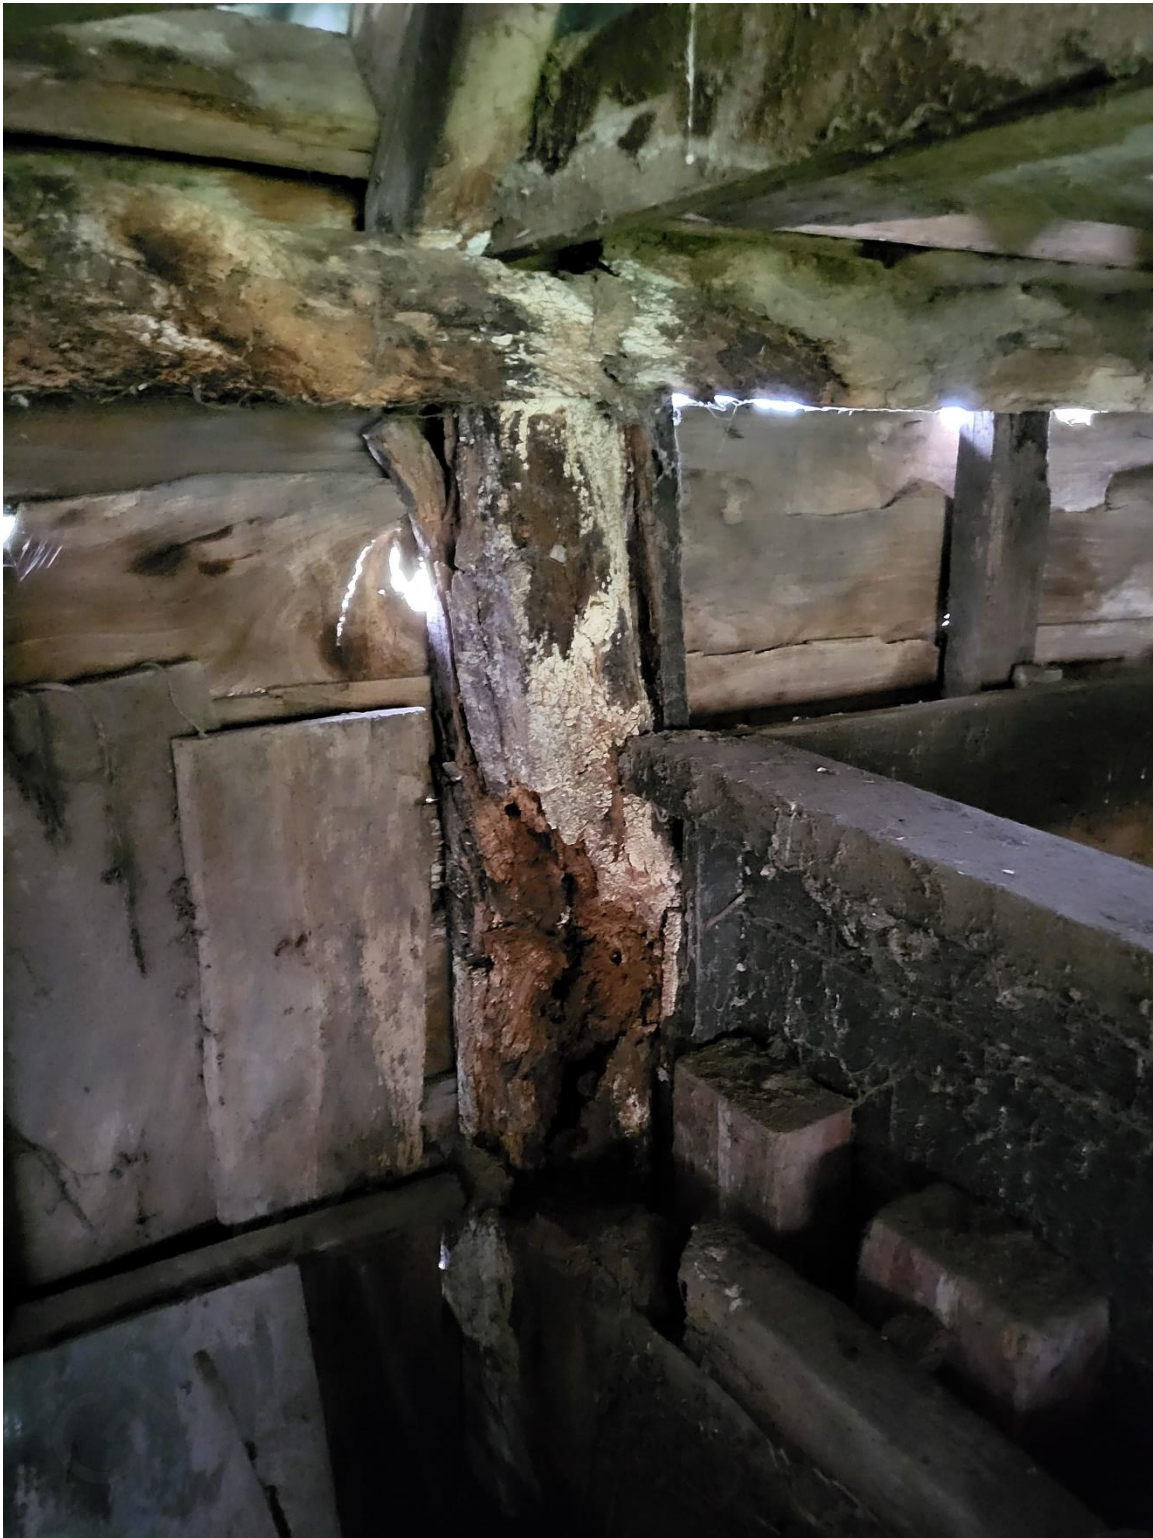
There was evidence of considerable rot in an existing post on the west elevation, the rot extended into the low level eaves plate either side (photograph 5). The brace beam connecting to this post had also deteriorated and had been splinted for strength. Slight signs of wood softening to the post between the east window casements was evident (photograph 6).

**Photograph 5 - Extensive rot to side post in west wall - Grid 5**

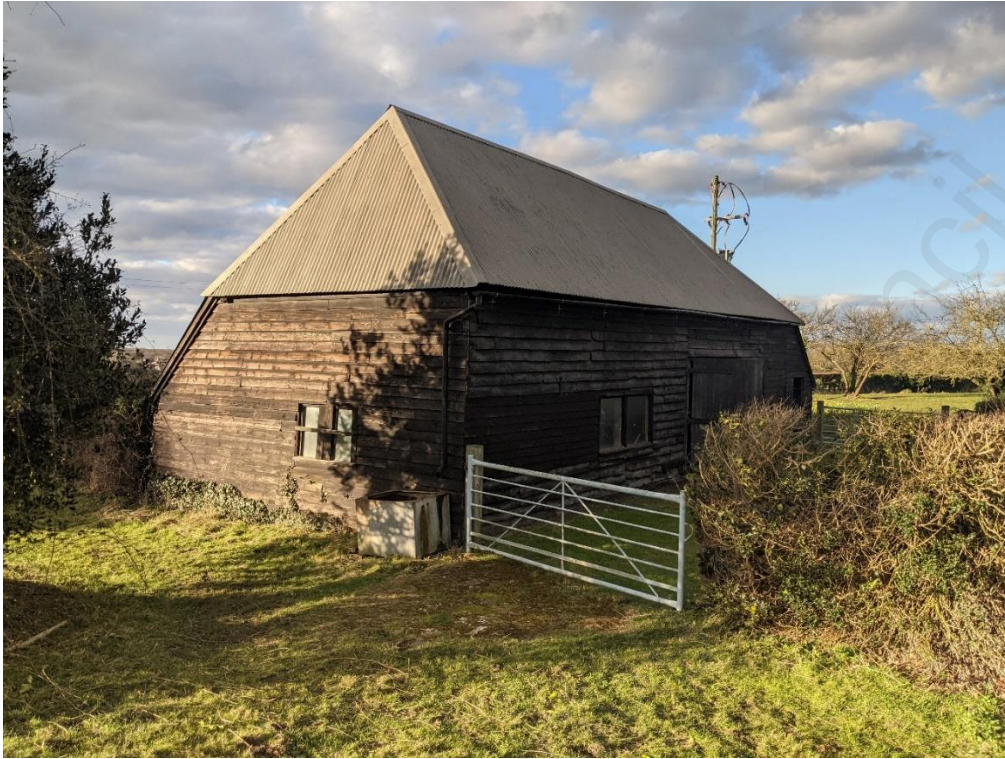
The barn currently has a modern profiled cladding sheet fixed to the roof, supported from a regular grid of modern timber rafters and cross purlins. The load from this sheeting is comparative to light tiling and currently does not cause a structural concern. (Photograph 15).

**Photograph 15 - External roof cladding to barn**

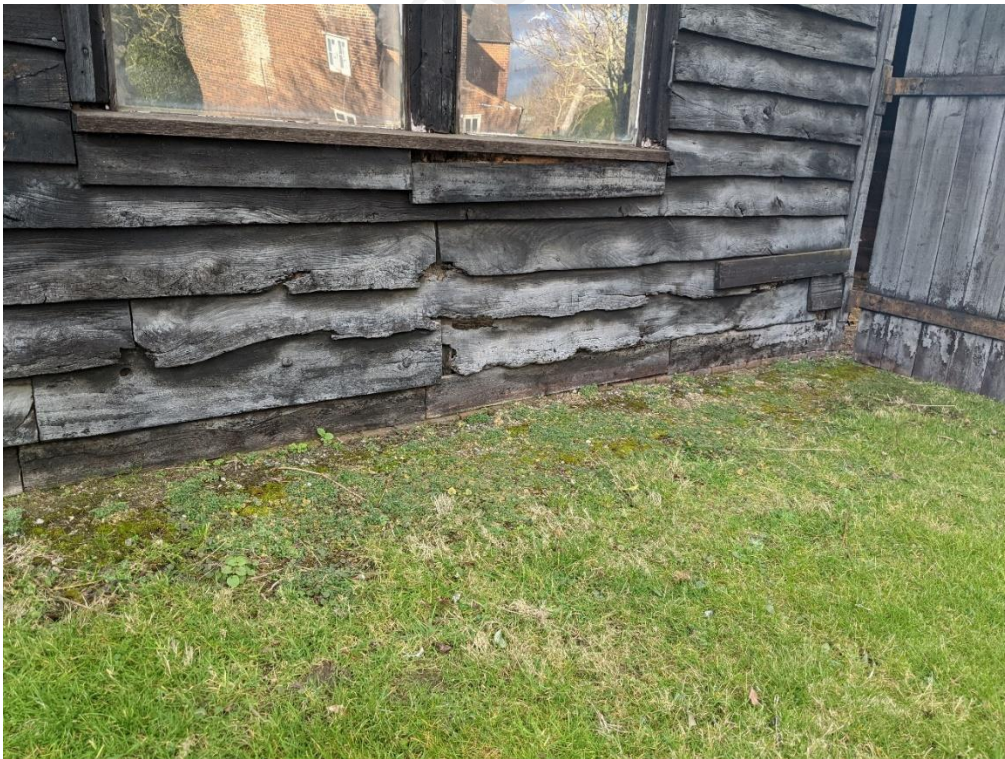
The timber weatherboard cladding to the building is in reasonable condition, with evidence of board replacement relatively recently to most elevations. The board sections have warped a little, pulling nails, and some re-fixing would be helpful. They would benefit from preservative treatment.

**Photograph 16 - Weather boarding to east elevation**
