Project Name: Bailiffs House Barn, Camer Park,  
Camer Road, Meopham DA13 0XT

Structural Heritage Assessment Report

Date: April 2022

Project Number: A8542

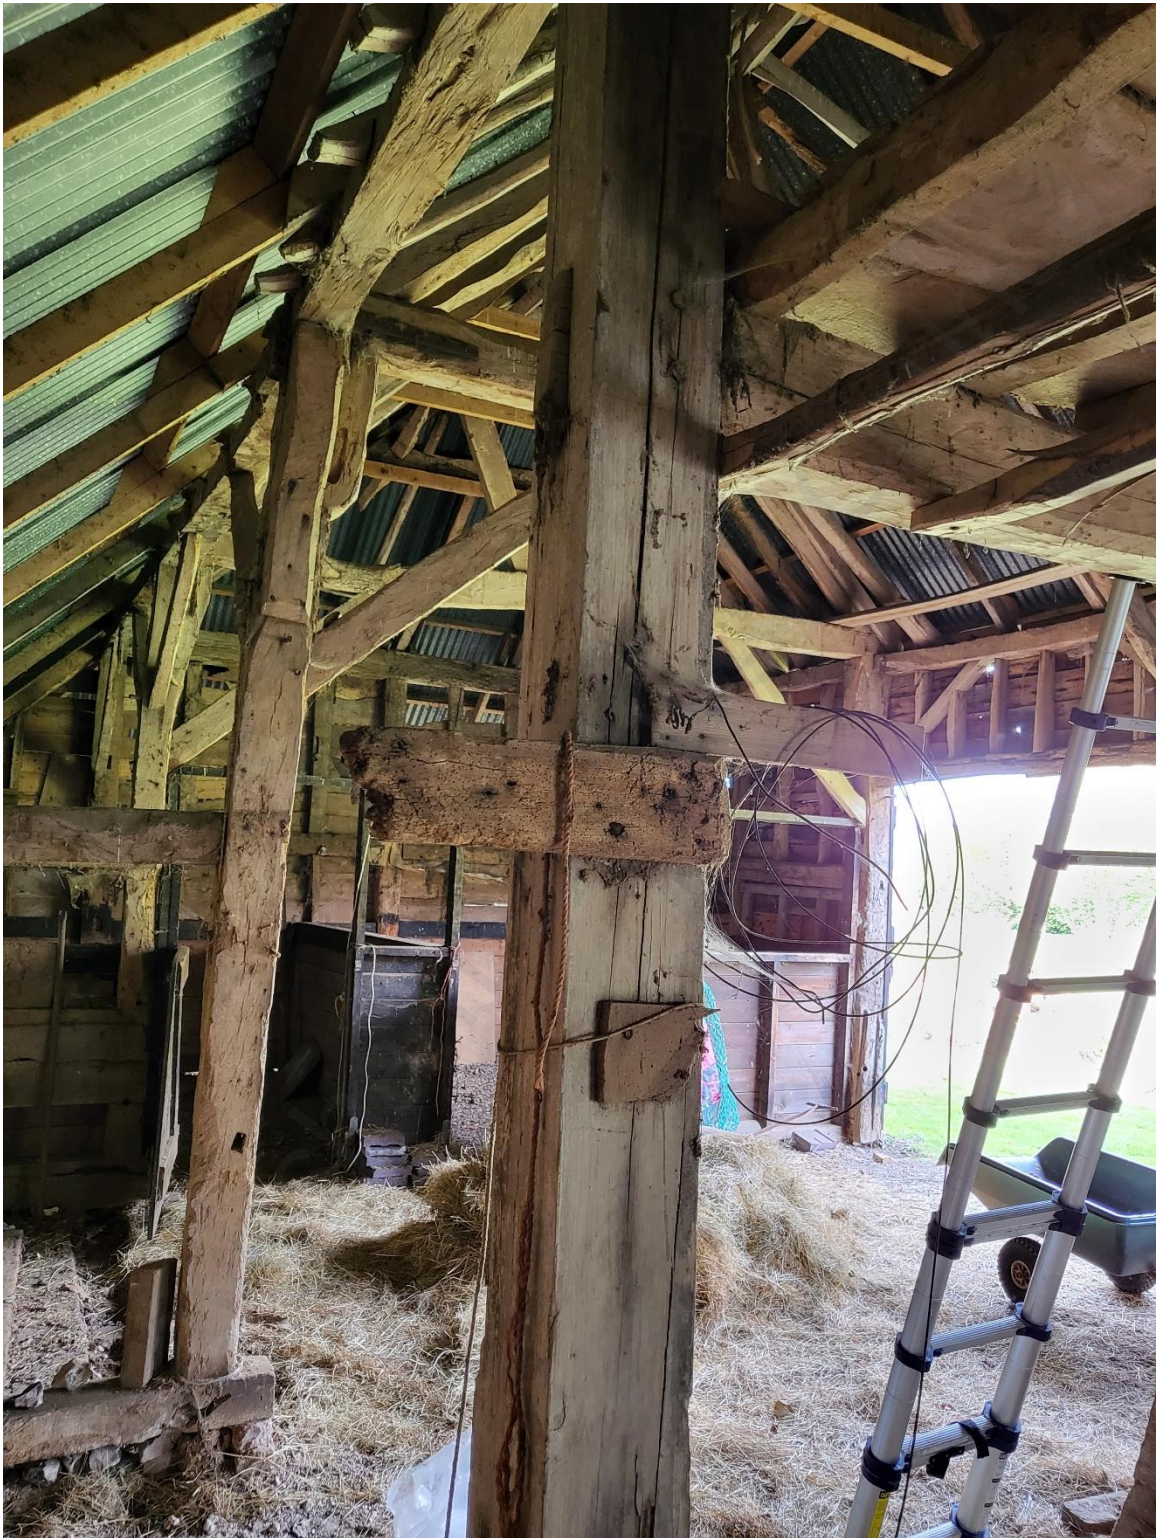
Defects to these frames include missing or damaged brace beams (photograph 1) and evidence of previous lateral displacements at eaves level. Previous beetle infestation was also noted in some areas, whilst some of the main posts contained noticeable splits. The missing brace beam adjacent the mezzanine post frames is not an immediate structural concern.

**Photograph 1 - Brace beams to West Elevation**

Horizontal brace beams at low level eaves help to restrain the western wall and prevent the eaves from pushing out. The missing or damaged brace beams on the west should be repaired or reinstated where possible.

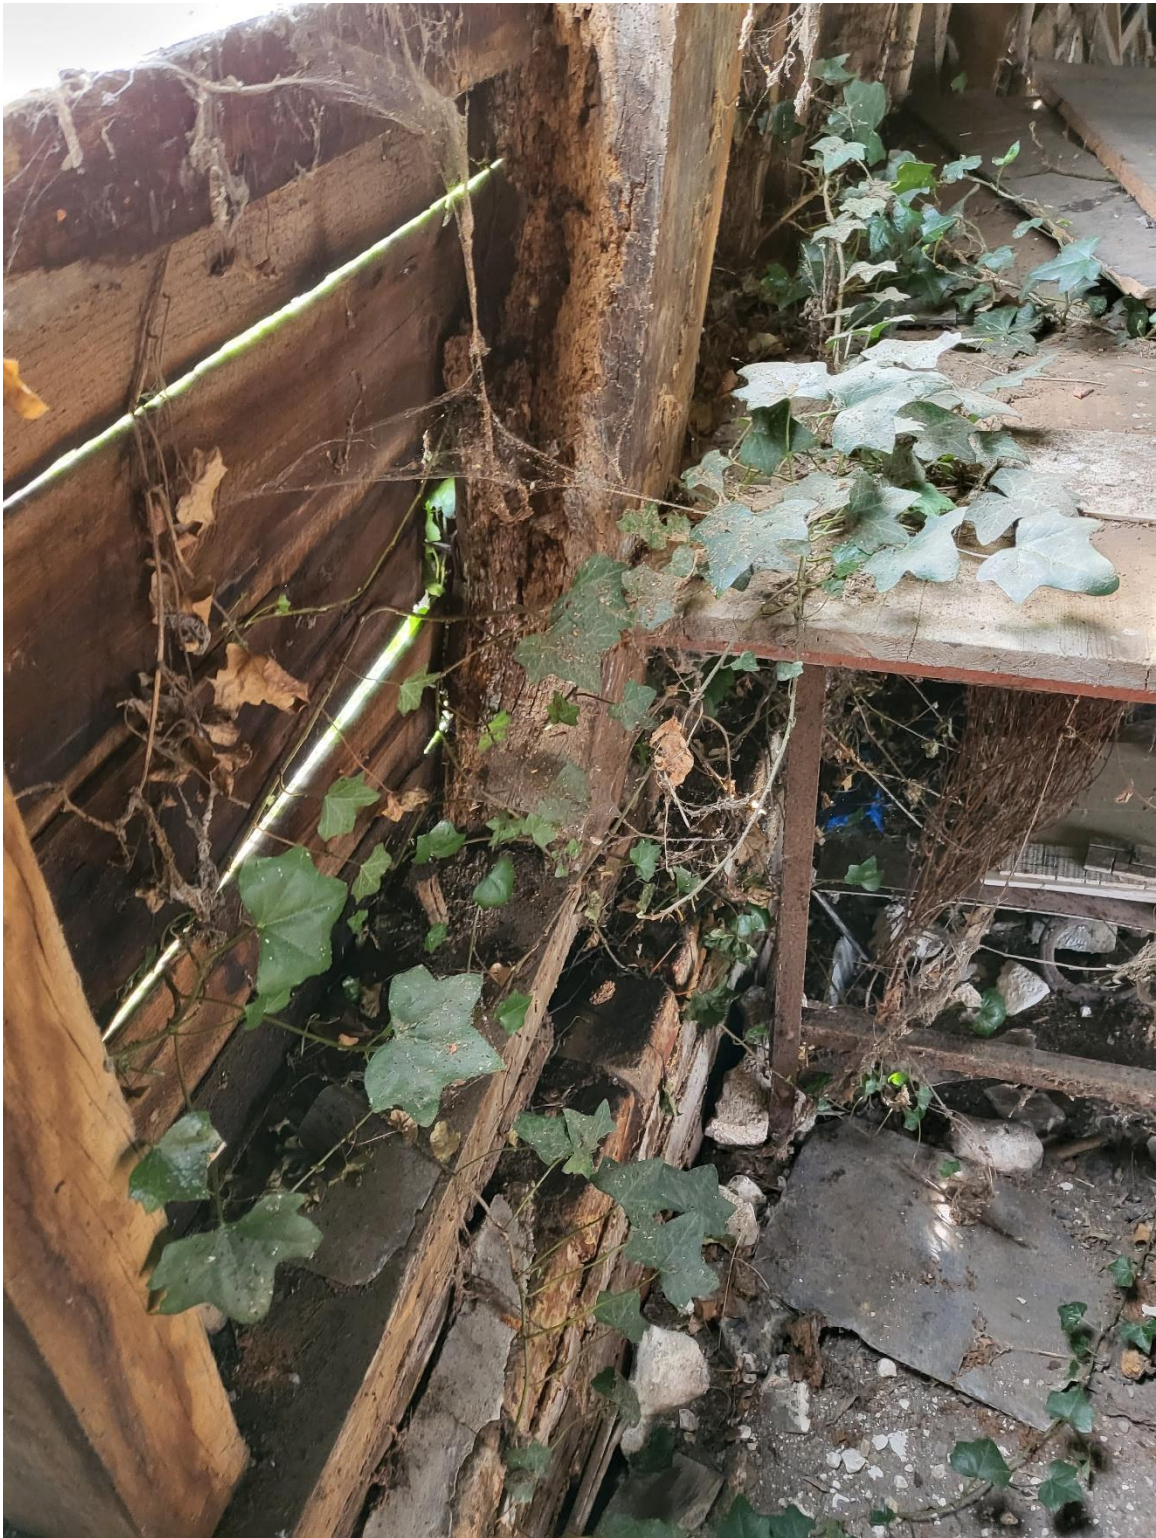
Defects to these frames include local rot to lower sections of post and plate on the south (photographs 2 and 3), and evidence of previous beetle infestation. Missing weather boarding was noted to the north.

**Photograph 2 - Rotten central post to south below window**

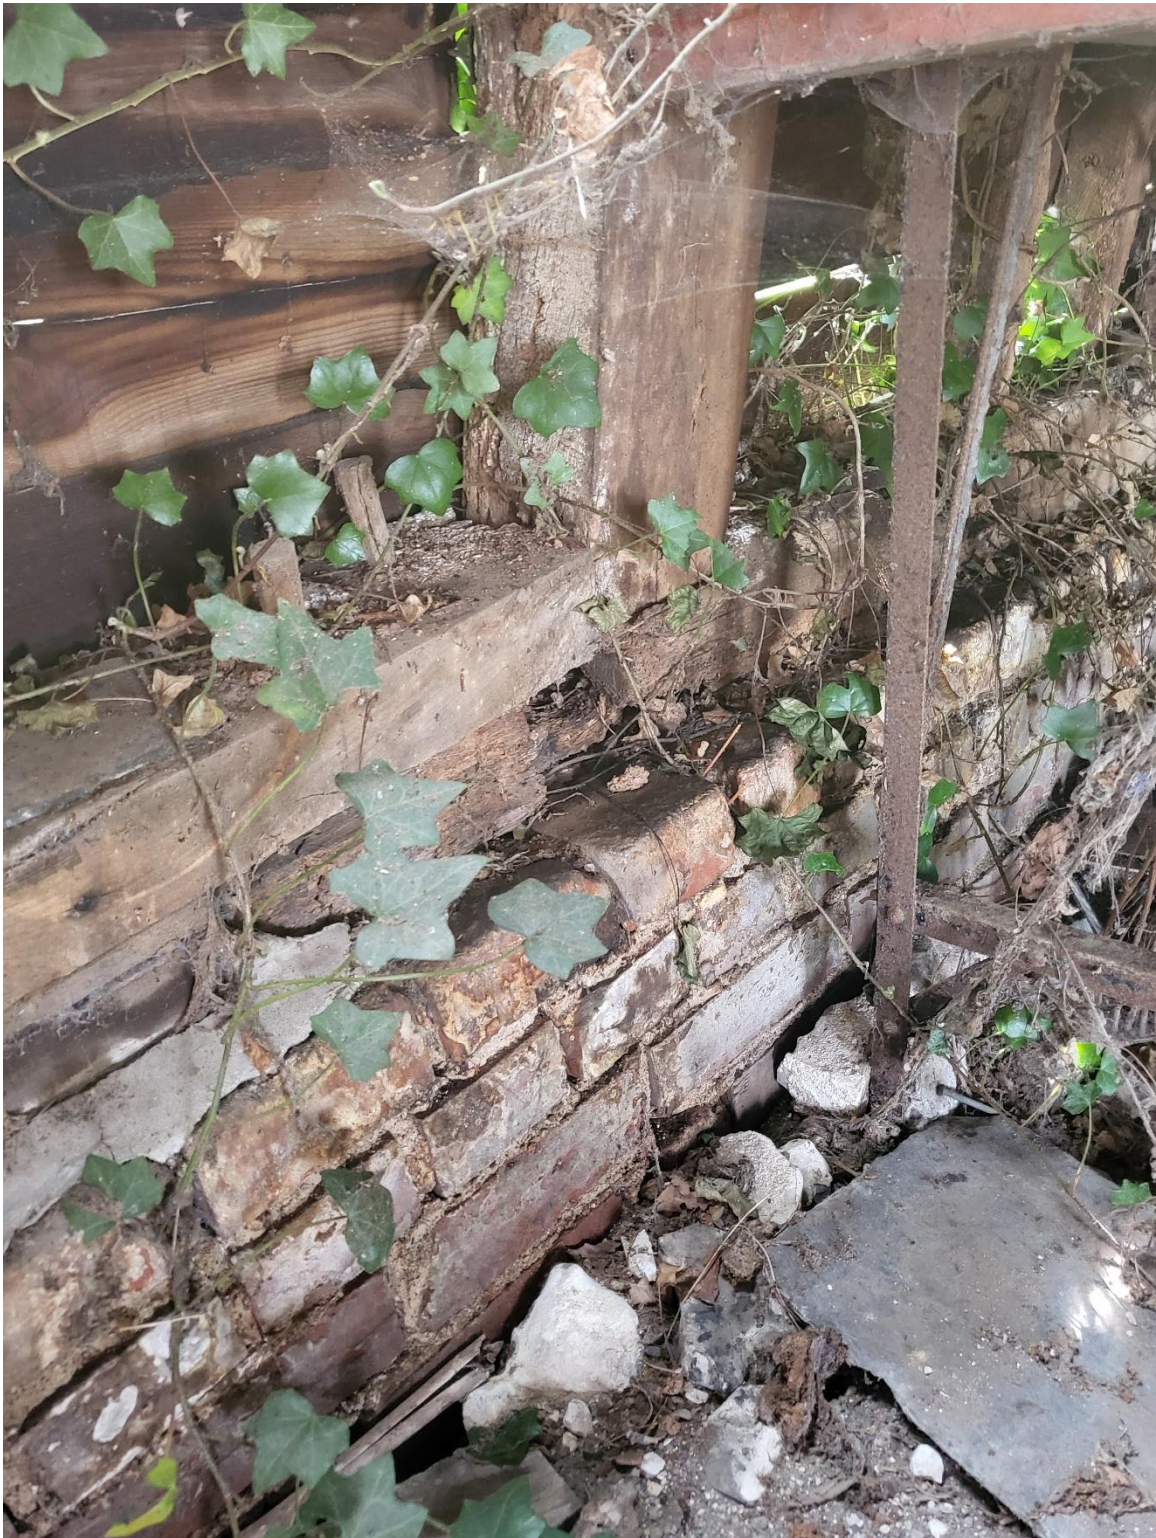
The plates below the timber walls are in general more heavily decayed particularly beneath rotten posts described above and are typically 150mm square (6" x 6") in section. There is no obvious DPC between the plates and brick plinth below. They generally lie level but sometimes bridge over loosened wall construction (photographs 8 and 9). The southern wall plate is bowing outwards through the lean of the dwarf wall below.

**Photograph 3 - Rotten sole plate to south plinth and wall lean**

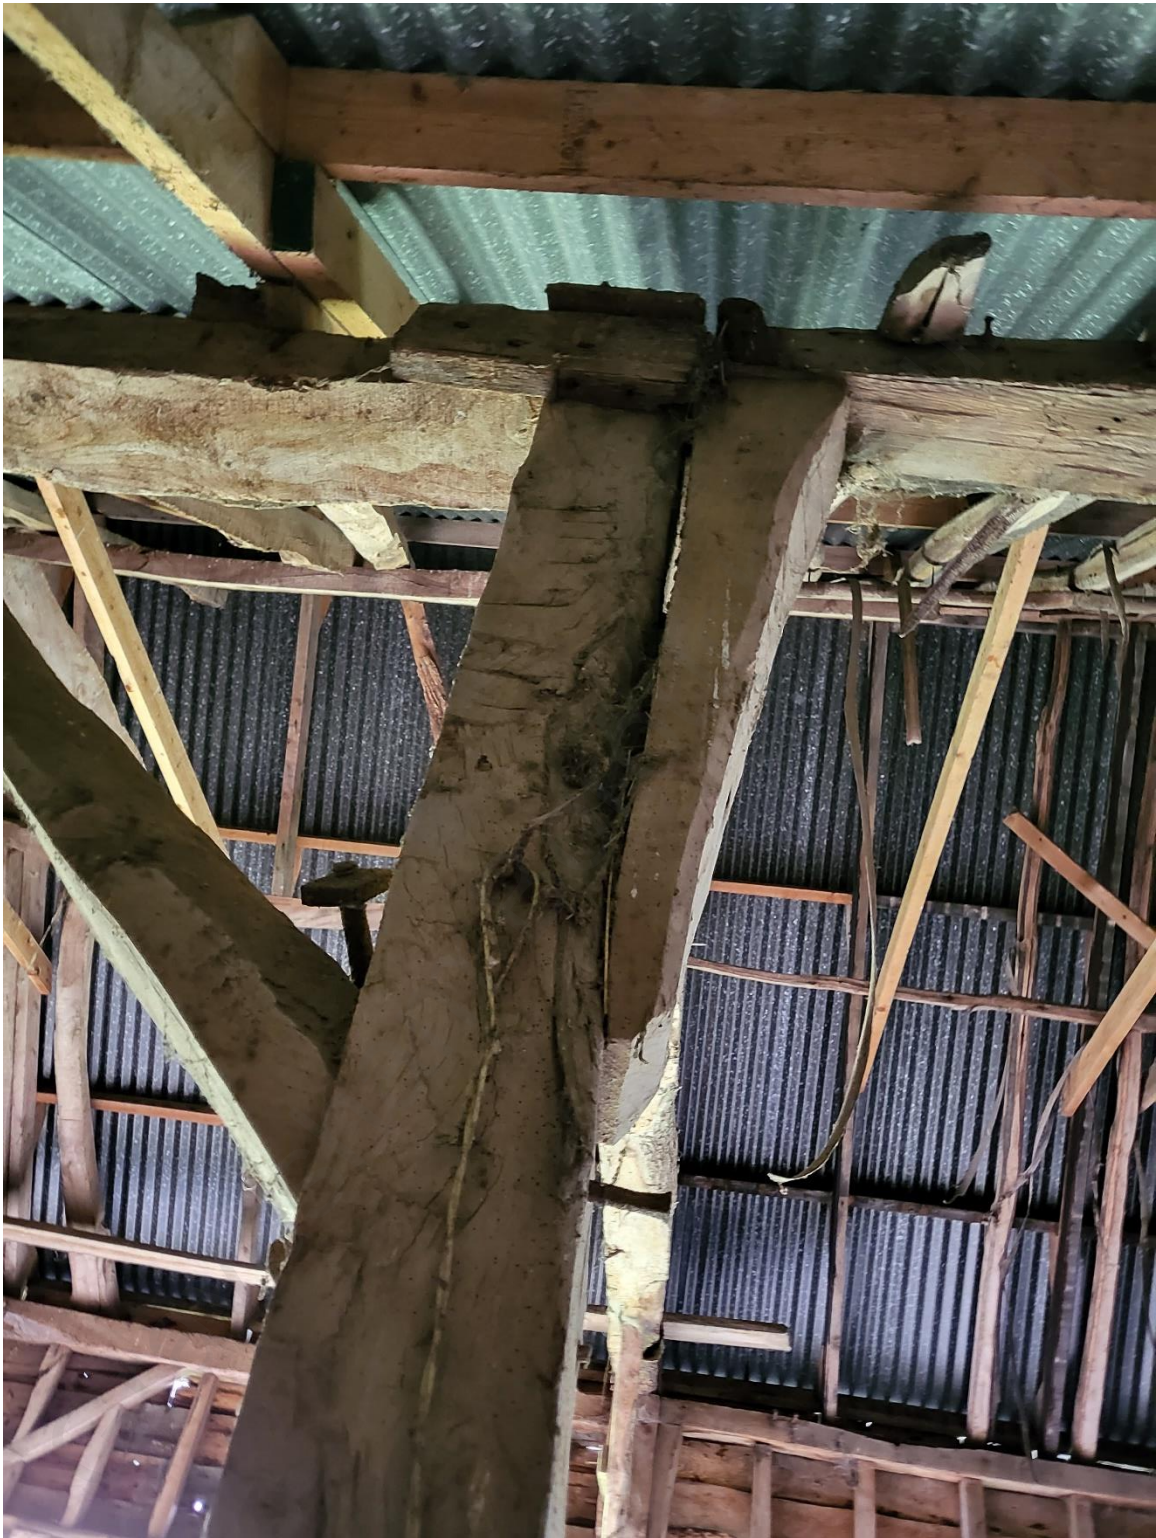
Defects to these include the loss of connection of the side jowl (photograph 4) and evidence of previous repairs to eaves plate

**Photograph 4 - Side jowl fixings prising out**

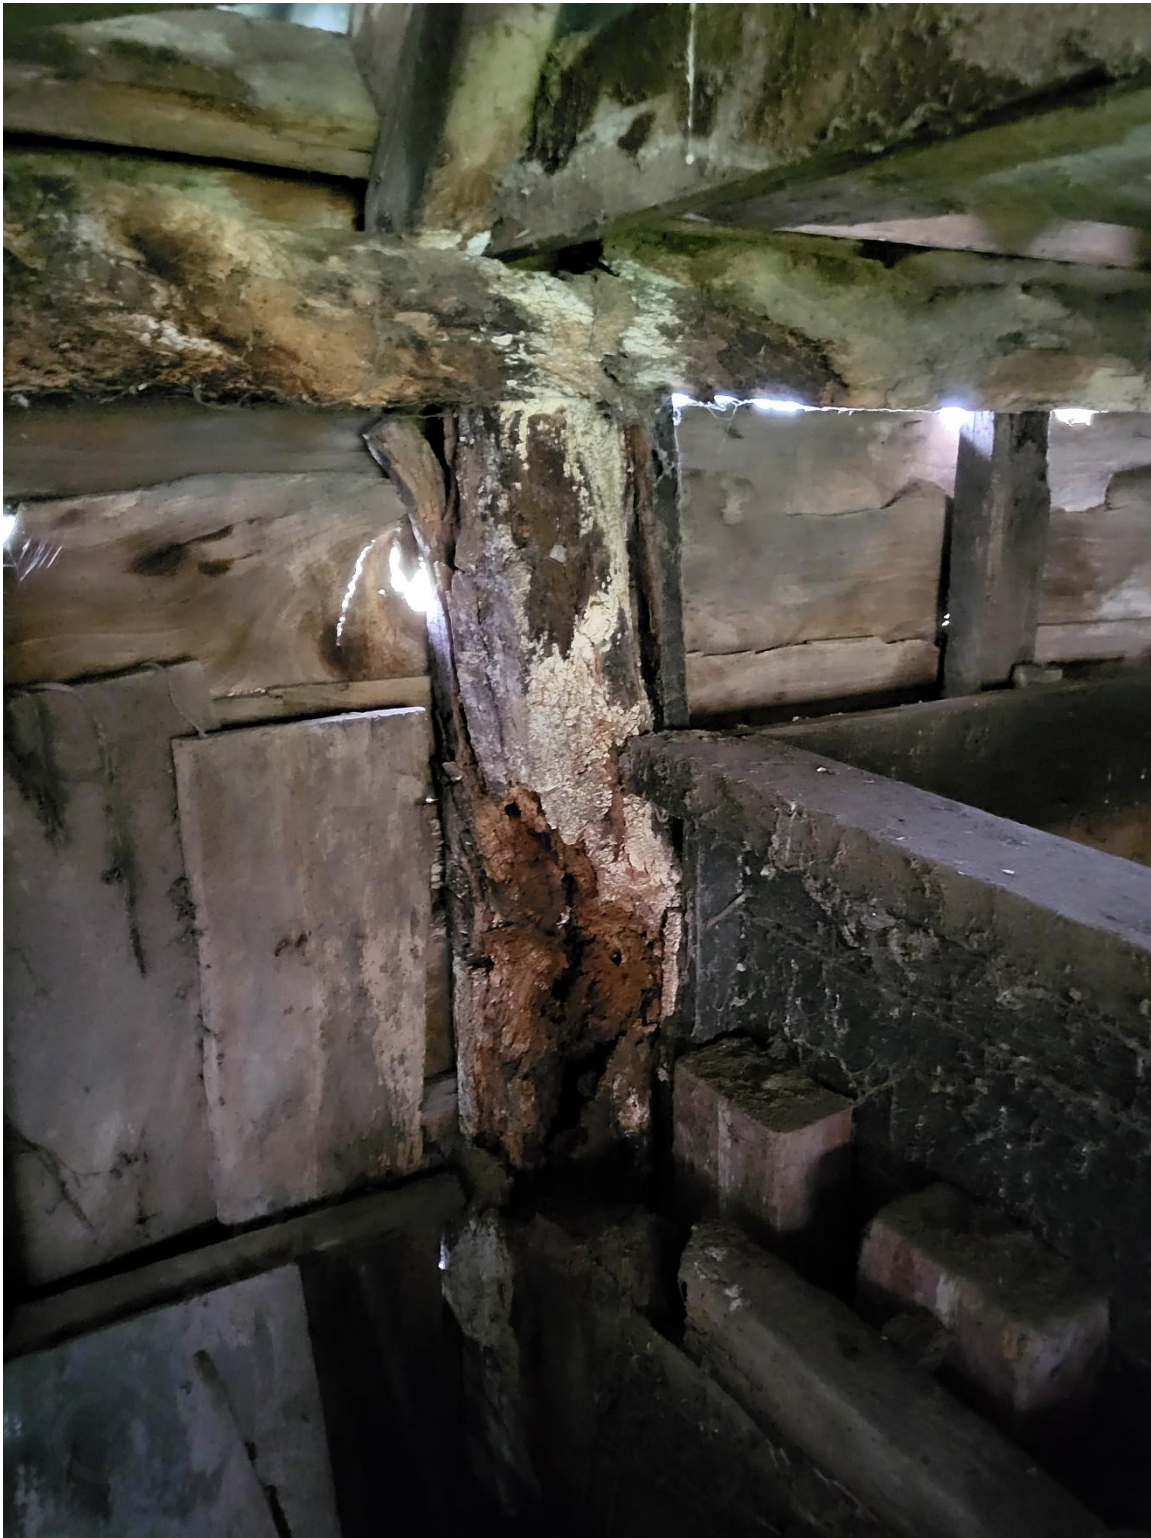
There was evidence of considerable rot in an existing post on the west elevation, the rot extended into the low level eaves plate either side (photograph 5). The brace beam connecting to this post had also deteriorated and had been splinted for strength. Slight signs of wood softening to the post between the east window casements was evident (photograph 6).

**Photograph 5 - Extensive rot to side post in west wall - Grid 5**

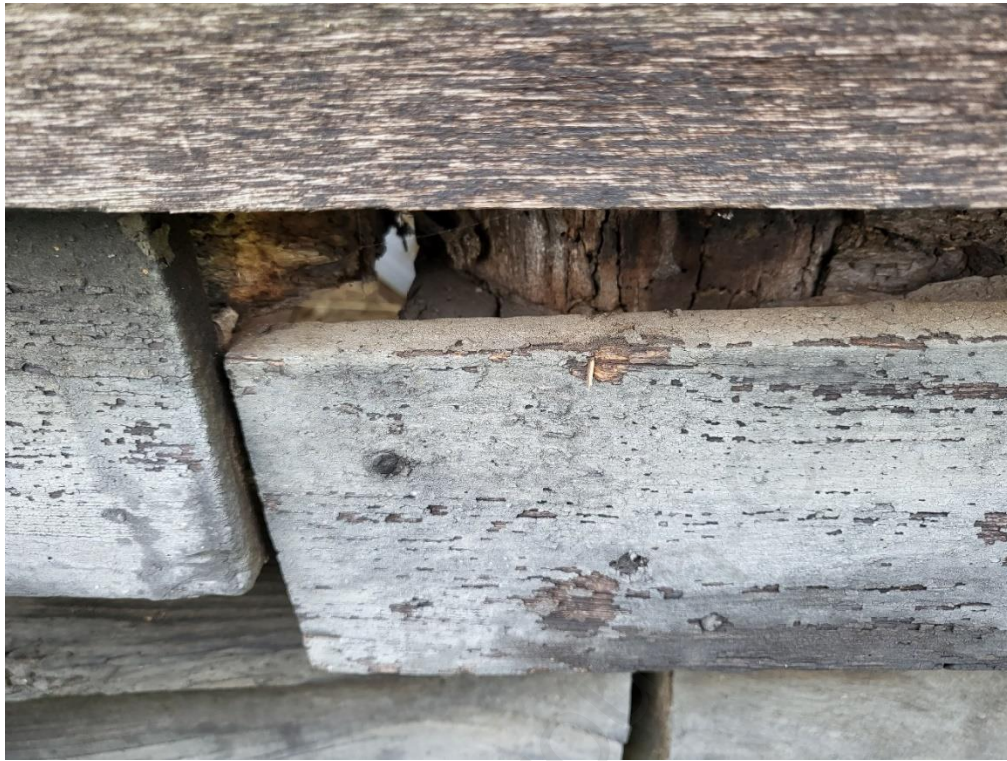
**Photograph 6 - External face of window post on east elevation**

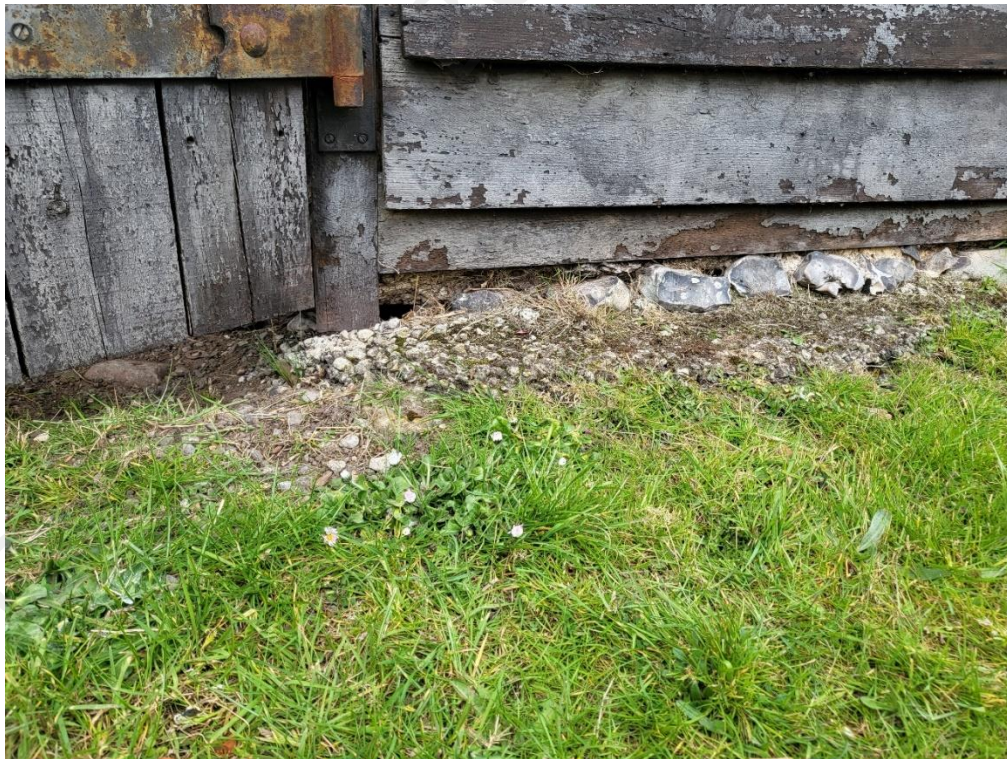
The plates below the posts are typically 150mm x 115mm deep (6" x 4.5") in section. They show local decay but are still functional, the decay generally being from worm attack and having eaten the sapwood and wicked down natural splits in the end grain (photograph 7).

**Photograph 7 - External sole plate with rot at ends**

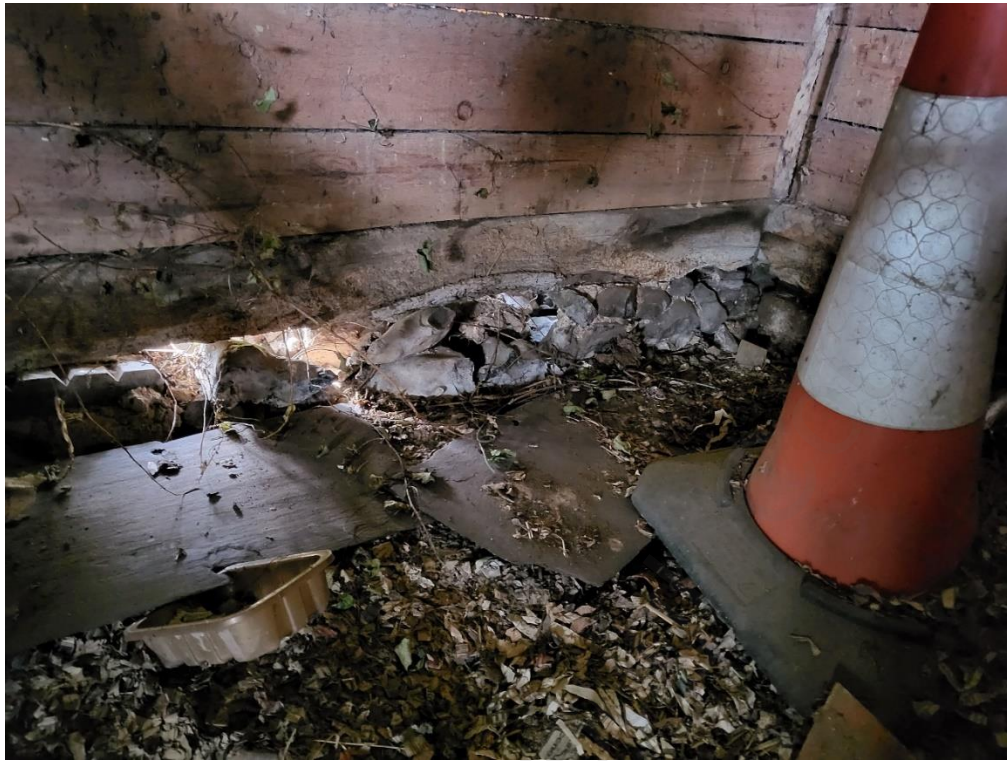
**Photograph 8 - Loose and missing plinth to east wall**

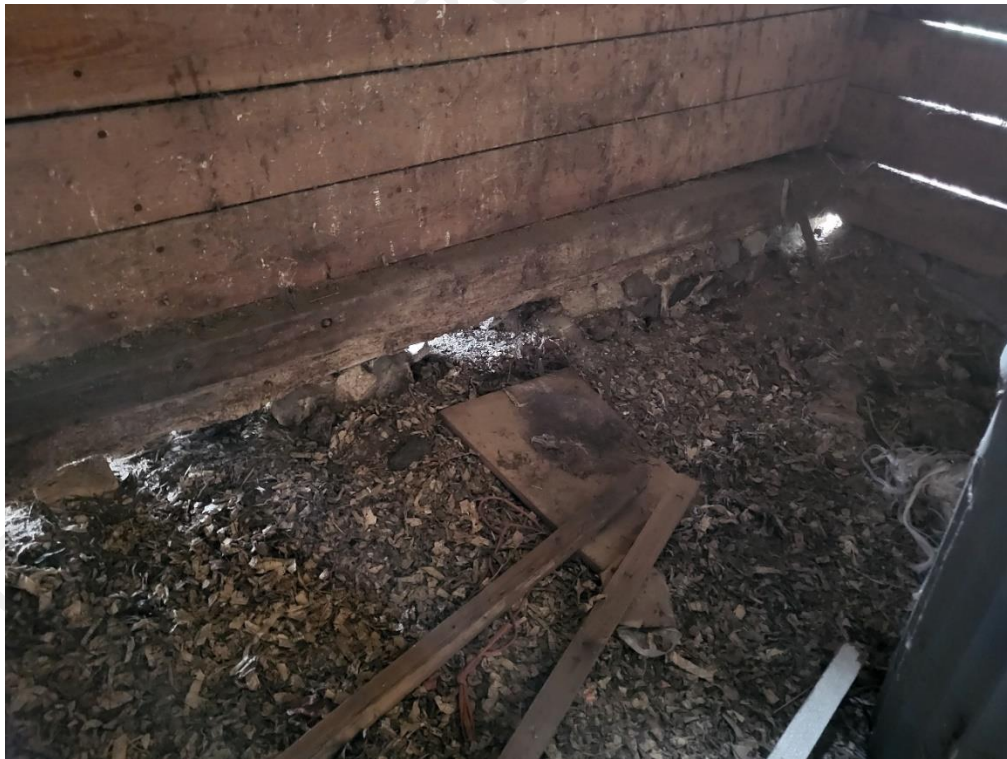
**Photograph 9 - Loose and missing plinth to north sole plate**

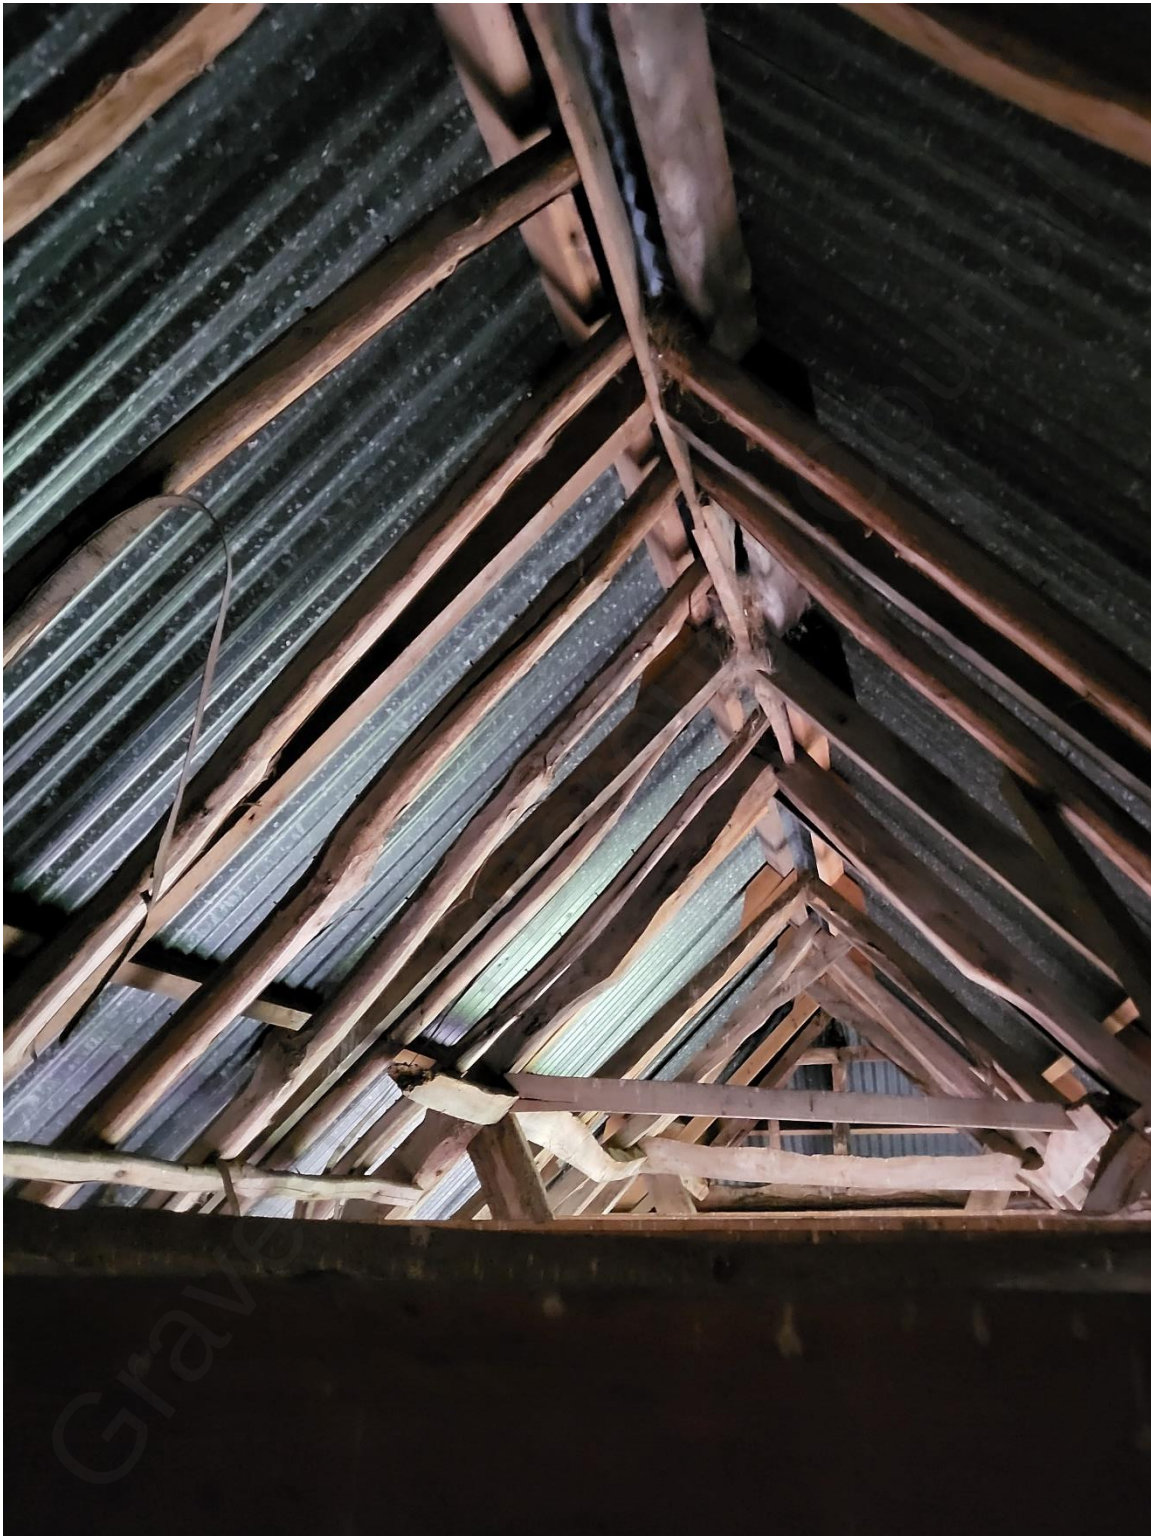
In common with early timber structures, there originally were no ridge-boards, the rafters being halved at the ridge. Previous historic damage has caused some existing rafters to skew or separate, and a ridge board can be seen in places to provide alignment for the modern secondary timber frame above (photograph 10).

**Photograph 10 - Ridgeboard insert to roof and new rafters**

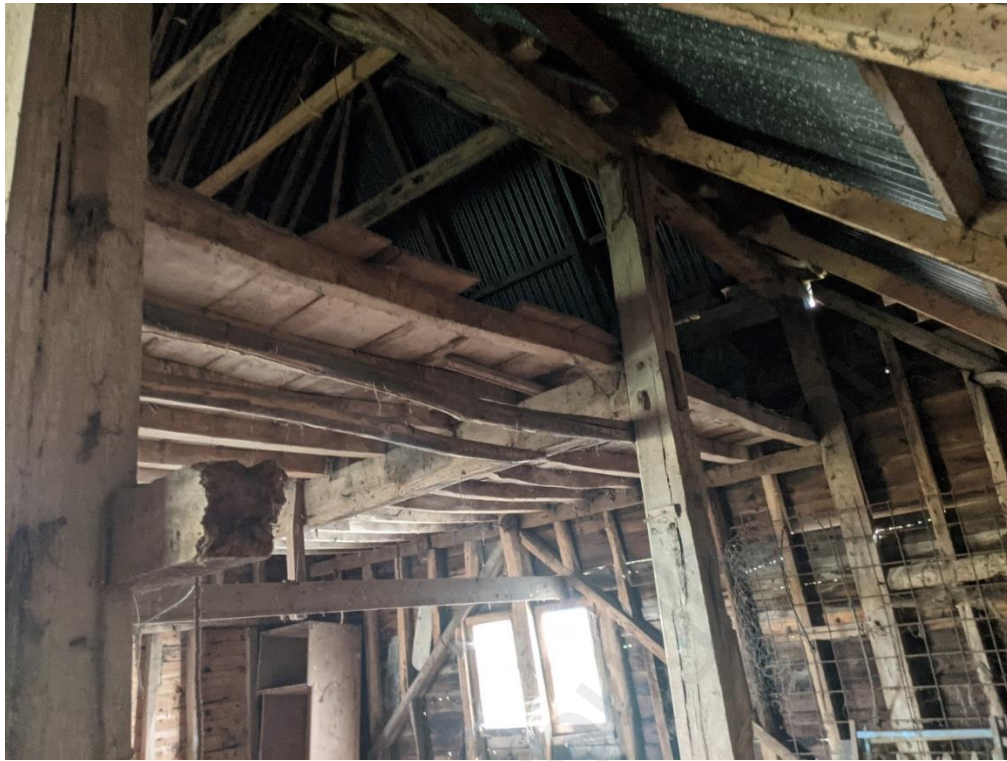
**Photograph 11 - Shallow floor joists to mezzanine**

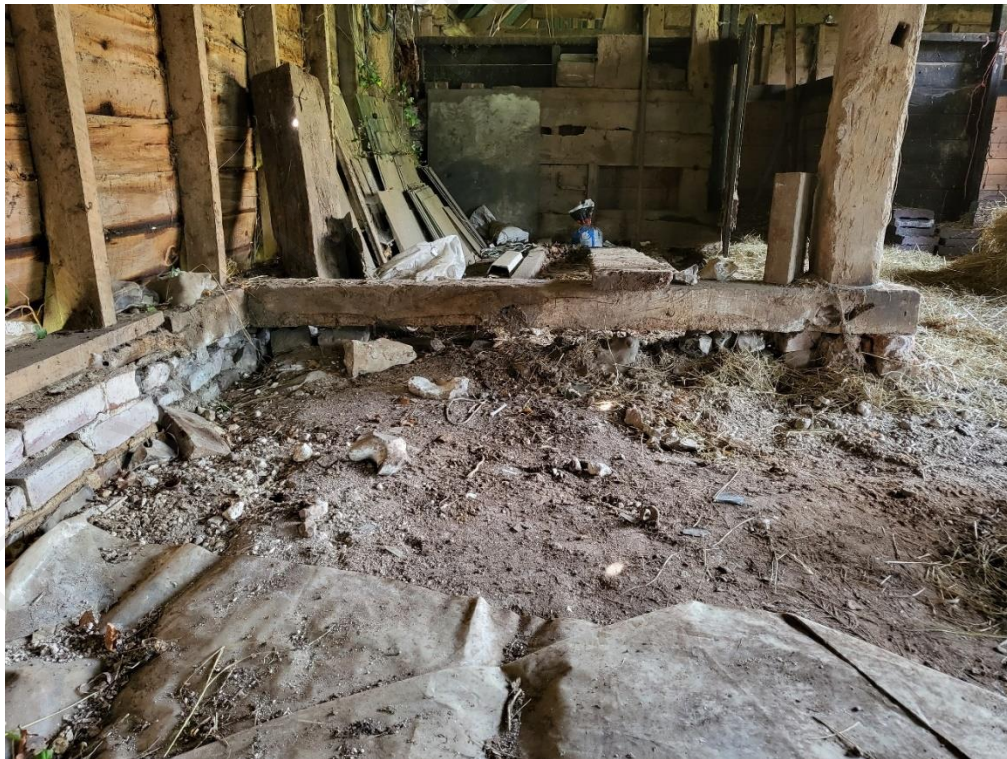
The earlier brick plinths below the internal posts are in relatively poor condition. The lime mortar has generally been eroded and some half-bricks lost. Most require repair and repointing (photograph 12).

**Photograph 12 - Internal plinth support inner post**

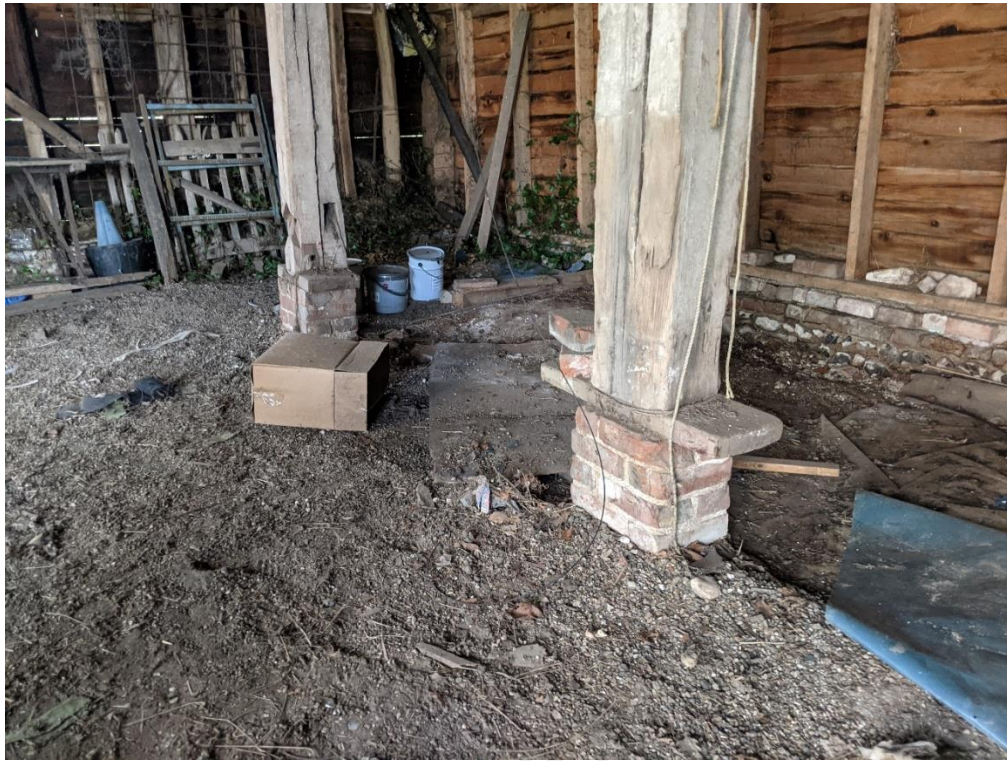
The modern internal brick plinths below the internal posts to the mezzanine are in reasonable condition (photograph 13).

**Photograph 13 - Internal brick plinths**

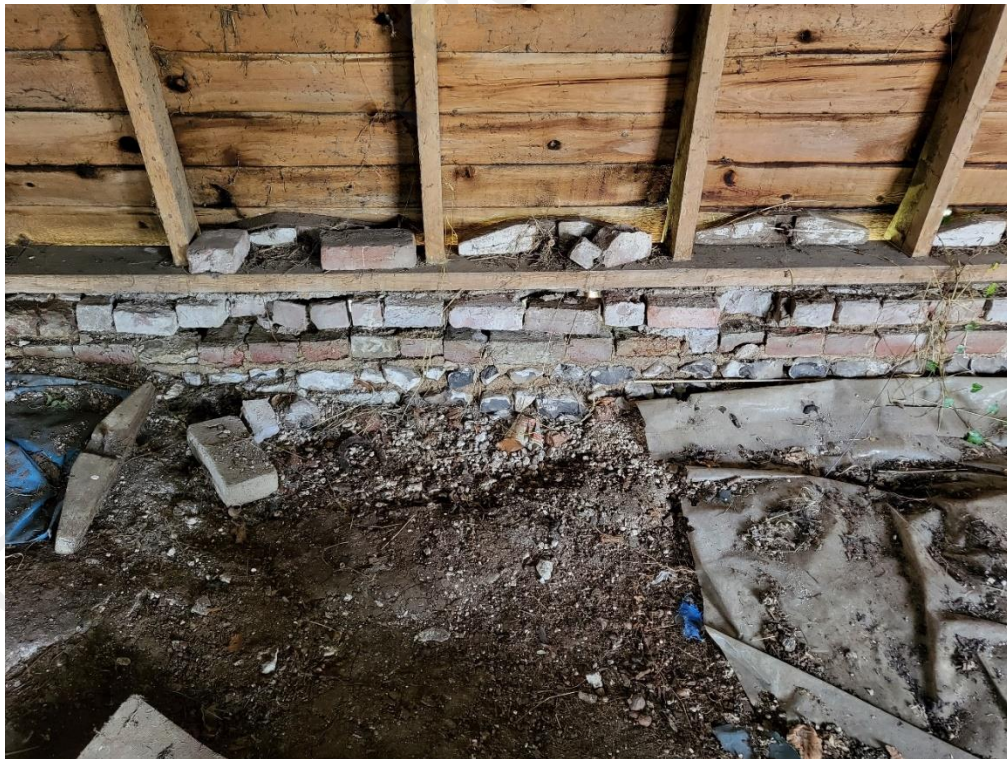
The brick plinth beneath the walls appears in generally poor condition, (with the exception of the east elevation), with most walls having their lime mortar eroded away, loosening the upper brick courses (photograph 14). The southern plinth has a noticeable outward lean, possibly through the failing of the central post along with shallow foundations. From trial pits excavated, nearly all plinths have very shallow footings, generally 400mm below ground level, with no founding width wider than the 225mm thickness of wall. Plinths to the northern walls (internal and external) are almost non-existent, with only small retained sections directly beneath primary posts.

**Photograph 14 - External plinth to west wall**

The replacement of the external brick plinth in short sections, together with insertion of a DPC, would help ensure longevity of the structure.

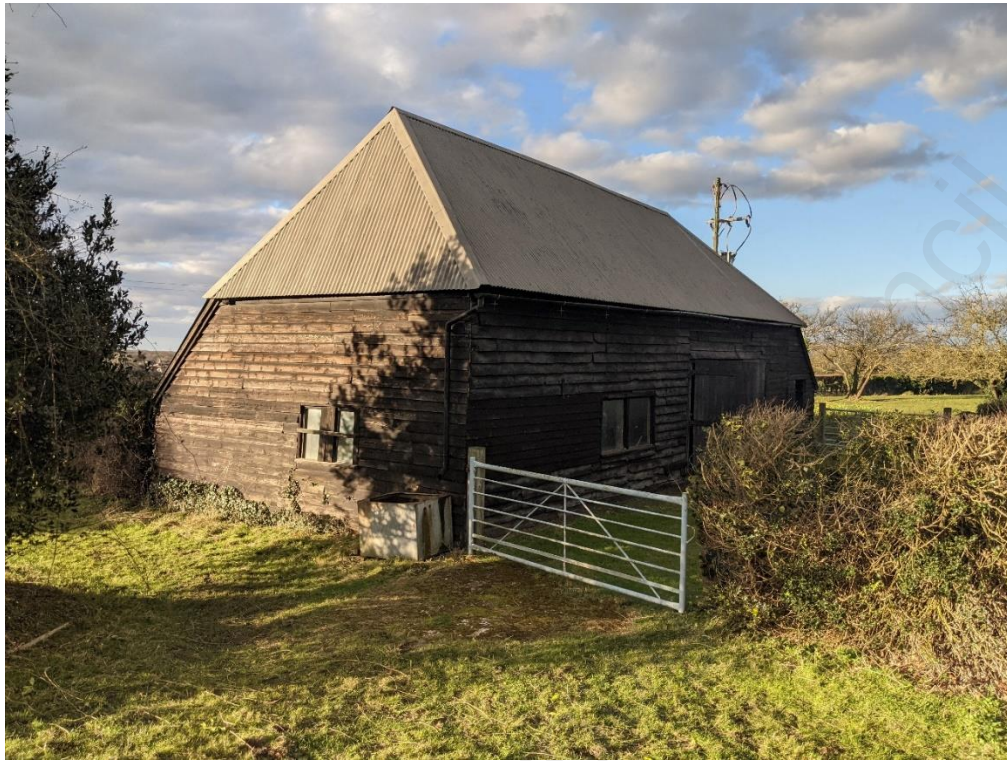
The barn currently has a modern profiled cladding sheet fixed to the roof, supported from a regular grid of modern timber rafters and cross purlins. The load from this sheeting is comparative to light tiling and currently does not cause a structural concern. (Photograph 15).

**Photograph 15 - External roof cladding to barn**

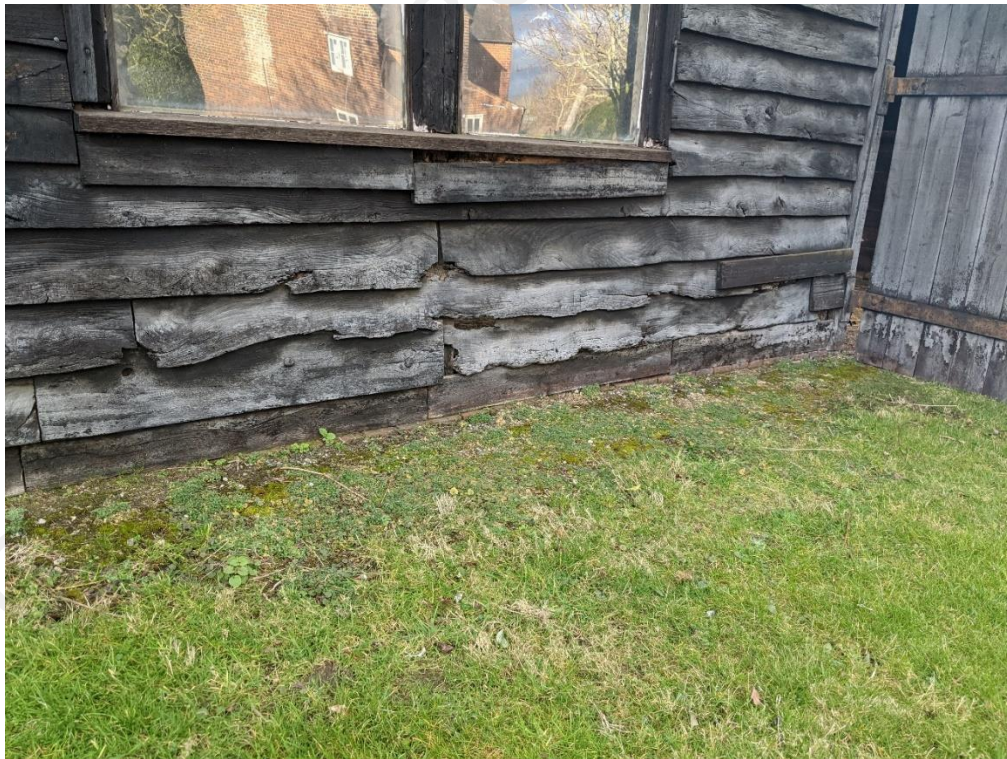
**Photograph 16 - Weather boarding to east elevation**

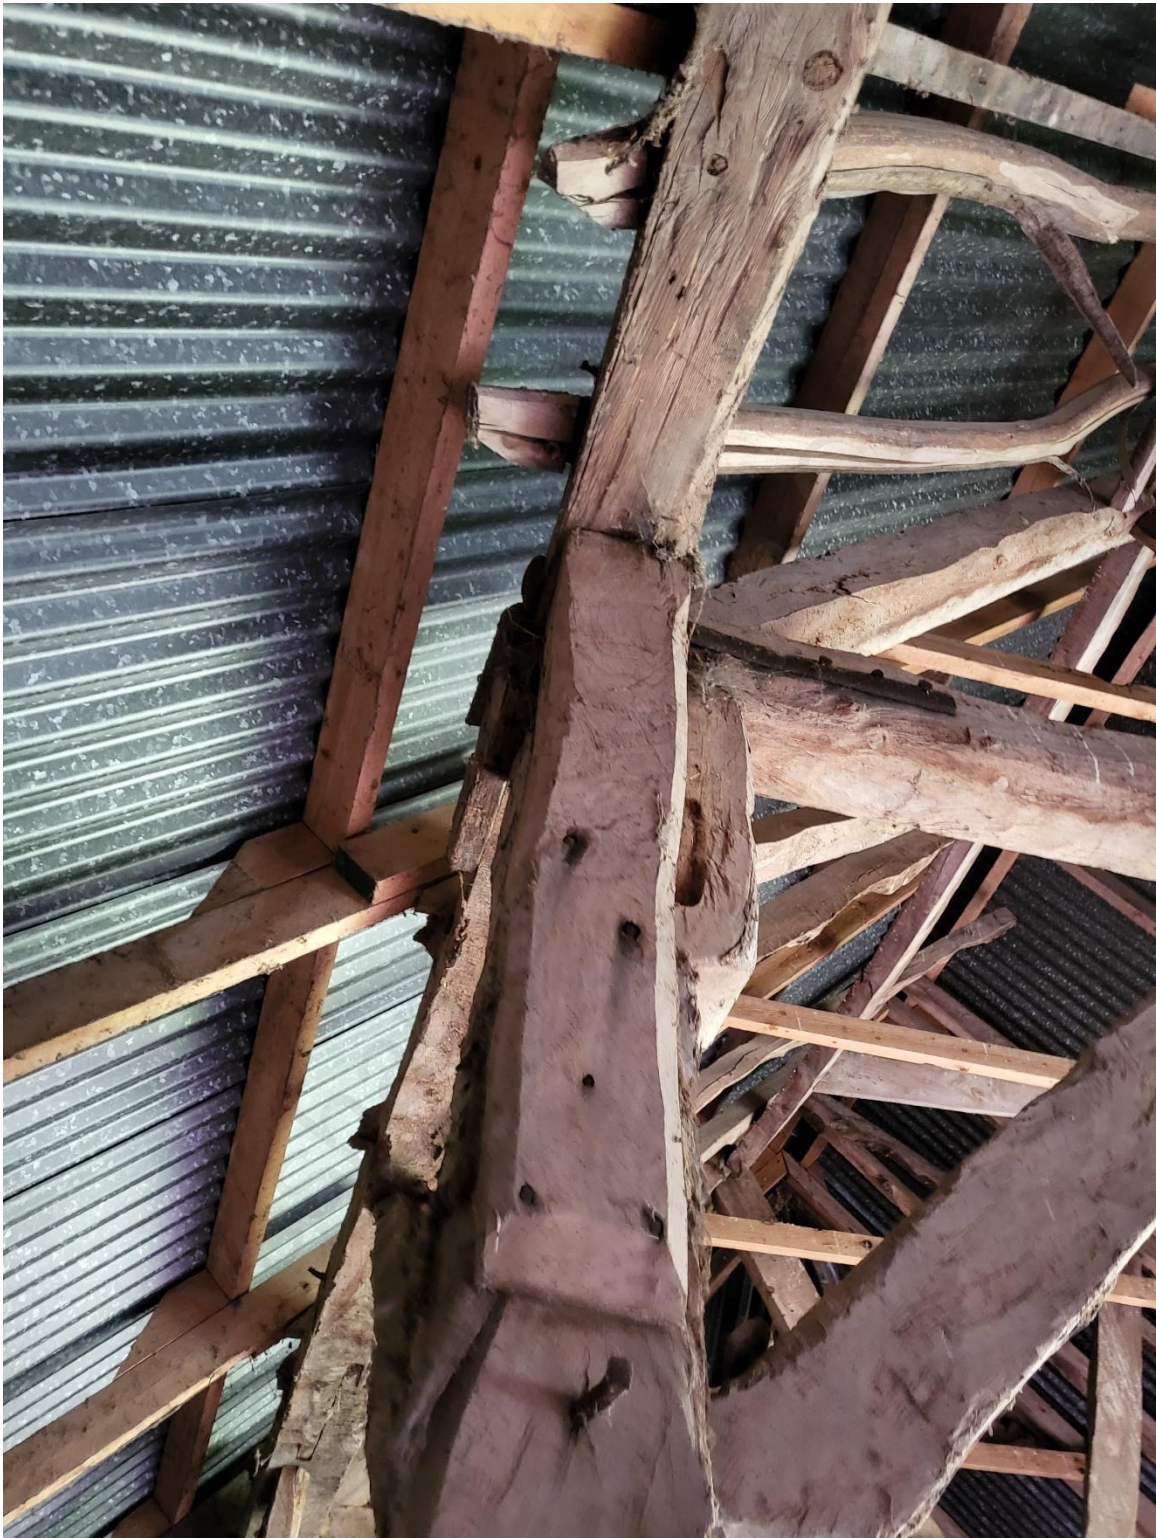
**Photograph 20 - Strapping around eaves frame - grid 4**

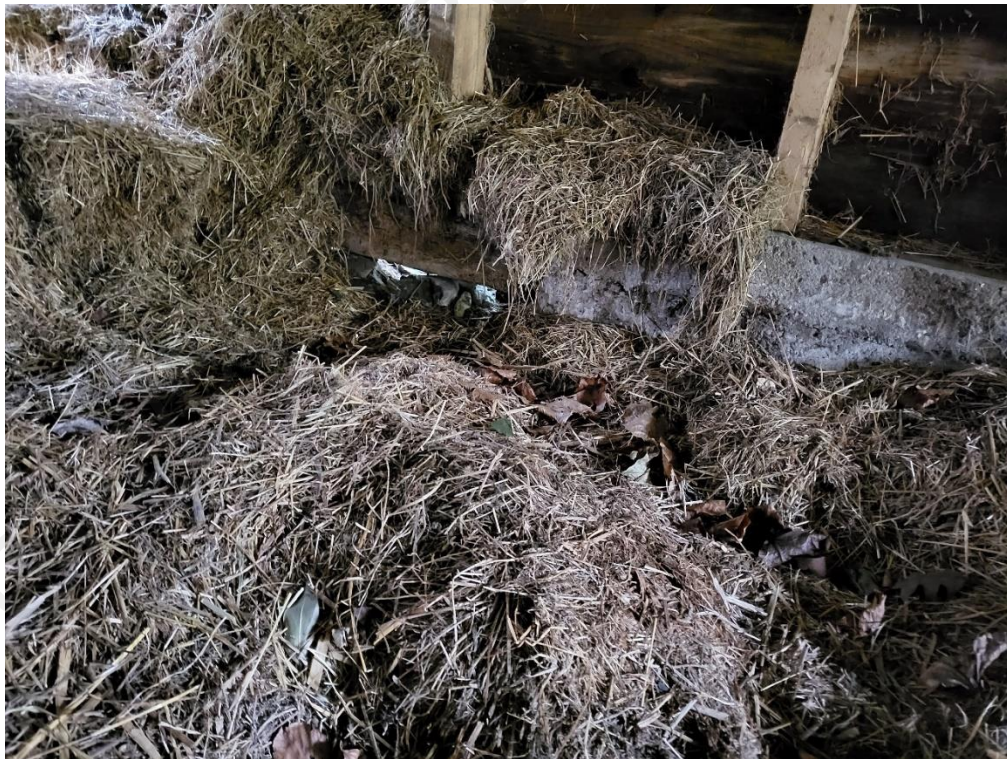
**Photograph 22 - Concrete edging to sole plate in north stable**

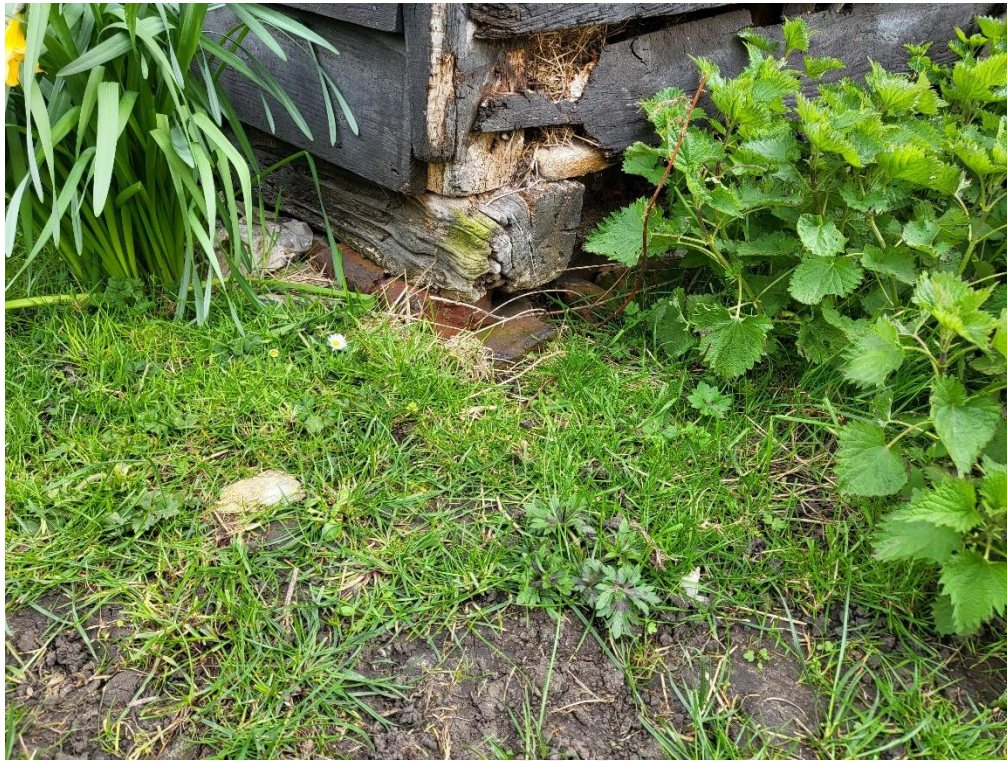
**Photograph 23 - Sole plate deterioration in north west corner**
