**STRUCTURAL APPRAISAL OF REDUNDANT BARN**

**PREISTHOOD**

**PROJECT No. 4614**

**DATE: August 2021**

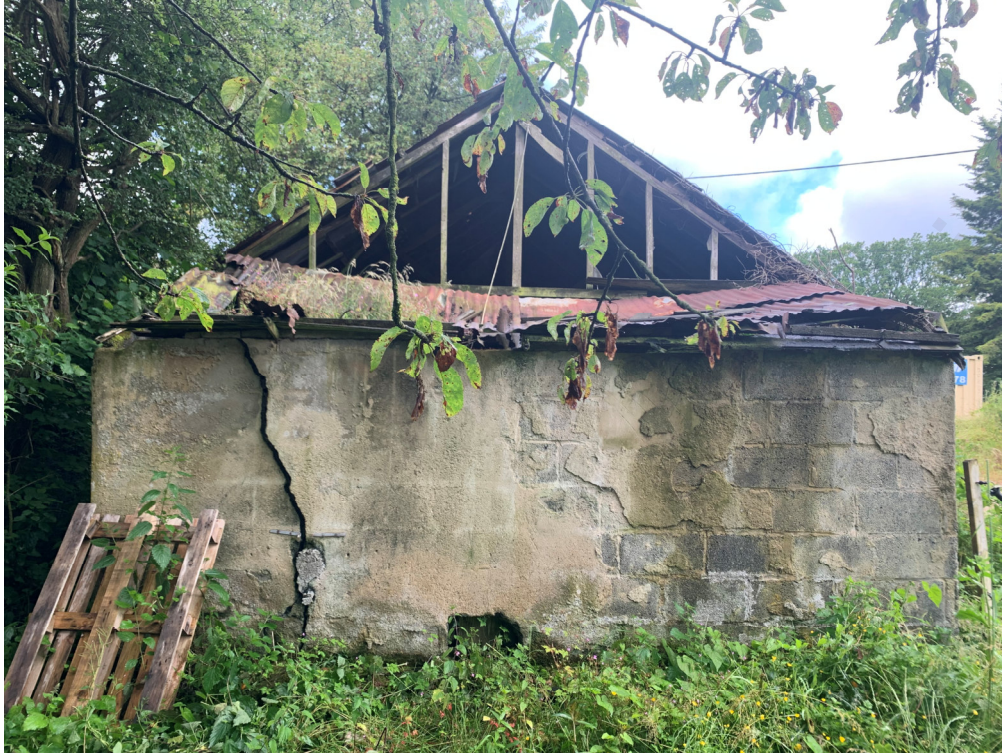
The existing roof is clad in a profiled roof sheet. The roof appears to have suffered with water damage and the wall bearer on gridline 2 has failed. Subsequently the rafters have dropped / failed (Plate 1). The proposal is to remove the roof cladding and replaced with a tiled roof. The current rafters will need to be upgraded to suit the new roof structure and the wall bearer on gridline 2 will need to be replaced and the rafters re-supported.

The wall to gridline 1 is a single skin block wall with historic render evident in places and a major vertical crack was evident in the blockwork wall. This has a horizontal step of approximately 25mm (plate 1). The blockwork wall will need to be replaced / repaired. The footing for this wall will need to be investigated further to determine the repair works required.

Plate 1 – Section A Wall to Gridline 1

- i. Roof cladding to be removed and replaced with a tiled roof. Strengthening works will be required to the existing roof structure.
- ii. Wall to gridline 1 will need to be replaced / repaired.
- iii. Trial holes will be required to determine the damage to the footings adjacent the damaged wall on gridline 1.
- iv. Subject to levels, it is assumed that the existing slab will be retained (subject to trial cores), with insulation, DPM and screed added on top.
- v. Carry out an asbestos survey prior to commencement of any works, including demolition works.
- vi. Provide new rainwater and foul water discharge systems.

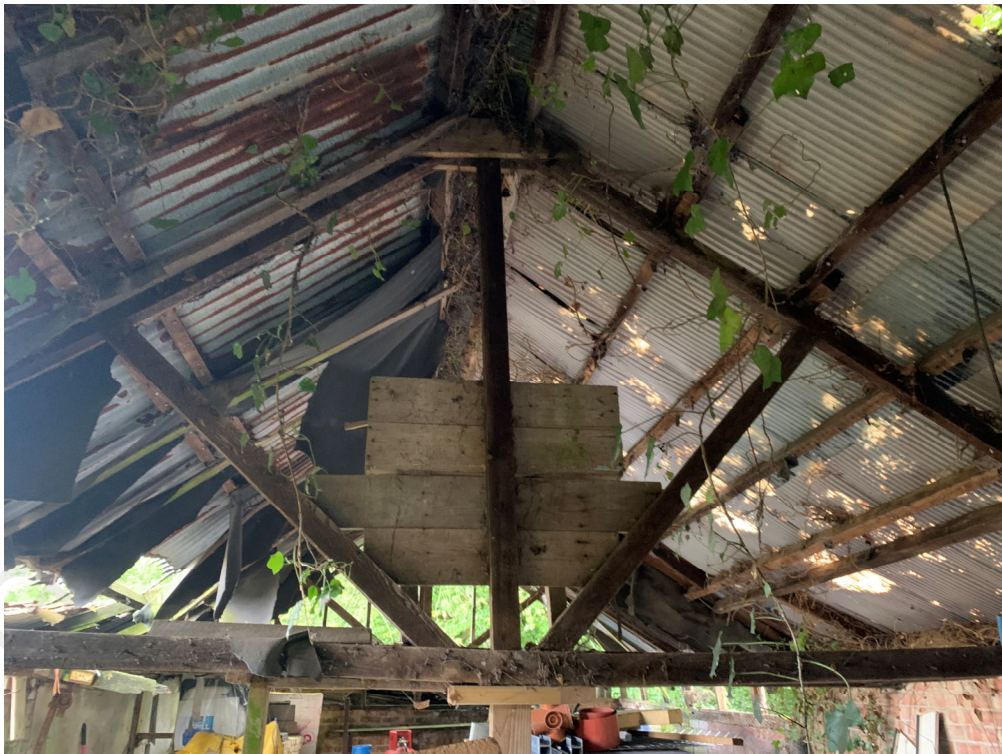
The existing roof is clad in a profiled roof sheet, this is damaged and has extensive foliage coverage. The cladding is supported on timber purlins at approximately 600mm centres. The purlins span between 5 timber trusses at approximately 2.2m centres (plate 2). The truss on gridline 4 has suffered severe damage and will need to be replaced (plate 3). The proposal is to remove the roof cladding and replaced with a profiled steel cladding system. The existing structure will need to be reviewed for the new roof loadings. The purlins and trusses will need to be analysed for the loadings and strengthened if necessary.

Plate 2 – Section B Roof construction

- i. Roof cladding to be removed and replaced with a tiled roof.
- ii. Strengthening works will be required to the existing roof structure. In the order of strengthen purlins, strengthen timber trusses / replace damaged truss.

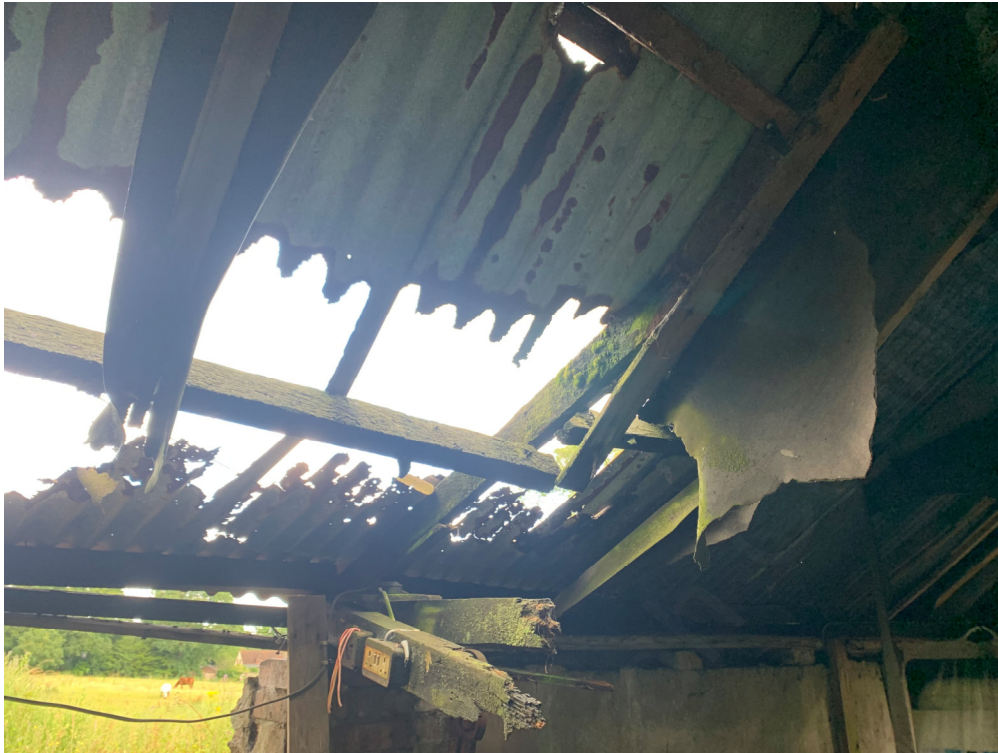
Plate 3 – Section B Truss damage on Gridline 4

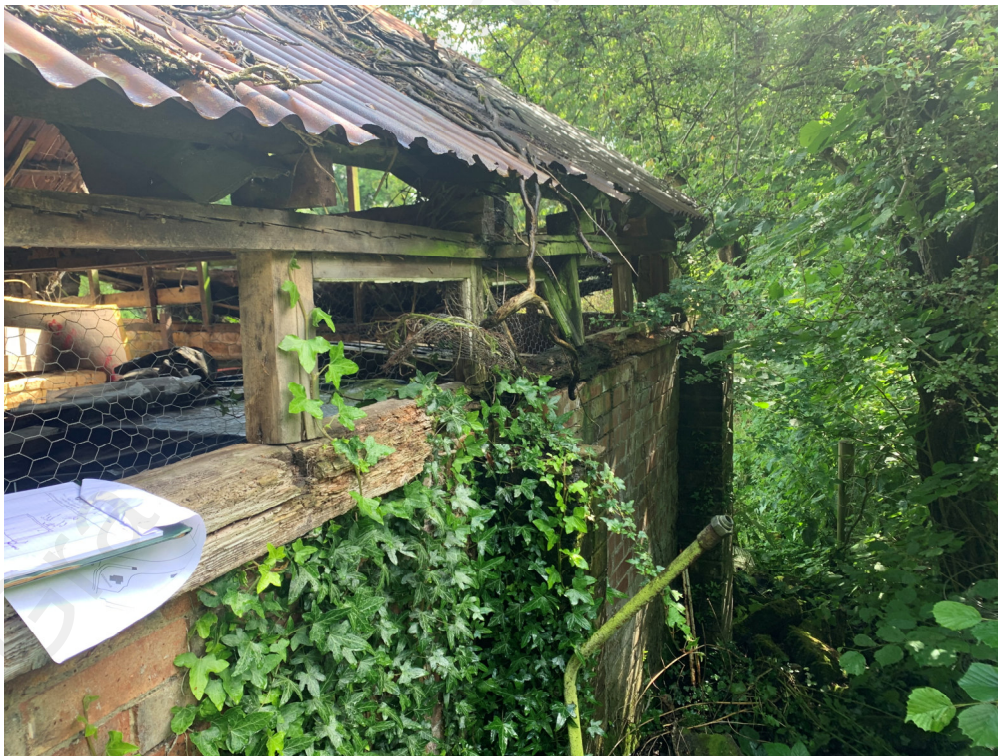
The wall to gridline A is of single brick construction with brick piers at approximately 2.2m centres, between gridlines 2 – 4 the wall is 450mm below wallplate level. Above this level are timber framed windows to the wallplate level. The wallplate and cill plate are showing signs of rot and will need to be repaired / replaced in places (plate 4). Minor cracking was noted between grids 6 & 7. This would benefit from tying back together with stainless steel heli-bars concealed within the bed-joints.

Plate 4 – Section B Gridline A Wallplate

- vi. Minor cracking was noted on gridline A between grids 6 & 7. This would benefit from tying back together with stainless steel heli-bars concealed within the bed-joints.

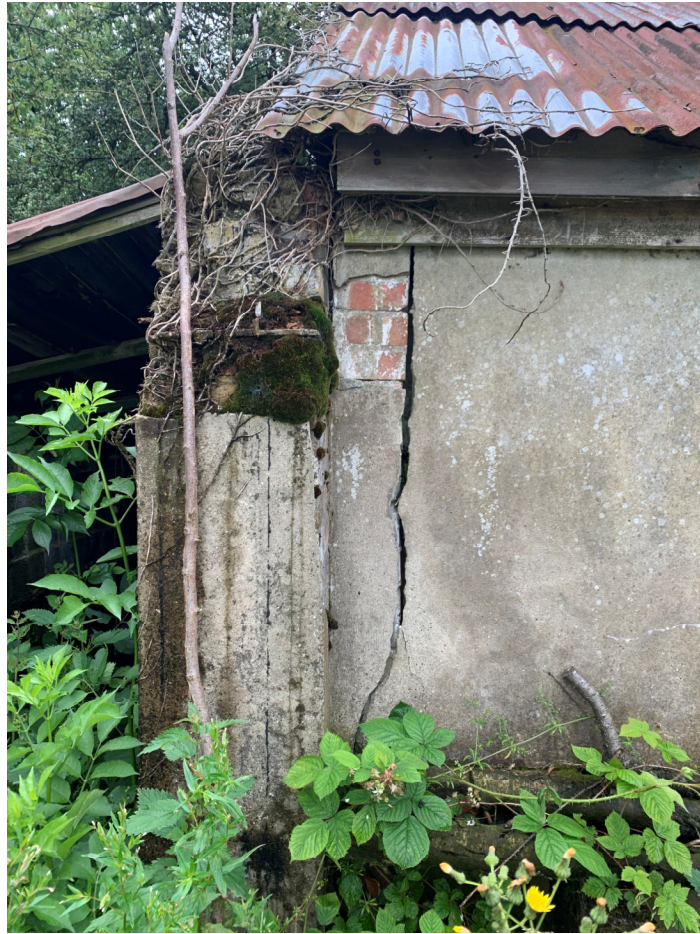
The wall to gridline C is of single brick construction with brick piers at approximately 2.2m centres, this wall is rendered externally. Between gridlines 2 – 4 & 5 – 7 previous openings appear to have been infilled with blockwork. The wall between gridlines 5 – 7 is 450mm below wallplate level, above this level are timber framed windows to the wallplate level. A vertical crack is located adjacent to grid reference C2 this will need to be repaired or rebuilt (plate 5). The footing in this area will need to be investigated to determine the repair works required.

Plate 5 – Section B Grid Reference C2 cracking

- vii. Wall to grid reference C2 to be repaired / rebuilt.
- viii. Trial holes will be required to determine the damage to the footings adjacent the damaged wall.

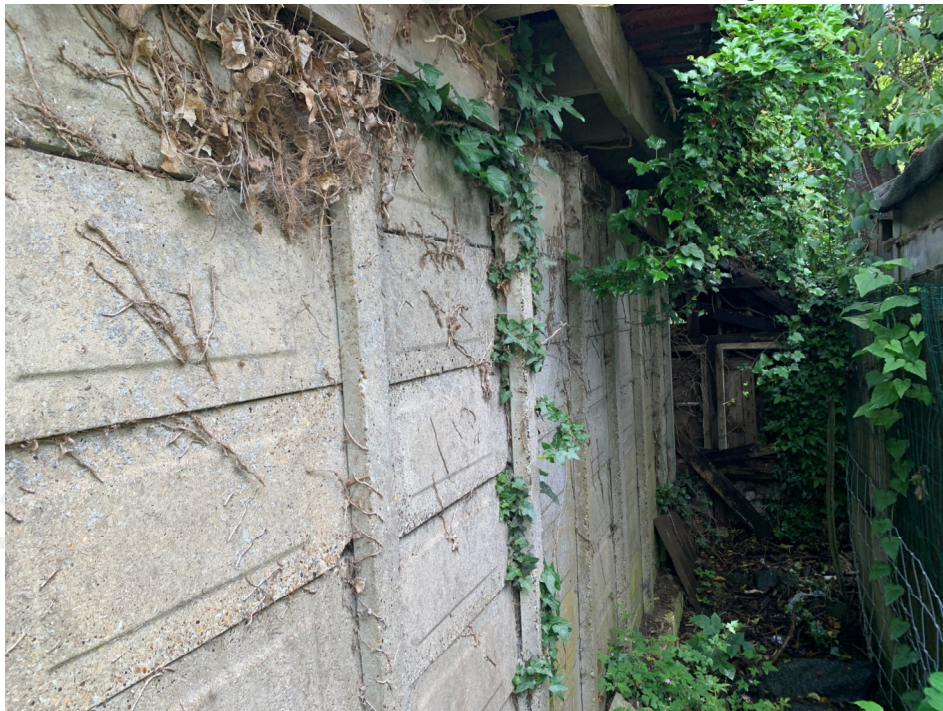
The walls on gridlines B and C are constructed from concrete posts at 700mm centres with concrete panels which are internally rendered (plate 6).

Plate 6 – Section C concrete panels
