## Arboricultural Report

### Tree Condition Assessment

**Pond Farm Cottage  
Harvel Street  
Harvel  
Kent  
DA13 0DE**

Ref: SA/1975/22

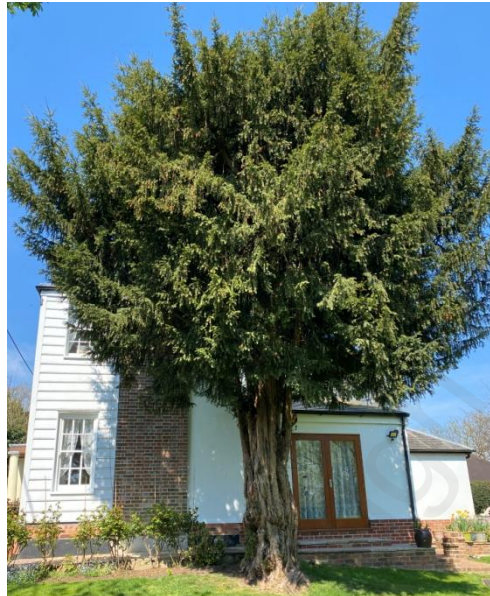
- 4.1 A single-stemmed early mature tree located 2.4m from the south-eastern flank wall of the house, adjacent to the point at which the 2015 side extension joins the main house.

Photo 1: General view of tree.

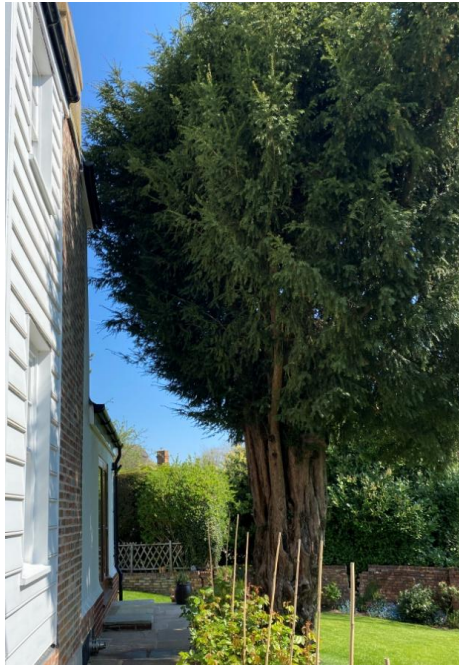
- 4.6 Regrowth has subsequently developed from the past reduction points with the north-western canopy now in contact with the roof of the house. It is recommended that a notification to the Local Authority be submitted to prune the canopy to maintain clearance from the building, as the action of branch movement presents a risk to fabric of the building (see Photo 2 and 3).

Photo 2: Tree adj. to house from south.

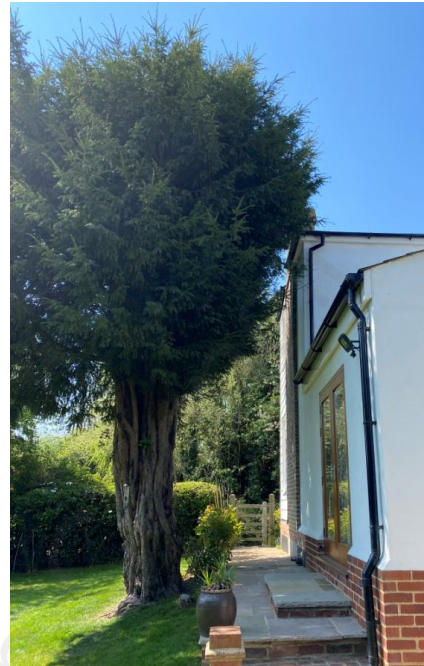
Photo 3: Tree adj. to house from north.

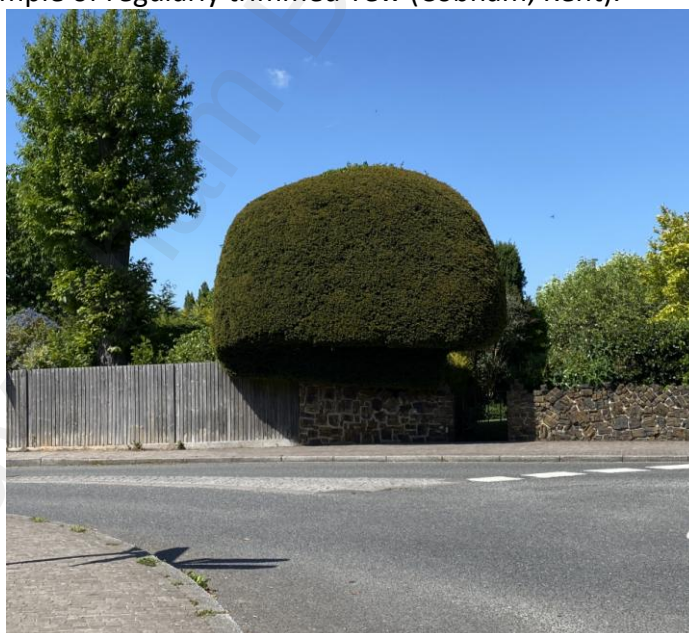
Photo 4: Example of regularly trimmed Yew (Cobham, Kent).

**Option 2:** Carry out the work under option 1 and also reduce the remainder of the canopy, then periodically manage the regrowth (perhaps every 4-6 years), to contain the ultimate height and spread of the tree. Alternatively, the management of the regrowth could be carried out more regularly (every 2-3 years), and the tree maintained as a formal trimmed feature, which would be in keeping with the style of the house and grounds, but would of course result in higher maintenance costs (see Photo 4).
