THE OLD FORGE

WROTHAM ROAD.  
MEOPHAM,  
GRAVESEND,  
KENT  
DA13 0JE

REPAIR  
METHODOLOGY  
STATEMENT

APRIL 2024

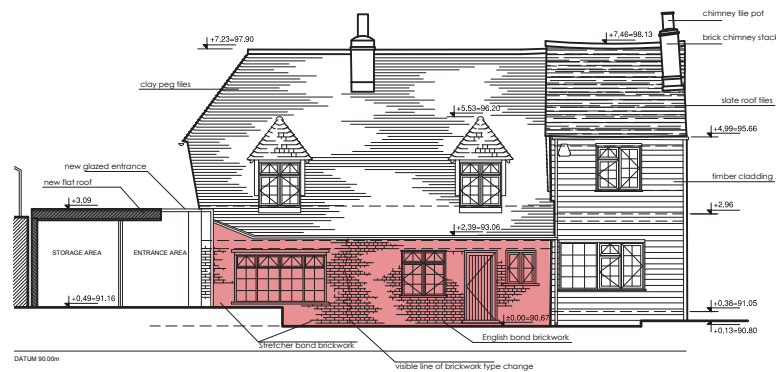
Fig. 8 - Proposed North East Elevation.

The brick walls on the existing front (North East) elevation are of traditional solid wall construction, some bricks have paint residue over the exterior surface. The mortar appears to be cementitious, which forces the moisture to travel through the brickworks rather than the mortar which would typically be the sacrificial element. This causes the bricks to deteriorate.

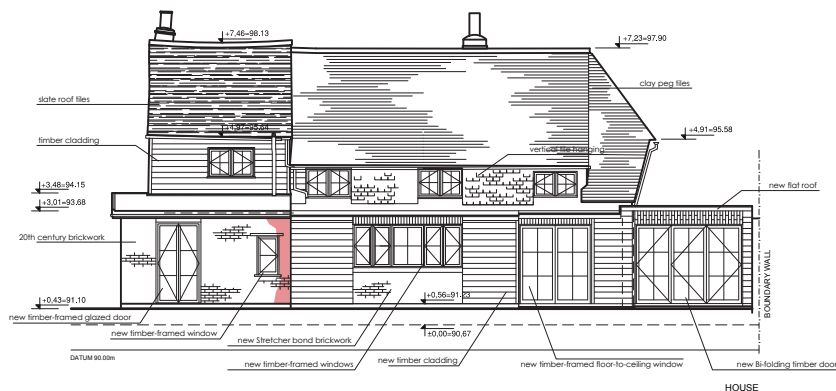
Fig. 9 - Proposed South West Elevation.

The bricks on the existing rear extension are in good condition generally, apart from the bricks adjacent to the cladded wall on the southwest elevation, which show sign of hygroscopic salts and erosion on some of the brick surface. This could be caused by the deterioration of the junctions between the two flat roofs which allow the ingress of rainwater, and/or the excessive amount of moisture within the solid wall behind the timber cladding transferring the moisture via capillary action. The flat roof has since been repaired/replaced which should be beneficial in protecting the long-term future of the brickwork.

The bottom section of the brick work has also suffered from dampness due to a historically leaking drain pipe, which has since been fixed temporarily. The drain pipe is to be removed and new soil vent pipe is to be installed to serve the ground floor shower room and bathroom above.

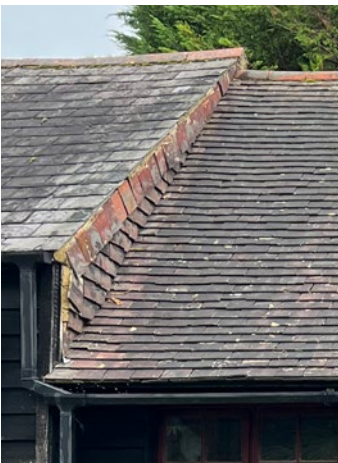
Fig. 10 - Photo of the existing Old Forge.

The vertical tile hanging is in overall good condition. The existing timber battens supporting the vertical tile hanging are to be inspected for signs of rot and decay because of moisture attacks or corroding nails.

In some locations where the cementitious mortar bedding starts to deteriorate and enable water penetration, the cement mortar should be raked out carefully and replaced by lime mortar.

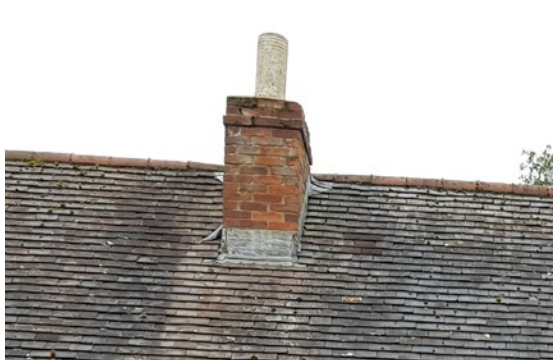
Fig. 12 - Chimney A.

Chimney A is located centrally within the plan of the property. As the photo shows there are some areas which are in need of re-pointing, from ground-level it is difficult to highlight the condition of the lead flashings and mortar may have been repointed in cement historically. No capping is present at the minute which leads to moisture ingress and potential for insect and water ingress. A ventilated cap would be of particular benefit to aid this. The condition of flaunching would be checked and repaired to match when suitable safe access is provided.

The existing brickwork needs repointing in the same method that has been outlined for the external brick walls. Some of the deteriorated flaunching need replacing to shed the rainwater as originally intended. Carefully remove the loose parts of the flaunching and brush away any dirt and loose materials. If the cement flaunching is too hard to remove, leave it as it is to avoid damaging the brickworks. Apply lime mortar carefully using a pointing trowel, scrape away any excess mortar and follow the profile of the existing flaunching. When the mortar is leather hard, smooth it over with a wood float.

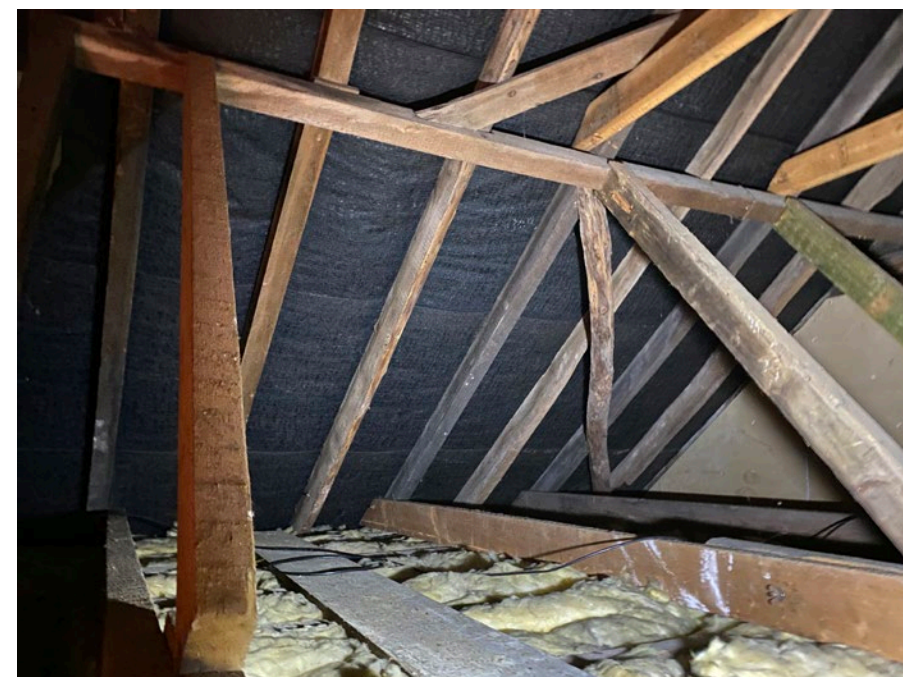
Fig. 14 - Photo of the loft space above the proposed bedroom 1.

Under the main clay tile roof, the loft space is being used as a storage and place to accommodate the water tanks/cylinders. The insulation is installed at the rafter level.

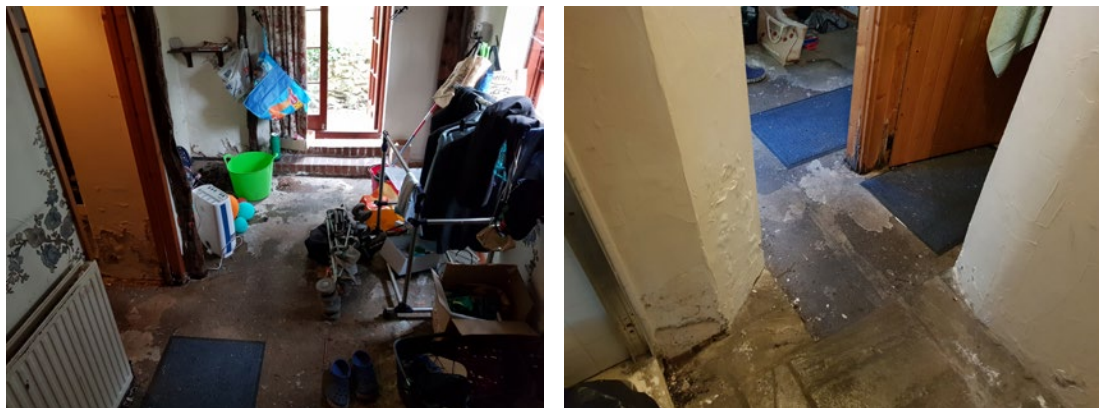
Fig. 16 - Photos of the existing ground floor.

The existing ground floor to the proposed Utility area is of concrete construction, which shows signs of dampness and has damaged the bottom of the walls in the area.

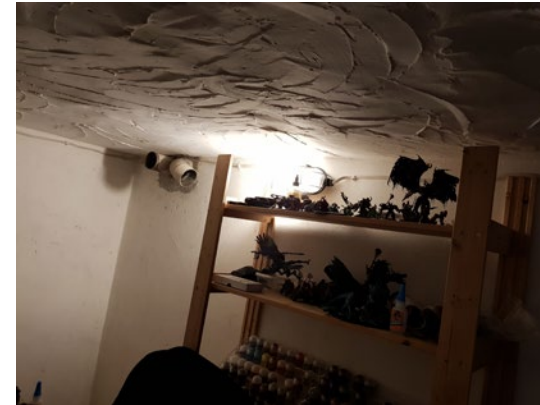
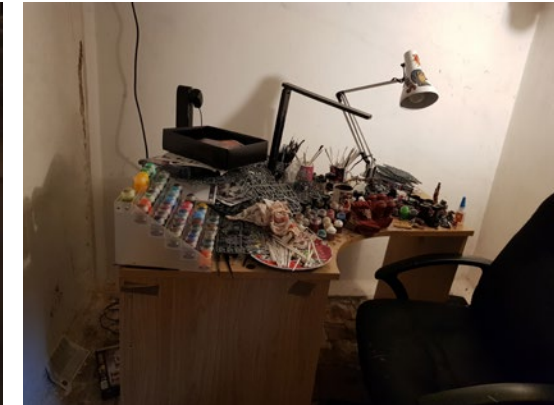
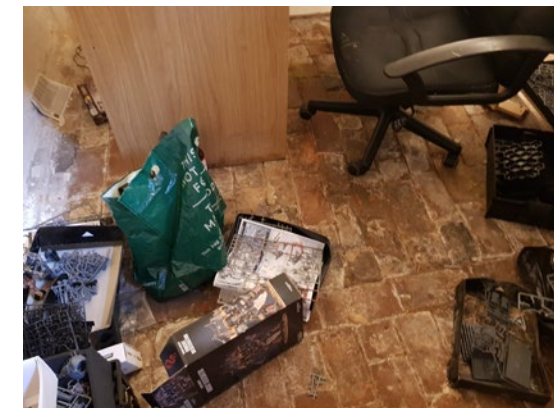
Fig. 17 - Photos of the existing cellar.

There is existing cement plaster and other modern finishes which affect the long-term protection of the future. As mentioned elsewhere cement-based plaster restricts the hygroscopic movement of moisture and as such can lead to damp and other deteriorative effects of timber etc.

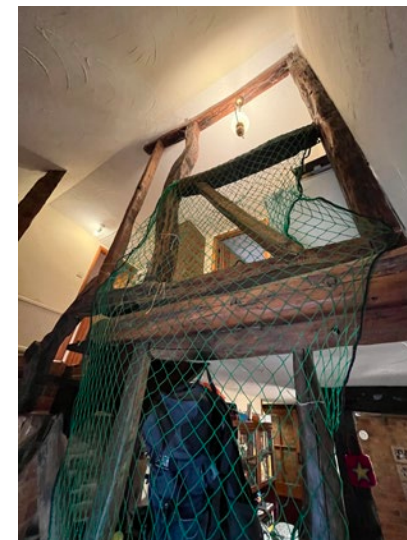
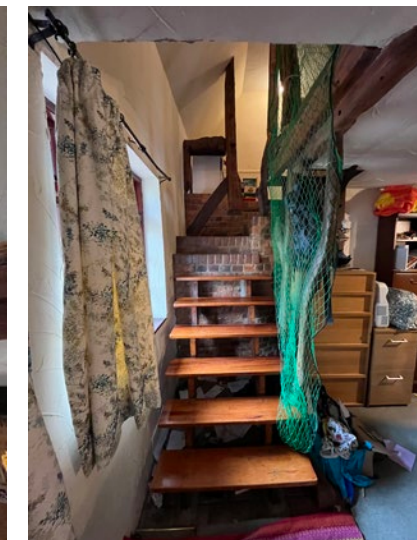
Fig. 18 - Photos of the existing stairs and landings.

The existing staircases do not have rigid / safe guarding, which creates hazards for the habitants and visitors. The existing internal steps are also steep with uneven risers and are of modern brick construction presenting a poor/hazardous means of circulation around the building. Young and elderly people are especially vulnerable to the existing arrangement
