# Owletts Mansion: Heritage Statement (including Method Statement)

PROPOSED LISTED BUILDING CONSENT

FOR CONSERVATION REPAIRS TO OWLETTS MANSION AT THE STREET, COBHAM, KENT

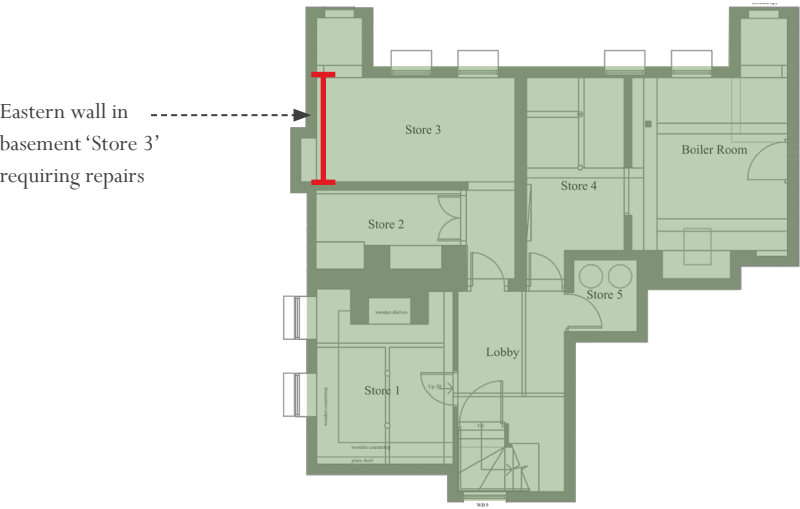
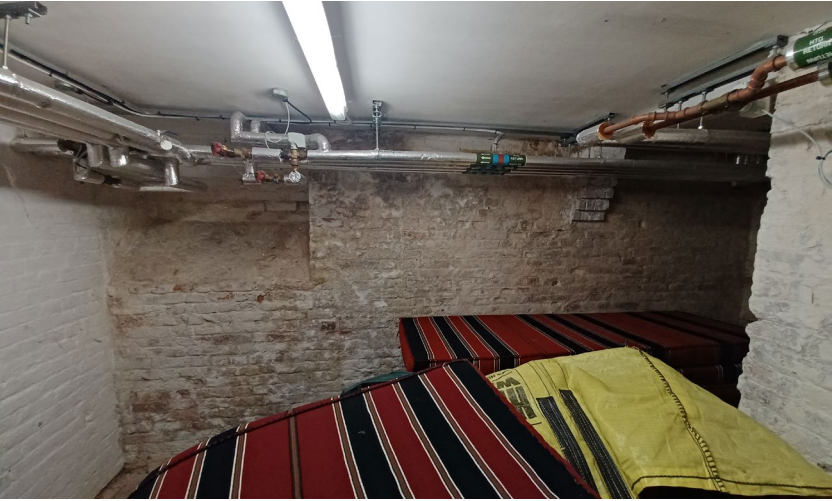
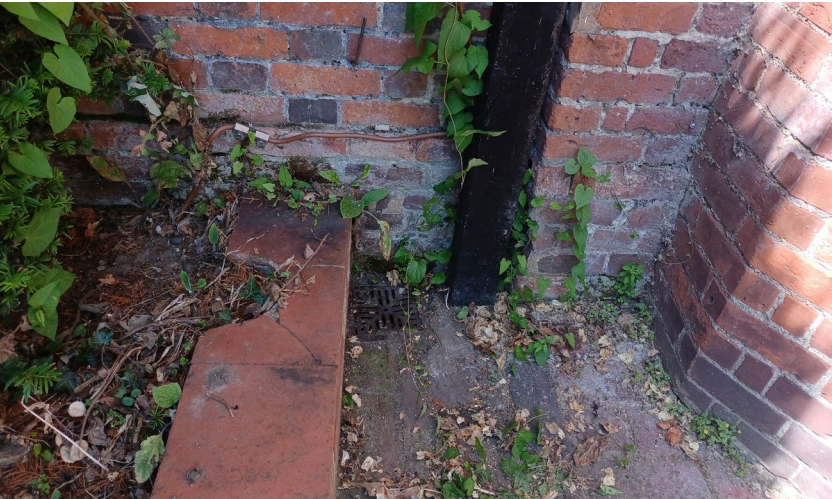
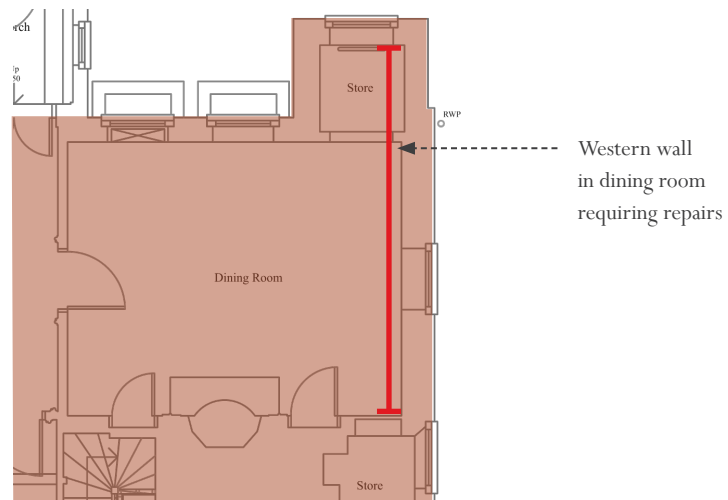
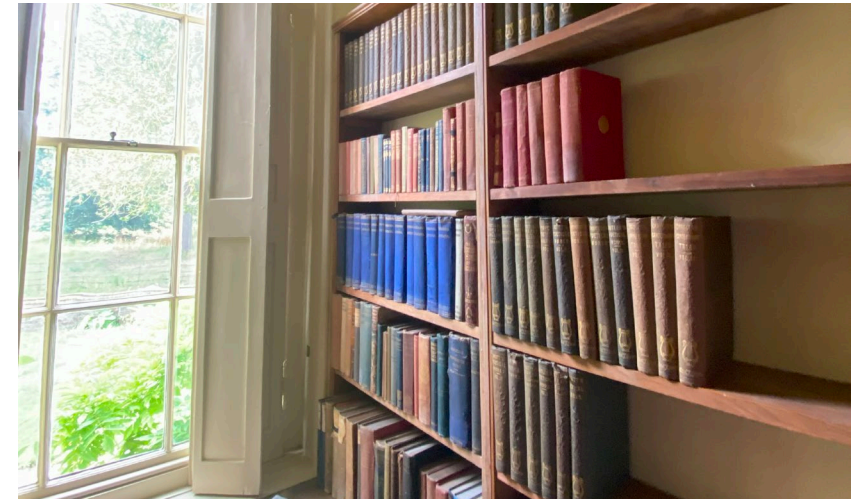
## Basement

Rainwater is flowing down the eastern wall in ‘Store 3’ in bad weather. There is significant wall dampness and water ingress. The possible causes could be lack of ventilation, the gulley and downpipe located on the external wall, the outside pavement gently sloping towards the wall, as well as vegetation and soil directly abutting the external wall.

The proposal would be to create an inner wall, and between the existing and new wall, place a tanking membrane and floor level drainage channel, with a pump system that will extract the water to the external drain.

Use a wire brush to remove all paint and mould growth. Clean the existing wall with a fungicidal wash and leave to dry. Possible removal of a section of the floor to install the drainage and pump.

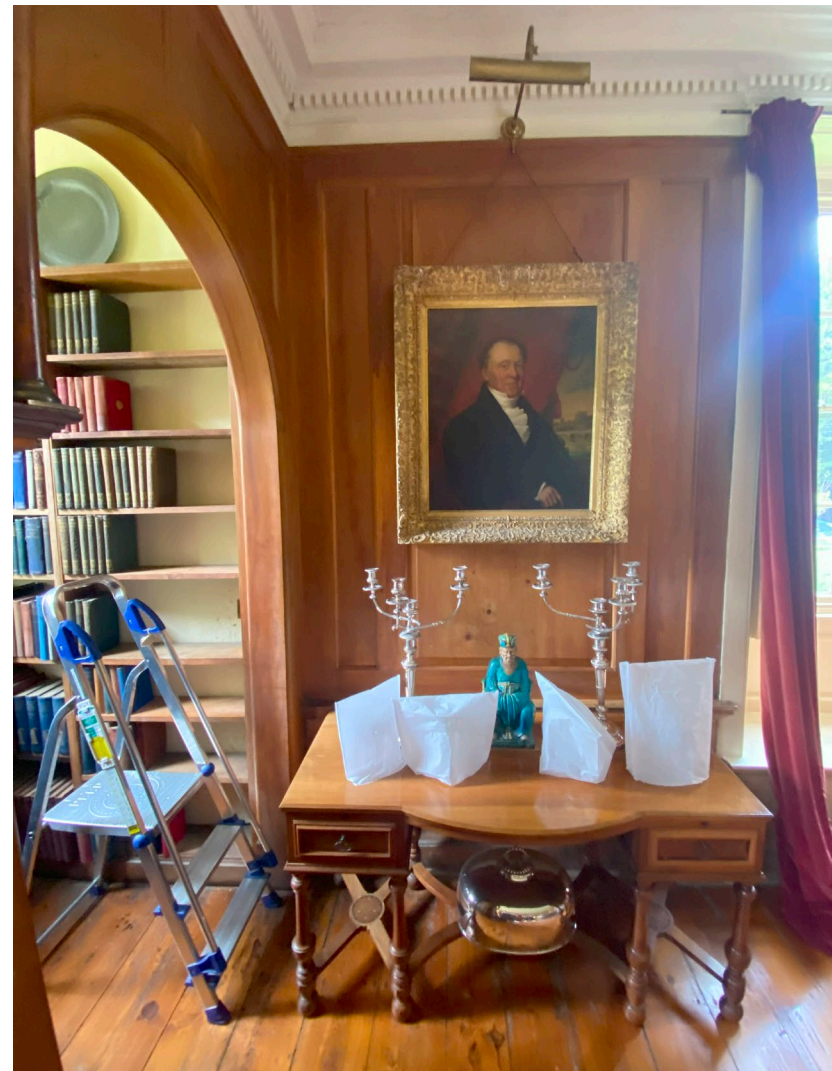
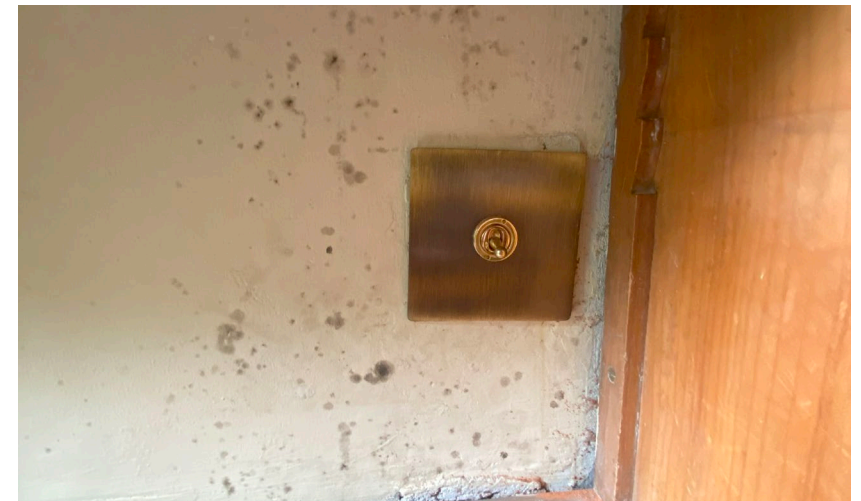
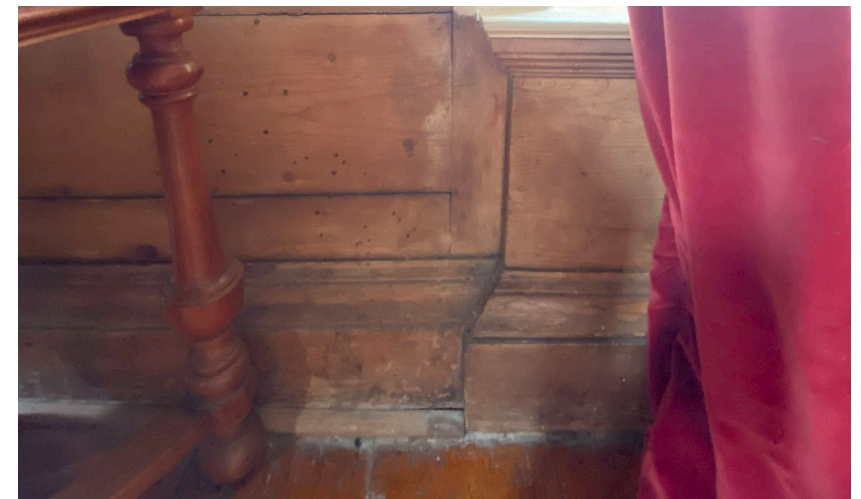
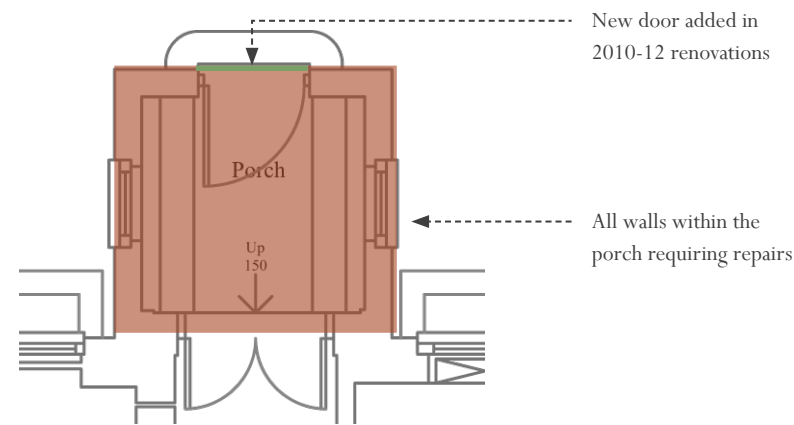
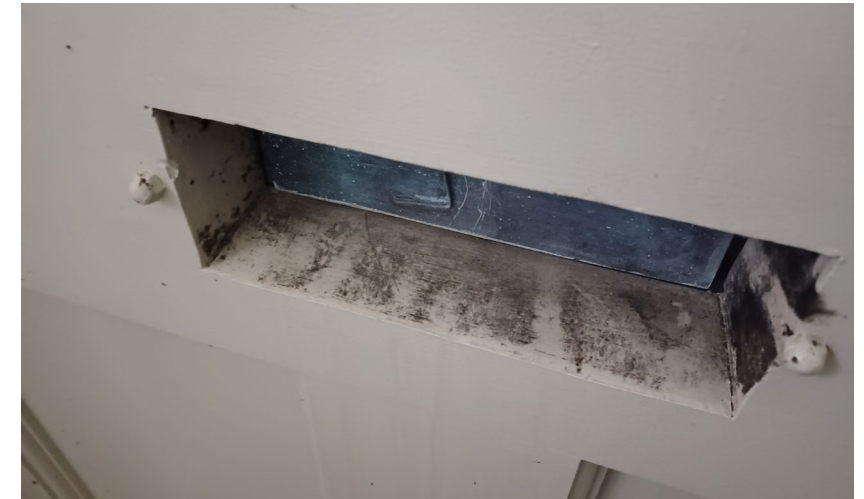
## Dining Room

There is damp ingress on the western wall, an external wall, which has affected some render behind the bookshelf, decorative ceiling and timber decorative panelling.

Consent is sought to remove the panelling and some plaster, investigate, and re-apply. There needs to be a detailed internal wall survey across the entire length of the external facing elevation (internally) of the panelling.

Careful removal of the timber panelling, which includes the tall thin section to the pier, the larger wall panel, dado rail and skirting, collections and paintings to be removed, set aside and stored. The plaster behind is to be investigated, following the removal of a small 150mm<sup>2</sup> section. If the wall is saturated, all the plaster will need to be removed, with a dry out period and followed by a lime plaster, decoration and reinstatement of the timber panelling.

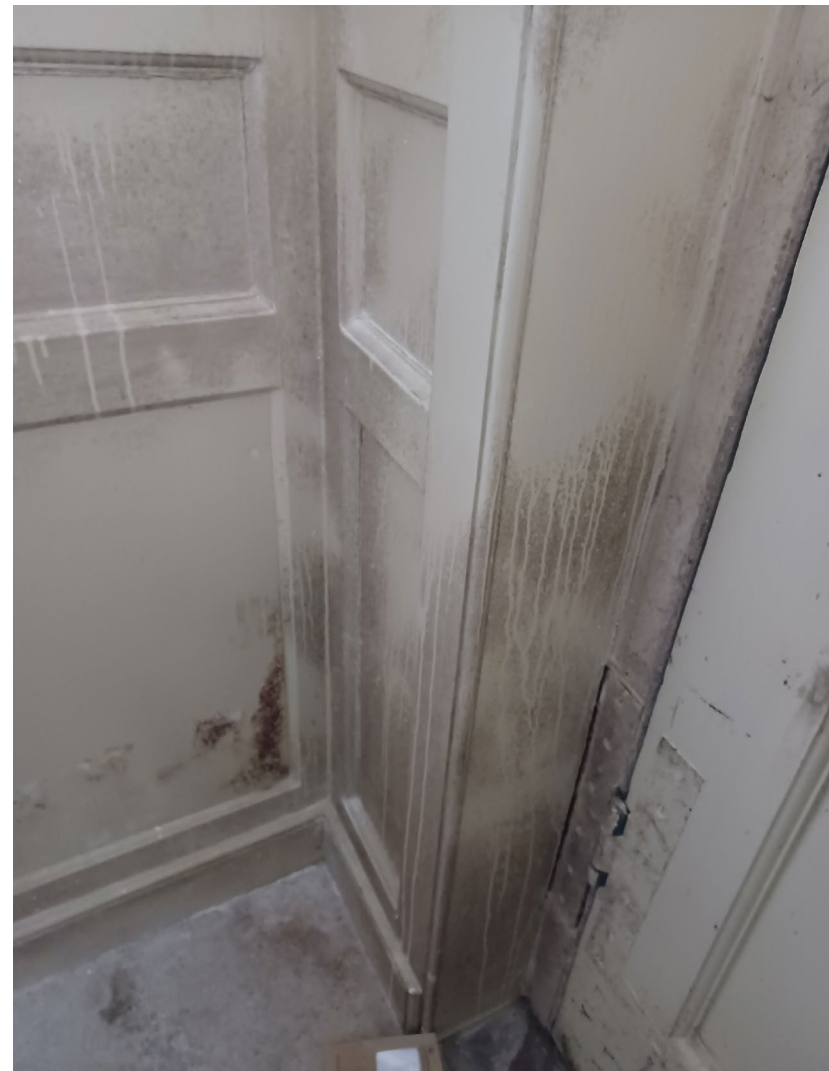
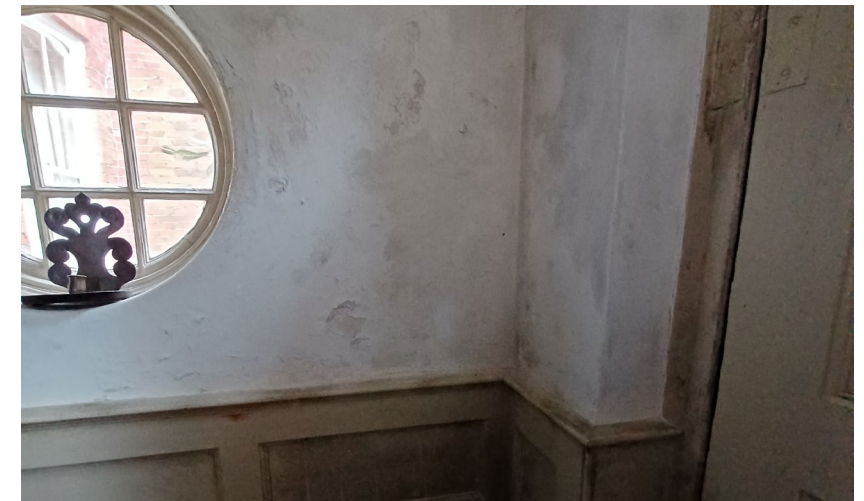
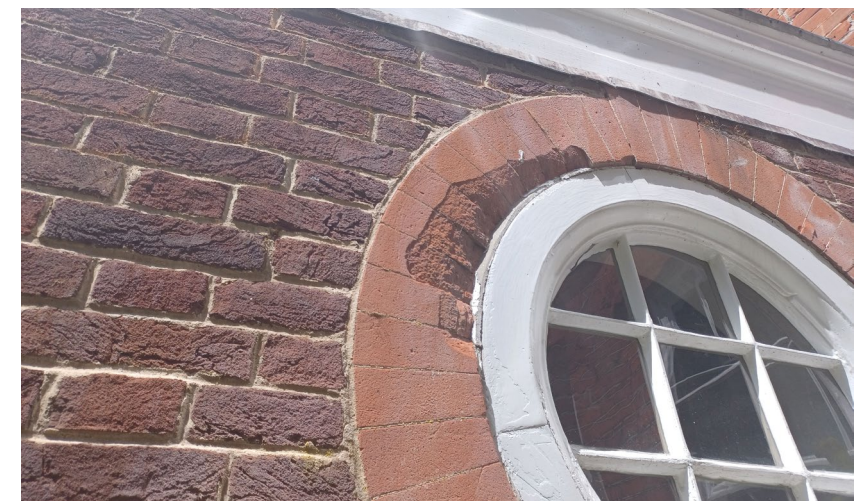
## Porch

The main entrance is suffering from wall peel and light mould. The porch is between the extremely cold and the warmer interior, therefore a space which can condensate easily. Externally there is porthole window brick damage.

The proposal is to completely redecorate the porch – ceilings and walls and clean the timber. To draught proof all sides of the front door – including the bottom rail. Also, repair work to the external brickwork.

Draft strips will be added around the door, which may require router gaps to the door frame and also draft strips to the letterbox reveal. Installation of secondary glazing to the fan windows and portholes. To repair the wall damage, a fungicidal wash is proposed, which will remove the paint and then after drying, a lime wash is proposed. To clean the panelling, a sugar soap, with a light sand and then a further sugar soap will remove the residue. Then painted with a colour to match the existing (Dulux satin wood). A heater will also be added, which matches the style of the historic fabric.

To repair the external porthole window brickwork, the existing loose and friable mortar is to be carefully raked out by hand and repointed using a lime mortar.

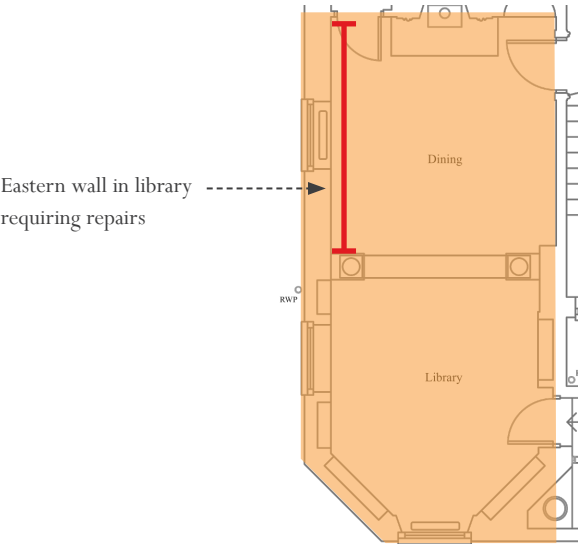
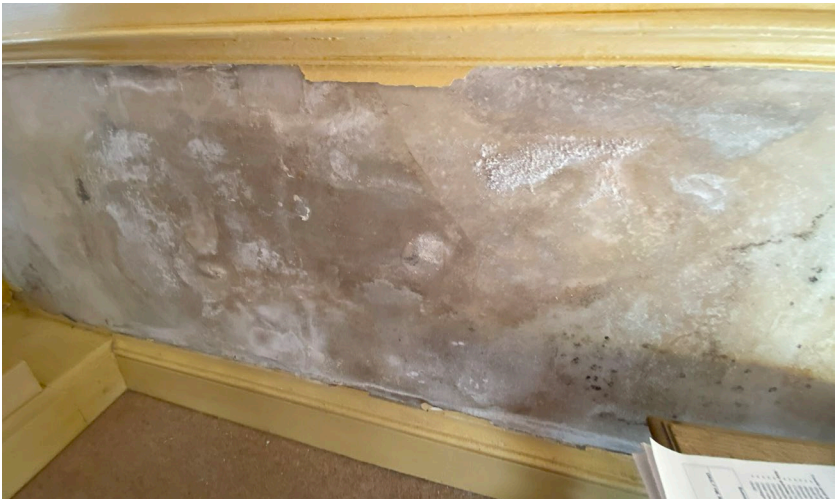
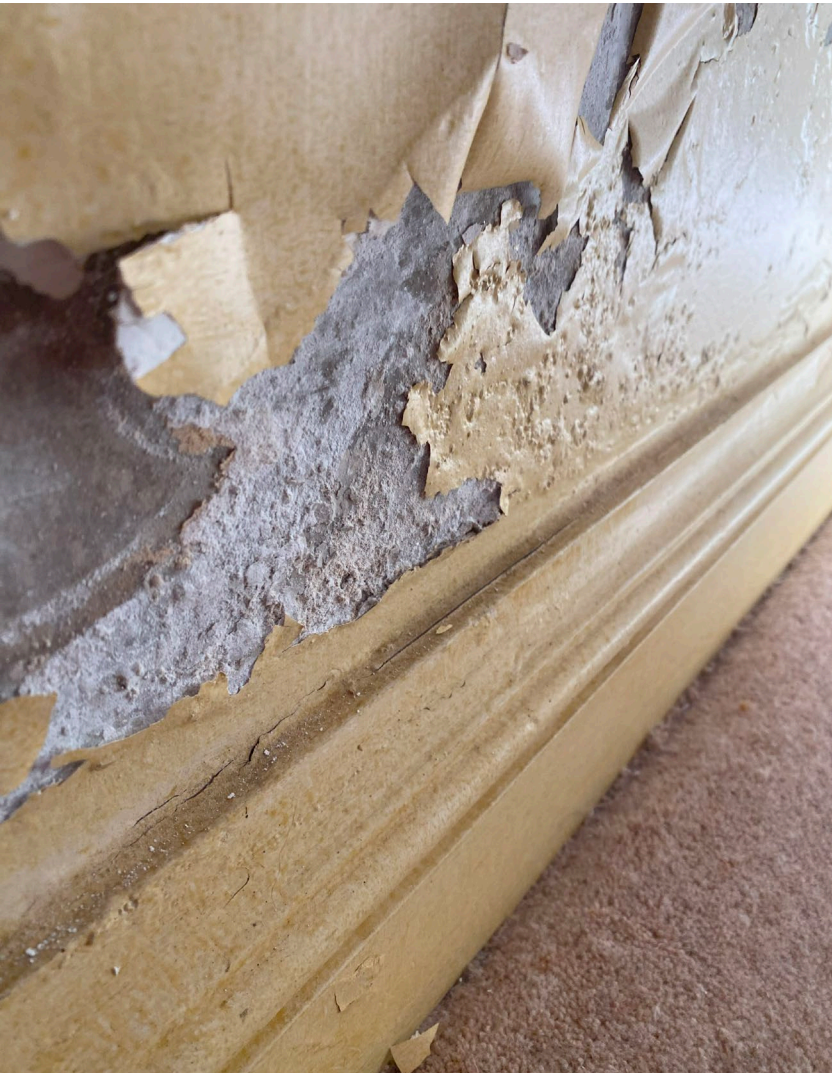
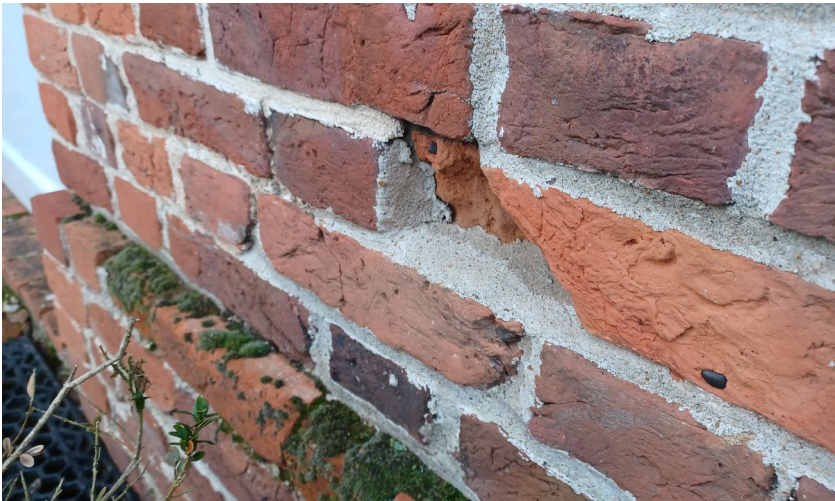
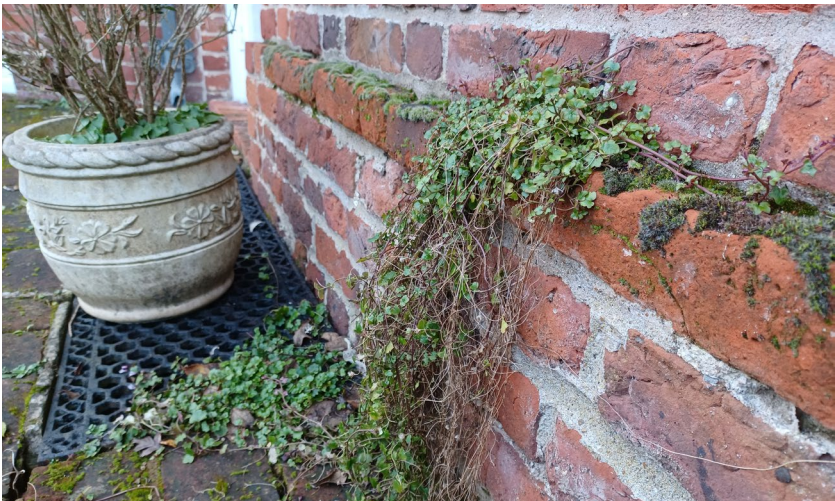
Library

Externally, presence of cementitious mortar, spalled bricks, moss and vegetation on flat headed plinth. Internally, there is damage to the wall below the dado rail, where there is penetrative damp, due to water ingress caused by the flat headed plinth. The lead gutter on the roof of the north extension is falling towards the upstand, rainwater is ponding in this area and this is causing some damp on the ceiling internally.

The proposal would be to remove the cementitious mortar, fix the brickwork, remove the vegetation and clean the plinth. Then followed by internal cleaning and application of new lining paper. Also, minor repair works to the ceiling and roof within the extension.

External works would be carried out first, with the removal of the cementitious mortar below window level and above the plinth, this would be raked out by hand using chisels, avoiding damage to the existing historic brickwork. It will then be replaced with a ratio of 1:3 lime to sand, with crushed chalk additive mortar (a sample area to be approved).

Also, any spalled bricks will be carefully removed by hand, and should the internal side be structurally sound, these can be turned to face externally. However, where the brick is damaged beyond use, a suitable like for like replacement will be sourced.

On the flat headed plinth, a fine, stiff brush to carefully remove moss will be used and vegetation siting on top of the plinth will be picked out. Allow to clean with water. Followed by NHL2 fillet of lime along the entire length on top of the plinth to be slanted away towards the outer face of the plinth. Where the patio abuts the plinth remove a single course of brick and then line with a geotextile membrane and backfill with peashingle. Also, place a stopend between the shingle and grille, to prevent fall into the basement.

Internally, remove the existing lining paper below the dado rail. Sugar soap the wall, once it has dried thoroughly, re-line with paper and decorate to match existing paint.

On the roof, the lead gutter needs realigning to fall outwards and away from the building. Internally there is some cleaning and patch decorations to the ceiling.
