Existing Ground Floor Plan @ 1:100

Please note 'HS' refers to Heritage Statement - all drawings to be referenced alongside HS document for full description of defects and repairs. All works to be undertaken in line with conservation principles and techniques.

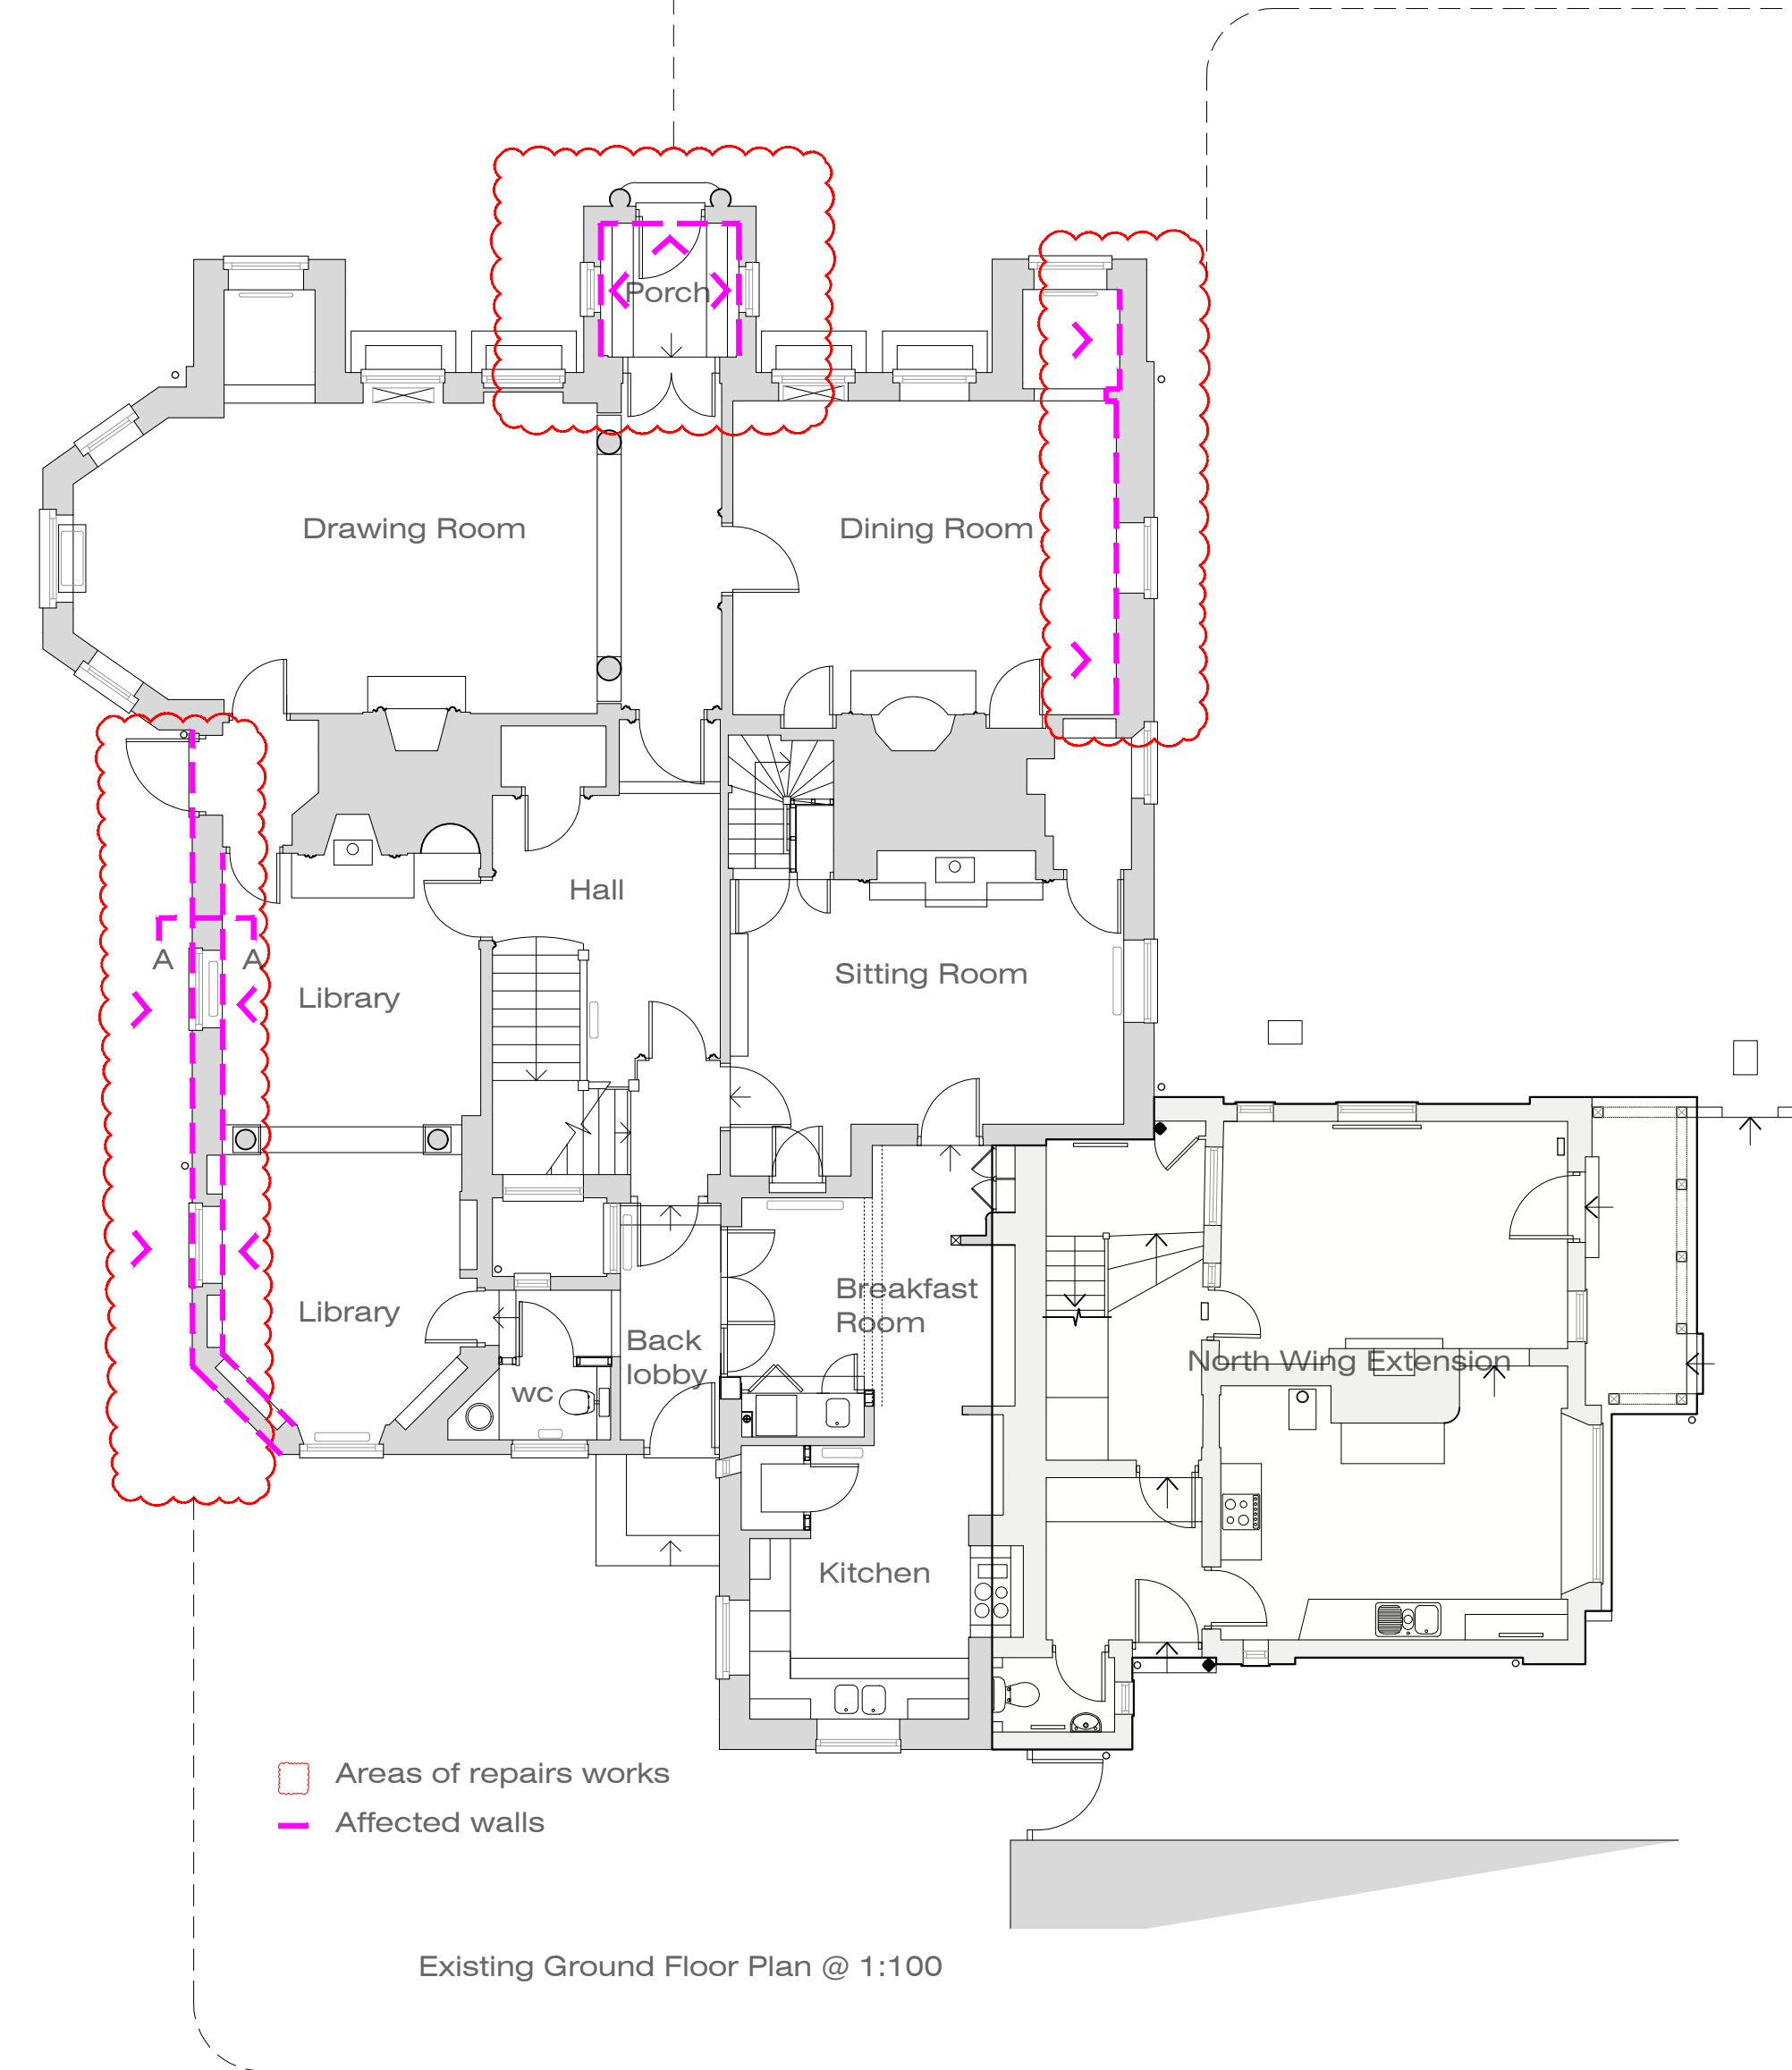
□ Areas of repairs works  
— Affected walls

- Defects Drawing Key:
- Spalling Brickwork
  - Improper Mortar Repairs
  - Mould
  - Water Damage
  - Water ingress

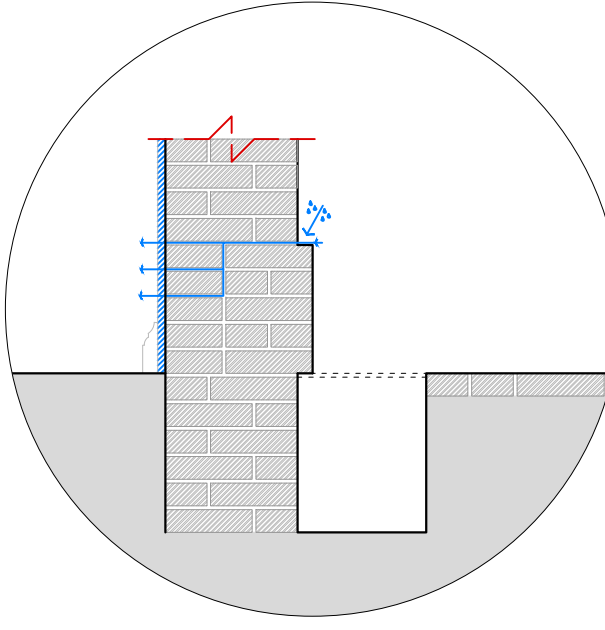
Plinth section AA @ 1:20 showing flat head plinth causing water ingress problems. Area catches debris, vegetation and holds water.
