## HERITAGE DESIGN AND ACCESS STATEMENT -18Q-01A – OCTOBER 2023

**To accompany an application for listed building consent for; Nurstead Hall, Nurstead Lane,  
Longfield Hill, Kent, DA3 7AN**

Scope of proposals: Repairs to external render and joinery. Structural reinforcement internally to timber-frame and chimney. Replace flat roof dormer to rear. Re-roof main house and add insulation to roof.

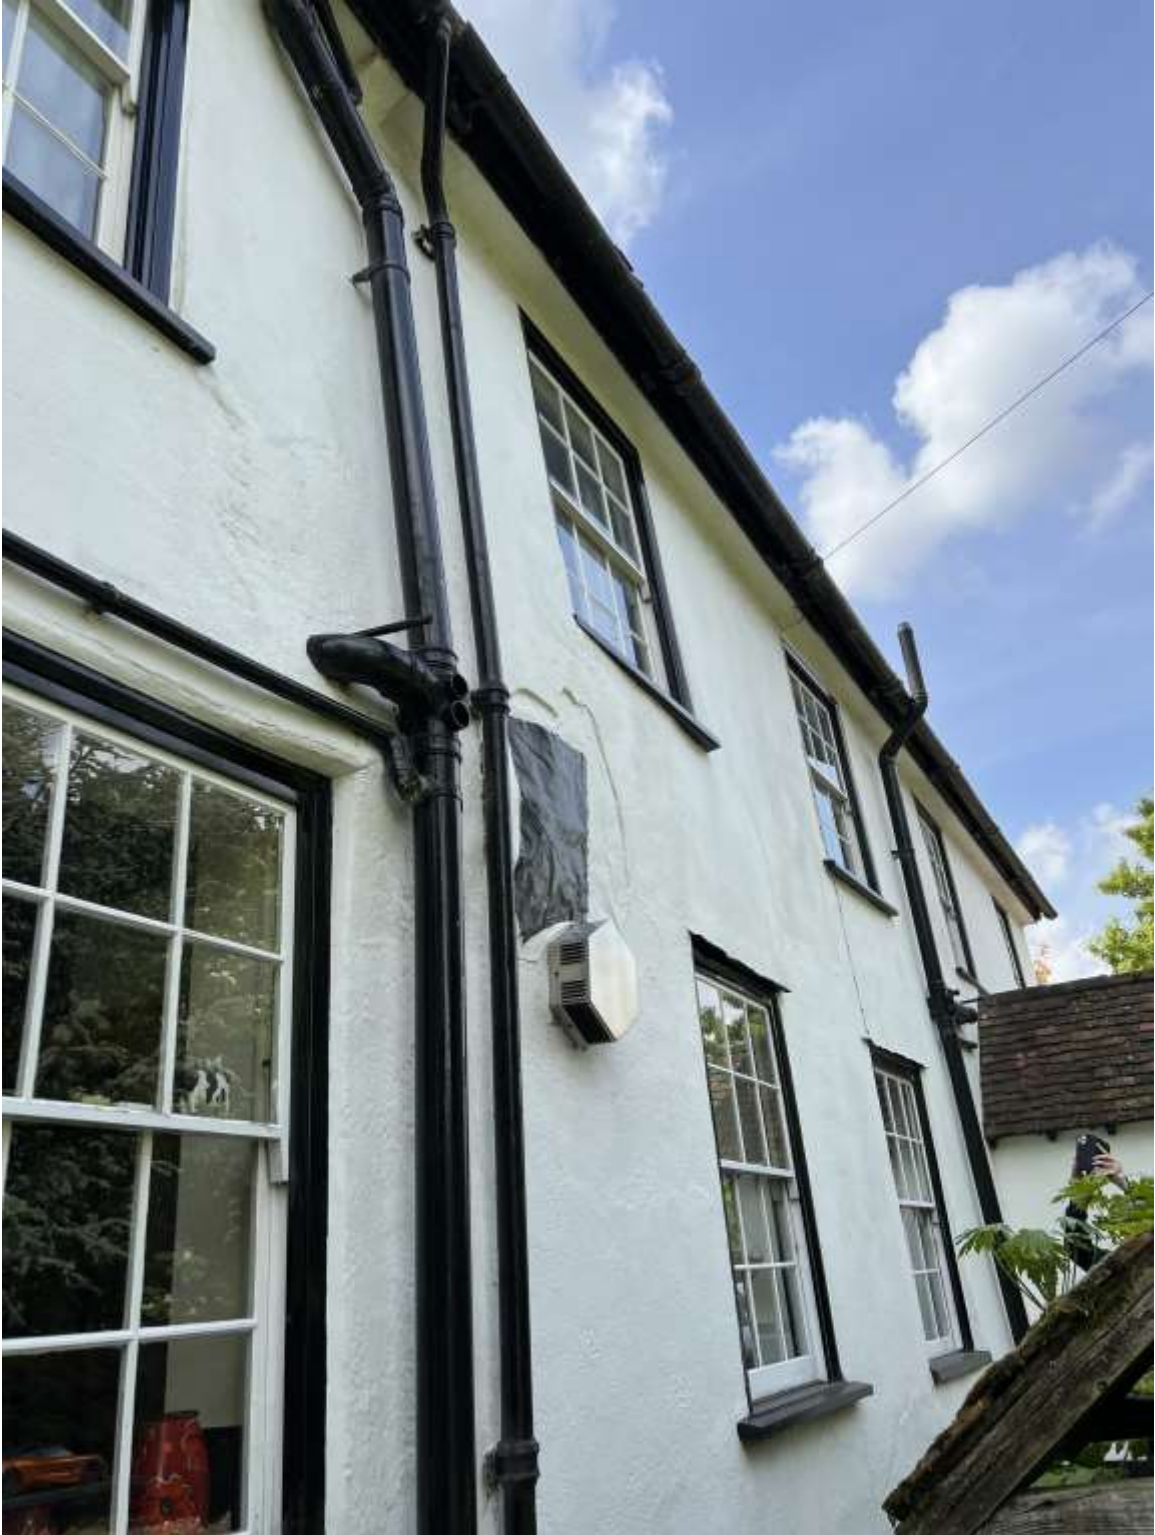
The north elevation has a large bulge in the external render where it has delaminated from the wall substrate and bowed outwards. Other areas of render have separated from the north wall, the extent of which is unknown at this time and cannot be fully established until scaffolding has been erected and opening up works has begun.

Bulge in external render on north elevation

The drawing numbered PP-18Q-06 (submitted with this application) shows the proposed areas of render to be replaced. A repair proposal can be discussed with the conservation officer once the delaminated render is removed, this may not end up a like-for-like repair and will depend on the practicalities of retaining sections of the render, as well as the materials used to affect repair / replacement.

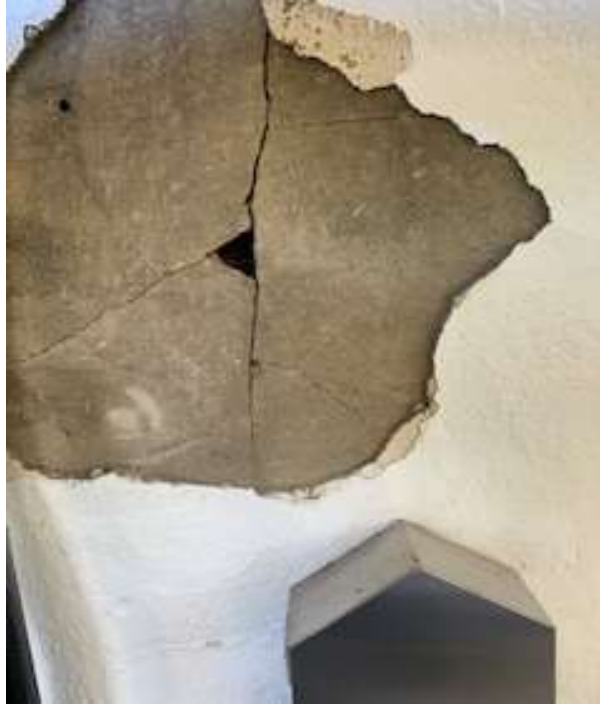
The external render has been built-up over time and through a failed section of wall, it can be seen that at least some of the rendered walls consist of three layers of render installed at different periods. The failed section of wall was partially opened to inspect the bulging render on the north (front) elevation where the first-floor timber-framed wall sits on an under-built masonry ground floor wall. Over the timber-frame the build-up consists of: sawn softwood laths; lime render; a full thickness of cementitious ashlar render; and a final layer, full thickness of cementitious flat render, painted white. It was not possible from the inspection hole to establish if both of the cementitious render layers cover the masonry sections of wall but it is most likely that the mid-layer (ashlar render) is below the existing flat render coat as ashlar rendering (the middle layer) was usually carried out to imitate a stone façade.

Top coat of render removed where cracking occurred at bulge in north elevation wall, exposing the second layer of ashlar render beneath.

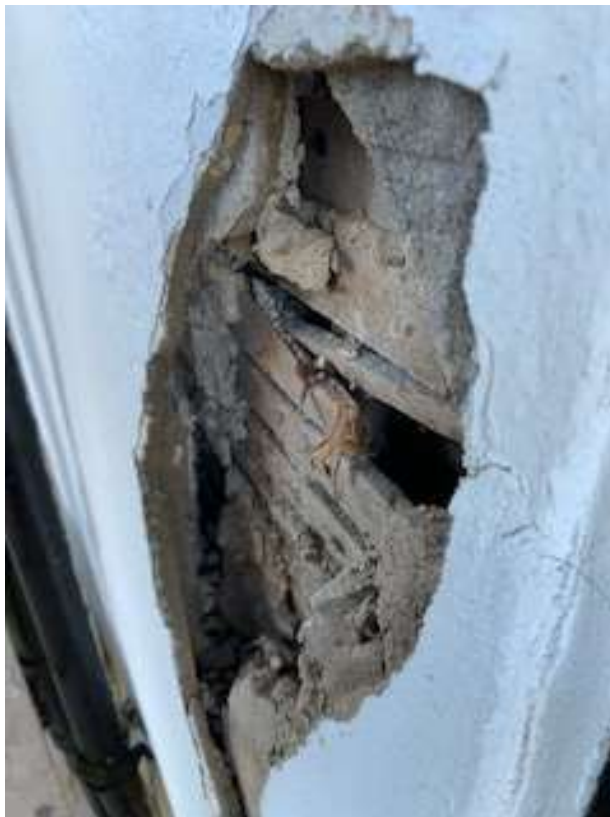
Inspection hole extended to the softwood laths showing the layers of render.

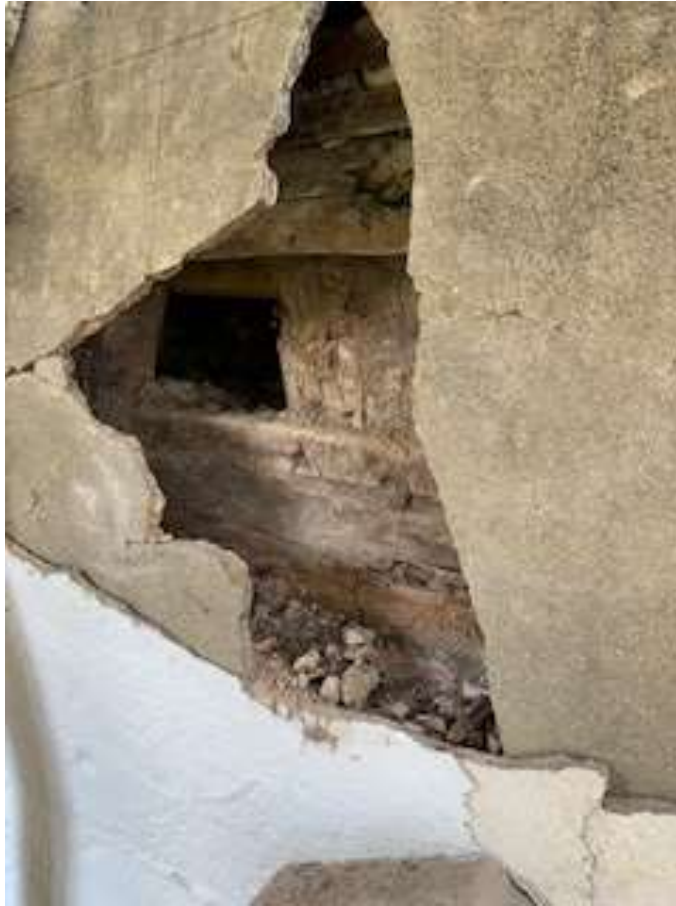
Inspection hole removing render build-up to expose framework behind.

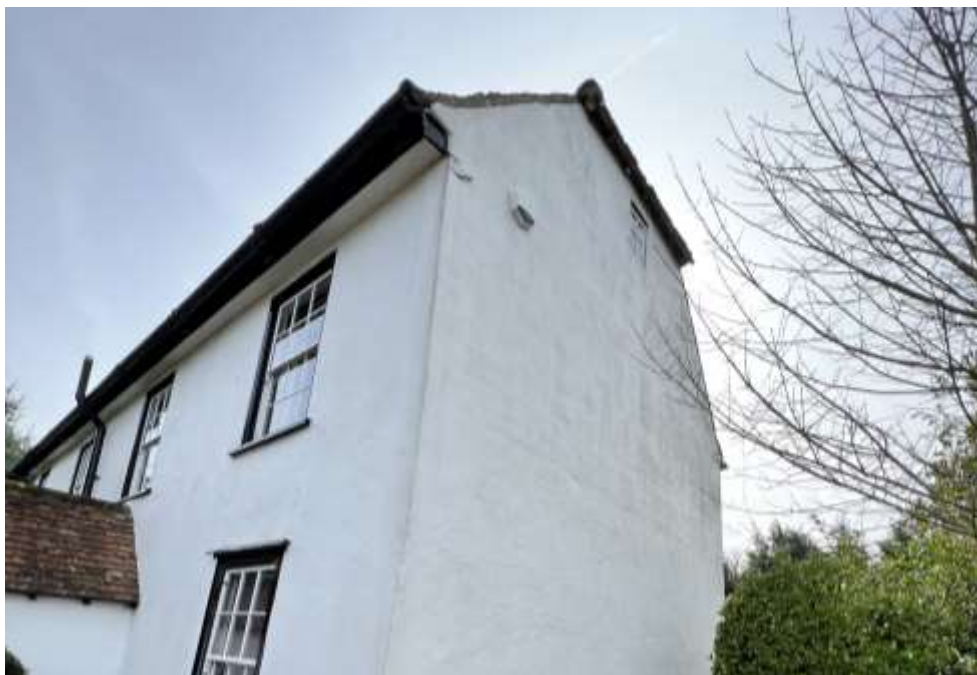
Roof verges do not extend fully beyond the face of the rendered wall.

The roof tiles, fittings and battens are proposed to be stripped to repair the roof cladding. Whilst the roof cladding and battens are off the roof, it is proposed we take advantage of that access and strip any impermeable roofing membrane and increase the level of insulation to the roof. It is proposed that TLX Gold is installed; a thin quilt insulation with a breather membrane as part of its build-up of layers. This insulation will add a minimal amount to the thickness of the rafter while maintaining the natural undulations of the historic roof. When the roof tiles are installed, the roof verges need to project from the rendered wall faces by approximately 50mm.

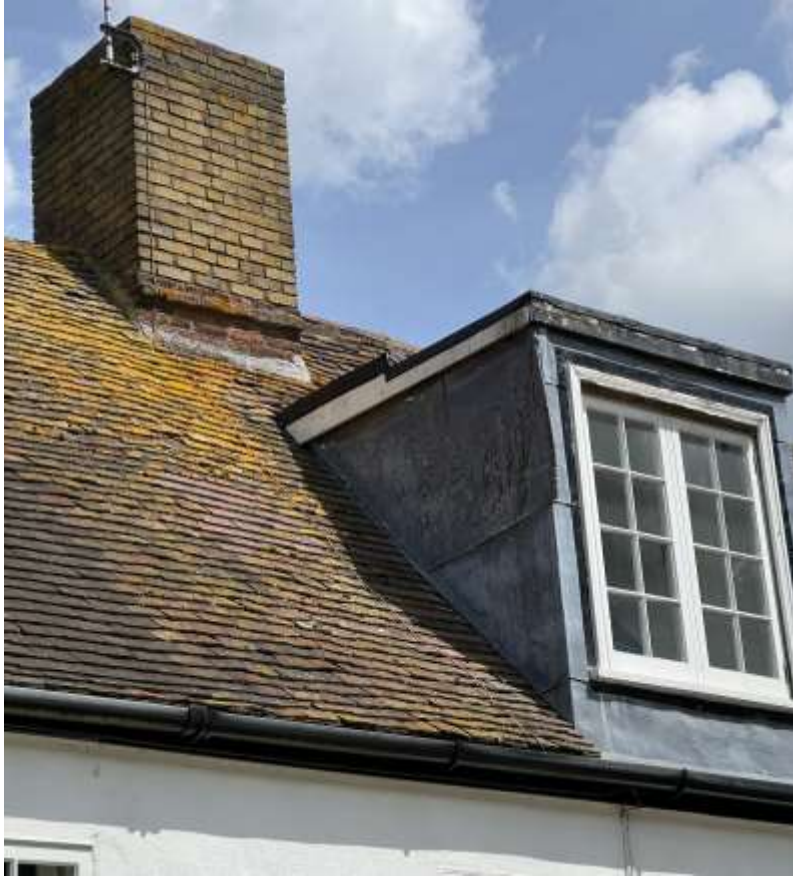
The chimney stack above the roofline of the large axial chimney has been rebuilt at some point in the late C20 in yellow stock bricks, an inappropriate match of brick with the remaining original chimney construction. This part of the stack has no historic or architectural value and would benefit from being rebuilt in an appropriate red brick.

Image of chimney stack above roofline and existing dormer window.

The central chimney is in need of structural repair and the stack above the roofline requires a rebuild in a more appropriate brick. The structural engineer has identified cracks above the west-facing bressummers of the ground and first floor that require 'Helifix' crack-stitching which will be pointed over in lime mortar to match the surrounding mortar. The fireplace of the first floor (west-facing) is a cast iron fireplace asymmetrically inserted into a larger fireplace opening and has been infilled with a mis-match of bricks and it is proposed that the lime mortar pointing to this infill section is repaired. See structural engineer's report pma 5291. The stack above the roofline has been rebuilt at some point in yellow stock bricks laid in cementitious mortar, whilst the remainder of the chimney is built in relatively thin red brick. It is proposed that the yellow bricks above the roofline are taken down and replaced with a more appropriate red brick and pointed in lime mortar.

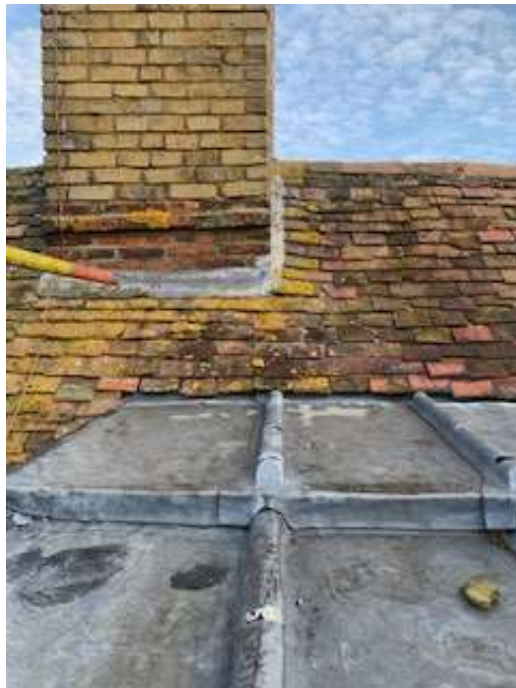
Image of chimney stack above roofline and existing dormer roof.

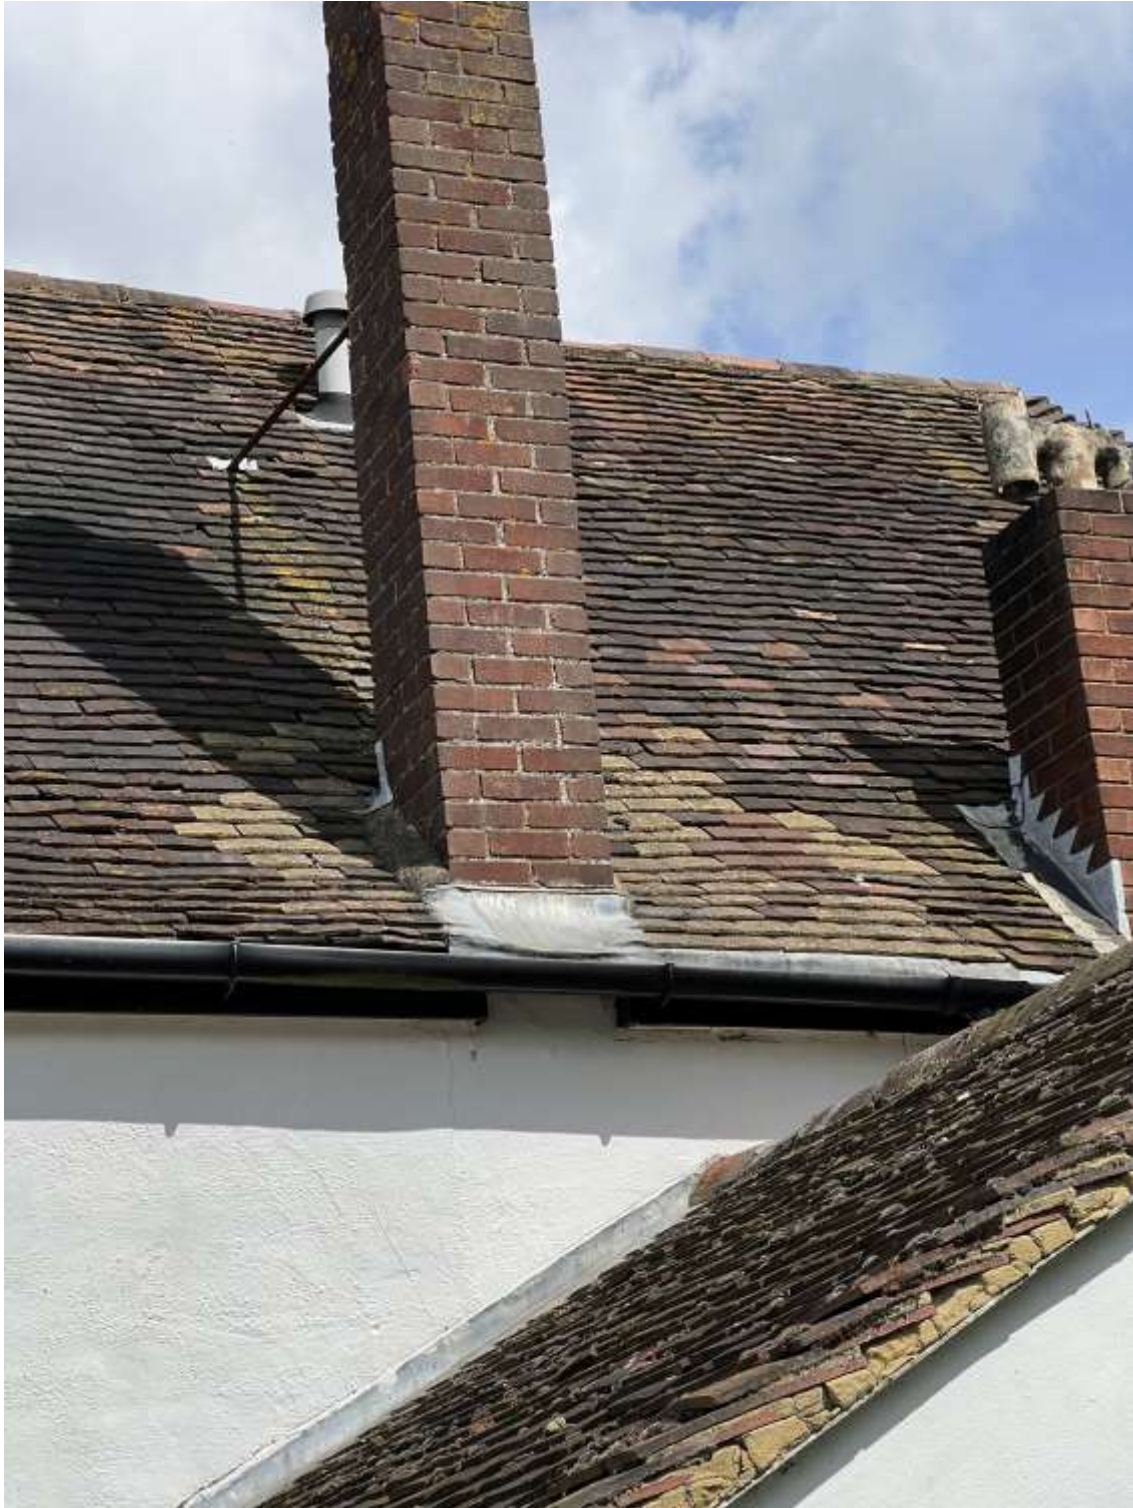
The existing roof cladding is in a poor state of repair, particularly the north-facing roof slope. It can be seen from the ground that there is a thick growth of moss clumps on this roof elevation and a high proportion of clay roof tiles are damaged and delaminated. There are some machine-made clay roof tiles in small areas where the roof has been repaired in the past. It can also be seen from the ground that the battens to the north roof elevation are damaged and there is pronounced waves of dipping where the battens span between the common rafters and the consequential rising of the roof at the rafters. This is likely to be caused by soft and decayed tile batten, which requires the batten to be stripped off the roof and new treated softwood tile battens installed. The rear (south) roof slope is in a better condition than the front. However, there appears to be a higher percentage of machine-made clay tiles and some concrete tile inclusions. The undulations in the roof at the rear is a more natural 'wave' where the principal timbers are the high spots and there is an even sag across the entire bay (and not between common rafters as can be seen on the front).

The small chimney on the south elevation, and towards the east end of the house, has a broken flue pot that requires replacing with a like-for-like flue pot.

Image showing some mis-matched roof tiles in the main range rear elevation roof-slope and broken flue pot.

Due to the high proportion of damaged and inappropriate roof tiles to the main roof slopes, the proposal is to grade, stack and store any salvageable hand-made clay roof tiles and utilise these for future repairs to the single storey extensions, out-buildings and porch. The roof slopes are proposed to be re-clad with new hand-made clay tiles; 'Churchland' blend manufacture by Spicer Tiles.

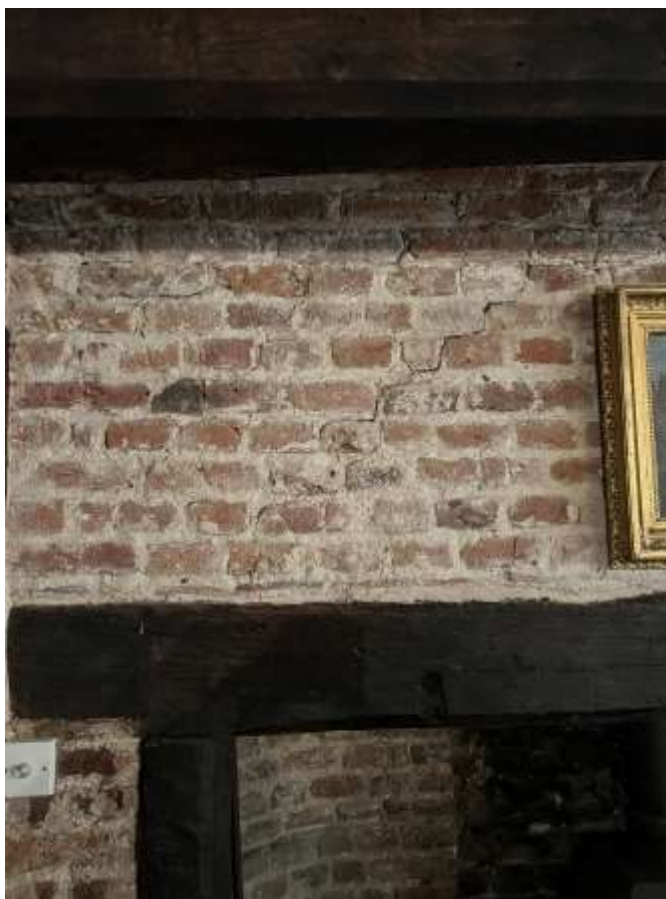
Image of the crack above the bressummer in the ground floor of the axial chimney facing west.

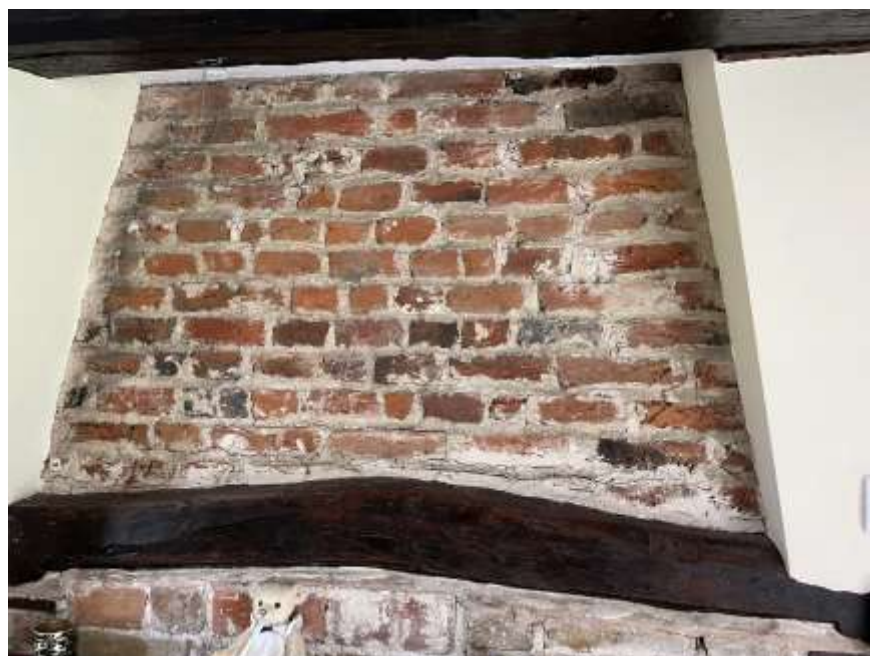
Image of the cracking above the bressummer in the first floor of the axial chimney facing west.

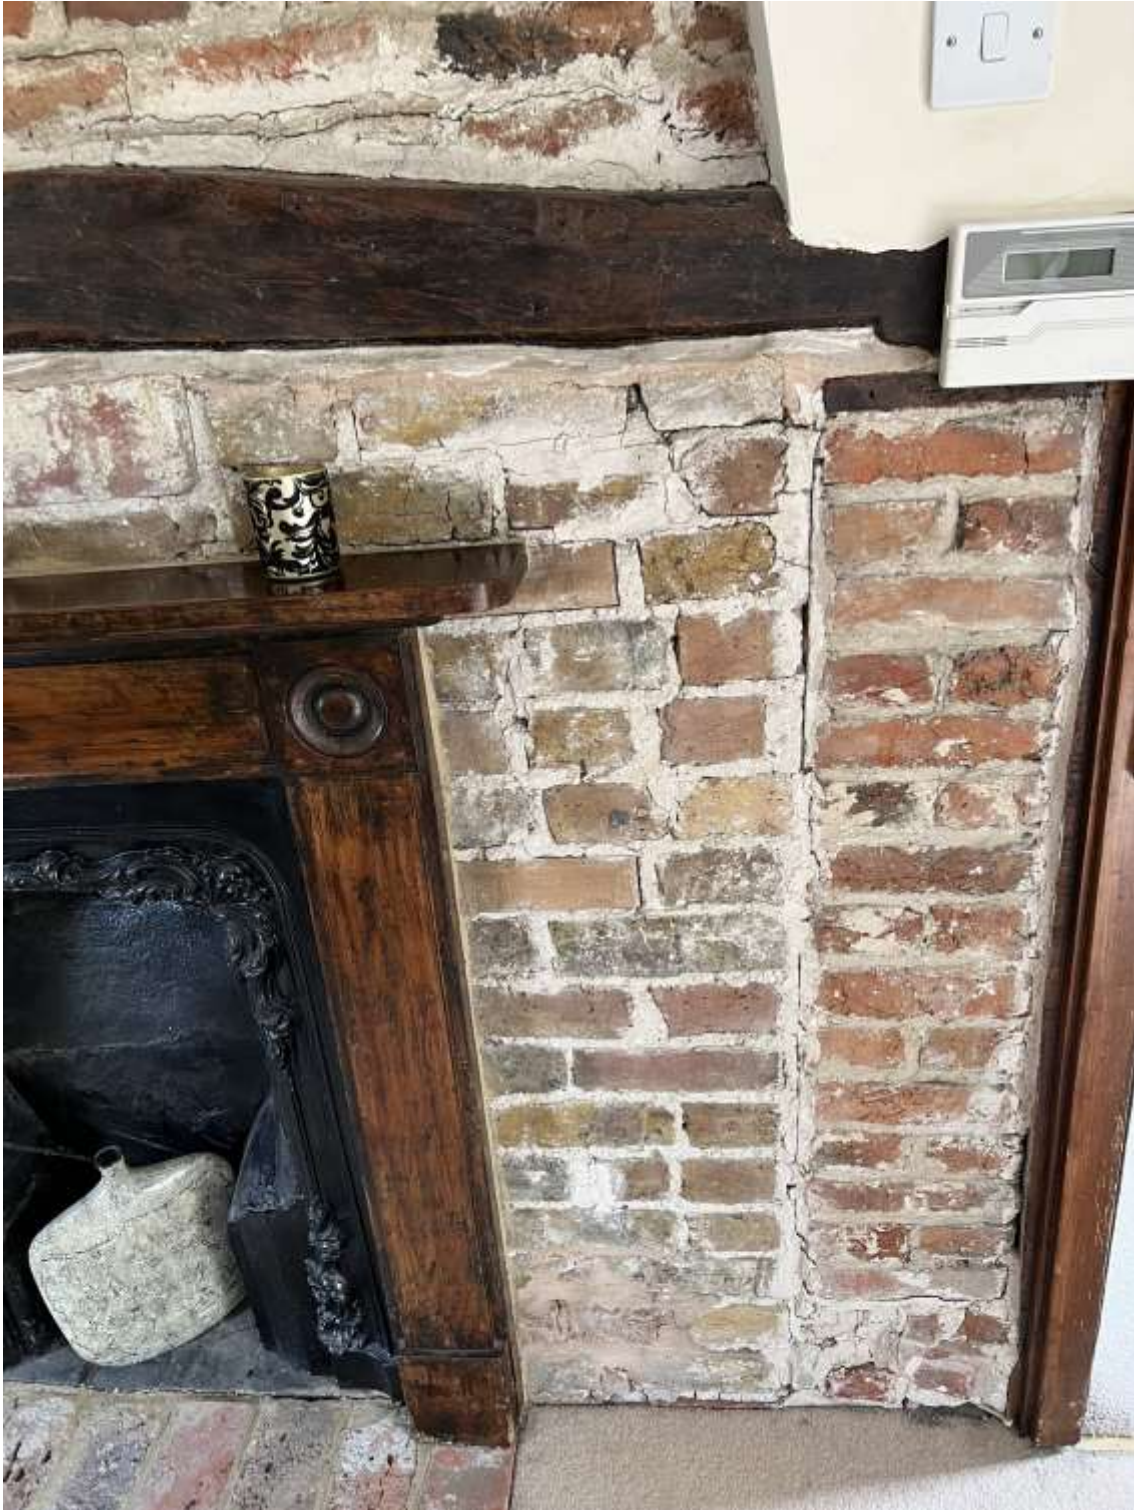
Image of the inserted fireplace and infill brickwork below the bressummer in the first floor of the axial chimney facing west.

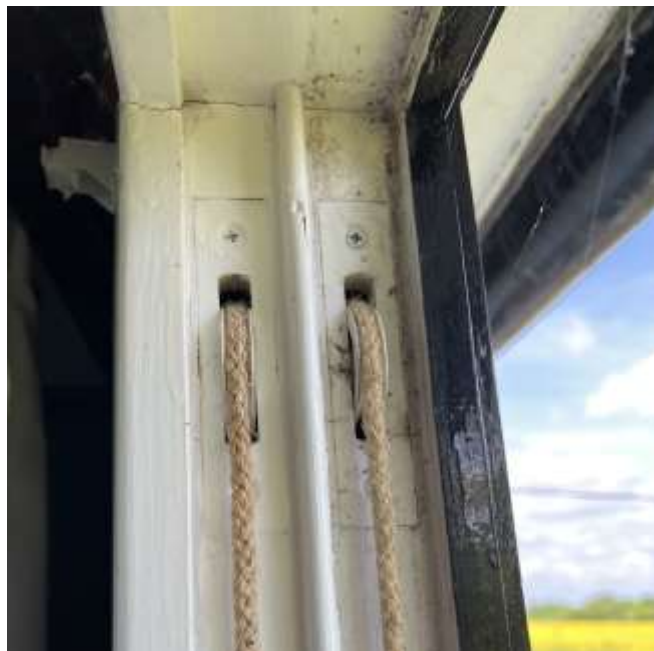
Internal image of the relatively modern axle pulley wheels and sash cords of the front elevation 'box-frames'.
