PLANNING DRAWINGS

| DESCRIPTION | |
|---|---|
| SECOND FLOOR PLAN AS PROPOSED | |
| LOCATION<br>NURSTEAD HALL | DRG No.<br>PP-18Q-05 |

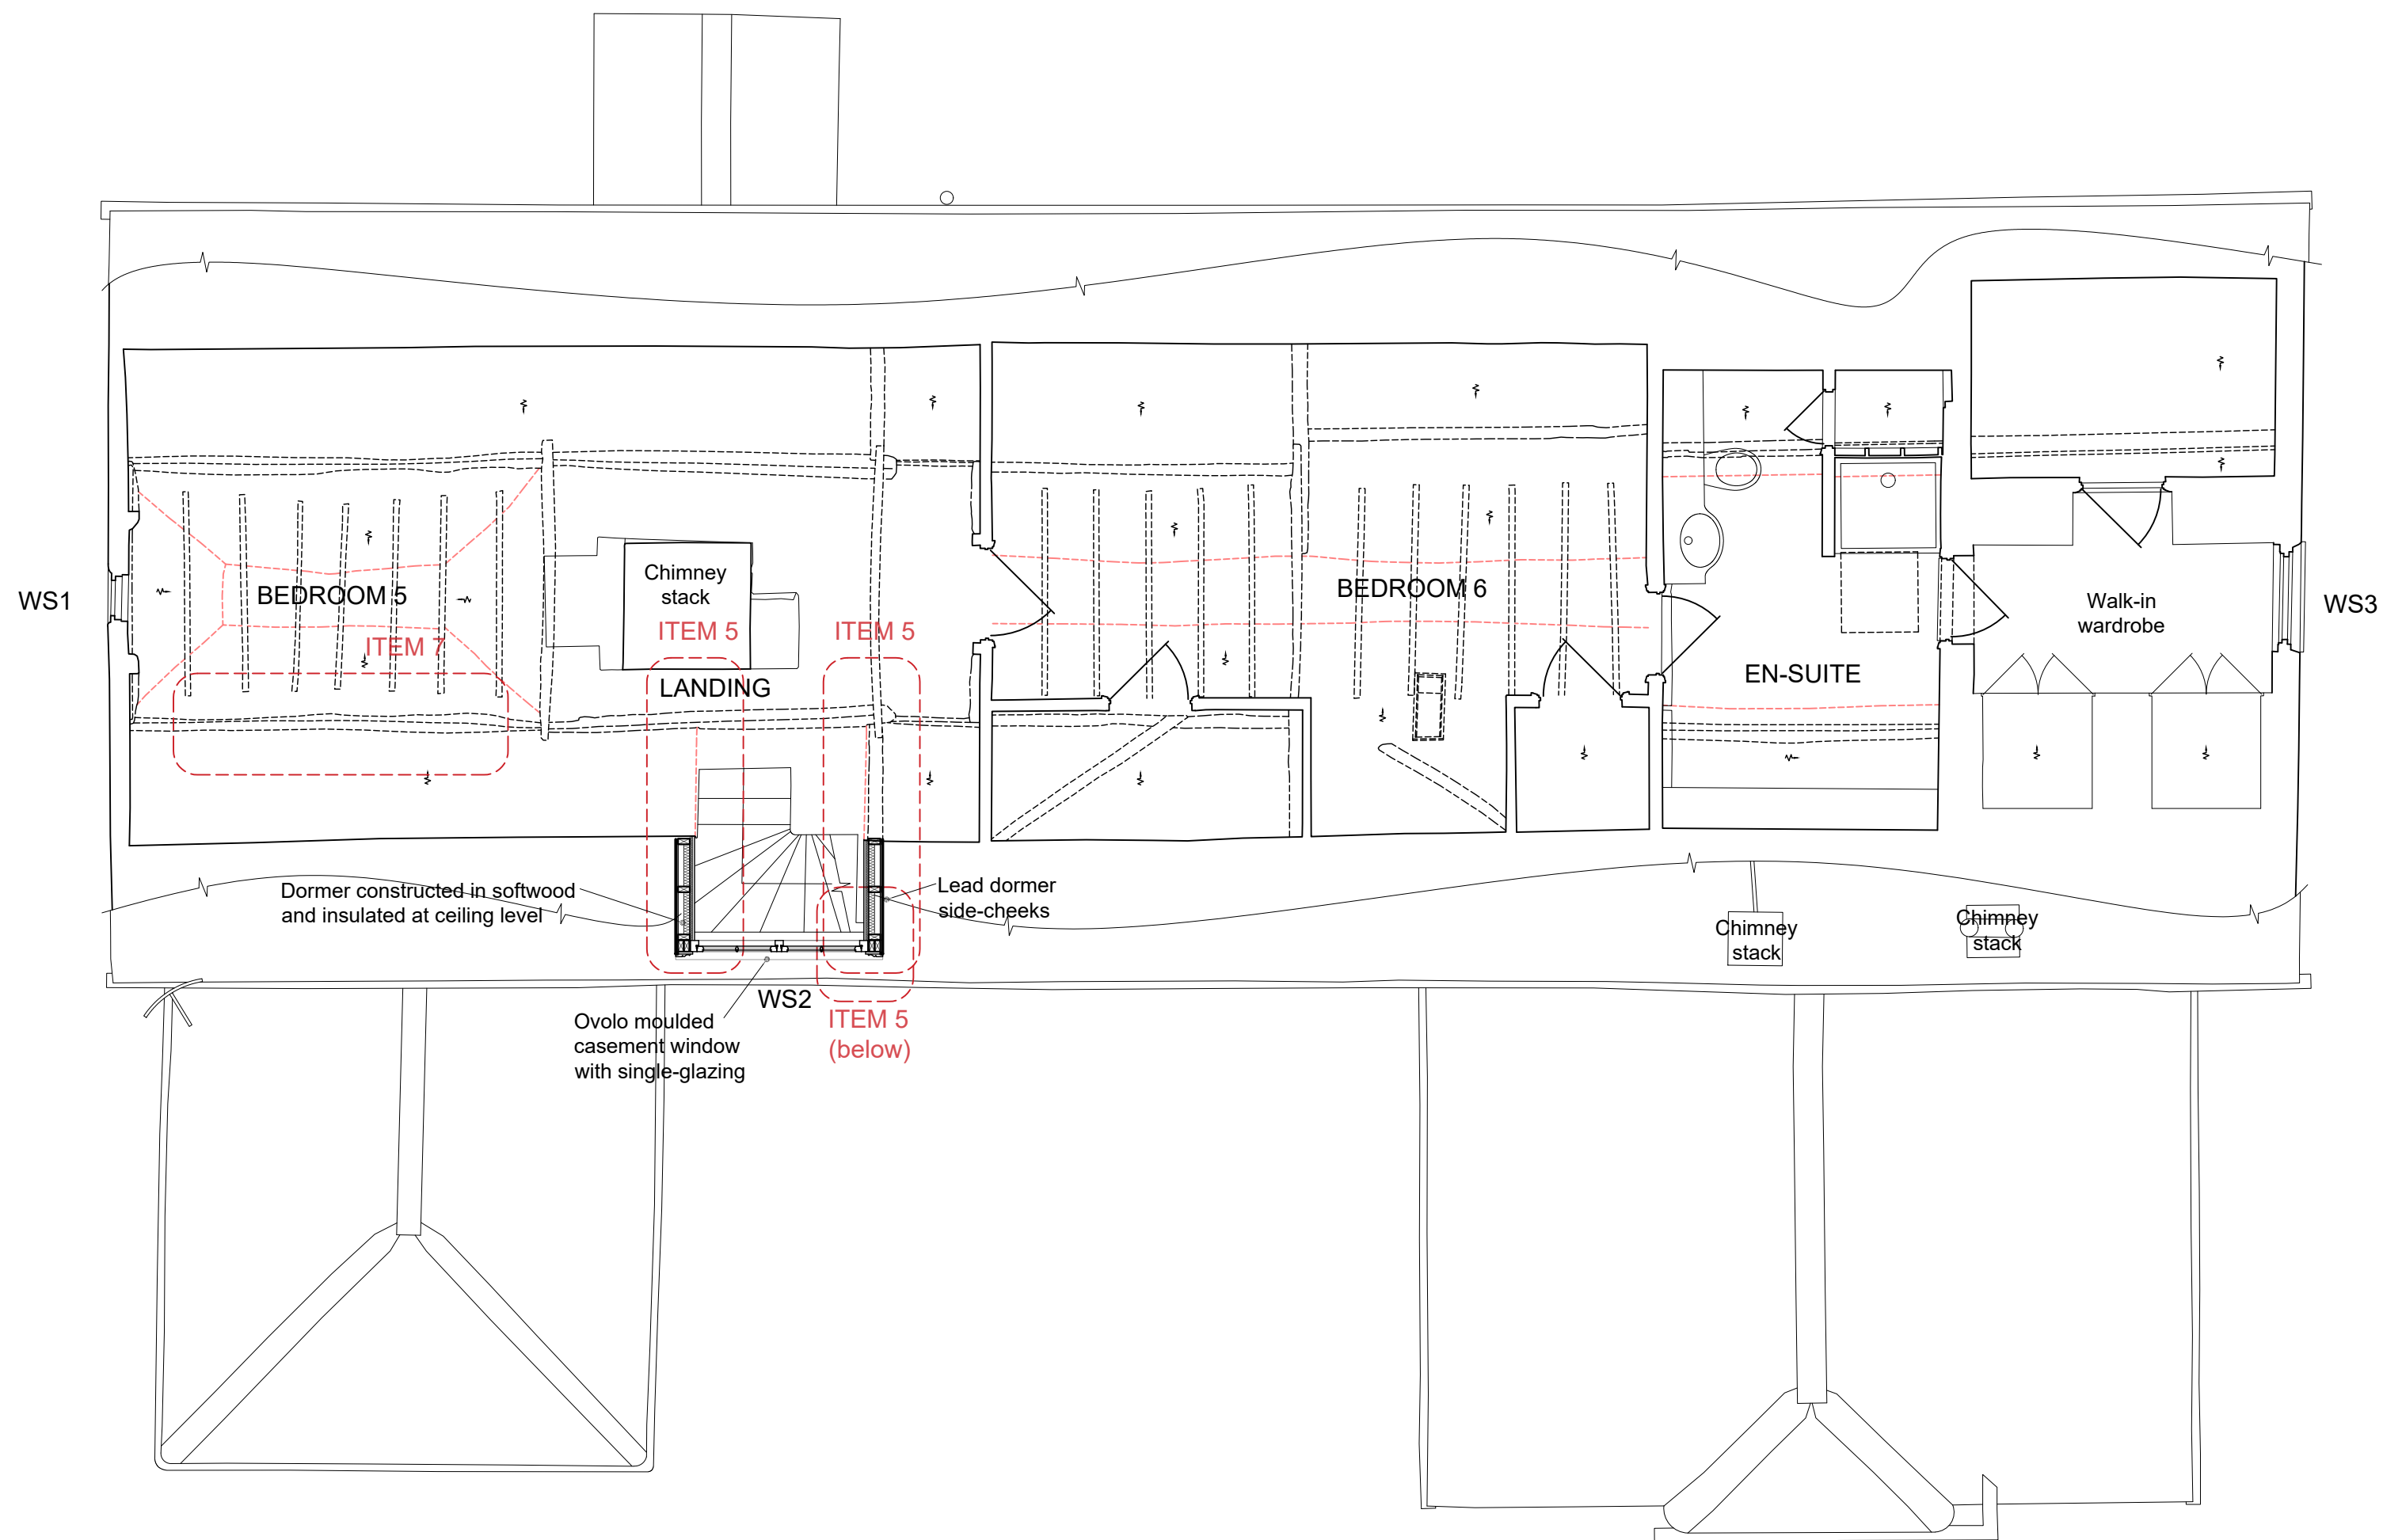
SECOND FLOOR PLAN OF PROPOSED REPAIR / REINFORCEMENT AND  
PROPOSED REPLACEMENT DORMER  
SCALE 1:50

**Item 5 – Possible Replacement Roof Dormer to South Elevation**  
We understand that it is proposed to construct a replacement dormer. The dormer is currently supported on the eaves wall plate, which contains a joint immediately below. As before, it is difficult to comment on the condition of the joint as the majority is concealed, so we would recommend that a small panel of the modern plasterboard below the beam is removed to ensure that the beam is adequate supported by the studwork frame below. Once the roof finishes are removed, the trimming rafters beneath the dormer cheeks should be checked for adequacy.

**Item 7 – Over deflected Roof Purlin with fracture to West End of Building**  
This purlin is located within the second-floor attic room of the property. The purlin spans approximately 3.4metres between the west elevation gable wall and a large collar. The purlin has a fracture along its length. Although the purlin is over-deflected, collars are present at a slightly higher level which will relieve the purlin of some weight. Due to the fracture, we would however recommend that a steel plate (8mm thick), profiled to suit the shape of the purlin is added and fixed alongside with coach screws at 400mm centres in order to regain its integrity. Note!!steelwork to be painted black.

Whilst walking around the property, it was also noted that the top of the west elevation gable wall projects out from the verge, which is enabling water to penetrate behind the render. This area will need further investigation when an access scaffold is installed and is likely to require some sections of render to be removed to check the condition of the oak framework behind. The verge detail will however need to be modified in any event to ensure the roof line projects behind the face of the wall in order to protect the top of the wall from water ingress.

**WS 1**  
Replace existing window like-for-like in hardwood painted.

**WS 3 - Pivot Casement Window**  
Complete some minor filling and repair putty.  
Prepare the surfaces of the existing window removing loose paint only and lightly sand to provide a key.  
Re-paint the window internally and externally with Superdec paint or similar breathable paint.

**Replacement dormer construction and WS2**  
Replacement dormer to be constructed from treated softwood.  
The roof will be a flat roof construction with a fall towards the front to suit lead sheet with leaded rolls. The roof is proposed to be insulated at ceiling level and the walls insulated between studs and over the inside of the studs. Both the ceiling and walls will be plaster-boarded and skimmed with gypsum plaster internally. The dormer cheeks are proposed to be clad in lead sheet.  
WS2 is proposed to be constructed in hardwood with single-glazing between glazing bars, painted internally and externally with Superdec paint or similar breathable paint.
