**Ref: 3962/22**

**PROPOSED REDEVELOPMENT AT  
UNIT K6, LOWER ROAD, NORTHFLEET,  
KENT DA11 9BL.**

**PHASE I GEO ENVIRONMENTAL DESK STUDY  
AND PRELIMINARY RISK ASSESSMENT**

**March 2022**

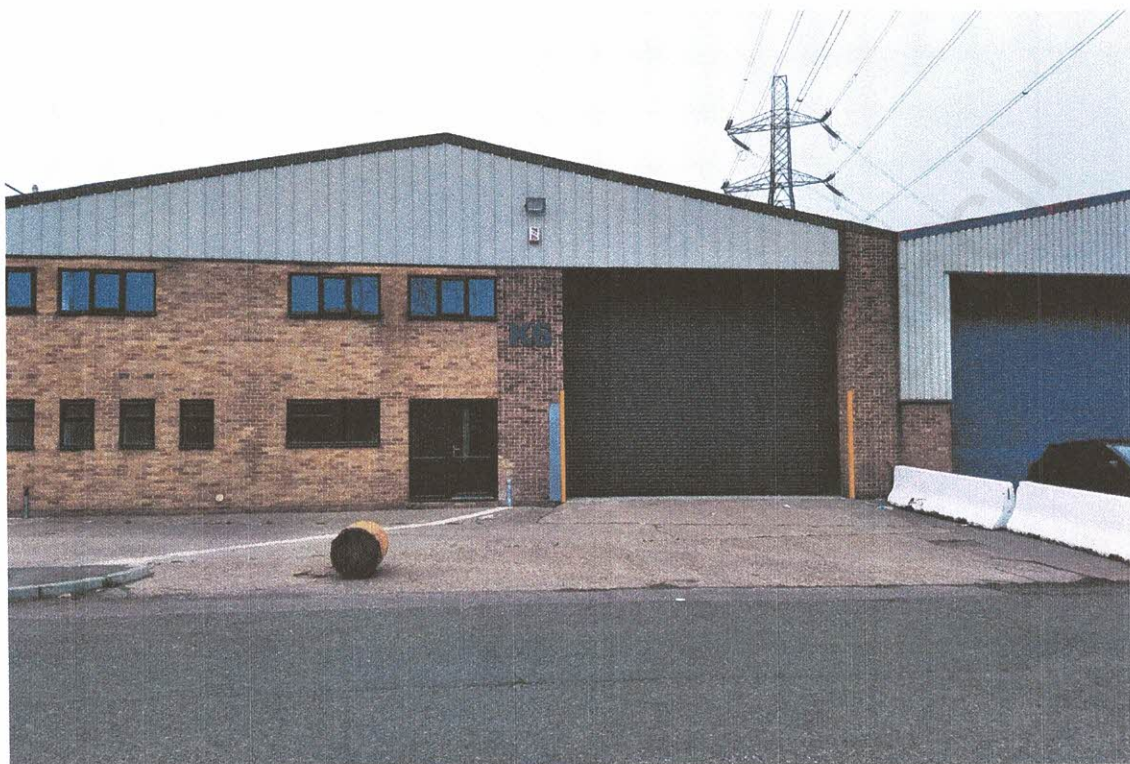
Plate 1

- 7.3 The site comprised a vacant unit of brick and steel construction contained within a larger rectangular block of similar commercial premises (Plate 1). The east section of the unit supported two-storey office accommodation, with a roll-over commercial vehicle entry point to the west. Access into the building was unavailable.

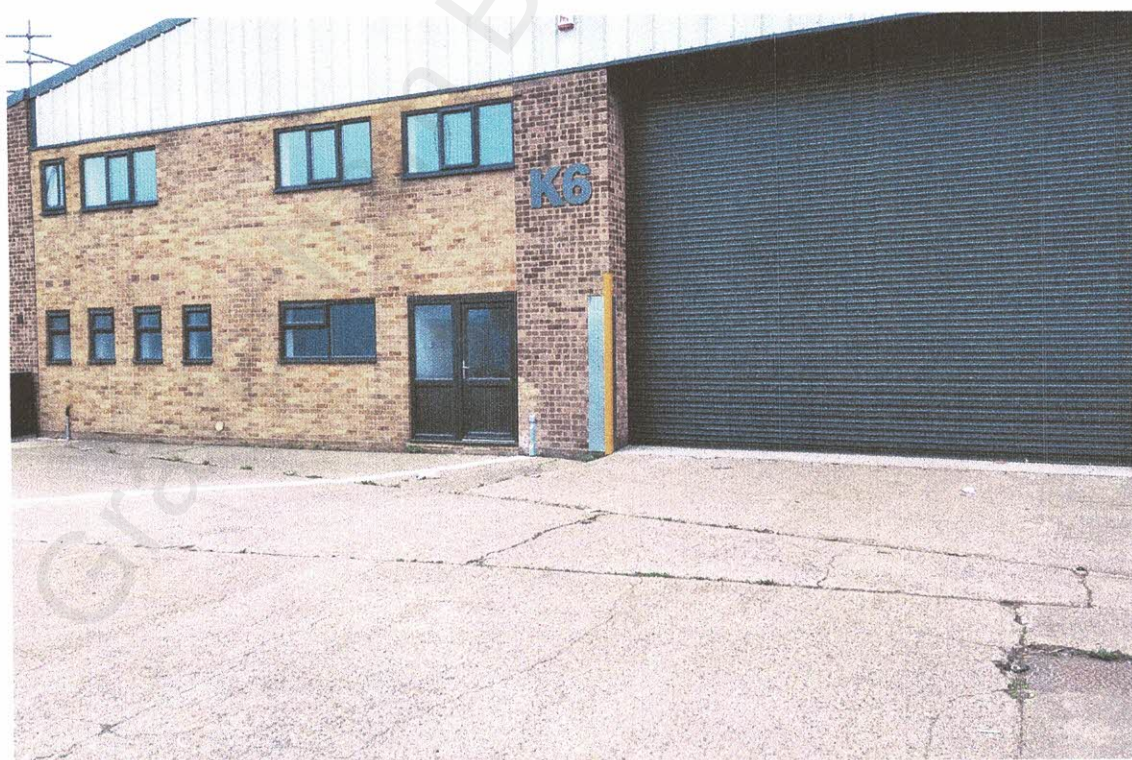
Plate 2

- 7.4 Concrete surfacing of an unstained appearance was present at the front of the building, adjacent to the estate road (Plate 2). A trailer was parked on the roadside to the front of the building.

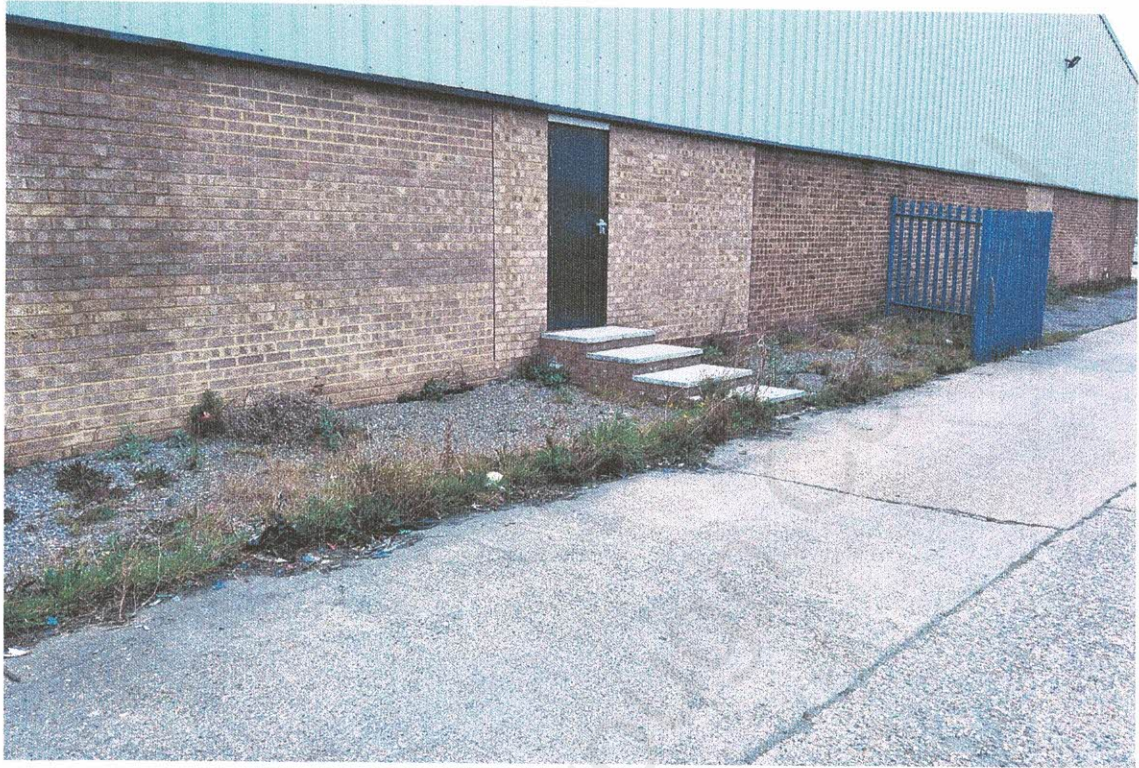
**Plate 3**

- 7.6 Access to the rear of the site was gained via a concrete road which led from the end of the estate road around the east end of the main block and alongside the rear of the units. The rear elevations of the units were of brick construction under a steel roof. A single door accessed via a short flight of steps was present on the rear elevation of the subject unit (Plate 3). Compact granular surfacing approximately 2m in width with patches of emergent weeds formed the ground surface between the concrete road and the rear elevation of the unit.

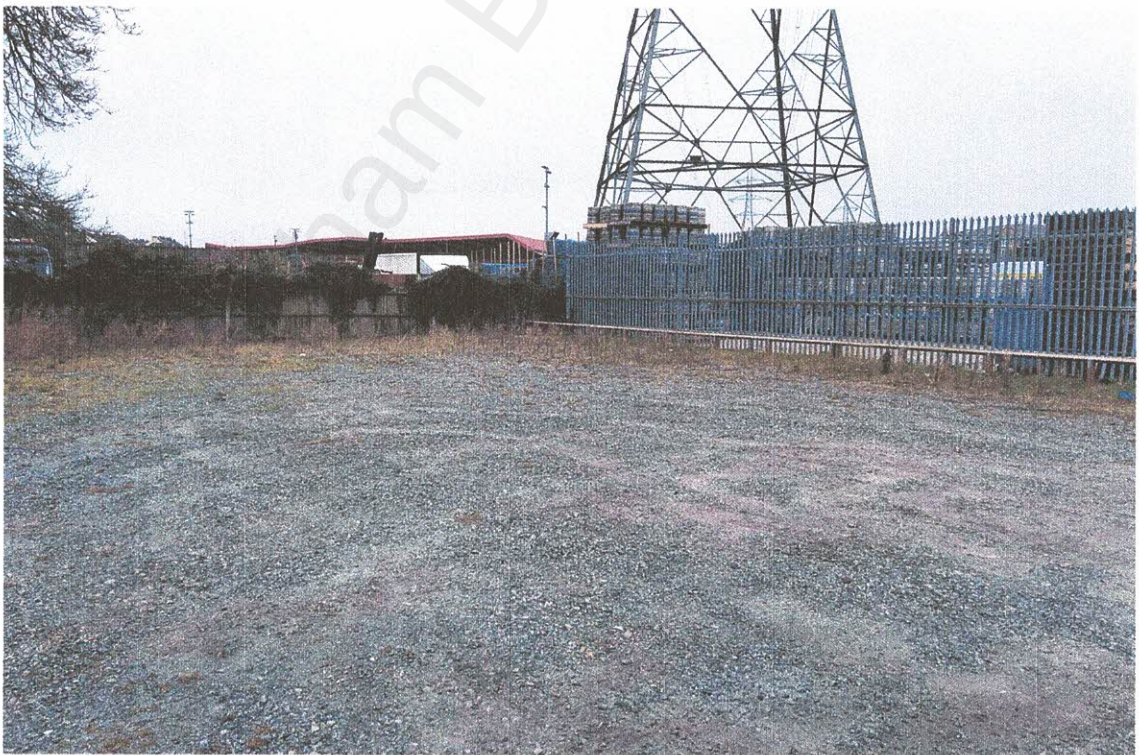
**Plate 4**

- 7.7 The rear section of the site comprised a vacant, roughly square area of compact granular surfacing located on the south side of the concrete road and enclosed on its east and west sides by steel railings. A panelled timber fence formed the south boundary of the site (Plate 4 to Plate 6). The southeast corner of the site contained a mature Oak tree.

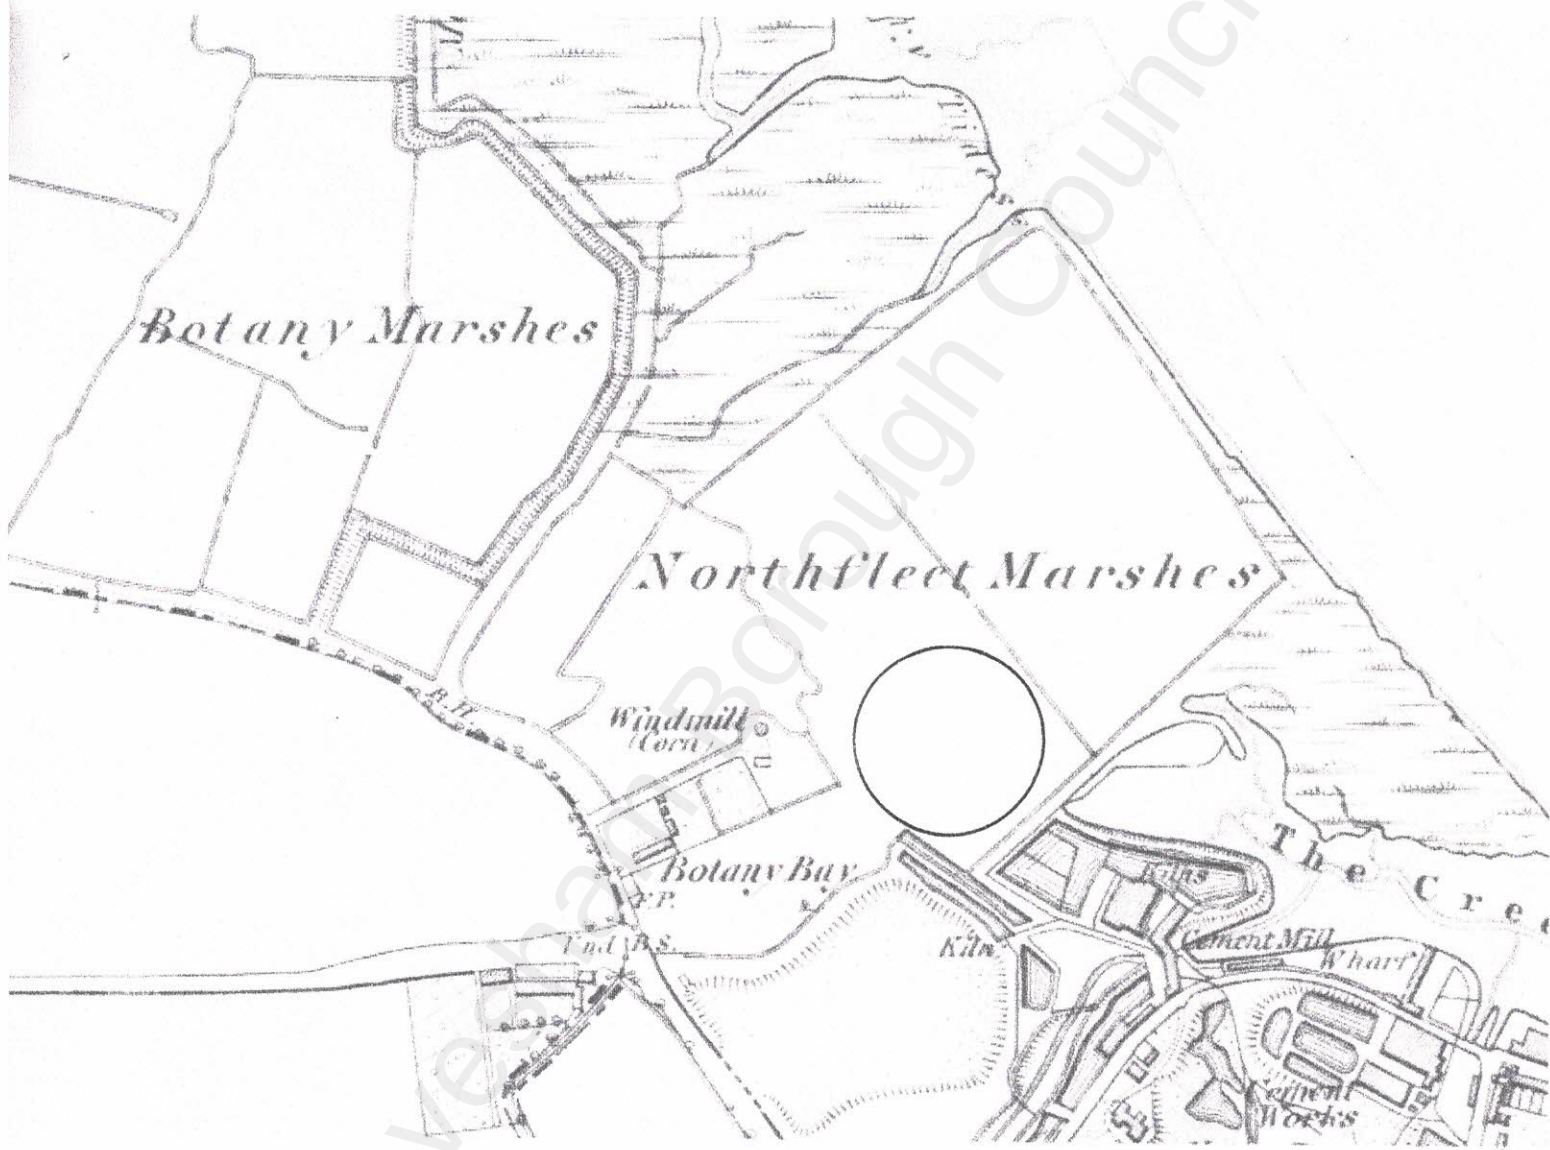
**Unit K6 Lower Road, Northfleet.**  
**OS map scale 1:2500 1869.**

**On site:** The site comprises undeveloped land located within an area of estuarine

marshes. A drainage ditch passes roughly west to east across the site, discharging into a meandering surface watercourse to the north.

**Off site:** A corn windmill and an associated building are located adjacent to the northwest corner of the site. An additional surface watercourse is present within 10m to the northwest. Kilns are denoted within 100m to the south and southeast, a quarry also being in evidence within 100m to the southwest. Cement Works are located within 200m to the southeast of the site.

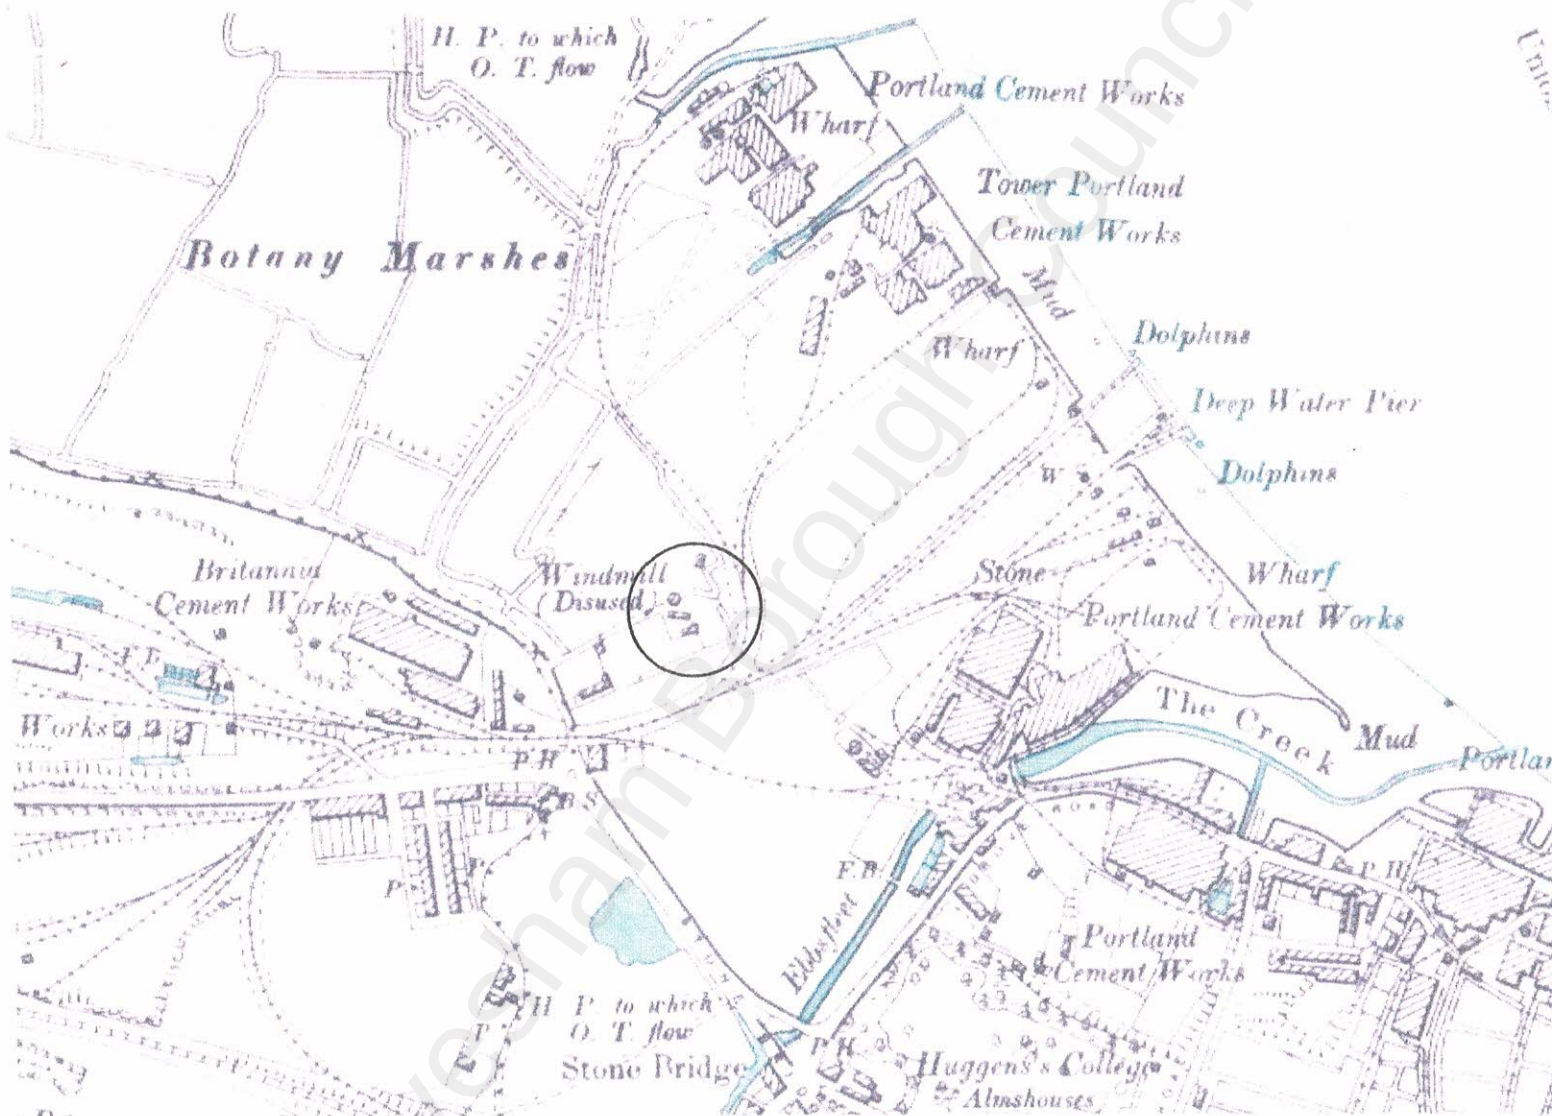
Unit K6 Lower Road, Northfleet.  
OS map scale 1:2500 1898.

**On site:** Tramways have been installed within the local area and appear to cross the southeast corner of the site.

**Off site:** An additional building has been constructed next to the windmill, though the windmill is now disused. Additional cement works and associated tramways have been installed within 200m to the west of the site and within 400m to the northeast, a quarry associated with the former cement works being located within 250m to the west. A flooded quarry is in evidence within 200m to the southwest. Wharfs have been installed alongside the estuary to the northeast. The quarry to the south is no longer denoted.

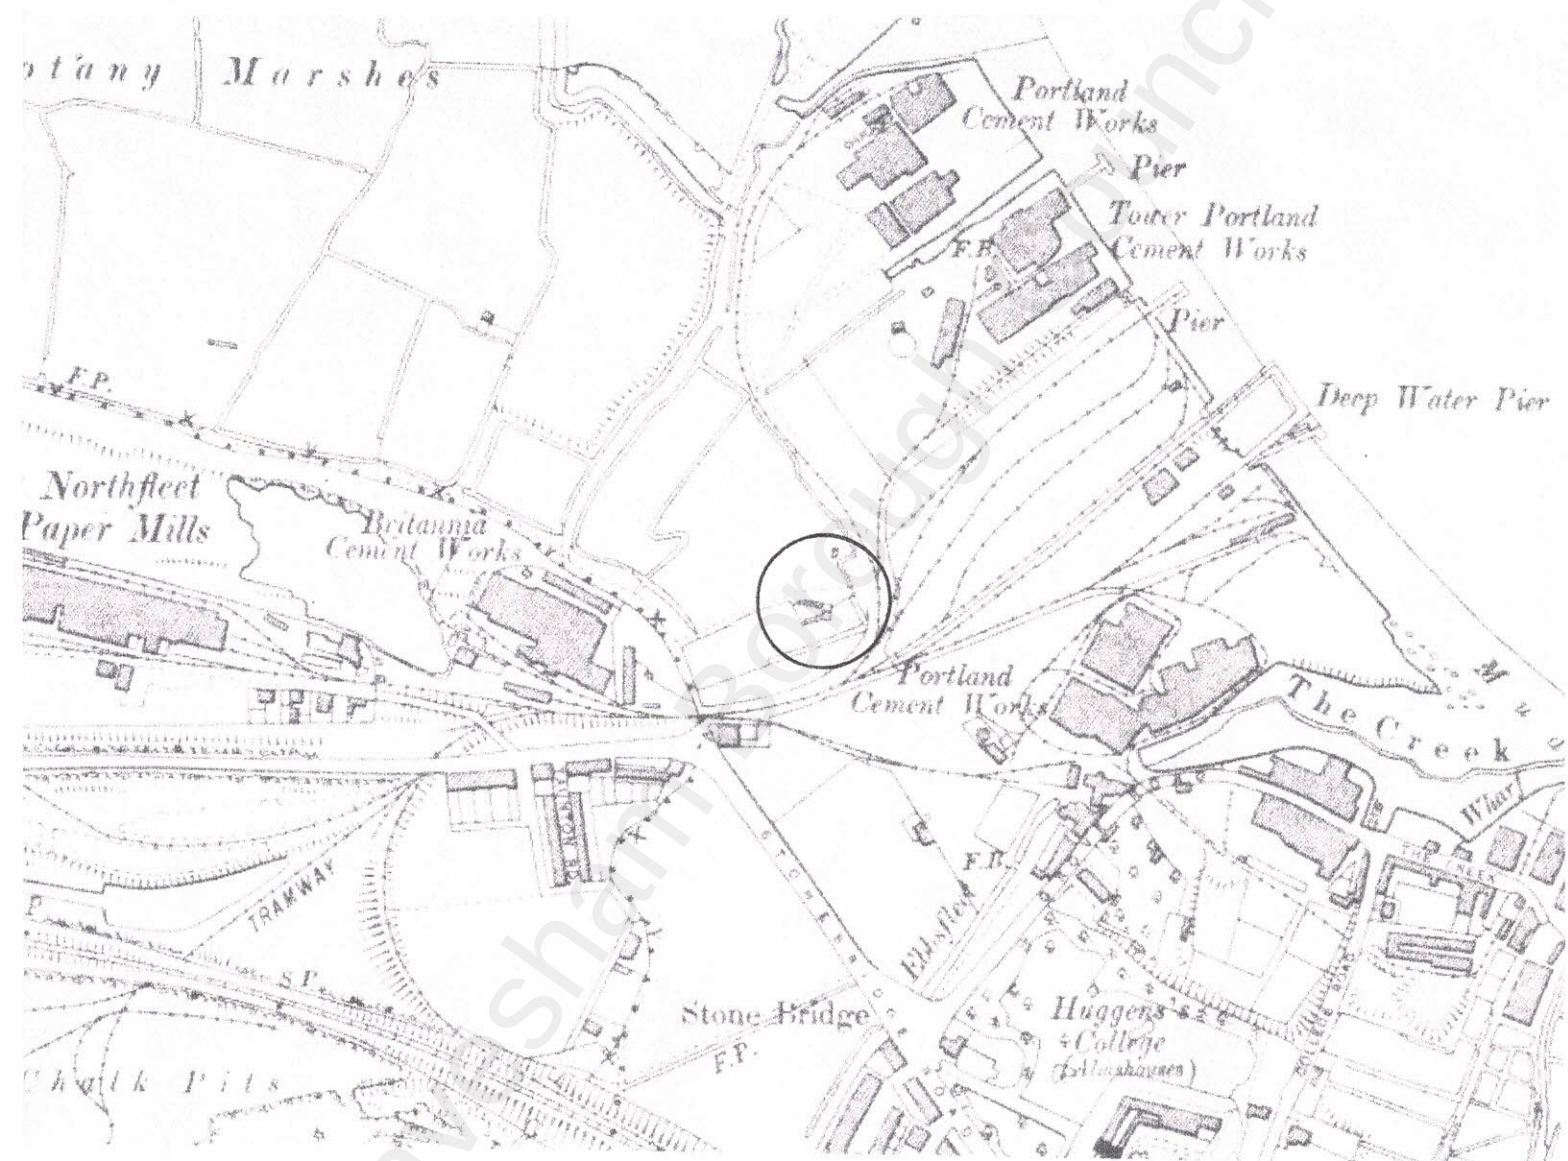
OS map scale 1:2500 1910.

**On site:** No significant change.

**Off site:** The windmill has been demolished, though the pair of adjacent buildings remain. The flooded quarry to the southwest has been infilled. Northfleet Paper Mills have been established within 300m to the west of the site.

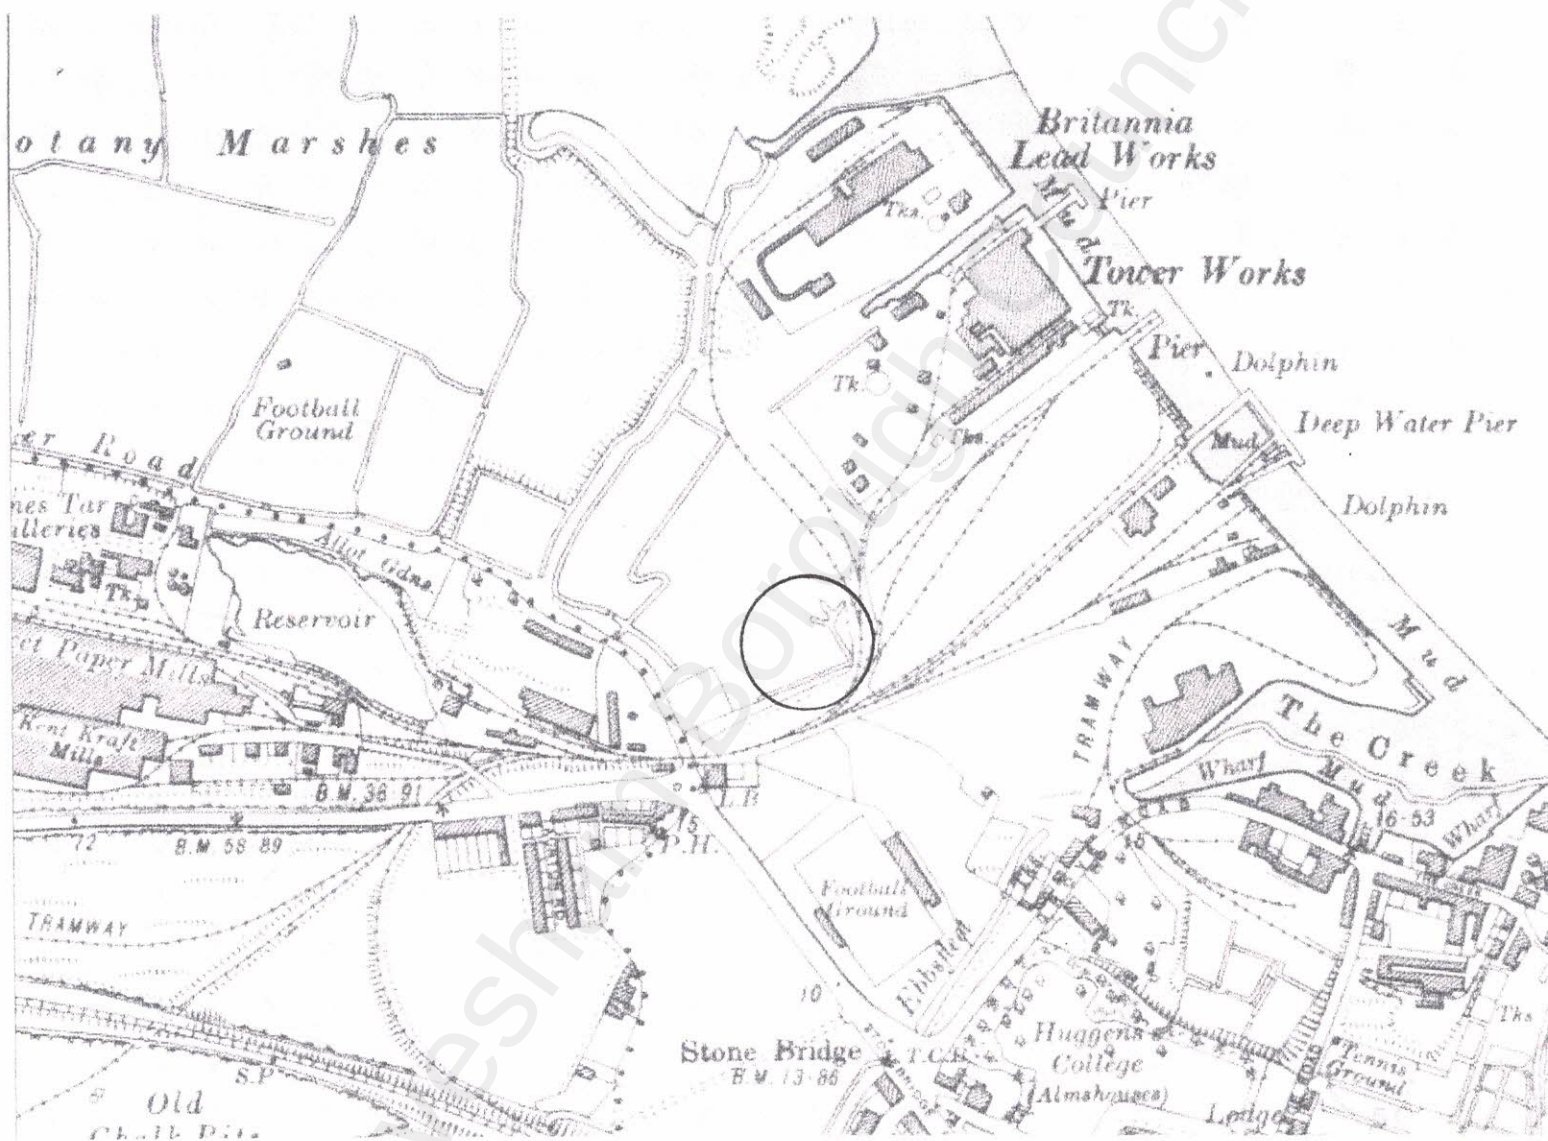
**Unit K6 Lower Road, Northfleet.**  
**OS map scale 1:2500 1934.**

**On site:** No significant change.

**Off site:** The quarry to the west is now referred to as a reservoir. The Britannia Lead Works are denoted within 400m to the northeast of the site.

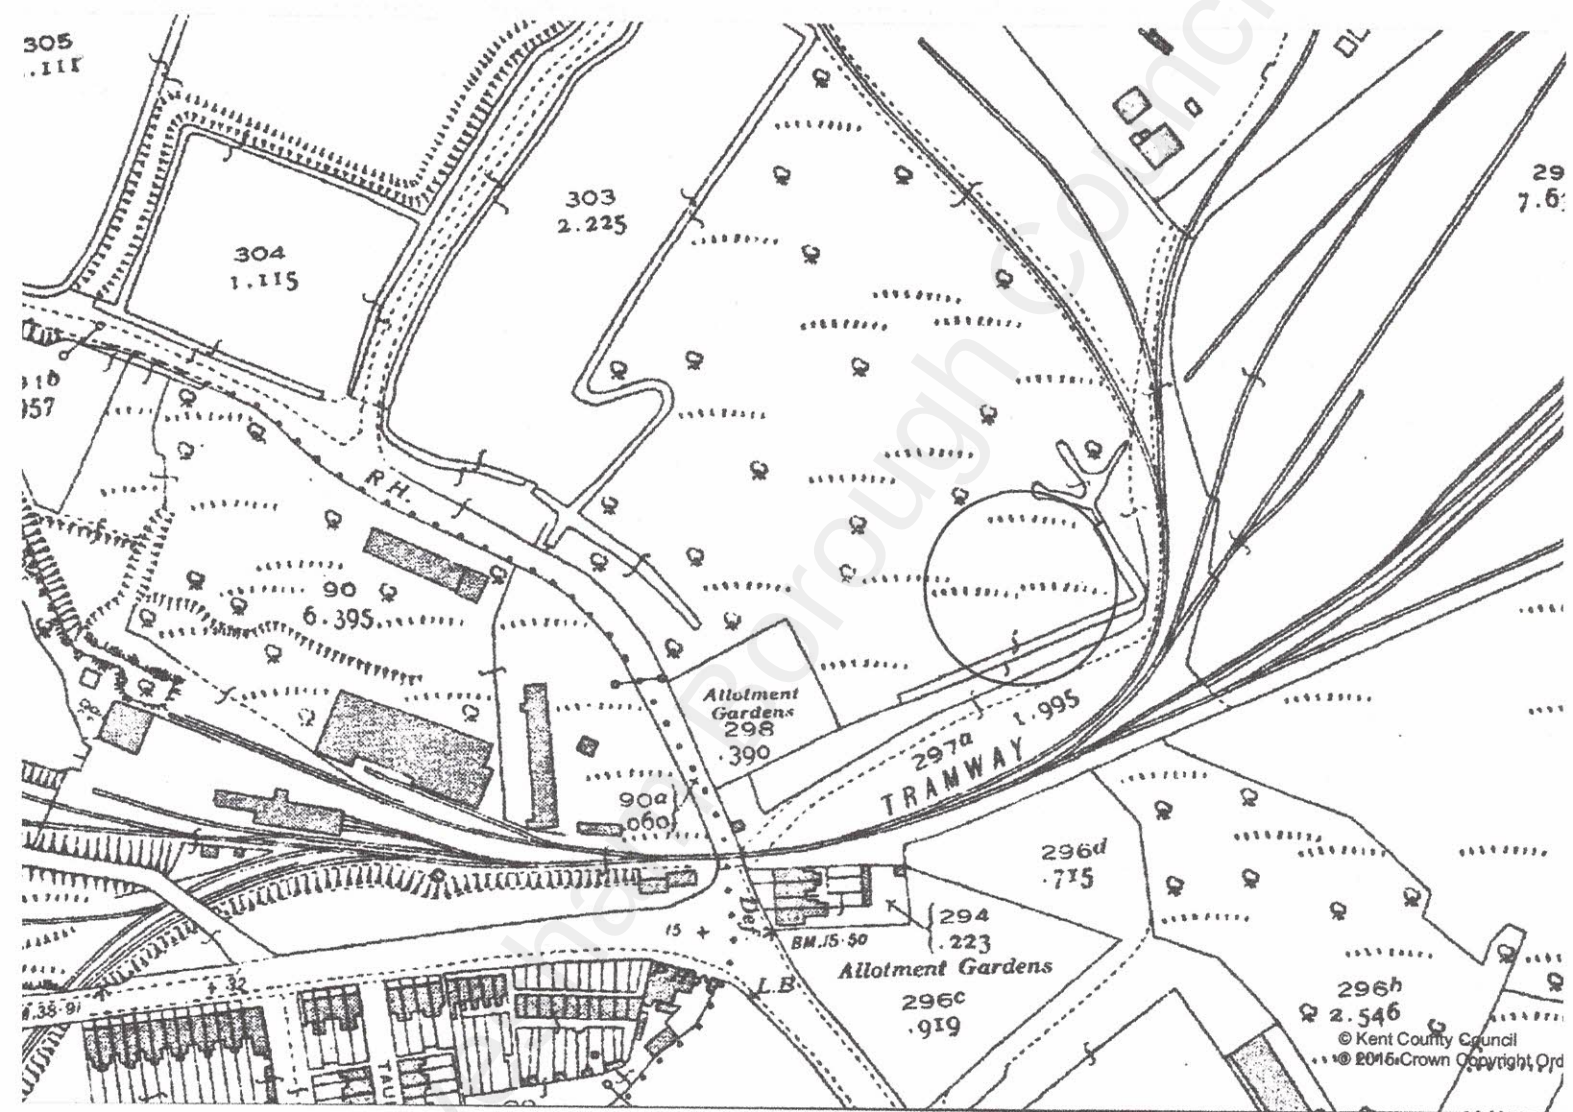
Unit K6 Lower Road, Northfleet.  
OS map scale 1:2500 1929-1952.

**On site:** No significant change.

**Off site:** Allotment gardens are denoted within 25m to the west of the site.

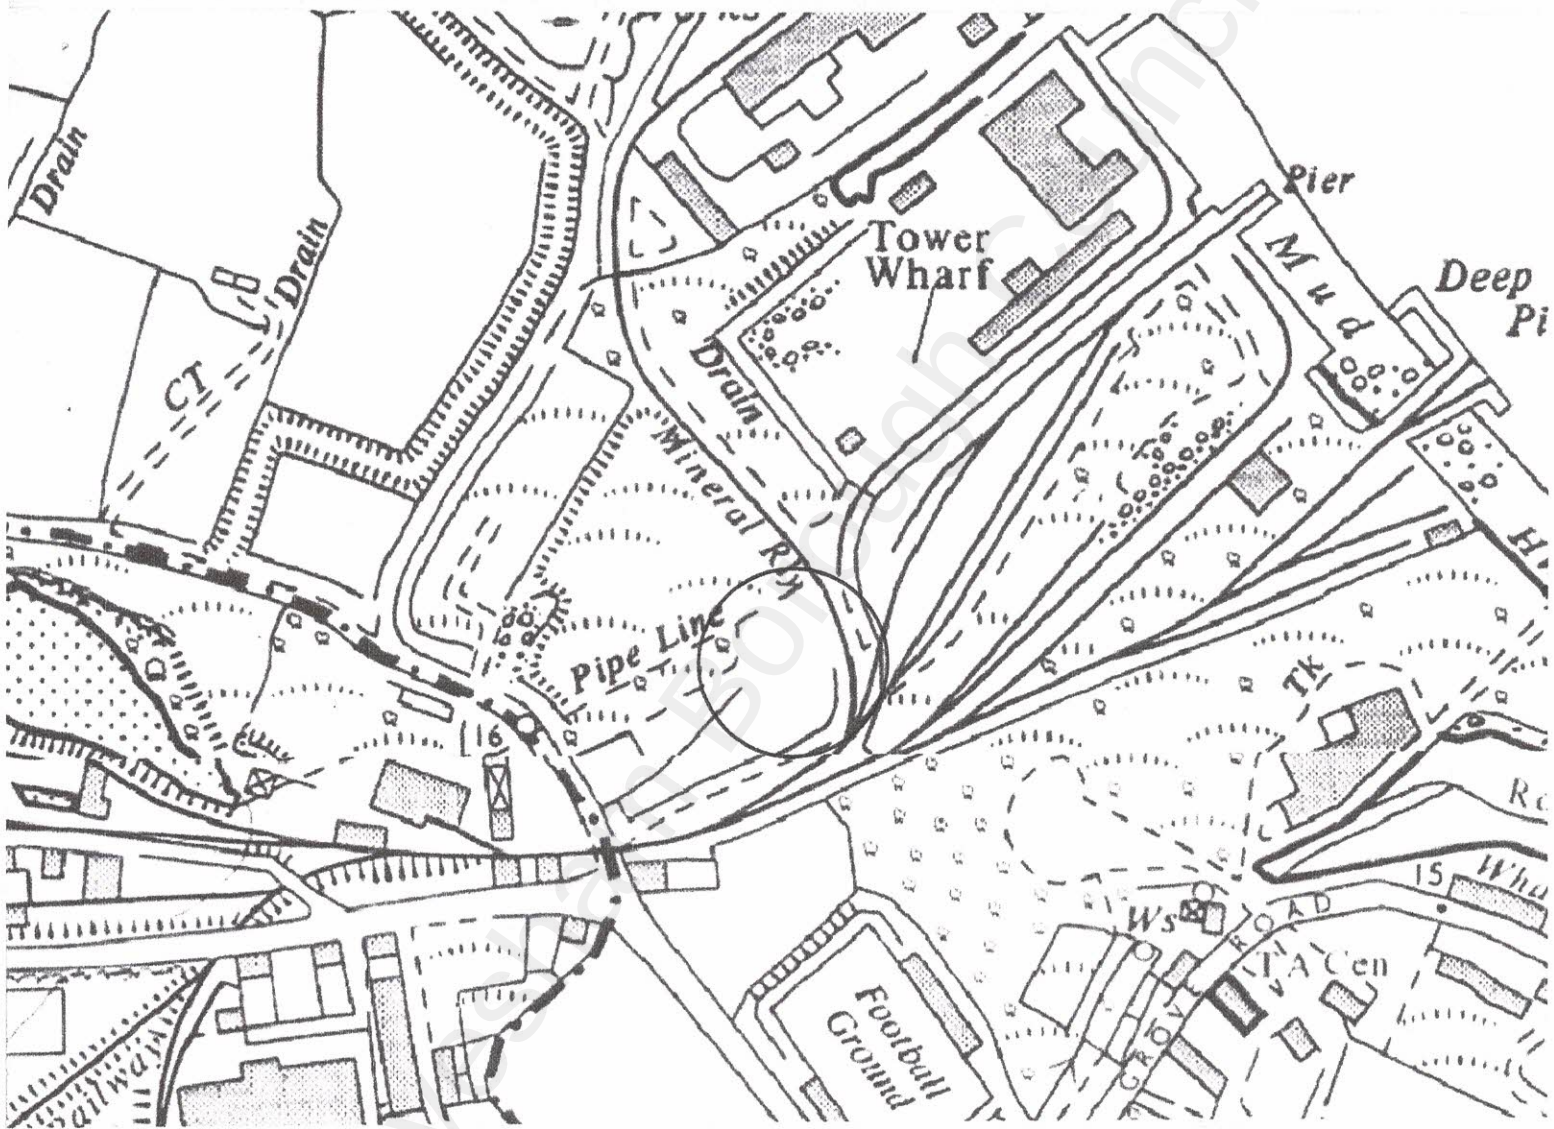
Unit K6 Lower Road, Northfleet.  
OS map scale 1:10560 1961-1962.

**On site:** The drainage ditch is no longer in evidence on the site.

**Off site:** A pipeline passing roughly southwest to northeast has been installed within 25m to the north of the site and a football ground has been constructed within 150m to the south.

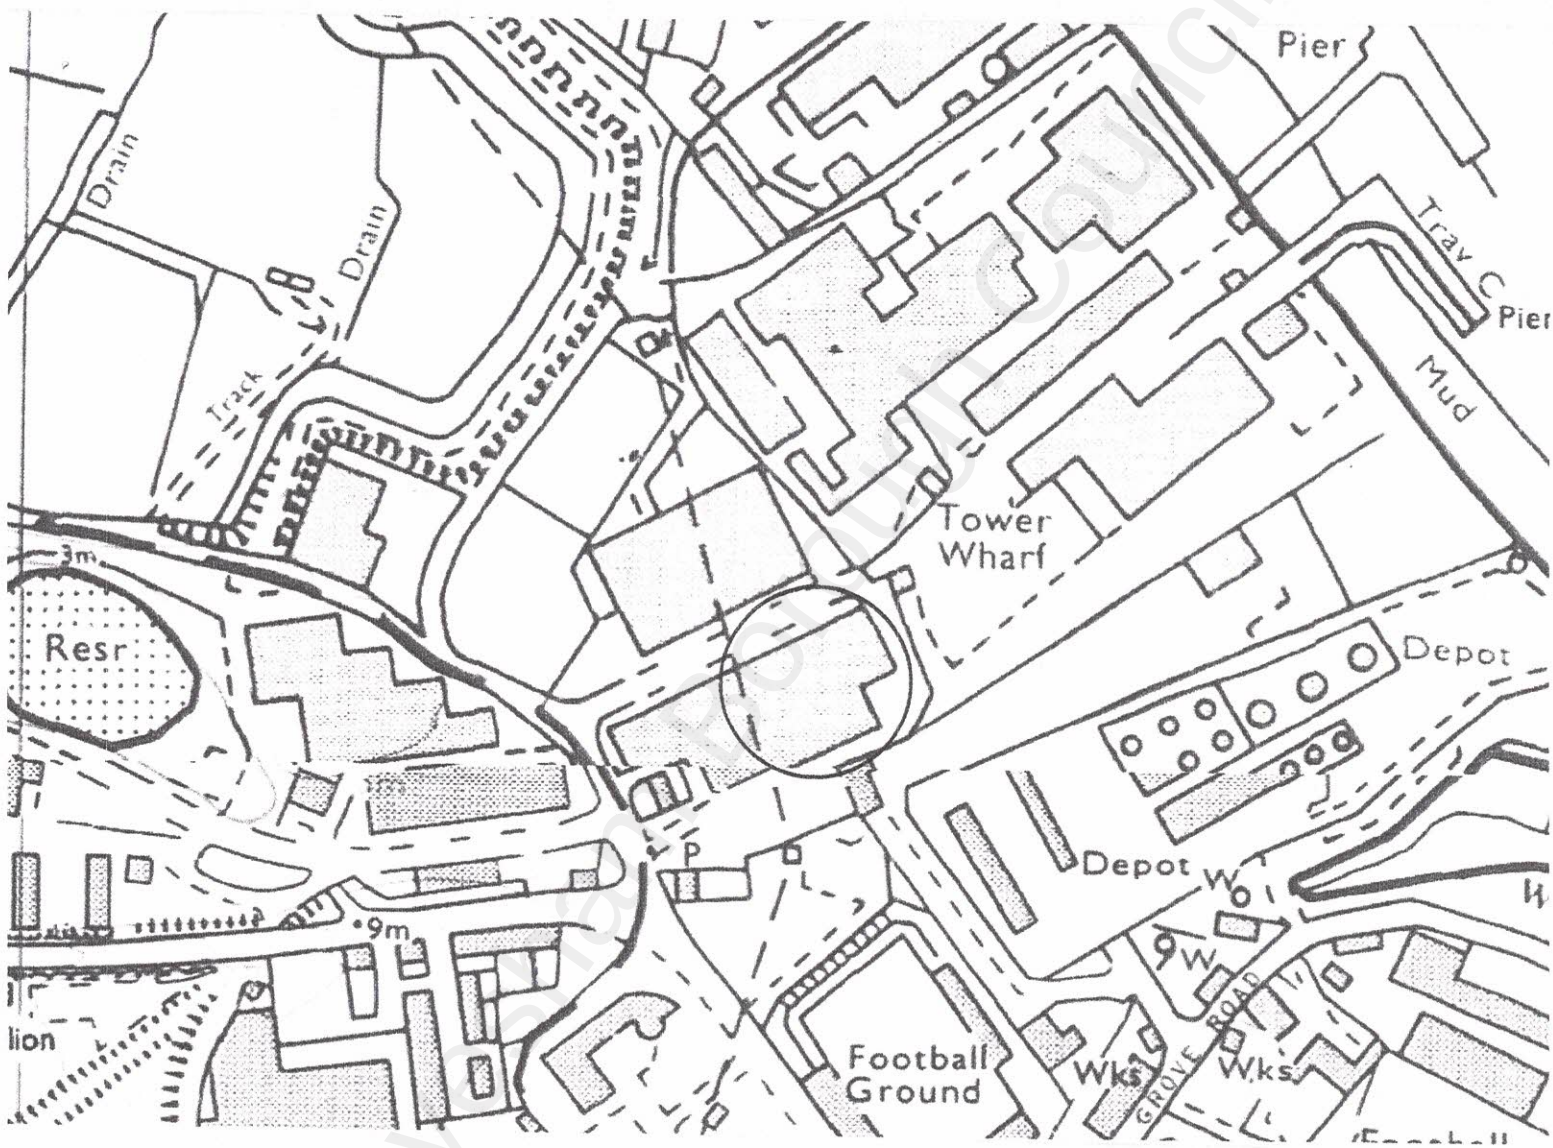
**OS map scale 1:10000 1991-1993.**

**On site:** A large building incorporating the existing unit is now present on the site, extending across the former allotments to the west.

**Off site:** The tramways have been removed and the surrounding area extensively developed with buildings of commercial appearance. Depots are denoted within 100m to the south and southeast. Works are also located within 200m to the southeast. The football ground remains to the south.
