JAMES CLAGUE  
ARCHITECTS

THE OLD FORGE

WROTHAM ROAD,  
MEOPHAM,  
GRAVESEND,  
KENT  
DA13 0JE

REPAIR SCHEDULE  
REV 0

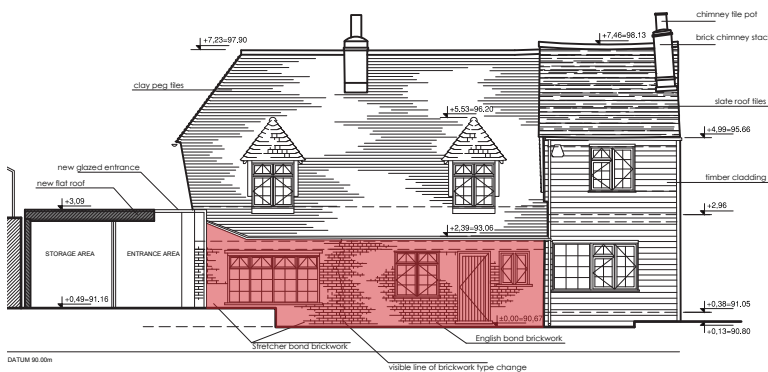
Fig. 7 - Proposed North East Elevation.

The brick walls on the existing front (North East) elevation are of traditional solid wall construction, some bricks have paint residue over the exterior surface. The mortar appears to be cementitious, which forces the moisture to travel through the brickworks rather than the mortar which was supposed to be the sacrificial element.

The severely damaged bricks should be cut out and replaced with new handmade soft bricks that match the existing ones as closely as possible in size, colour, texture, durability, and hardness. The less

The existing brickwork needs repointing. The existing mortar should be raked out to a depth at least twice the width of the joint; with the back of the cleared joint left as square as is practicable. To avoid damage to the bricks, the mortar should be raked out using appropriate hand tools – no powered tools such as a grinder may be used. All loose material from joints should be brushed away. The masonry must be thoroughly dampened with a hosepipe with a spray nozzle or a pump-action water sprayer, before placing the mortar. The mortar is to be 1:3 mix NHL 2.0 : sharp washed local sand. Water to be added to desired consistency. Pigments to be added, if necessary, in order to match colour of the historic brickwork joints. Work should start after a sample patch is considered acceptable by architects.

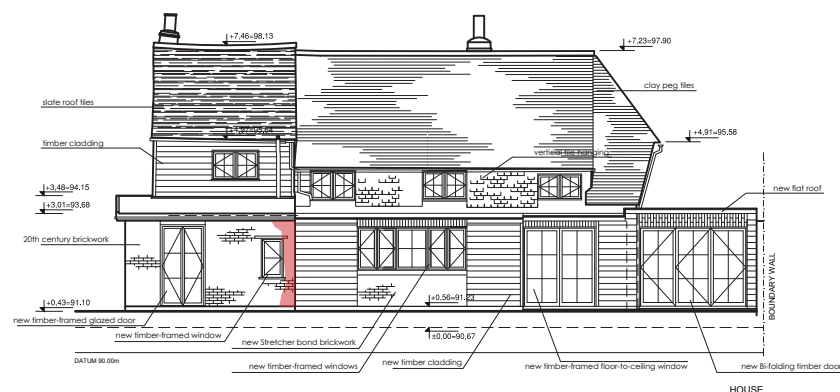
Fig. 8 - Proposed South West Elevation.

The bricks on the existing rear extension are in good conditions generally, apart from the bricks adjacent to the cladded wall on the South West elevation, which show sign of hygroscopic salts and erosion on some of the brick surface. This could be caused by the deterioration of the junctions between the two flat roofs which allow the ingress of rainwater, and/or the excessive amount of moisture within the solid wall behind the timber cladding transferring the moisture via capillary action.

The bottom section of the brickworks also suffered from dampness due to the previously leaked drain pipe, which was then fixed temporarily. The drain pipe is to be removed and new soil vent pipe is to be installed to serve the ground floor shower room and bathroom above.

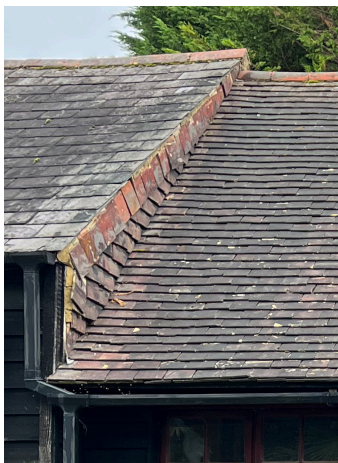
*Fig. 9 - Photo of the existing Old Forge.*

The vertical tile hanging is in overall good condition. The existing timber battens supporting the vertical tile hanging are to be inspected for signs of rot and decay because of moisture attack or corroding nails. Any timber members showing signs of decay are to be replaced. All existing material that is structural sound and in good condition will be retained.

In some locations where the cementitious mortar bedding starts to deteriorate and enable water penetration, the cement mortar should be raked out carefully and replaced by lime mortar.

The lime mortar should be packed firmly into the gap between the tile hanging and substrate using a pointing iron after all the loose material has been flushed out and the tiles wetted first to reduce suction. The gap needs to be thoroughly filled and compacted to avoid voids. It should be filled slightly proud of the intended finished level to allow for slight shrinkage and compaction of the mortar as it firms up. Any mortar that is smeared on the tiles should be sponged off with clean water before it has dried.

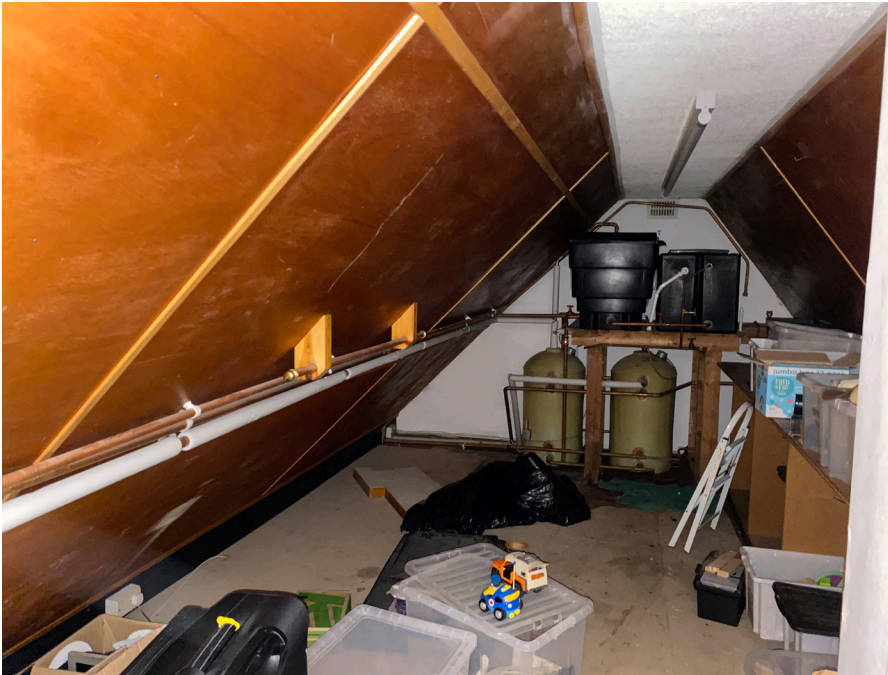
Fig. 16 - Photo of the loft space under the main clay tile roof.

Under the main clay tile roof, the loft space is being used as a storage and place to accommodate the water tanks/cylinders. The insulation is installed at the rafter level.

Replace the existing insulation between the rafters with sheep's wool insulation such as Thermafleece and install an extra layer of wood-fibre tongue and groove insulation board below the rafters, following by applying breathable lime plasters.

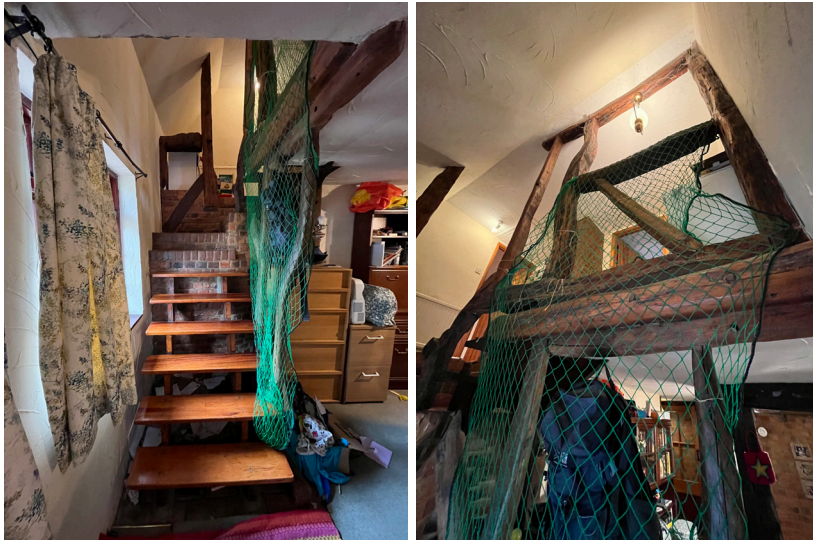
Fig. 19 - Photos of the existing stairs.

The existing staircases do not have rigid / safe guarding, which creates hazards for the habitants and visitors. Young and elder people are especially vulnerable to the existing arrangement. New guardings such as a very simple slimline back steel balustrades with railings are to be installing to the staircases and landing.
