**LISTED BUILDING APPLICATION ref PP-12034428 (C1332):**  
**Partial discharge of conditions 3.2 and 4.3**  
**Cupola repairs at Gad’s Hill School, Rochester**

Cupola condition discharge

# Brief report outlining the process to arrive at the final approach to cupola repairs

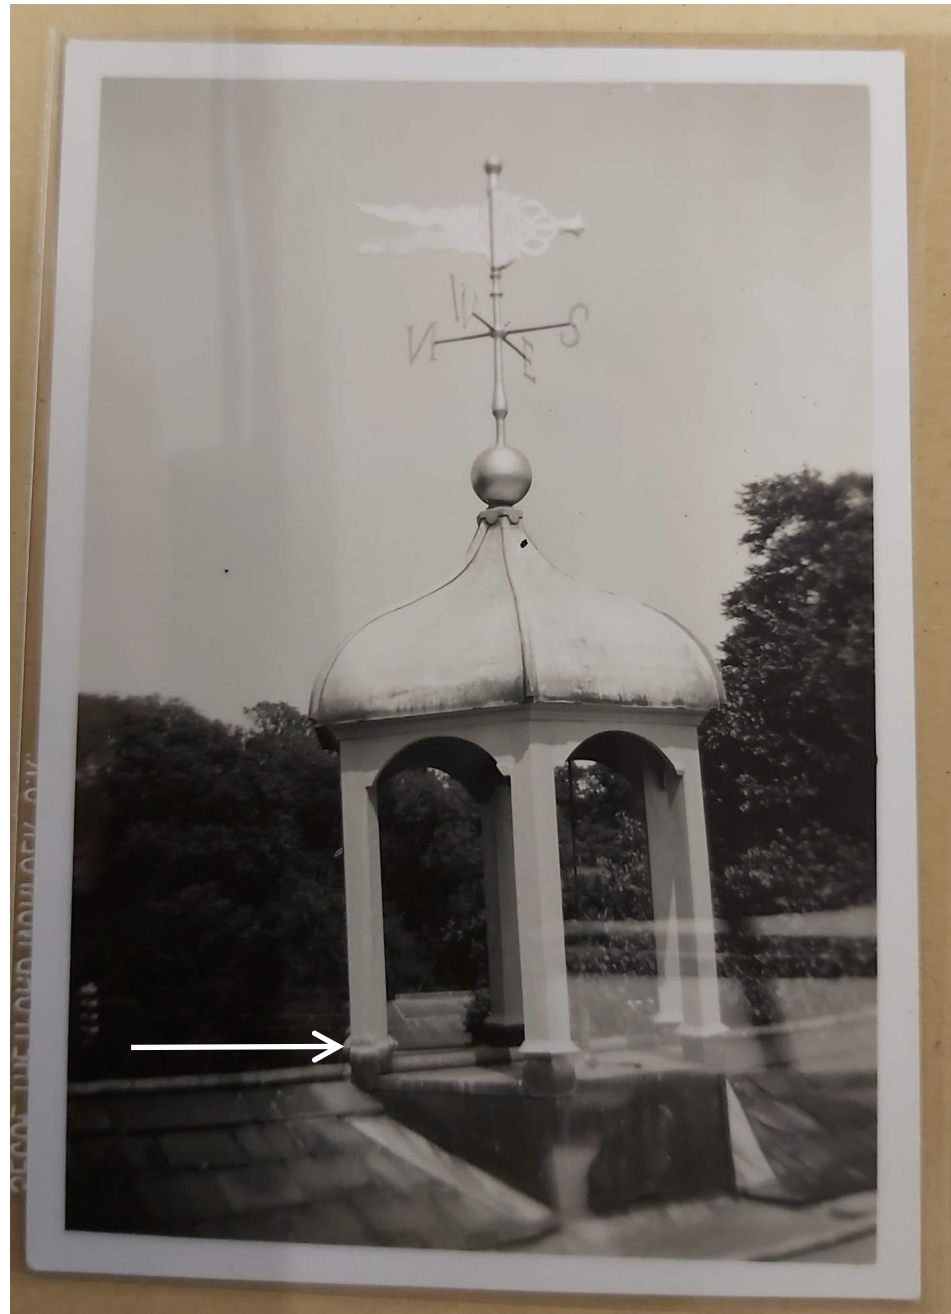
Historic photograph showing timber flashing covers

- Historic photographs show a timber flashing cover detail that is now missing. The missing flashing cover protected the junction between the top of the lead flashing and the posts. They also appear to show the cupola about half a foot taller than it currently is ( the posts may have been shortened in the course of previous repair work ). With the top of the flashing exposed and secured with copper nails and gaffer tape, this has made the 'feet' of the posts at platform level more susceptible to damp and rot.

- Reconstructing the timber frame of the cupola, extending the roof stalk / finial post and spindle and introducing a tie beam or strut across the rafters to provide more structural support and restraint for the weathervane
- Lowering the stock of the bell wheel to provide more room for the wheel and to avoid clashes with the new tie beam or strut
- Reintroducing the historic capping detail to cover and protect the lead flashing up the posts.

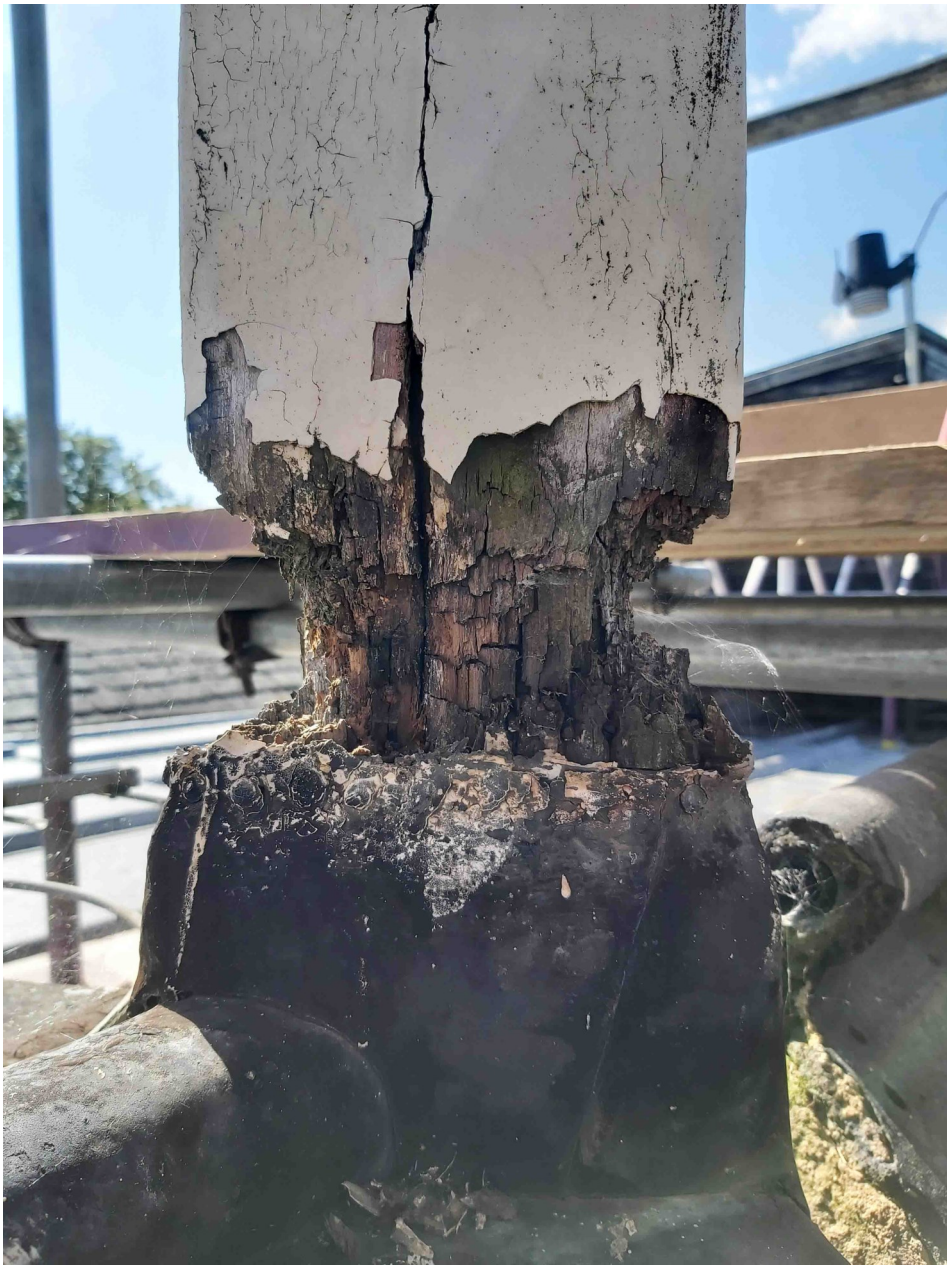
23/08/2023

Measured survey and drawing up of the cupola was carried out in August 2023; a LBA submitted in early September indicated the issues that were visible: the 'feet' of the posts were rotted above flashing level; more than half the girth of the timber posts rotted away on 2 of the 'feet'; roof twisting anticlockwise on its axis; weathering and deterioration of finishes all over.

Deterioration on cupola post

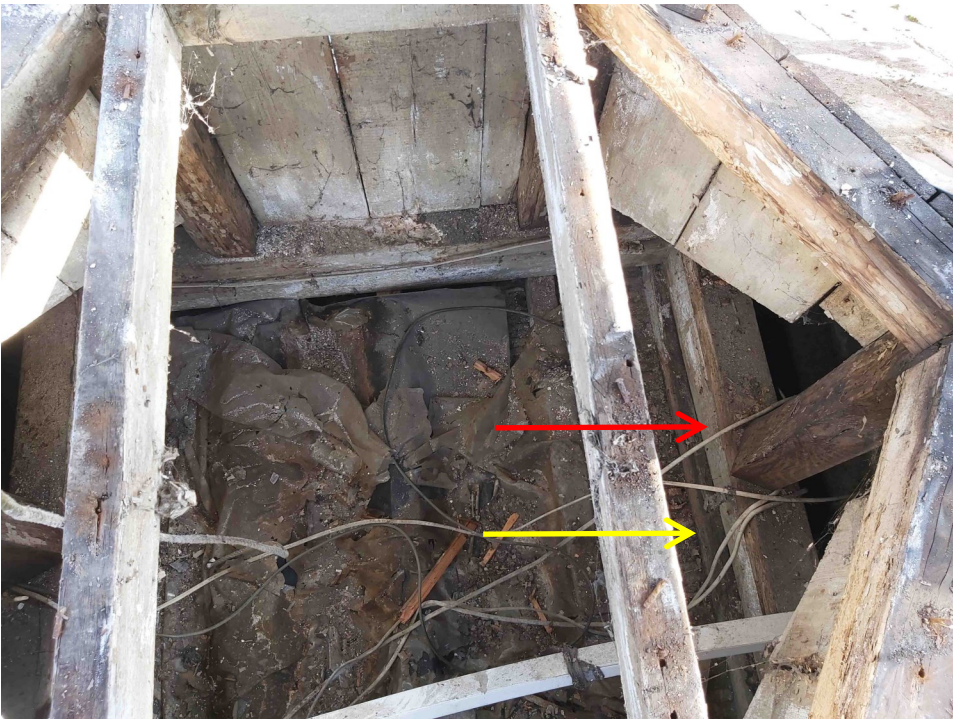
2/04/2024

During the opening of the roof, it is discovered that the existing cupola is supported on a more recent base frame, which is itself resting on top of the original historic base frame. The posts were tenoned into the more recent base frame in such a way that it was impossible to remove the posts without cutting the frame. The timbers of the removed base frame are made of pine, surface-planed, machined and repaired. The frame has rectilinear tenons which were tosh-pinned and probably dates to sometime after 1860.

Red arrow: 'Newer' base frame (after 1860) resting on top of  
Yellow arrow: original base frame

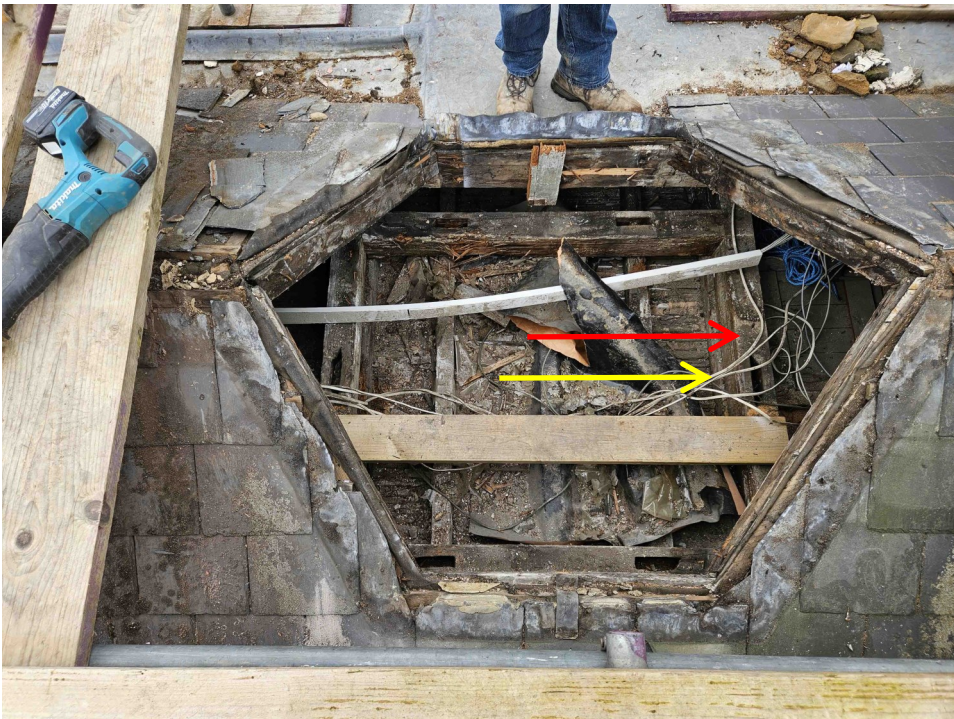
04/04/2024

With posts removed

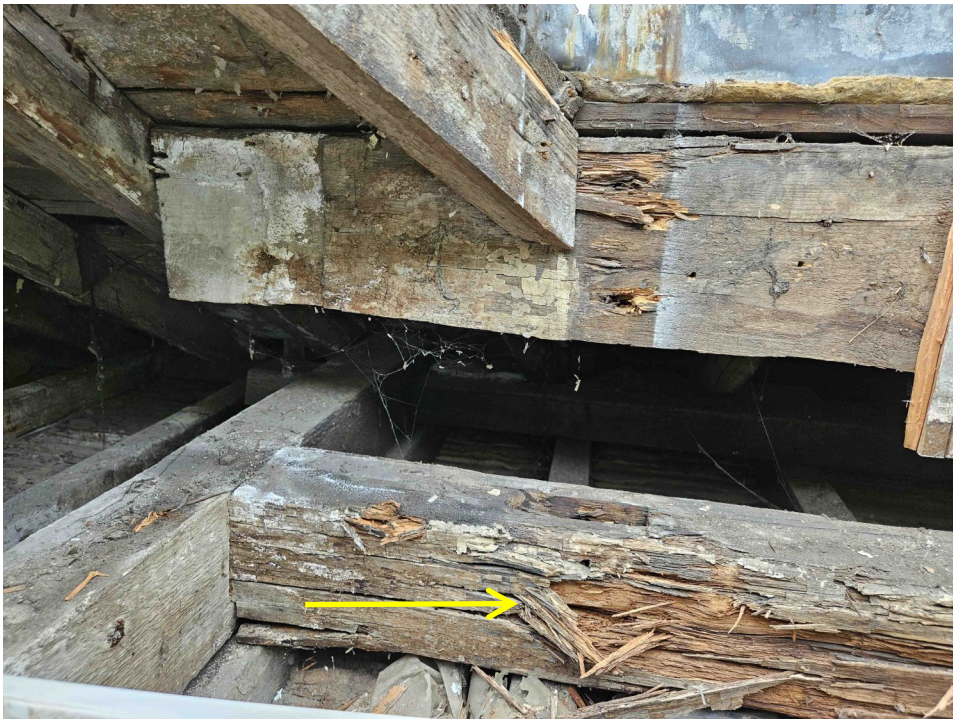
4/04/2024

One of the beams of the historic base frame has suffered significant

water damage and is not structurally sound.

Original base frame showing damaged beam

- A site visit was carried out with KG, JF, CP2 and CB on the 29/10/2024 to have a closer look at the damage to the beam of the original historic base frame. The beam is damaged beyond repair and not structurally sound— a new timber beam will be fitted in its place ( with joist hangars ) before the cupola is reinstalled.

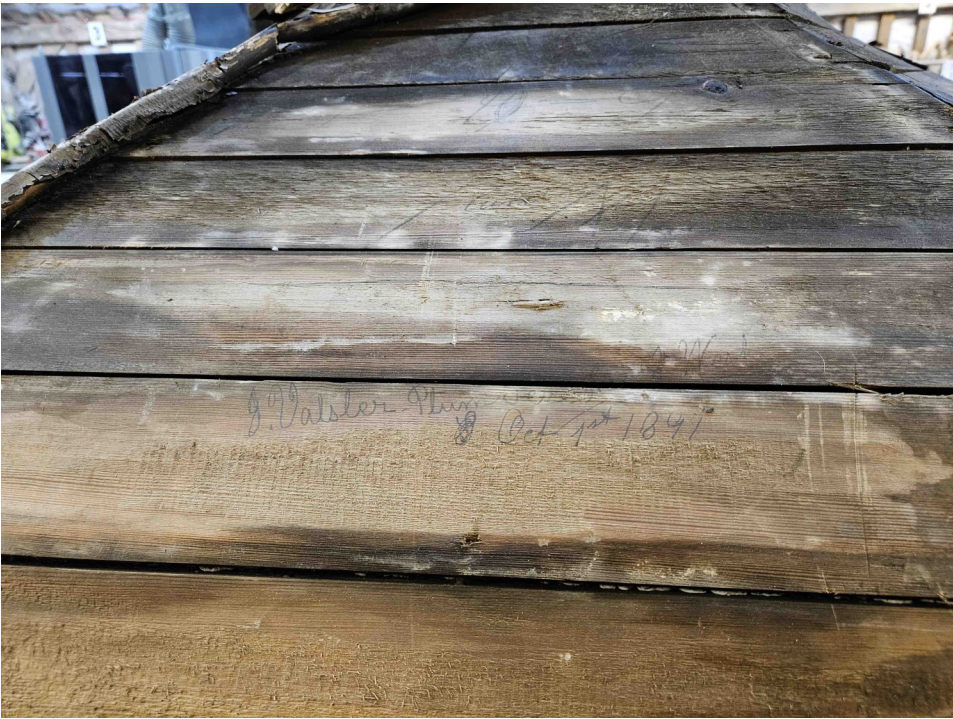
22/05/2024 ( at Faversham Joinery )

- Besides the weathervane and bell, it is difficult to tell what else of the cupola is original /18thC. Much of it is in poor condition.
- What is clear is that the cupola has been repaired more than once over the years. The plumber's mark on the roofing boards dates the last cupola roof repairs to 1897 ( Dickens died in 1870, the house was built in 1779 ).

Roofing boards with inscription: J Vasler plumbers: Oct 1st 1897

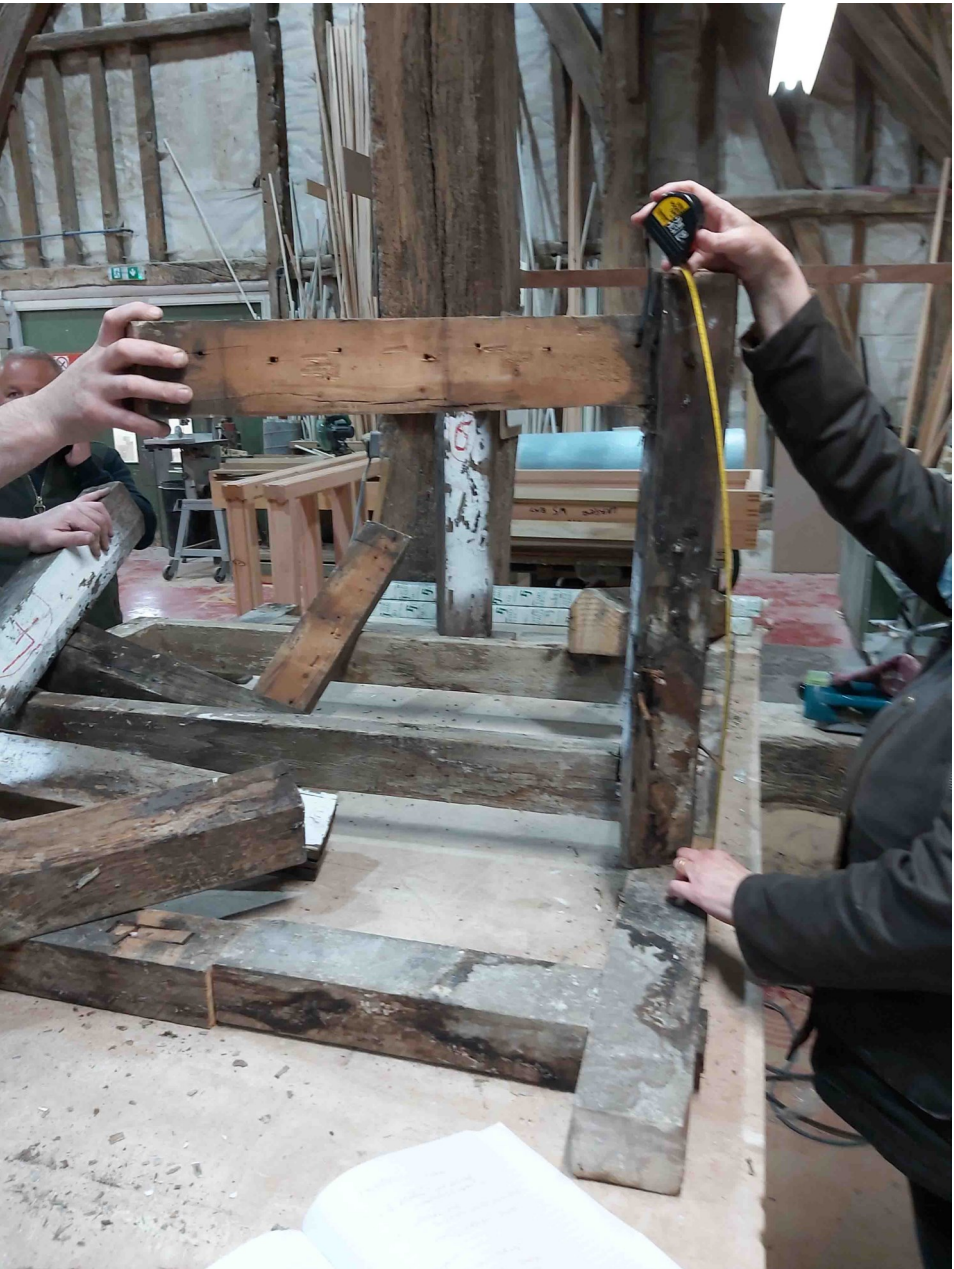
22/05/2024

Sorting through cut frame and post connections

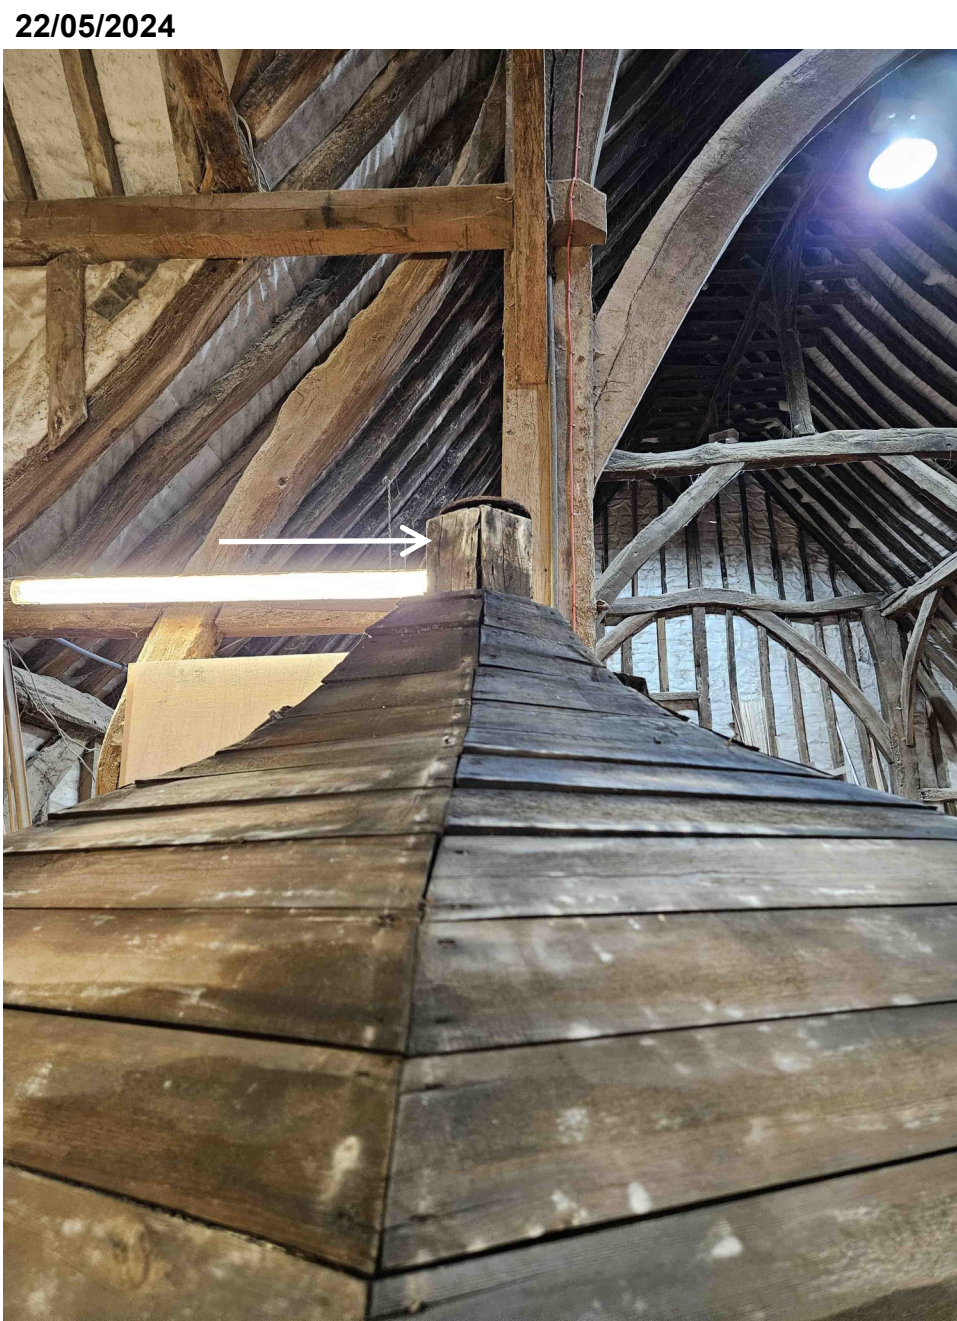
- The roof stalk / finial post is in a poor state. It is severely split in 2 places externally and split in half at the base.
- The weathervane is 60% lead. The metal washer where the weathervane meets the lead cap at the roof stalk is rusted through and the weathervane pivots out of line with its centre-point.

Split in the roof stalk

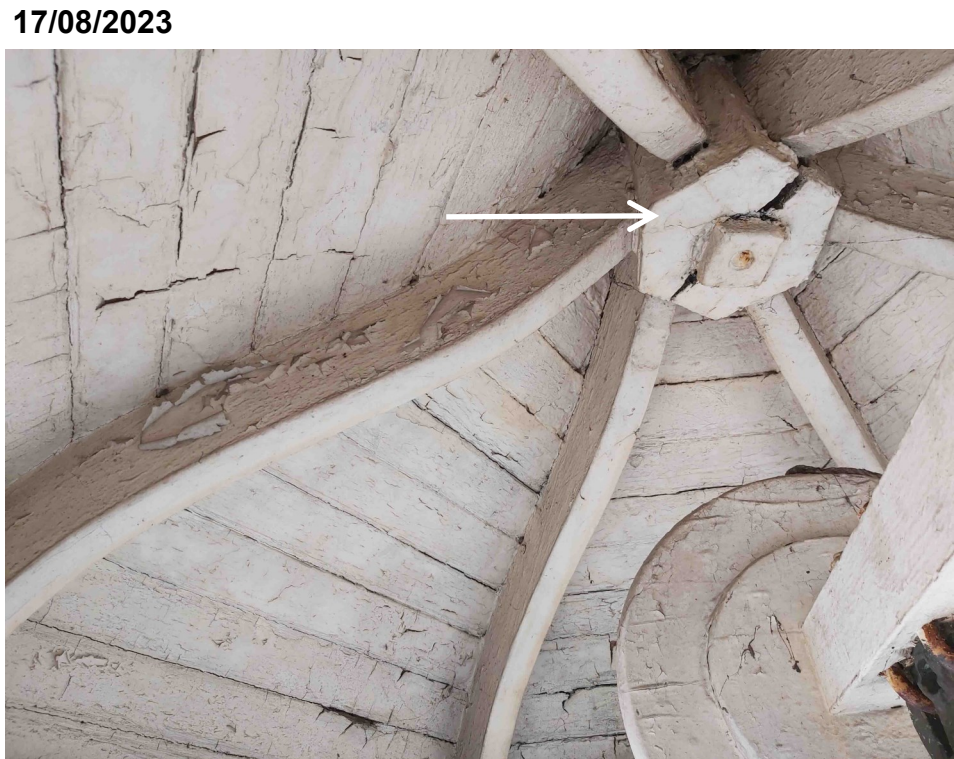
Roof stalk split in half at the base

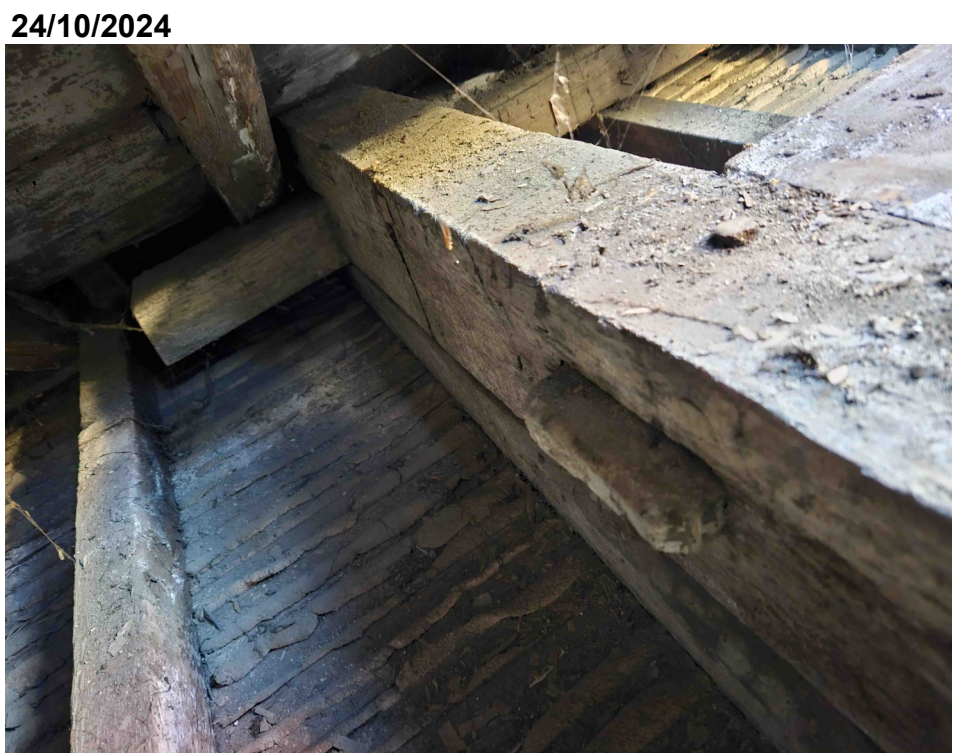
Original base frame resting on ceiling joists
