## HERITAGE DESIGN AND ACCESS STATEMENT -18Q-03 – NOVEMBER 2023

**To accompany an application for a 'Certificate of Lawfulness of Proposed Works to a Listed Building' at Nurstead Hall, Nurstead Lane, Longfield Hill, Kent, DA3 7AN**

Scope of proposals: Essential repairs and reinforcement to existing roof structure.

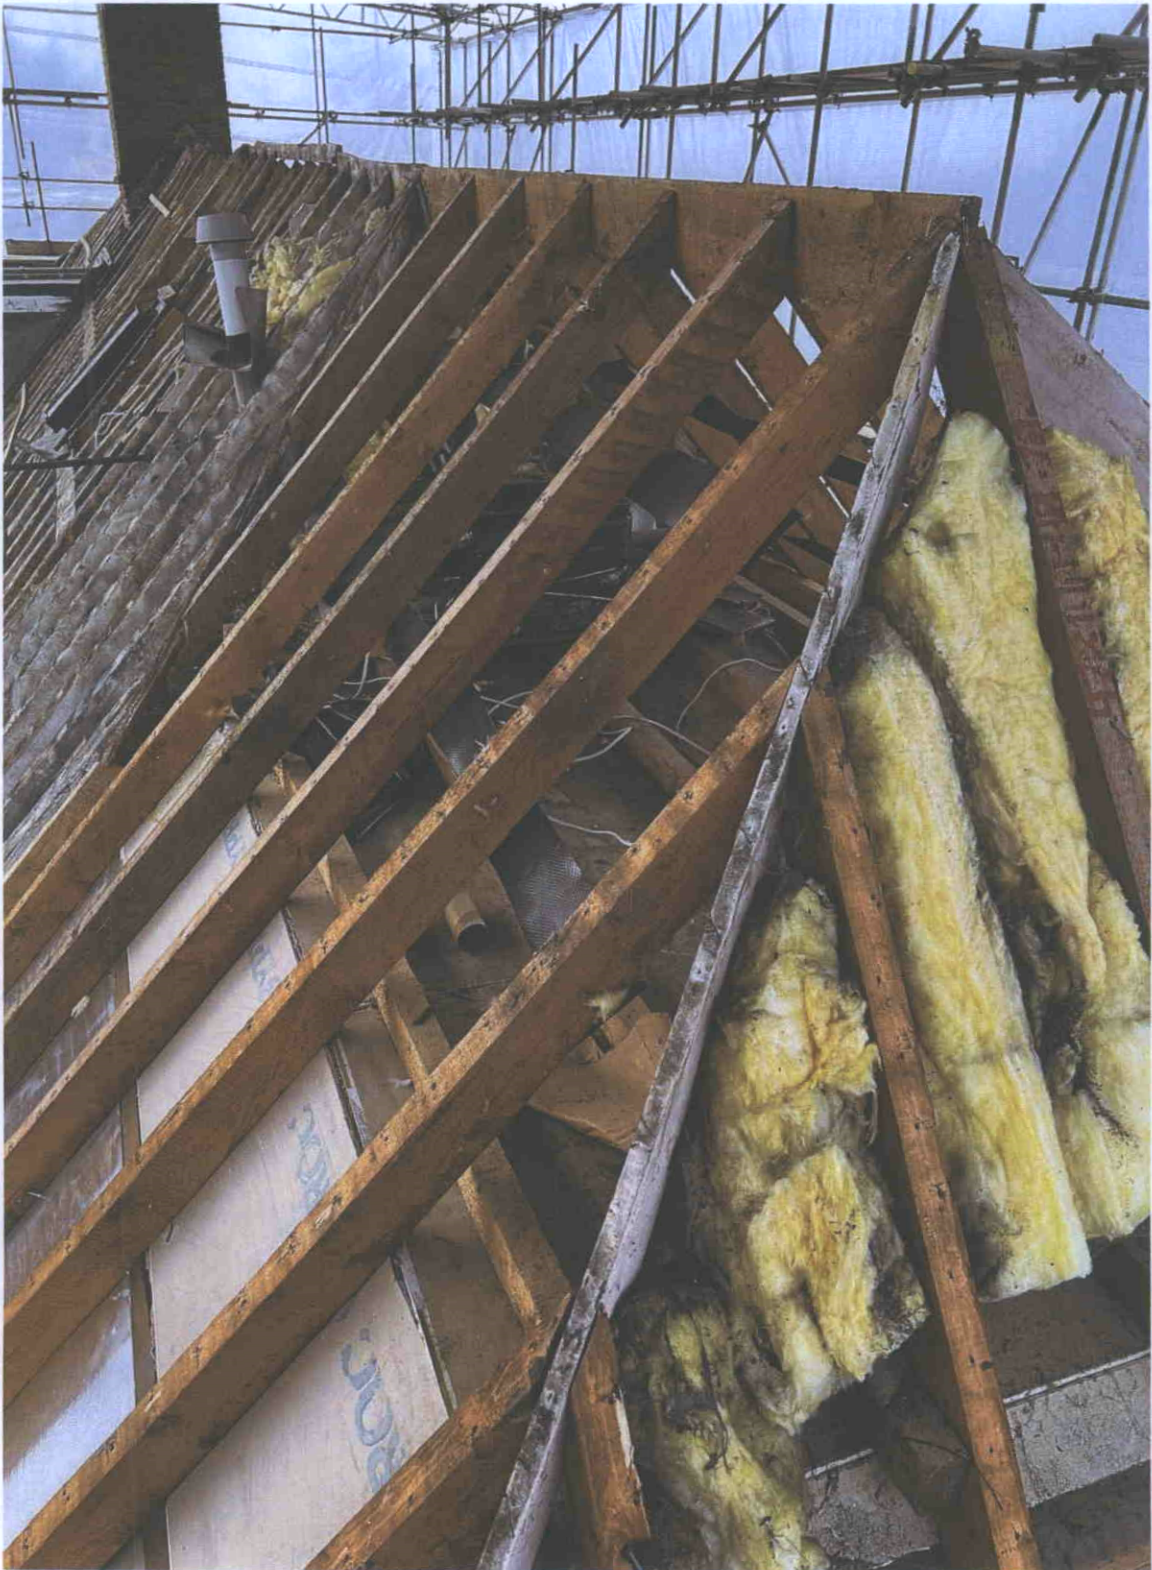
The C20 half-hip of bay 6 – east elevation

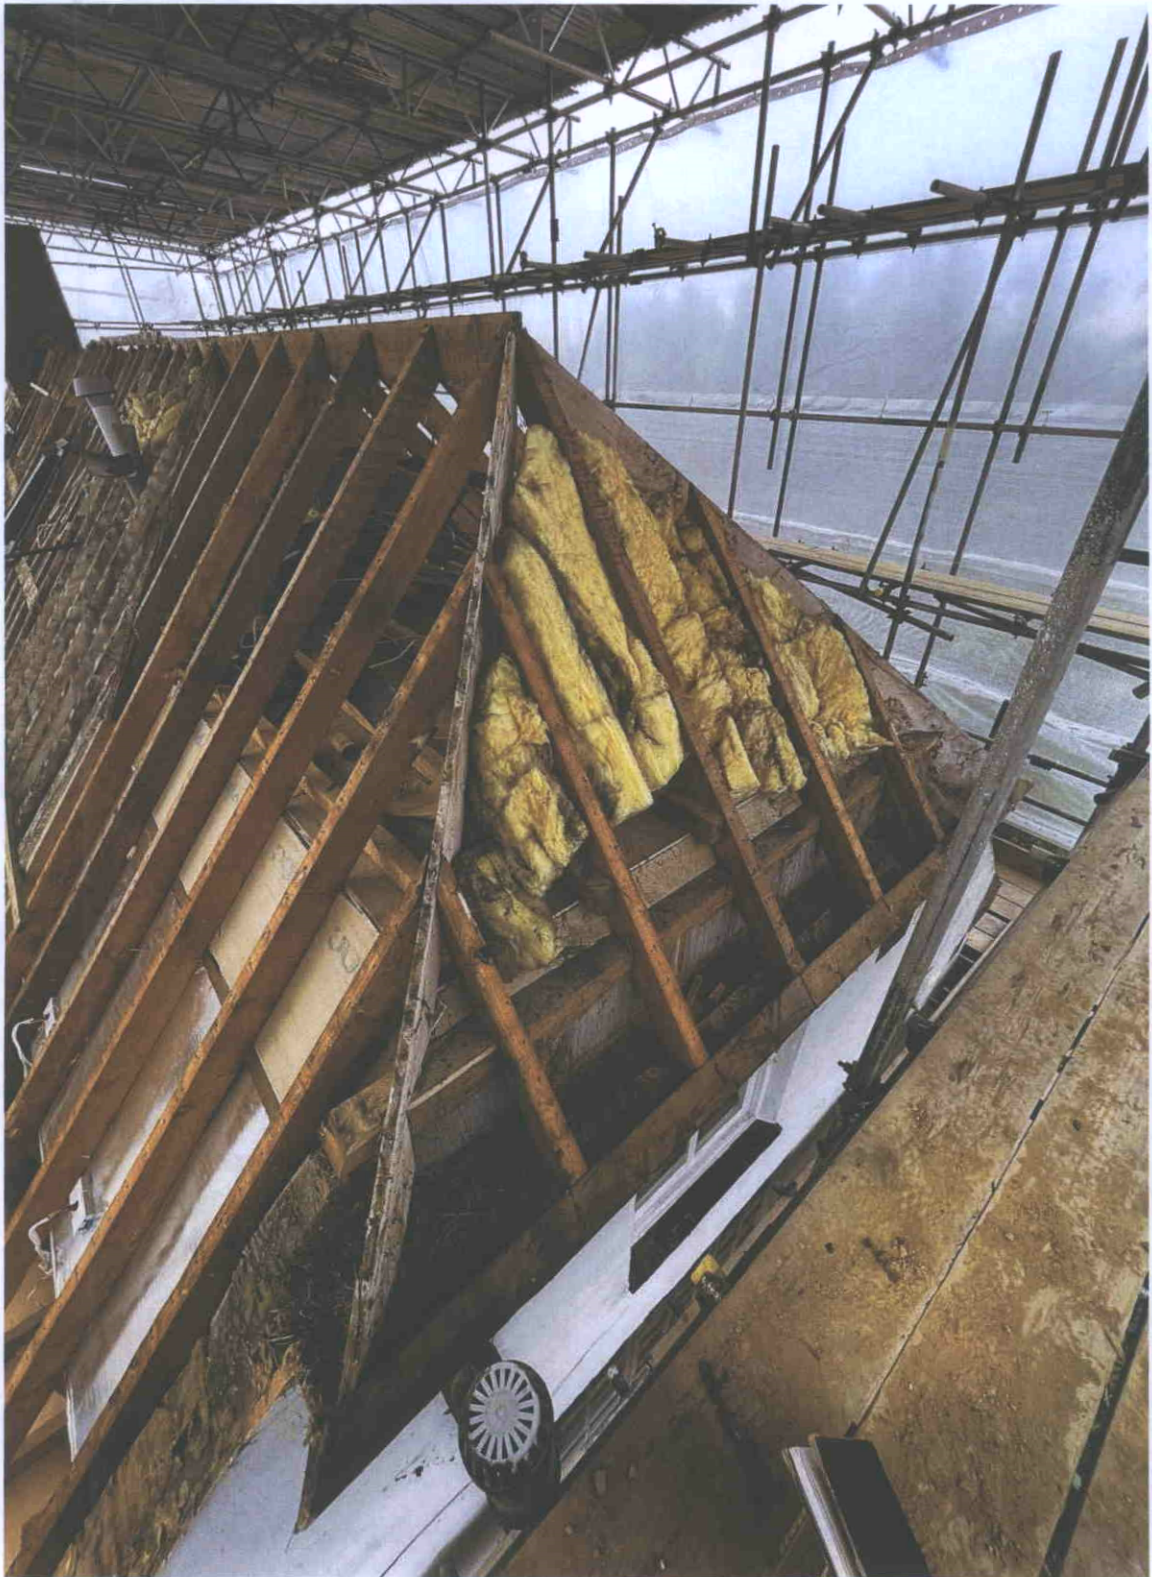
The C20 half-hip of bay 6 – east elevation

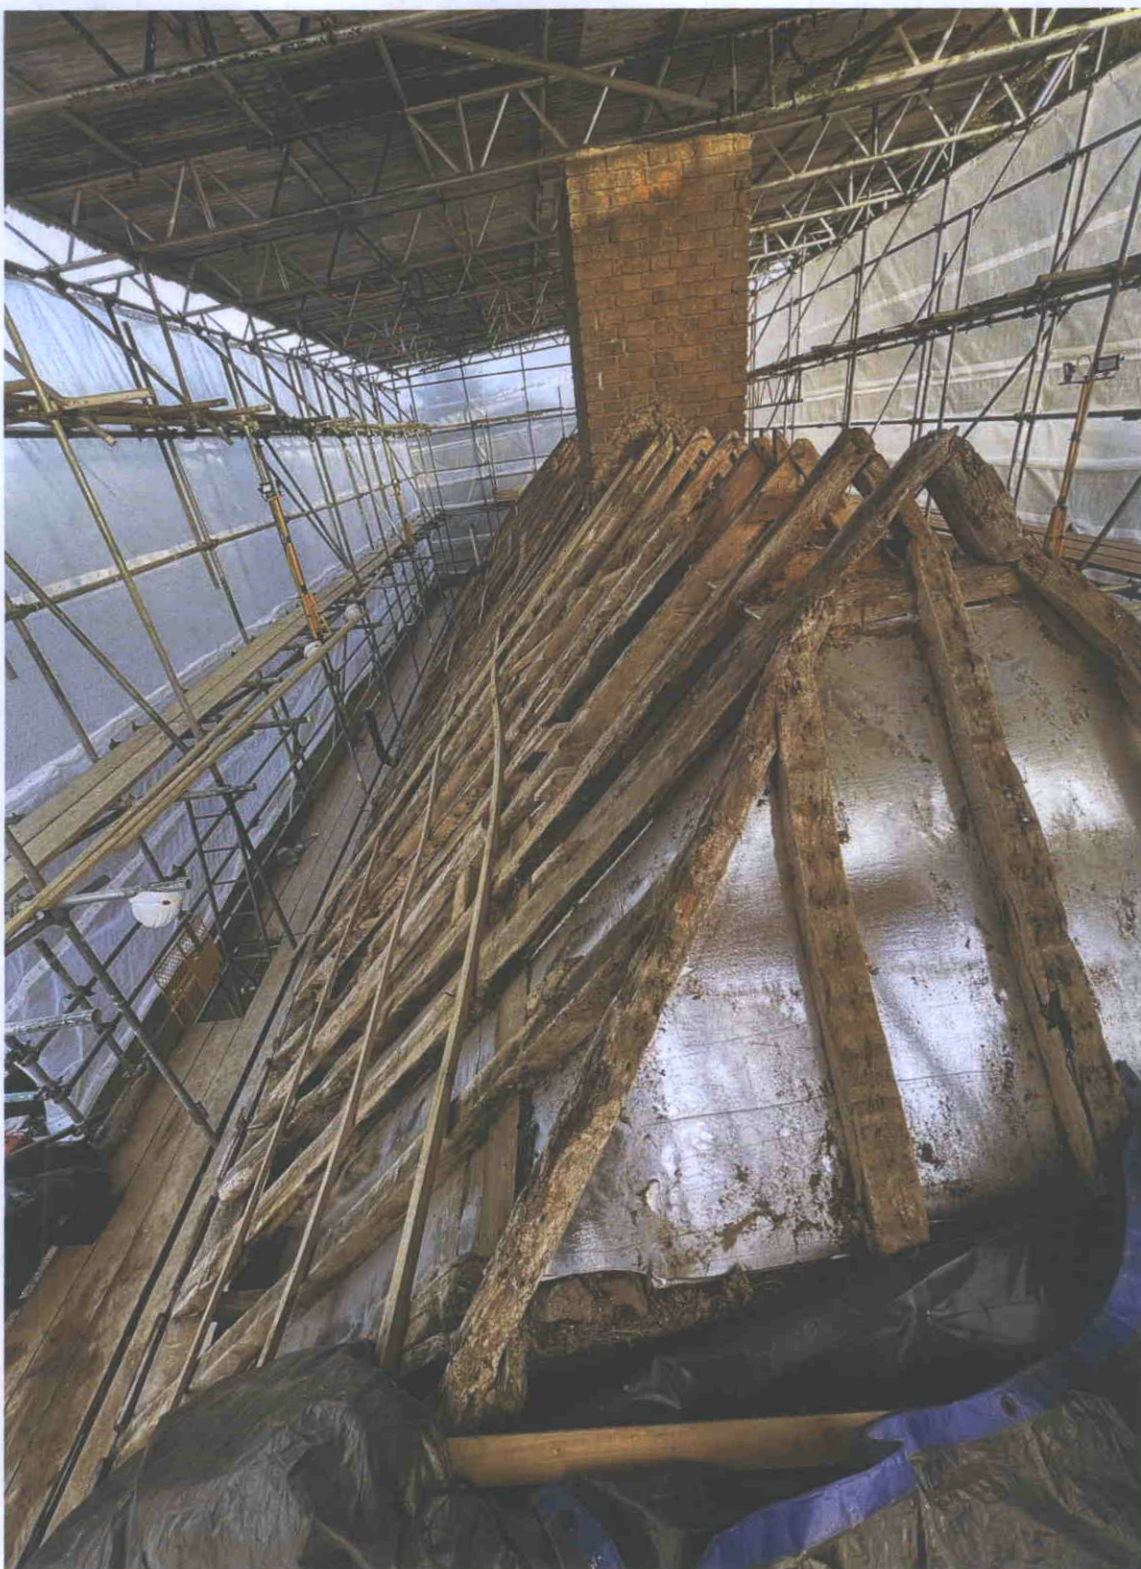
The bay 1 C17 half-hip of bay 1 – west elevation

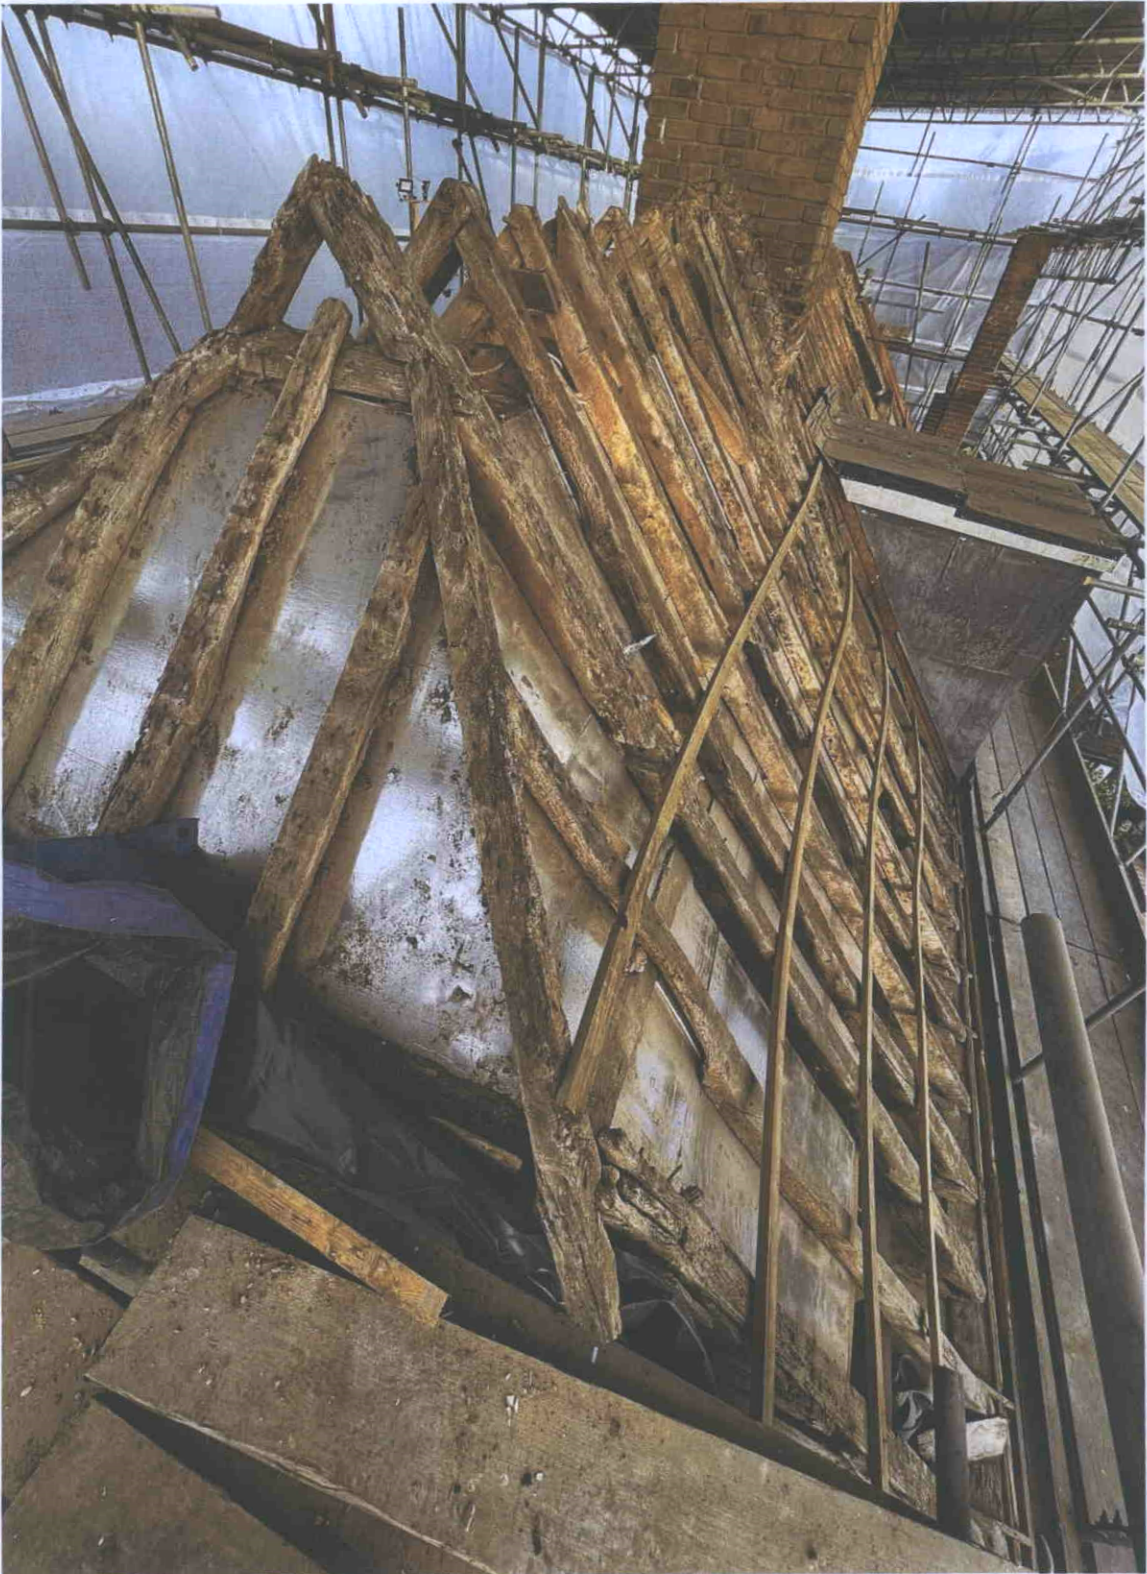
The bay 1 C17 half-hip of bay 1 – west elevation

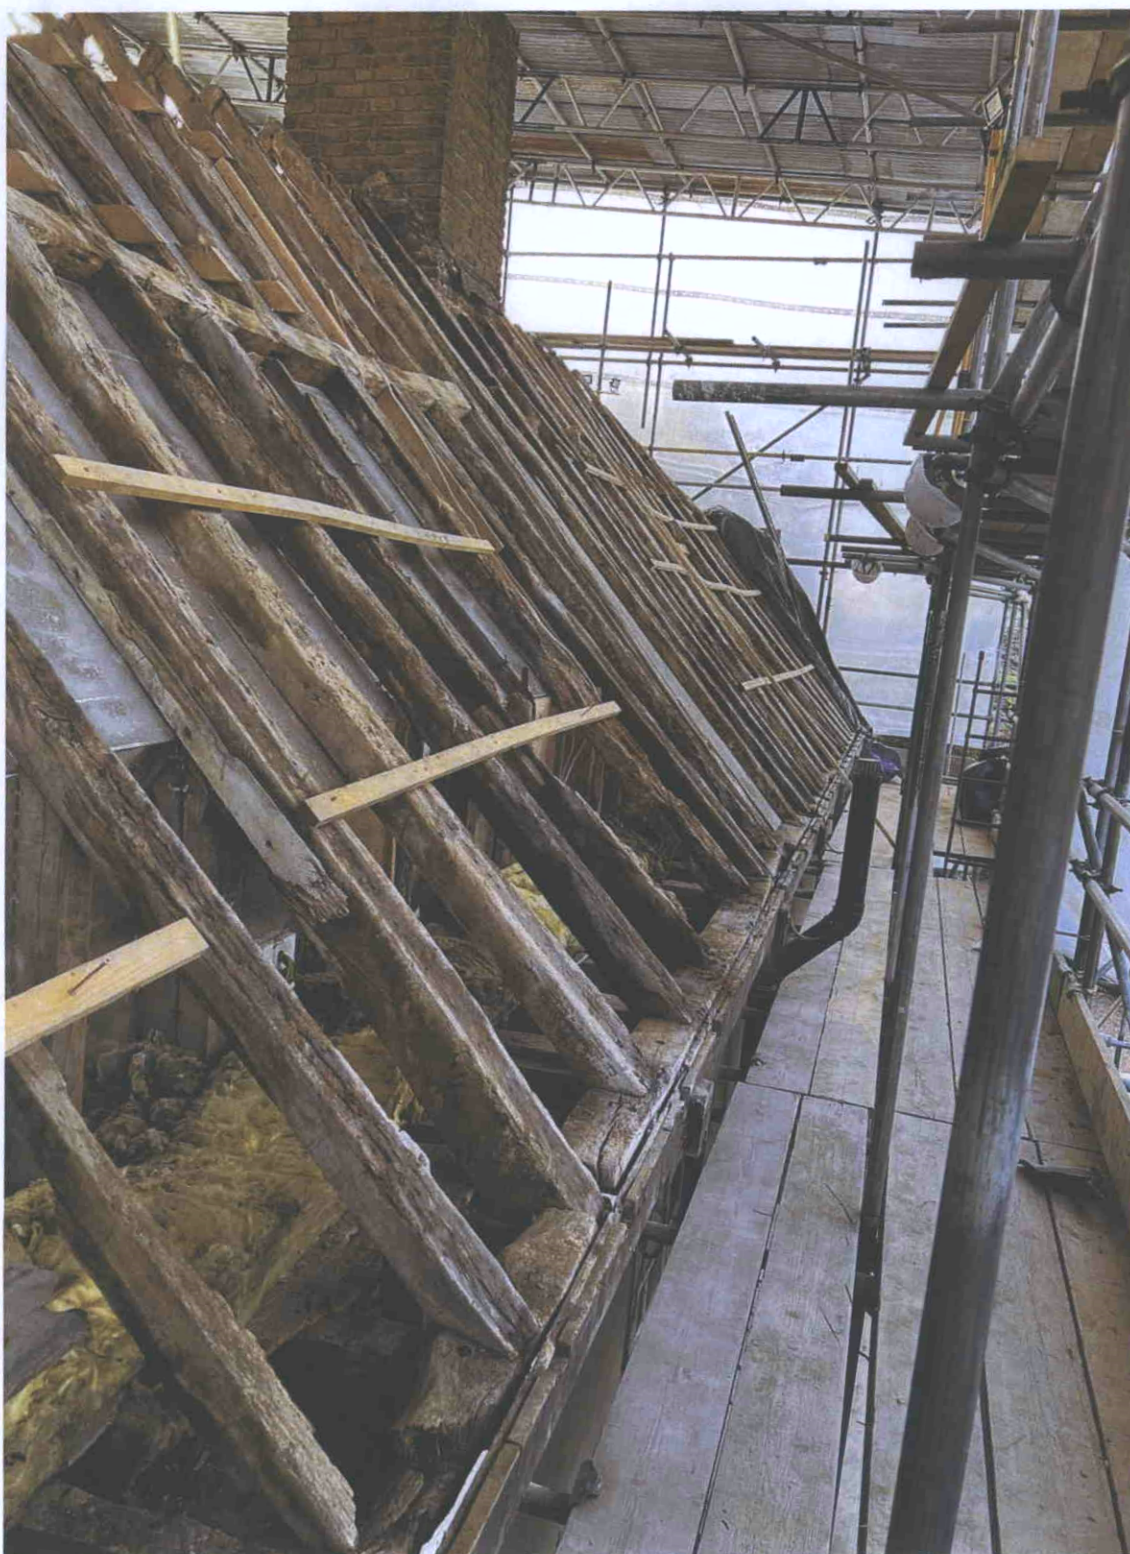
The C17 roof slope of the north (front) elevation showing deflected and decay damaged pole-plates; deflected purlin (bay 3); rafters resting on chimney with no trimmer; and deflected and misaligned rafters.

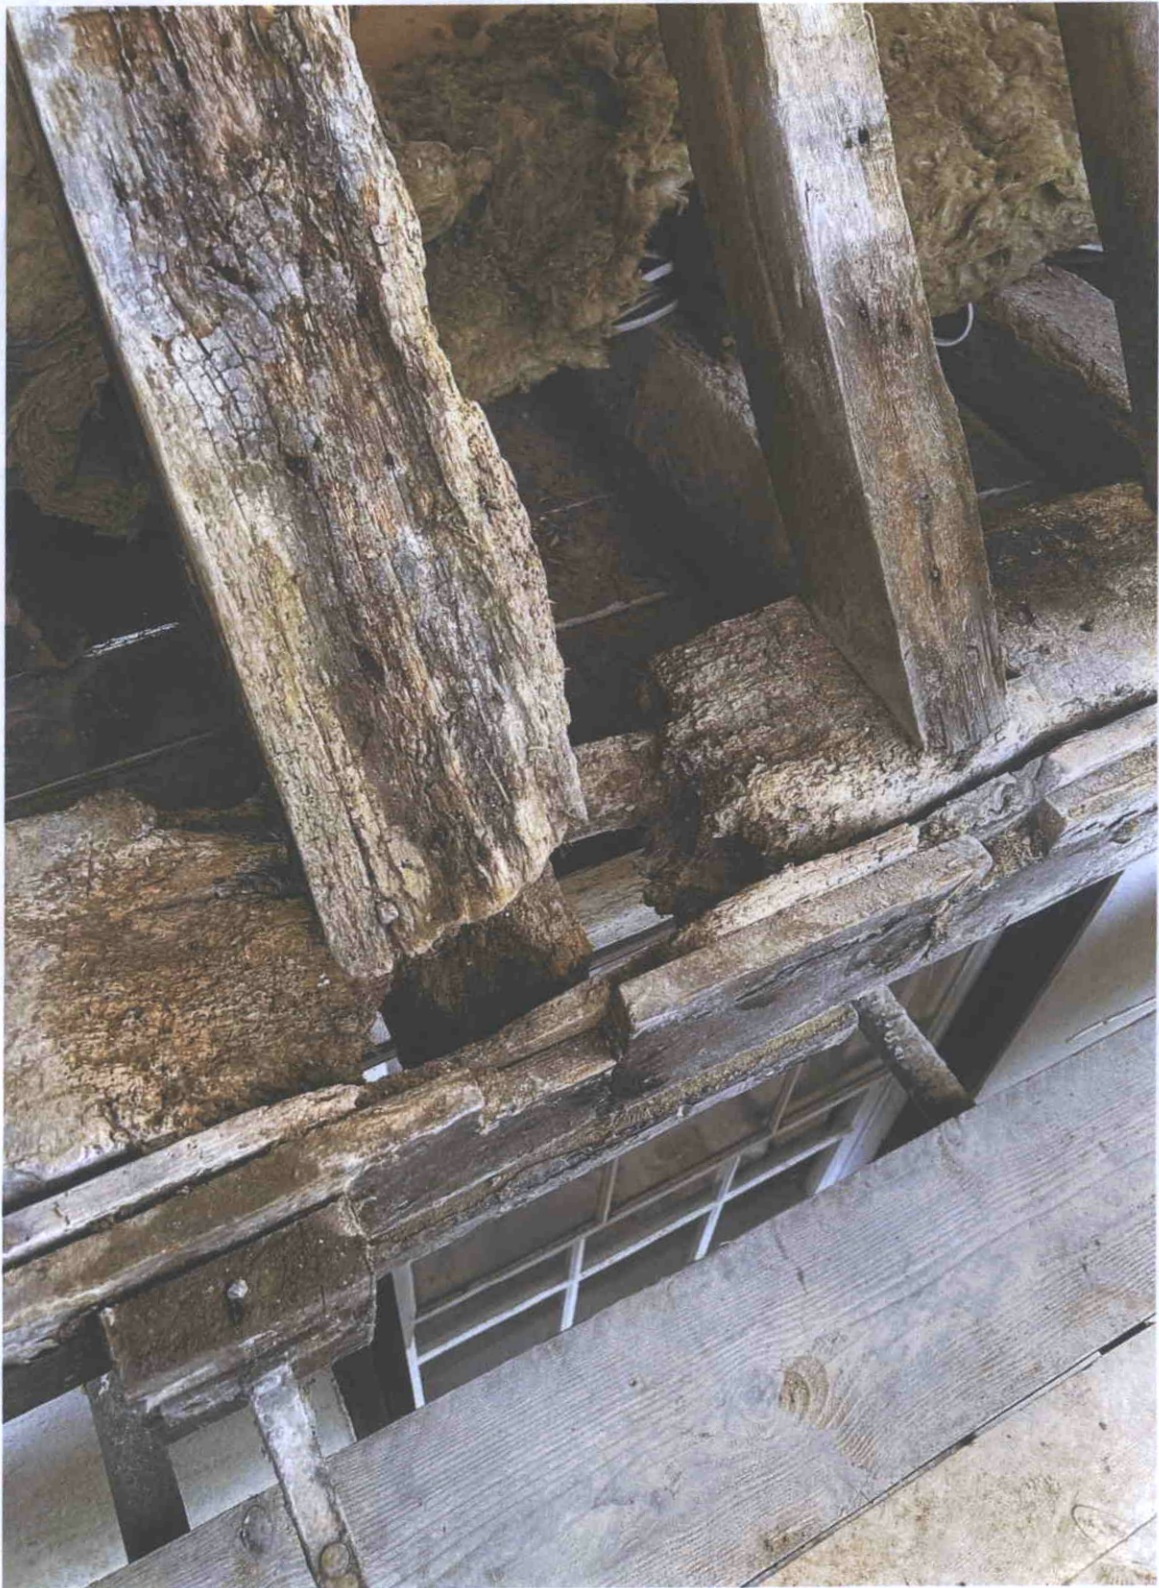
Example of decayed pole-plate on the north elevation

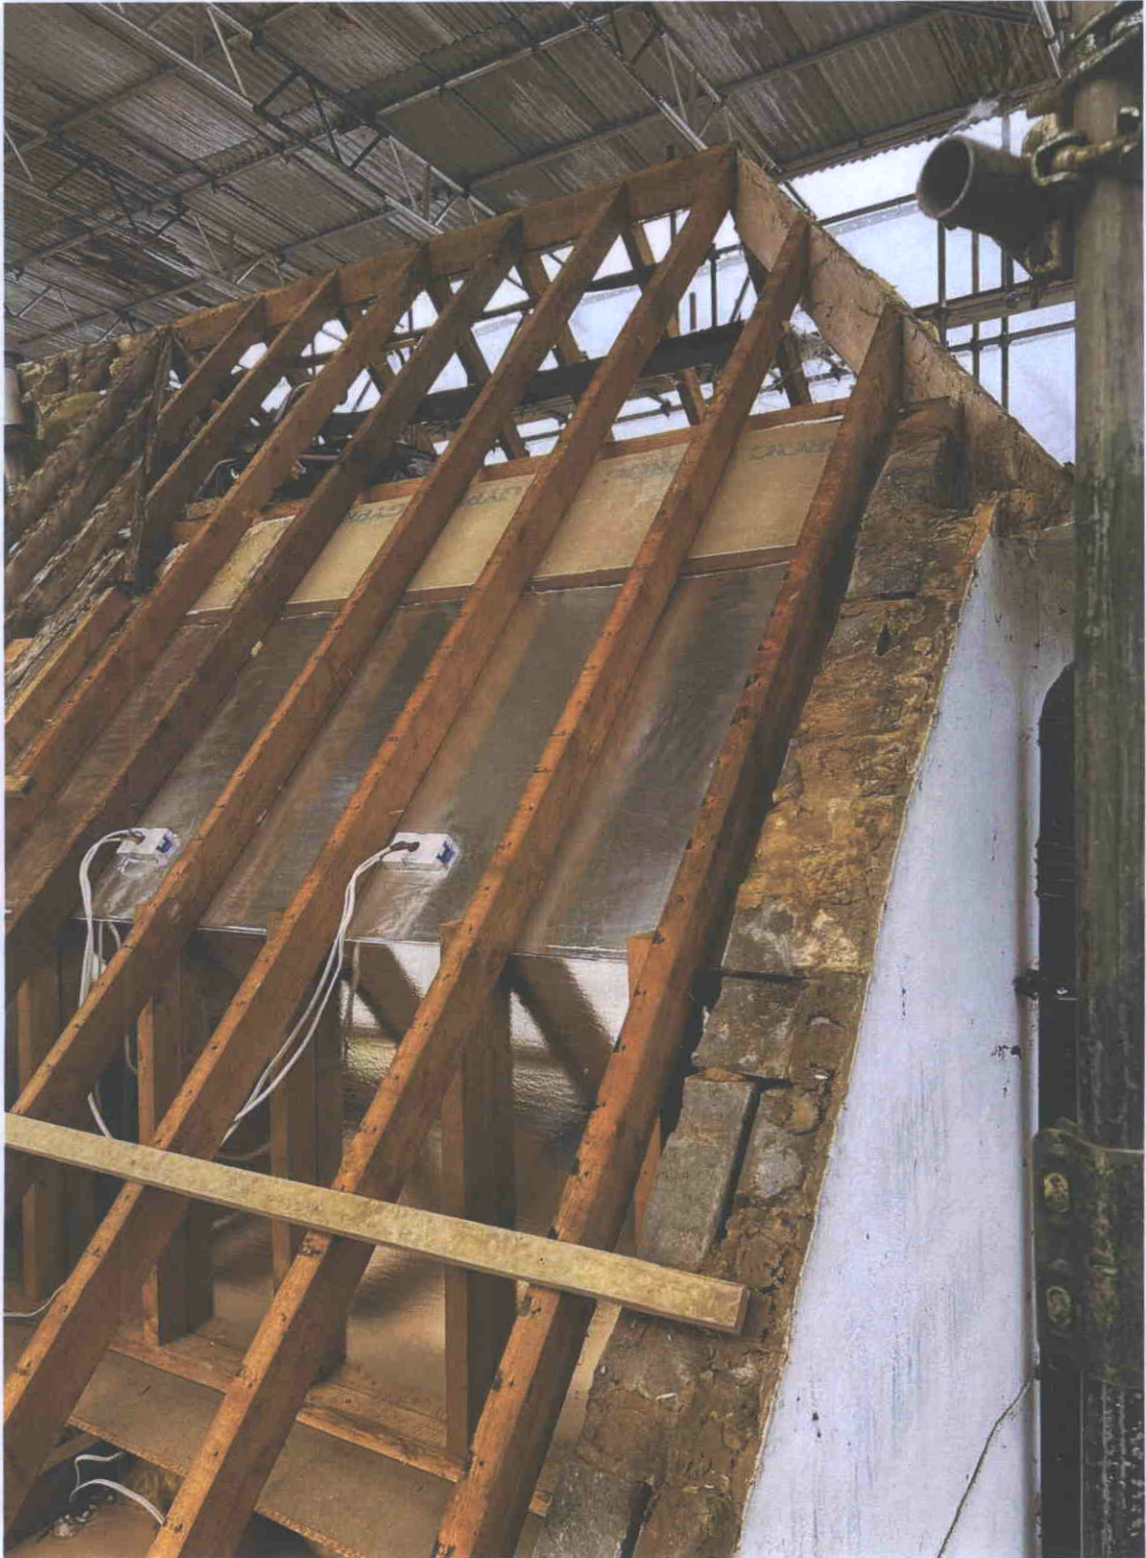
The bay 6 C20 roof slope on the south elevation (east end)

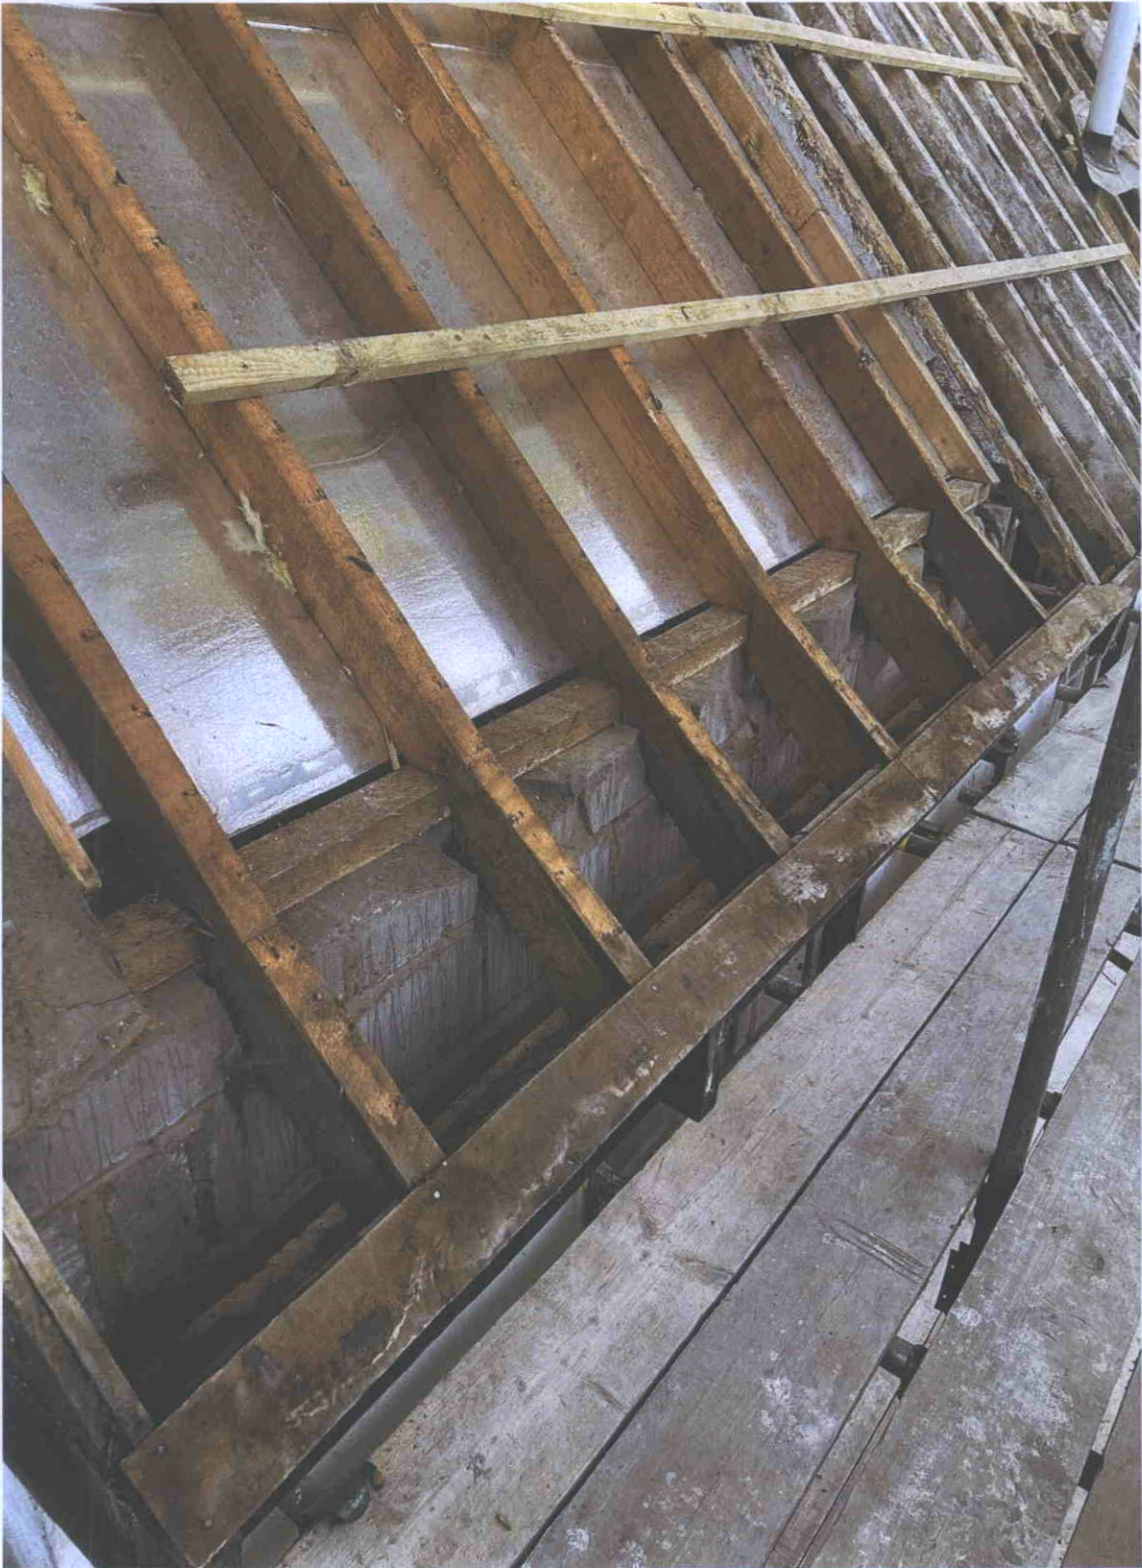
The bay 6 C20 roof slope on the north elevation (east end)

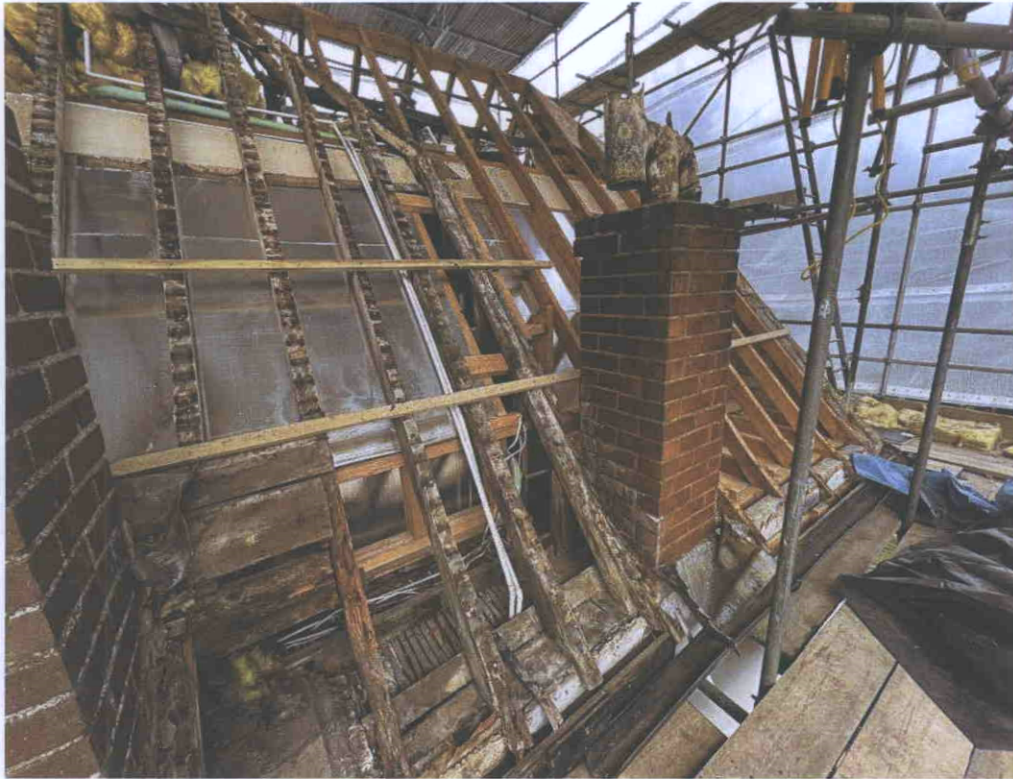
The bay 5 C19 roof slope on the south elevation and bay 6 C20 roof slope shown to the right of the photograph.

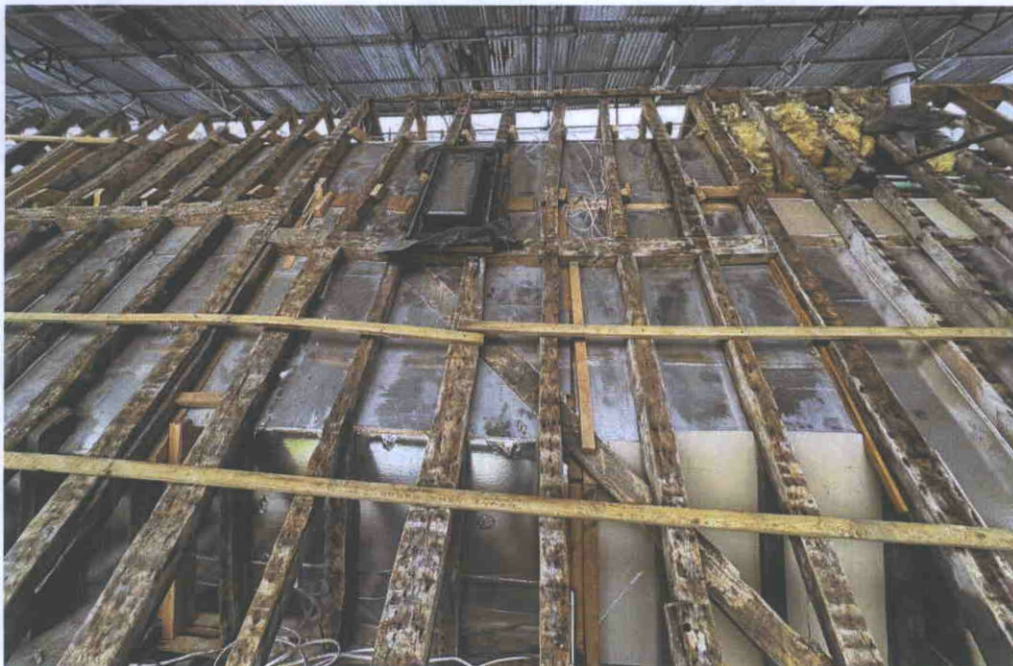
The south elevation roof slope of bay 3 shown on the left of the photograph; bay 4 centre of the photograph; and bay 5 shown to the right of the photograph.

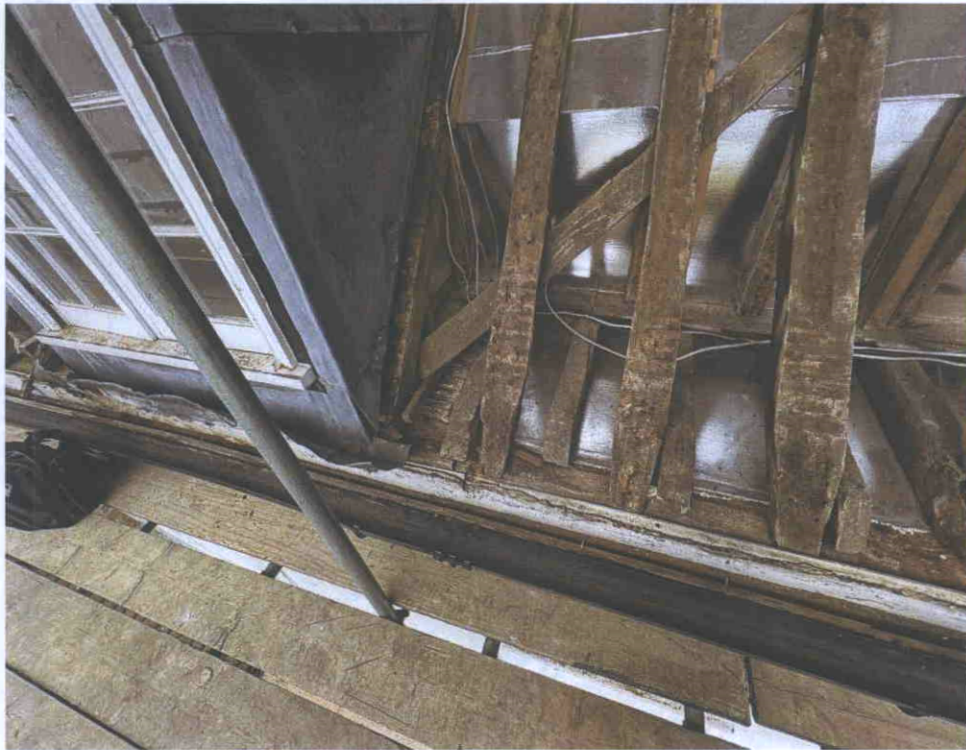
The south elevation roof slope showing short joist ends at bay 2 to the right of the existing dormer.

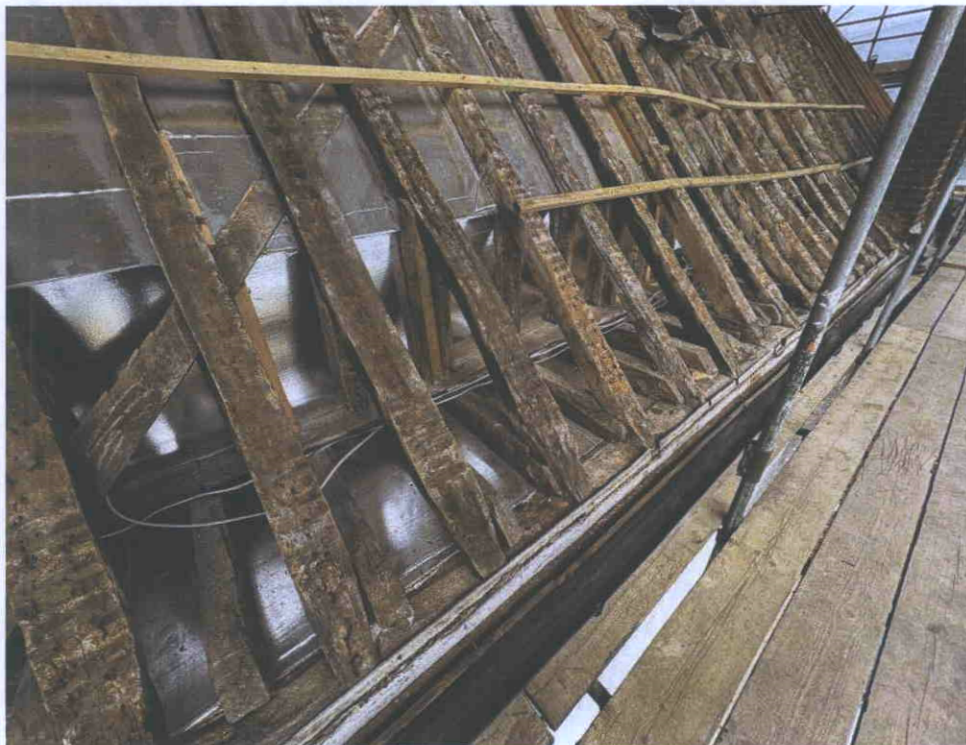
The south elevation roof slope showing short joist ends; at bay 3 at the left of the photograph and bay 4 to the right of the photograph.

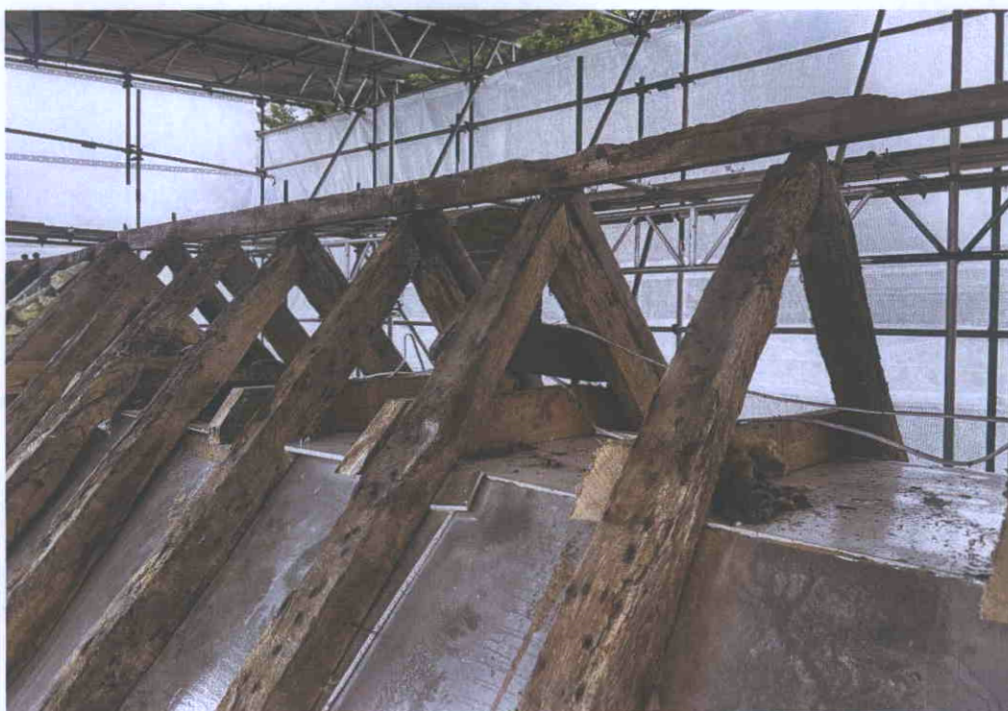
Rafter tops through bay 4 taken from the north roof slope. Note the fake 'ridge board' that had been installed for the now removed furring strips.
