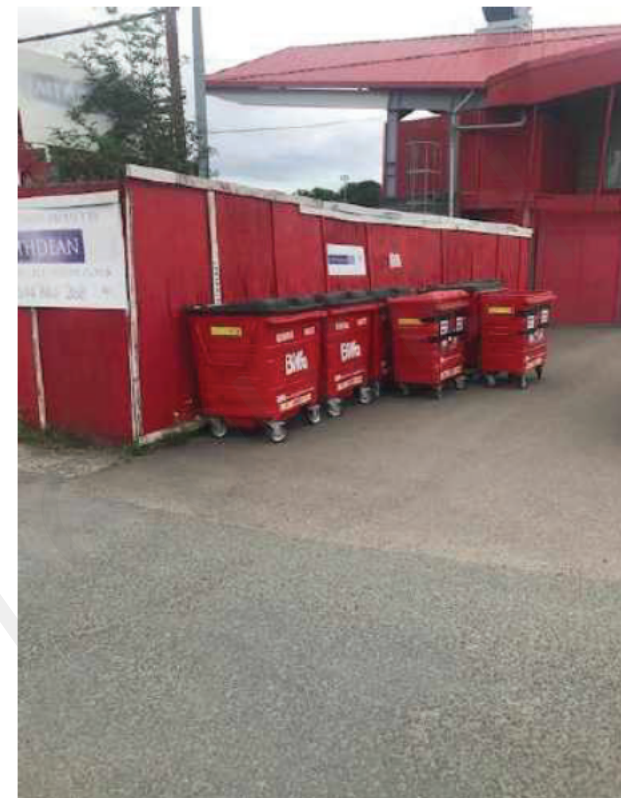
Photo 13: standing in the southern corner of the Football Ground site adjacent to a general waste storage area.

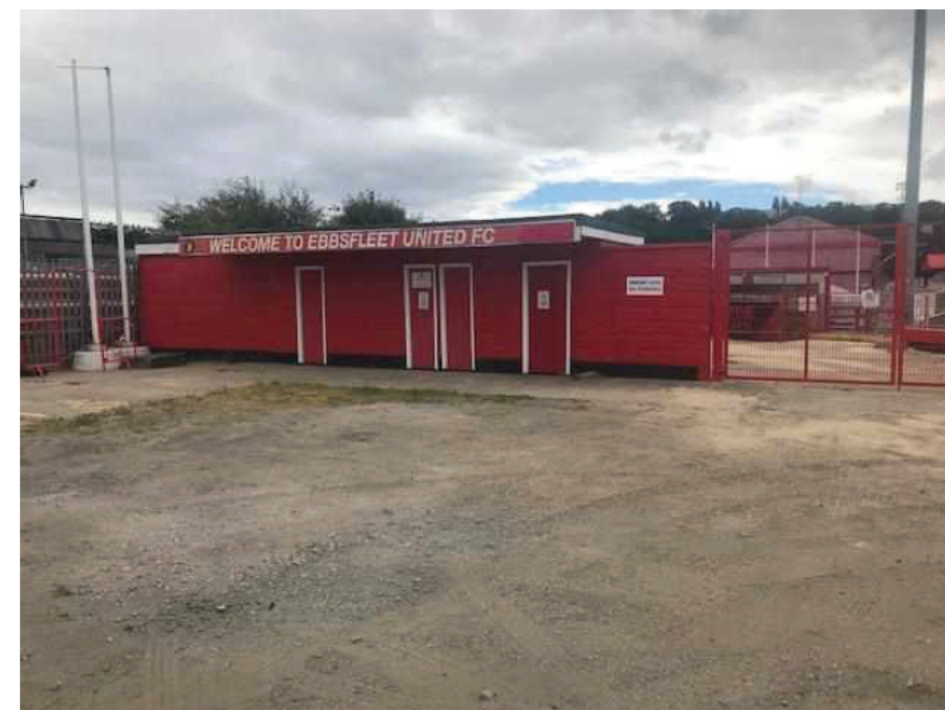
Photo 14: standing north-west of the Football ground looking west. Evidence of hydrocarbon spills on the gravelled ground which is used for vehicle parking.

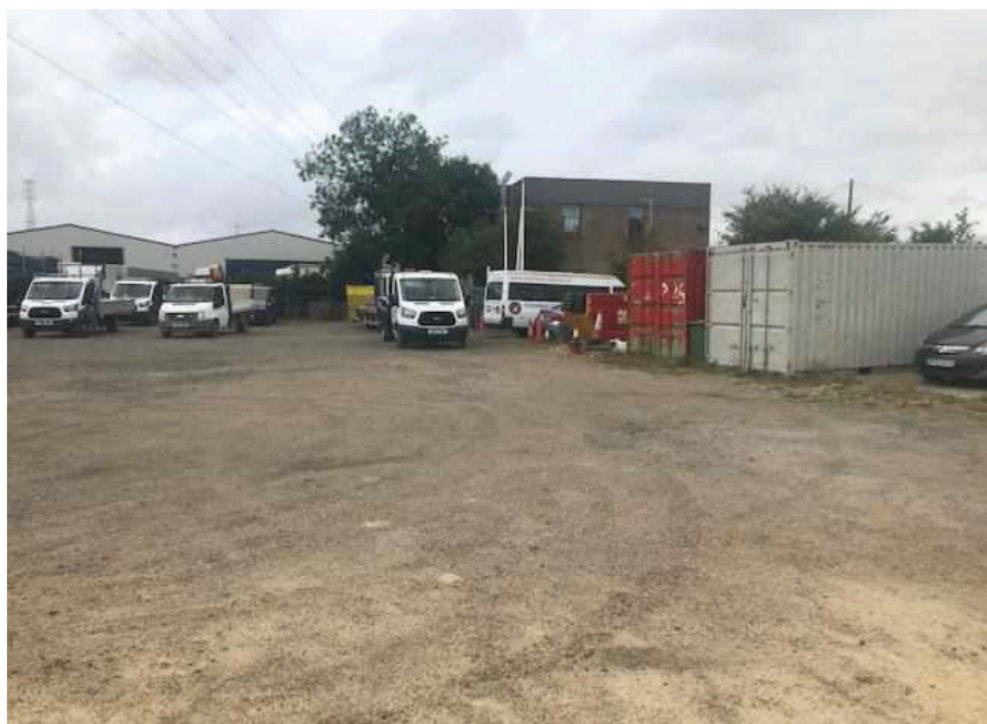
Photo 15: standing north-west of the Football Club. Moderate evidence of hydrocarbon spills on the gravelled ground.

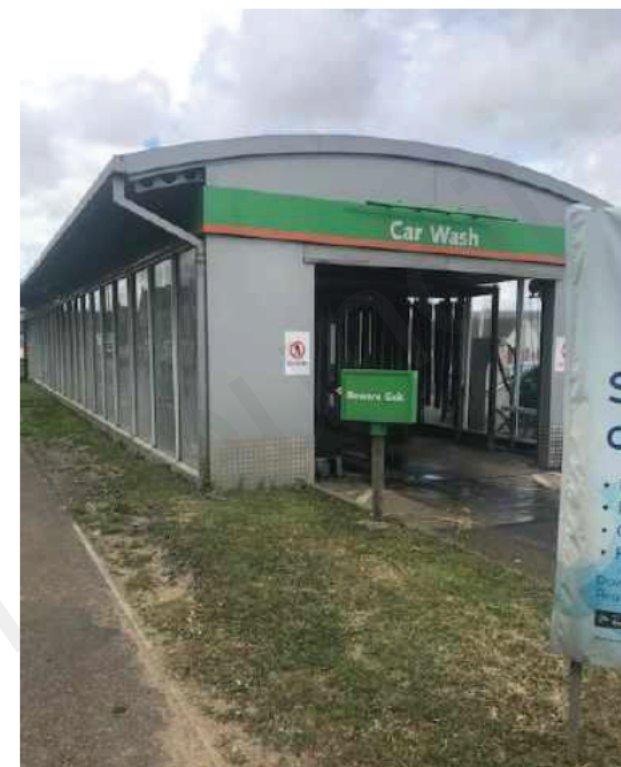
Photo 17: standing in the south-eastern corner of the football ground looking south at a car wash at the edge of the red line boundary area on Grove Road. Drained to foul.

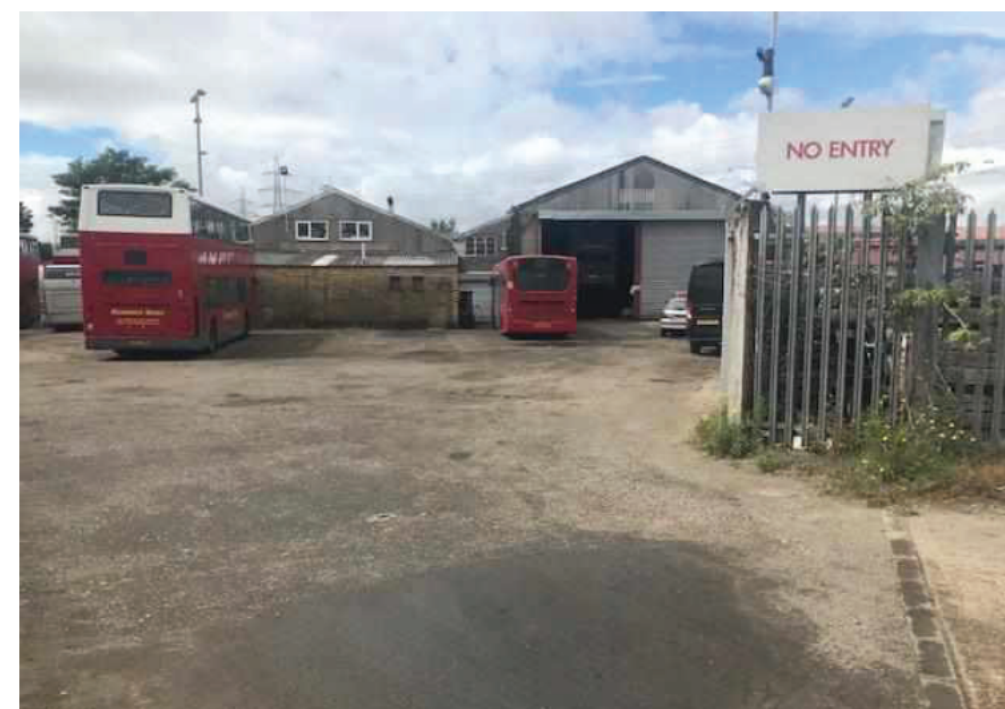
Photo 18: view of bus maintenance depot located along the eastern boundary of the site. This area had moderate to high evidence of hydrocarbon staining.

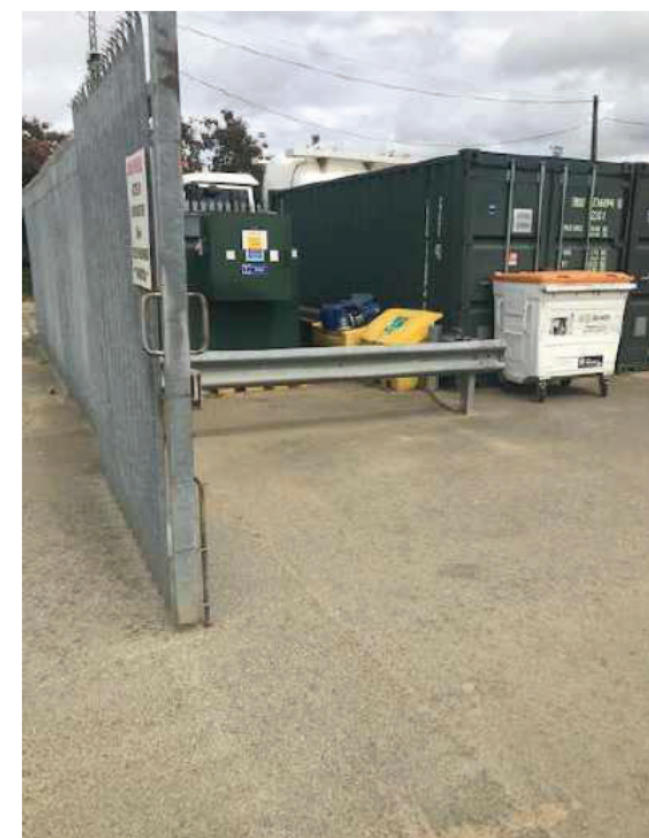
Photo 22: A diesel storage tank, protected and double skinned located in the EA depot.
