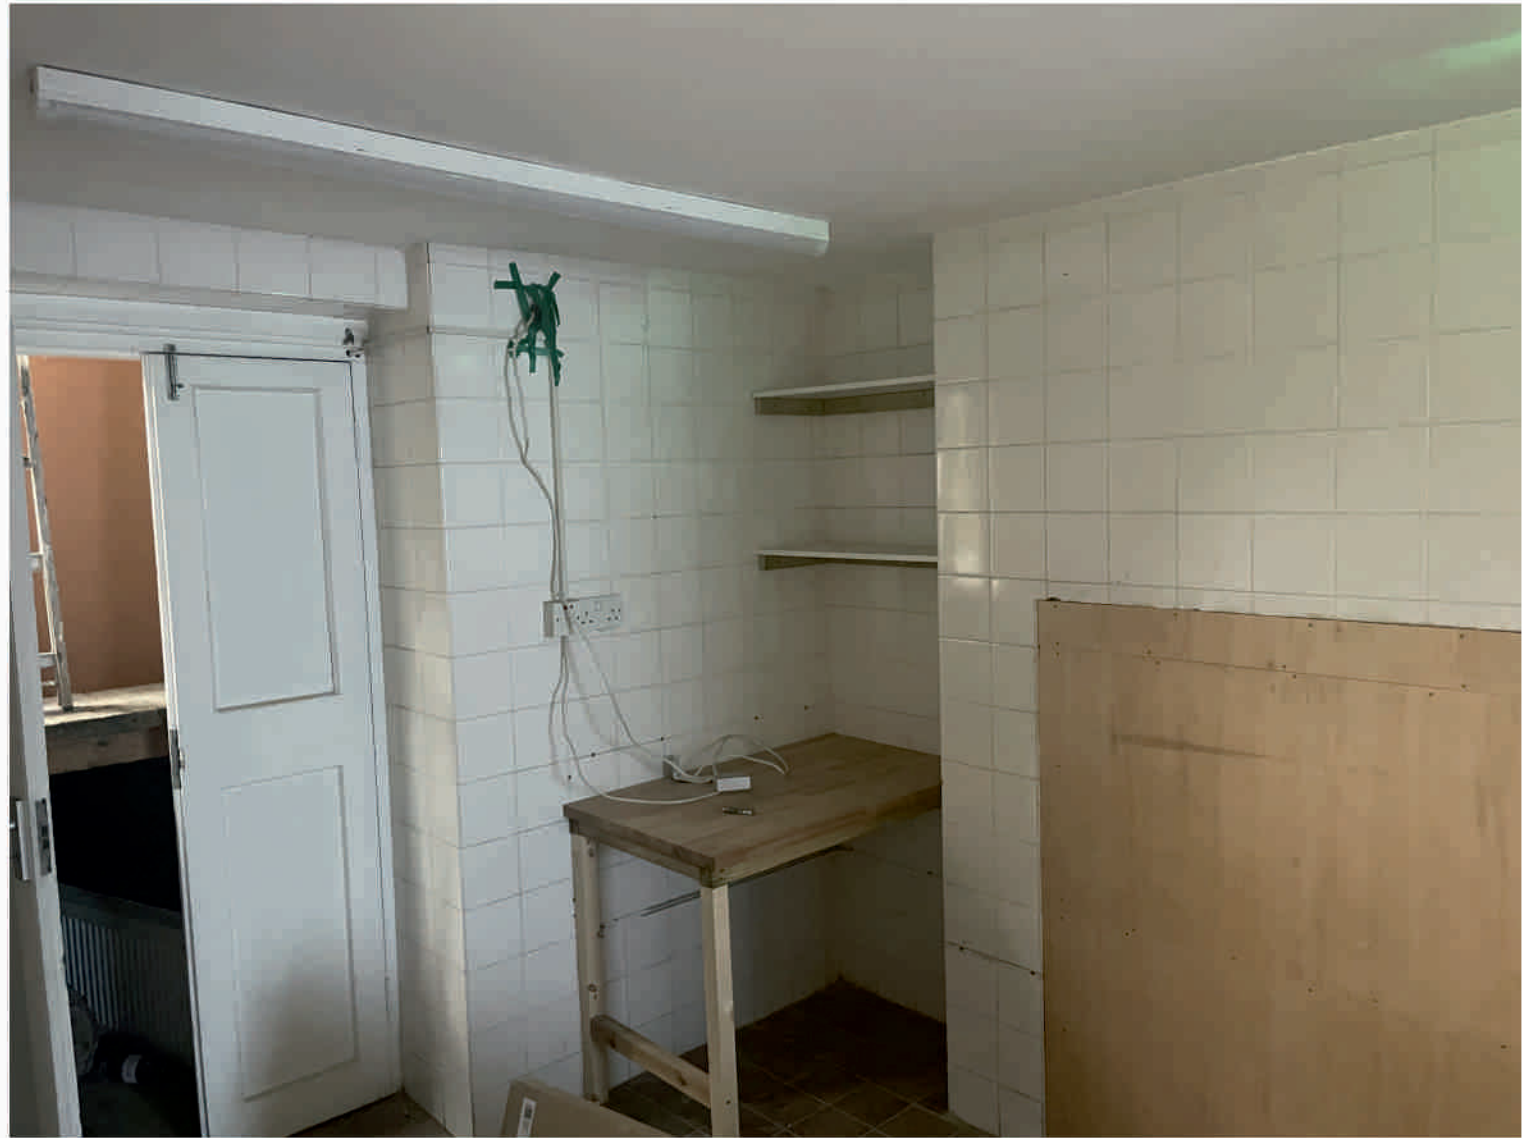
ROOM 12 - Facing double door to cellar flap recess noting ground floor level at half door height. No original features.

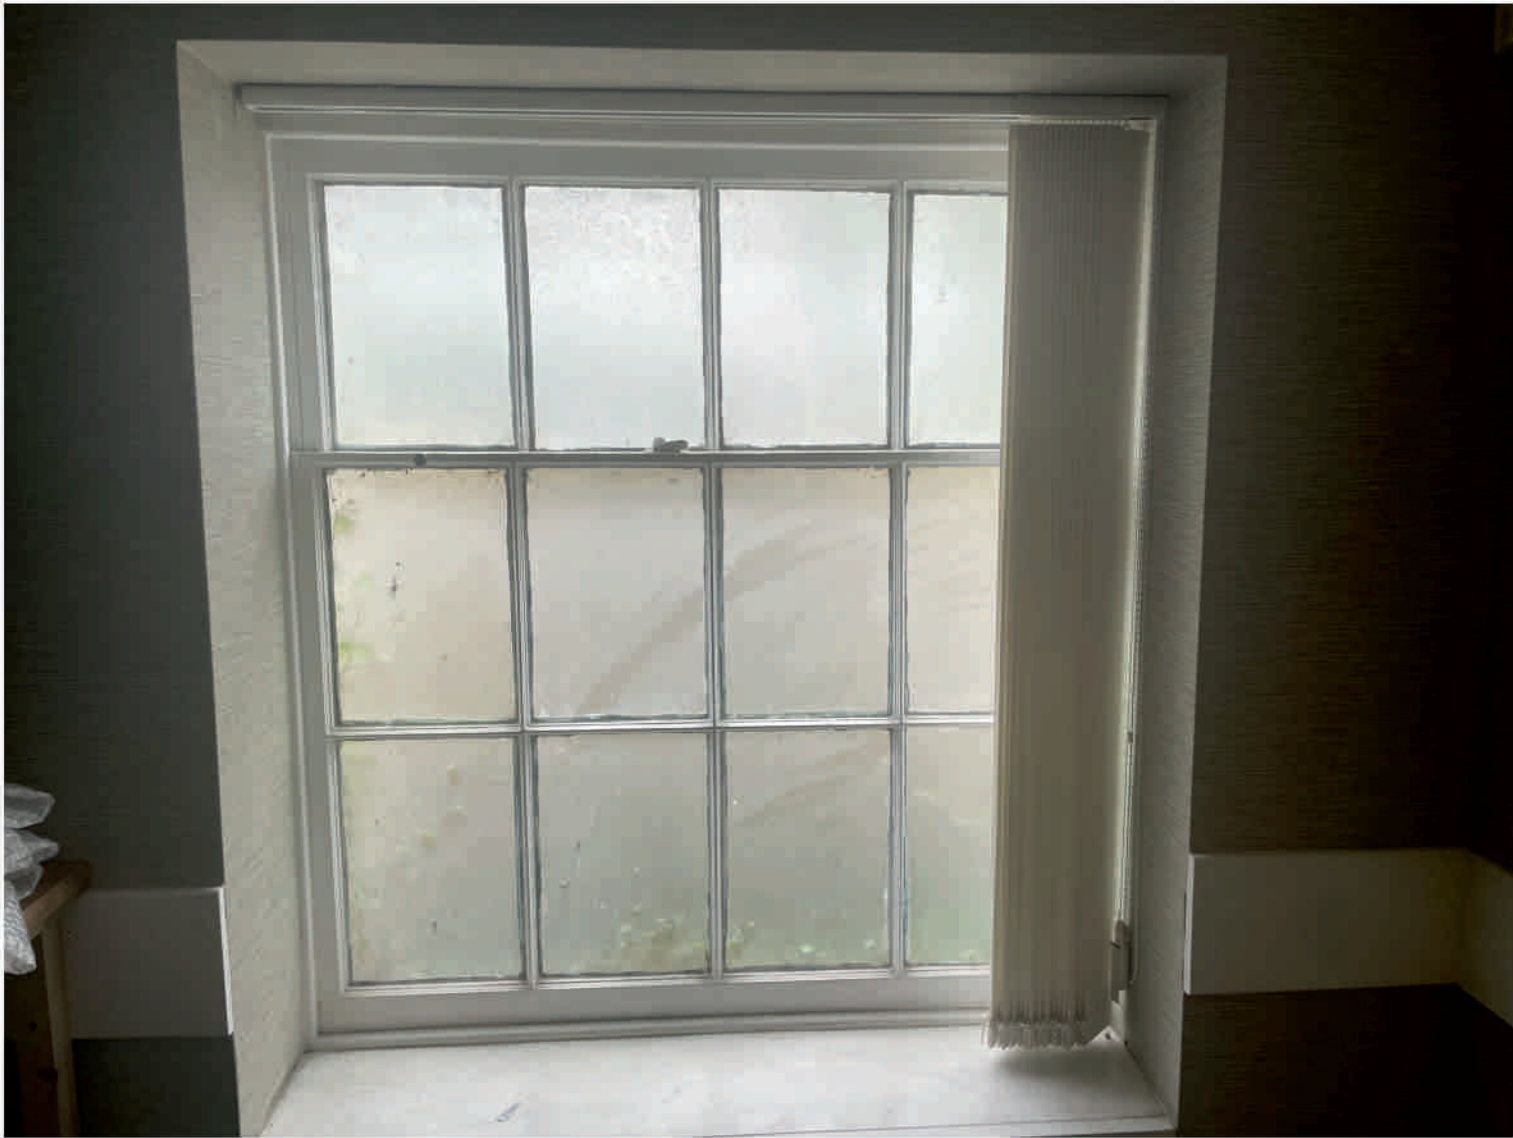
ROOM 13 - Photograph of original ash window in light well in good working order to be made good and retained incorporating new secondary glazing. No other original features.

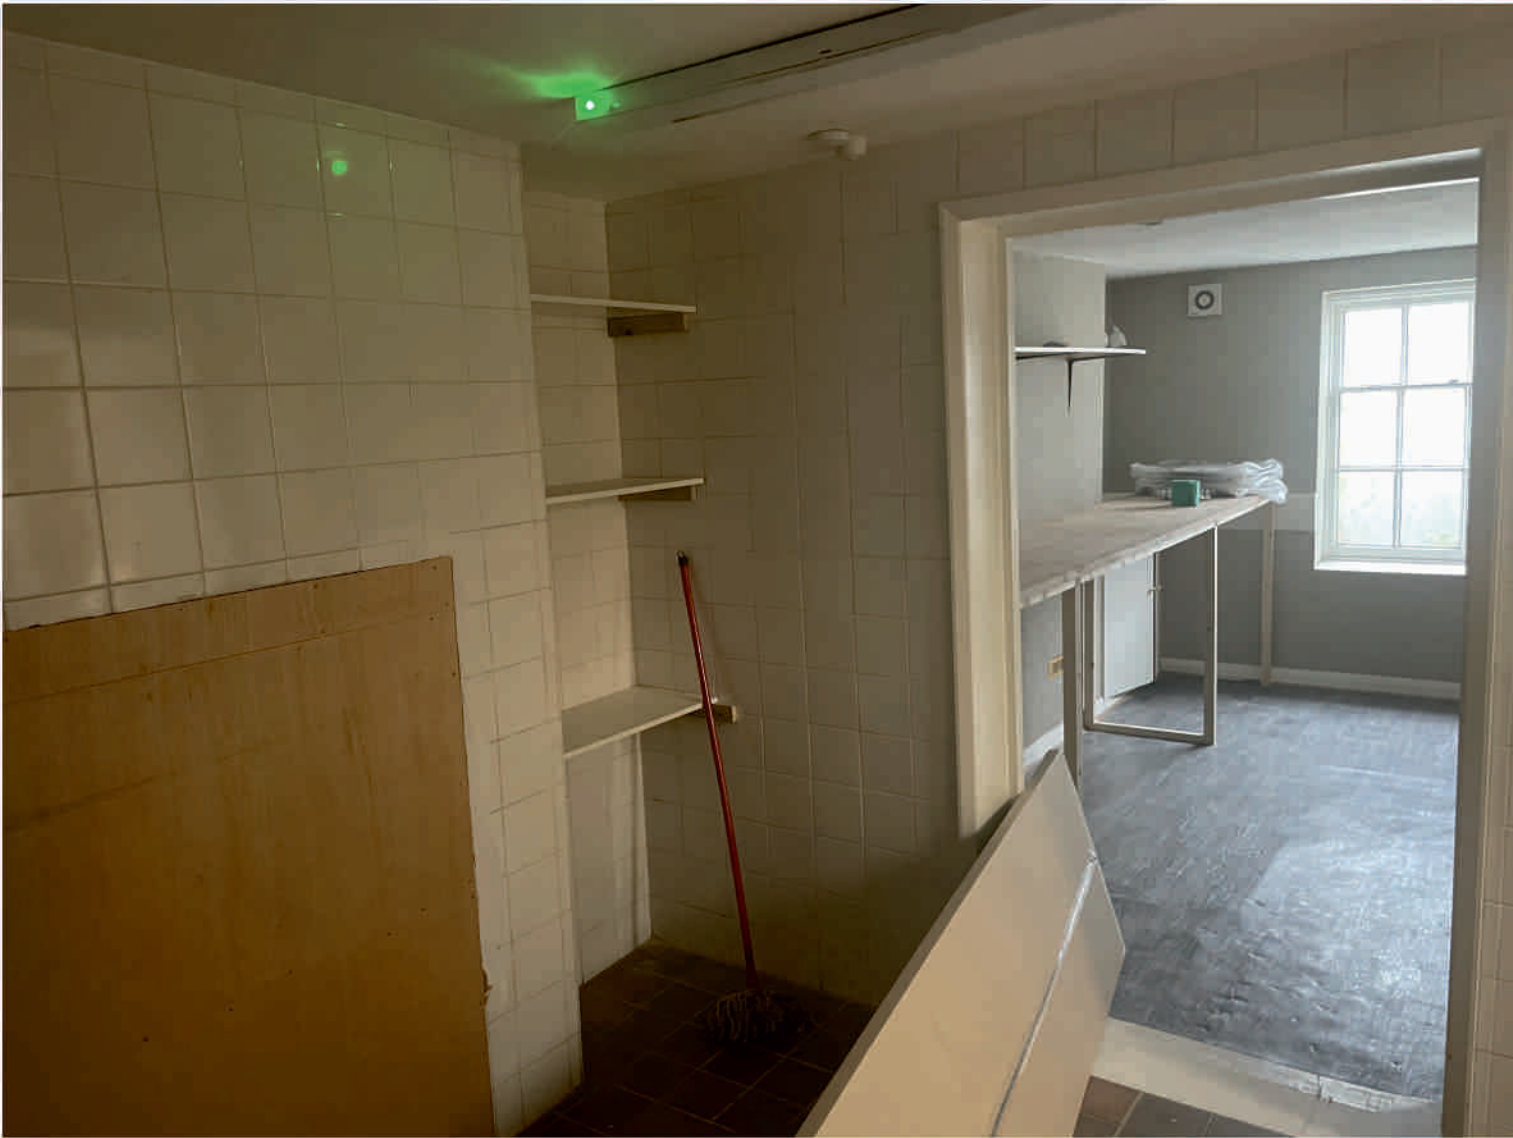
ROOM 12 - Facing light well window in room 13 through connecting double doors. No original features

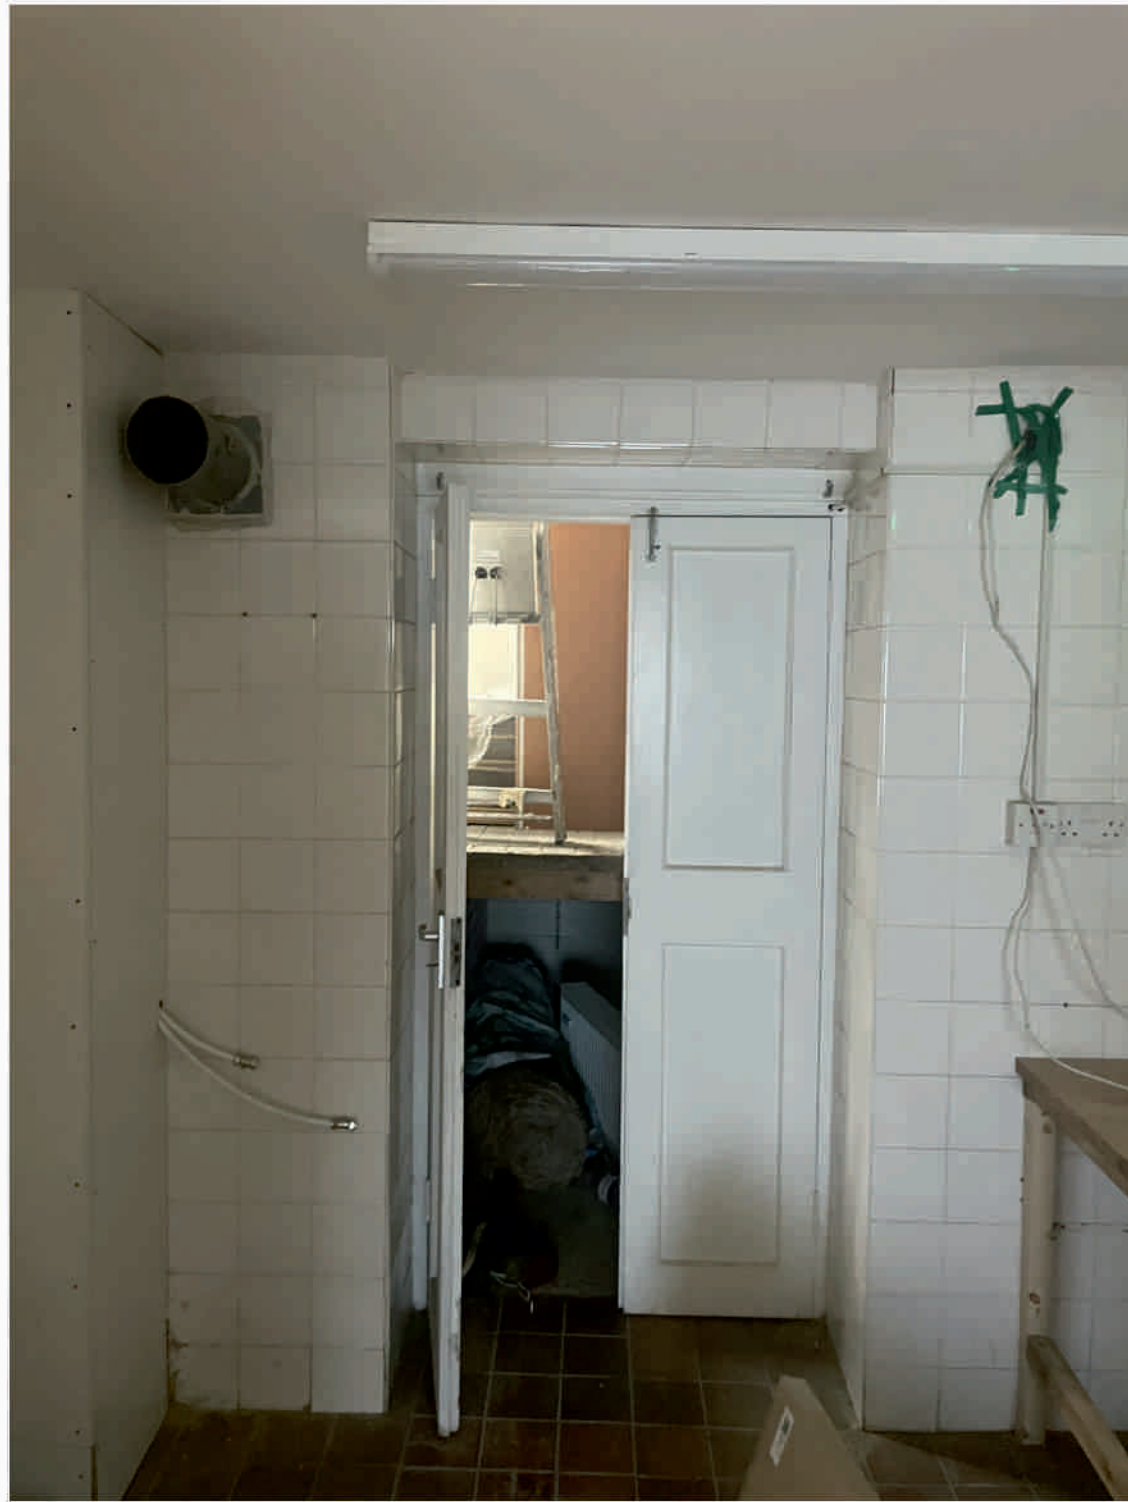
ROOM 12 - Looking toward double doors into cellar flap void and showing rear ground floor level

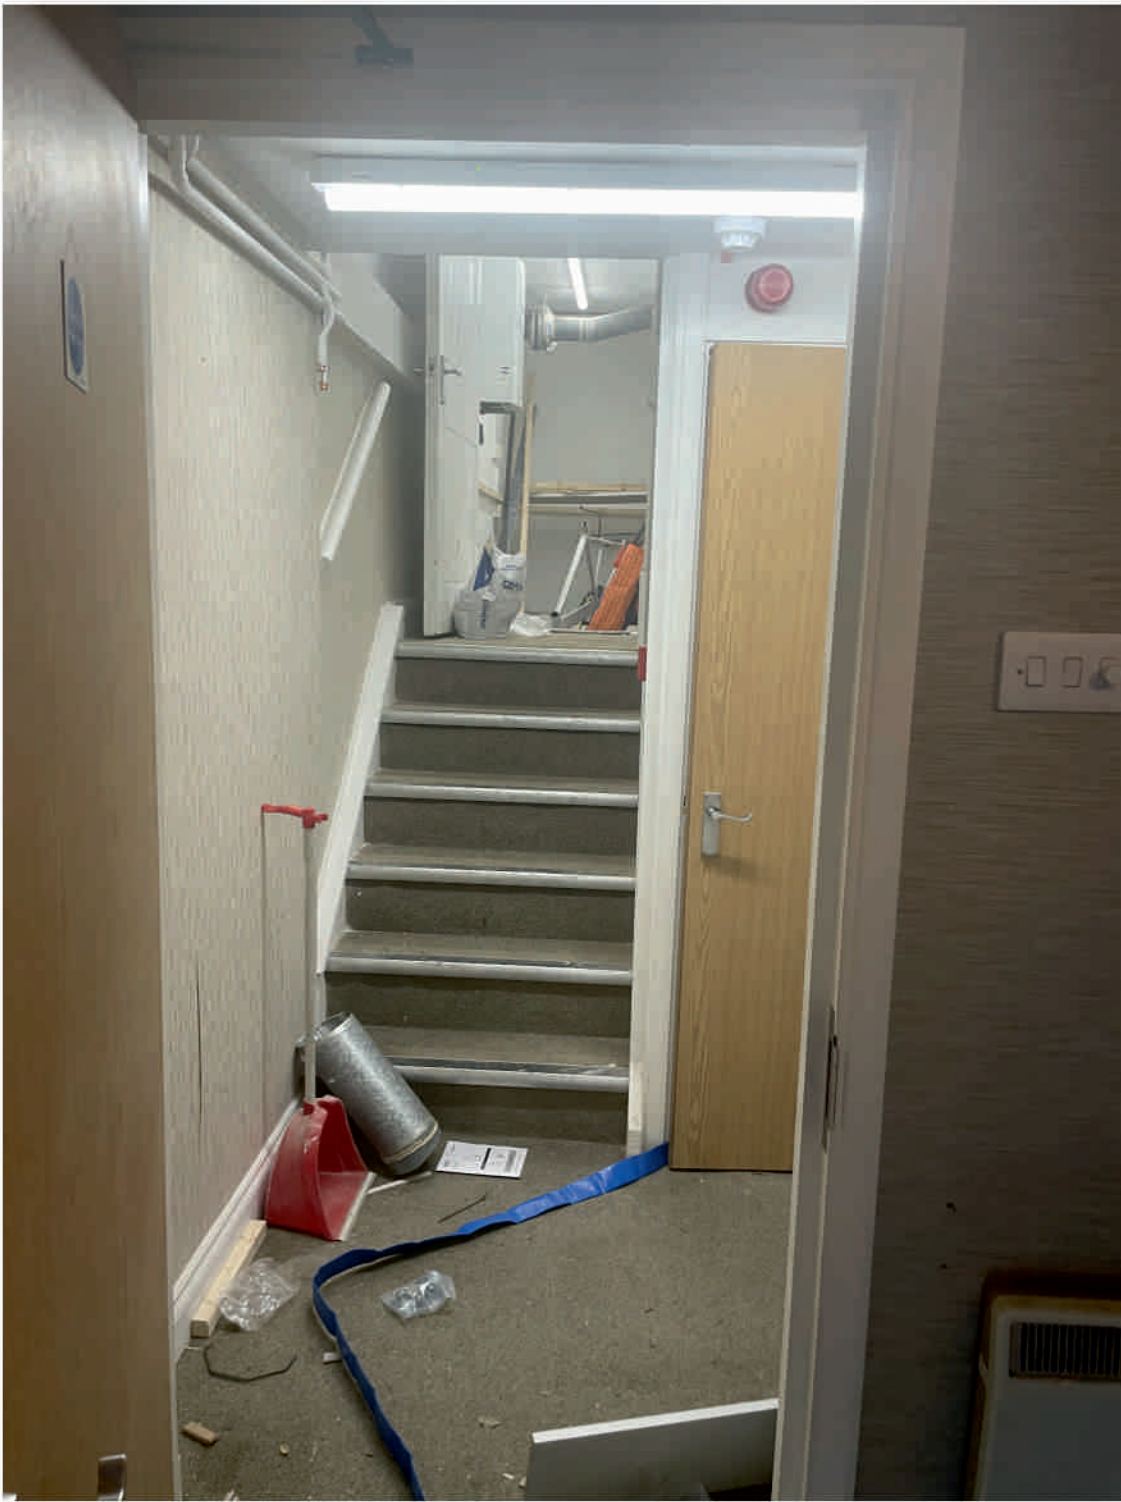
AREA 11 STAIRS - Looking from room 10 showing stair covered with nosings and carpet. Also shows door the lower cellar level no access. No original features except covered stair.

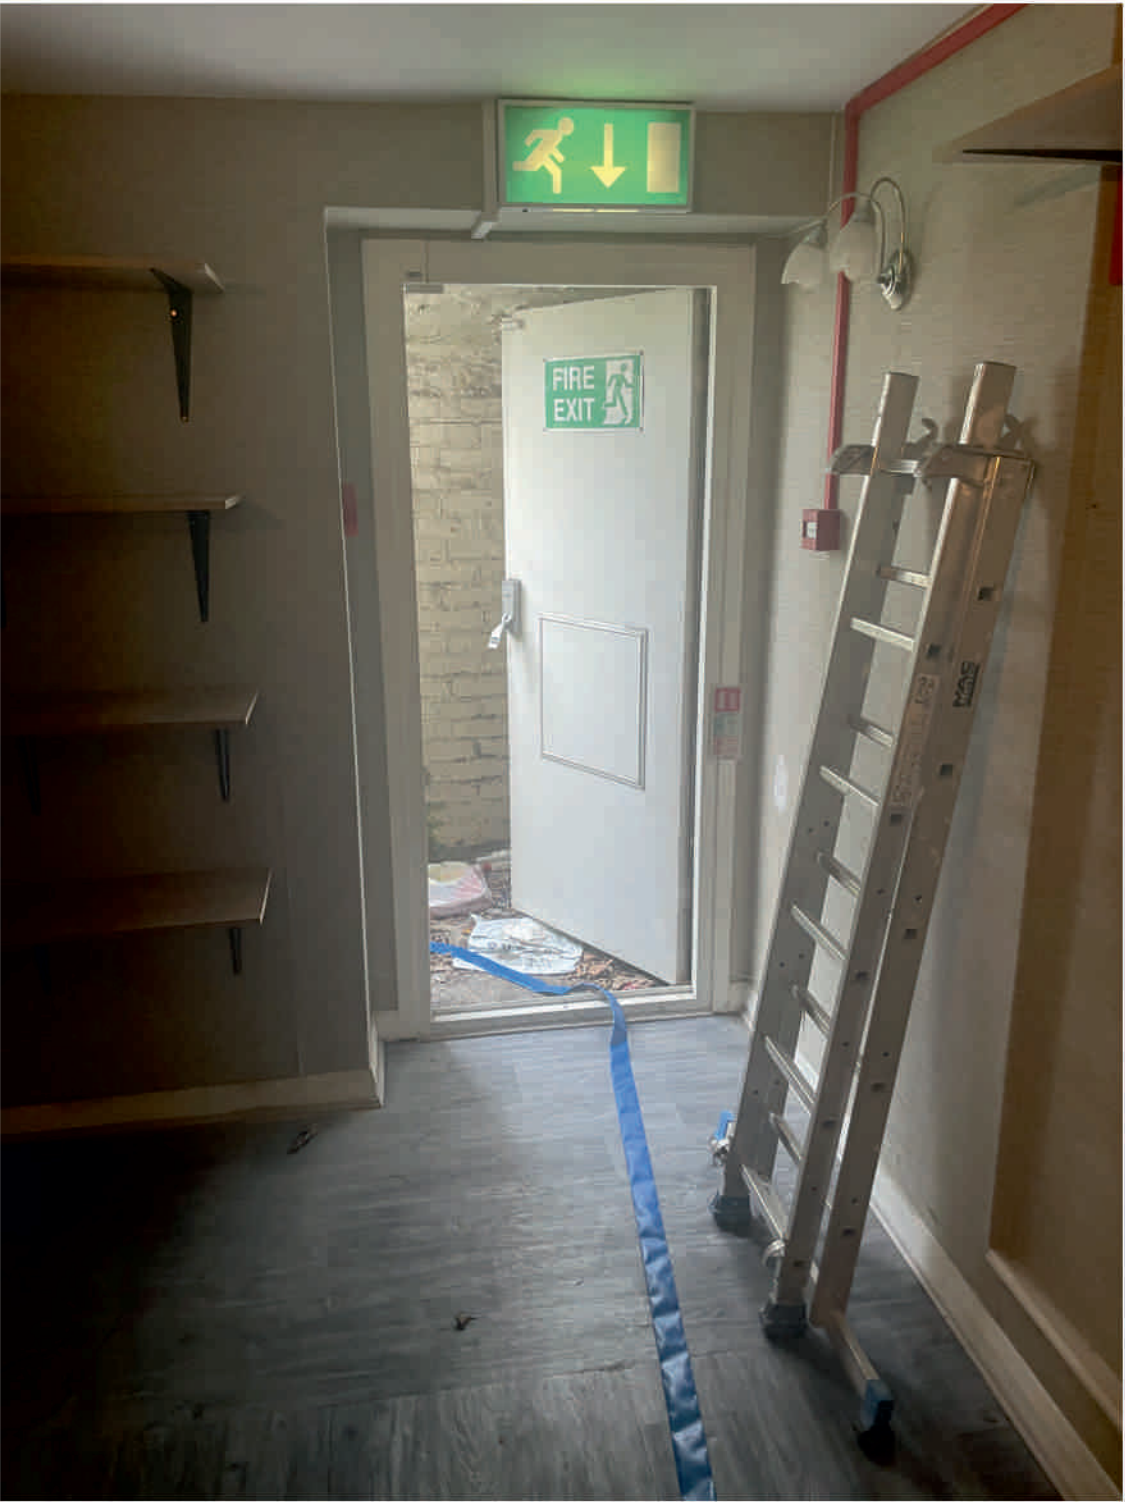
ROOM 10 - Facing toward fire exist door and external steps to footway under ground floor entrance steps. Partition wall to locked store is shown to the right. No original features.
