# STAC architecture

## Roof Works - Maintenance & Repair Statement

**Project:** Repair and maintenance of roof

**Location:** The Mill House, Mill Hill Lane, Shorne. Gravesend. DA12 3HA

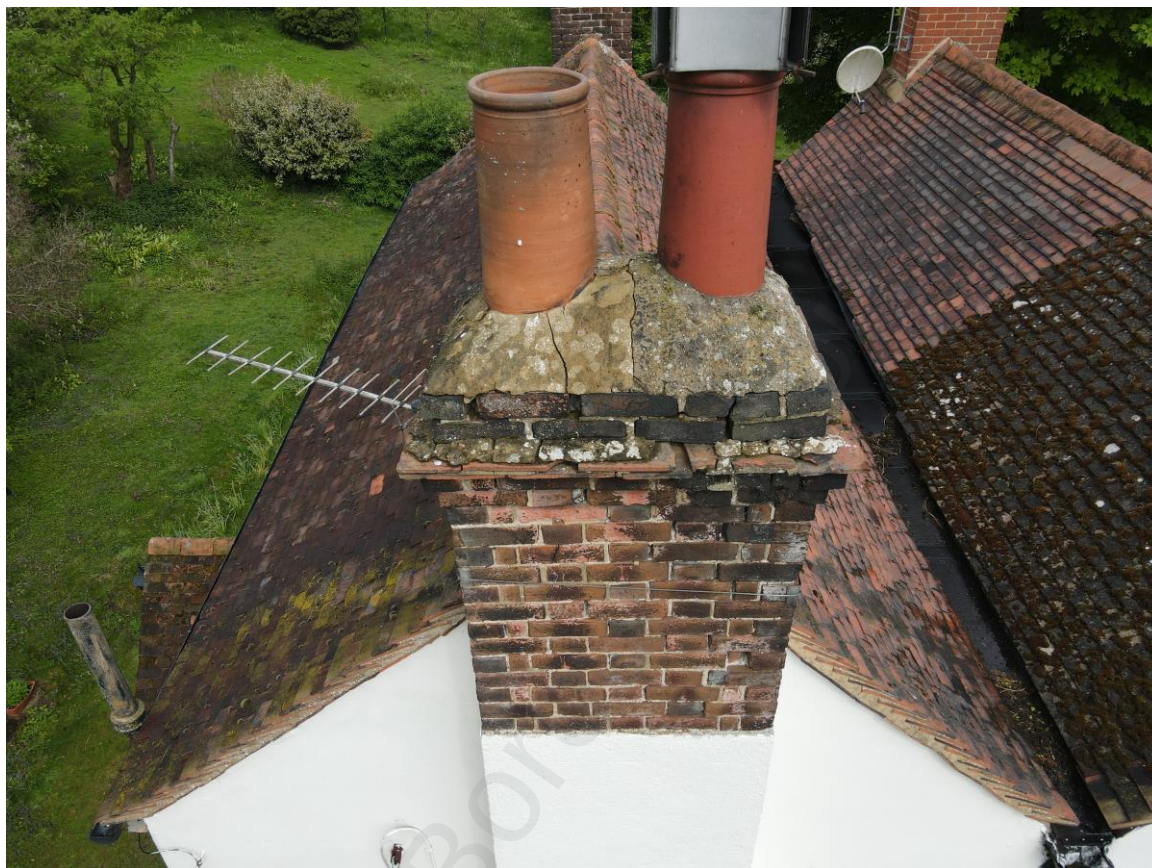
2.15 Chimney 1 - Front

- 3.01 The proposed maintenance and repair addresses a number of issues where the current chimneys and roof fall short of being fit for purpose.
- 3.02 Chimney stacks 1 and 2 are suffering from neglect and from the photos can clearly be seen as unstable from the corbelling upwards as are the pots with cracked and missing mortar. Chimney 3 has been re-built at some point, but the pots have become unstable in the recent storms. (Photos taken prior to the storms).

- i. Carefully removed chimney pots setting aside for reinstallation
  - ii. Take down chimney brick work to roof level to Chimney 1 and Chimney 2
  - iii. Re-use bricks from both Chimney 1 & 2 to re-build Chimney 2 complete with corbelled brickwork and tile creasing detail, new flaunching to bed original pots (replace 1 cracked pot with reclaimed matching pot). Mortar colour and joint style to match existing.

- iv. Re-build Chimney 1 above line of existing render in reclaimed matching brickwork to same height complete with corbelled brickwork and tile creasing detail, new flaunching to bed original pots. Mortar colour and joint style to match existing.

- viii. Remove redundant satellite cable and dish and tv aerals and wiring and leave one tv aerial
  - ix. Provide solid fuel chimney cowl to 1 existing pot to Chimney 1

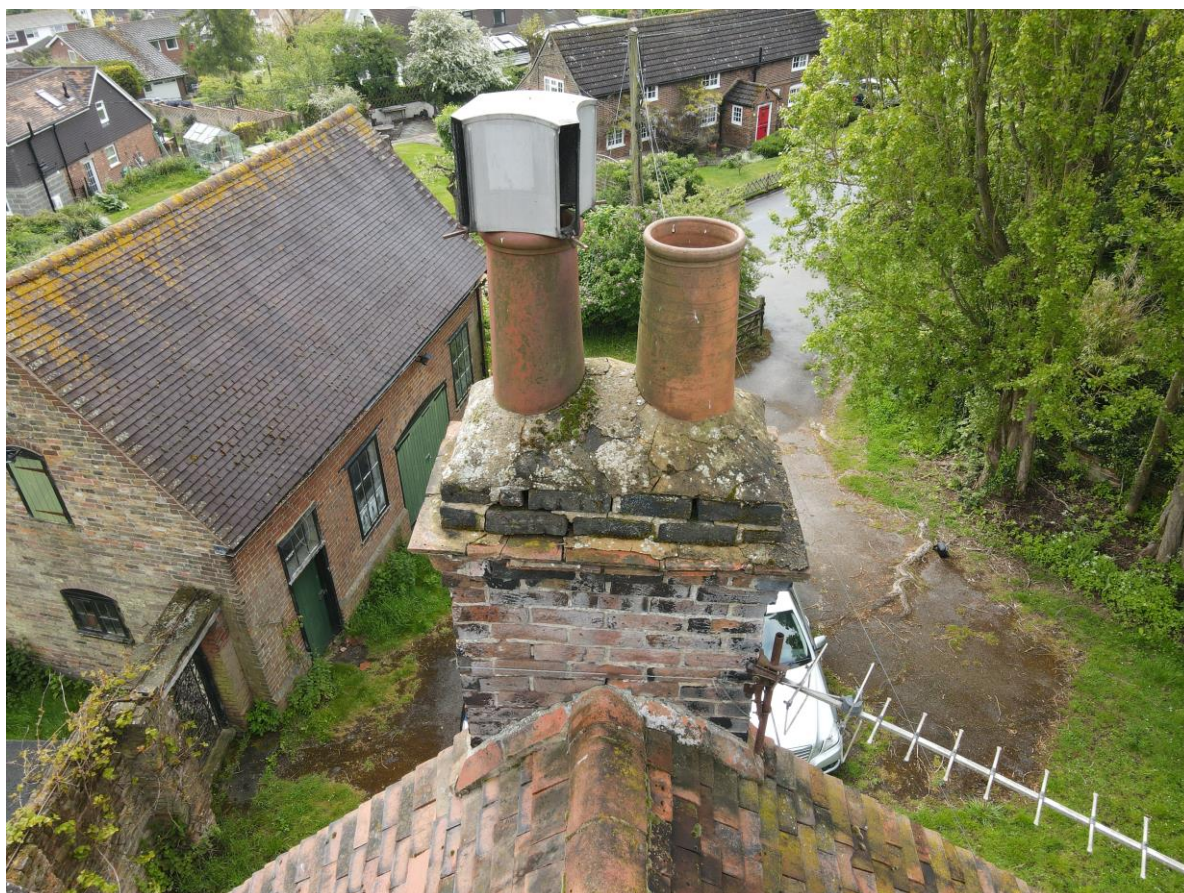
2.16 Chimney 1 – Rear showing bedded tile flashing detail

- 2.03 The flashing detail between chimney stack and roof tile is a cut roof tile bedded on mortar, this detail has a short life expectancy of 10 years with the mortar prone to cracking from movement caused by weathering. The detail is out of normal view and as such difficult to see and maintain. By replacing with traditional lead flashing the life expectancy is increased to a minimum of 50 years and in doing so reduces the risk of water ingress to the roof structure below.

- v. To reset chimney pots on Chimney 3 due to movement
  - vi. To provide vents to all reset chimney pots to stop bird and insect invasion
  - vii. To remove tile flashing detail between roofs and chimney stacks and replace with code 4 lead flashing dressed into stacks and beneath tiled roofs with lead soakers to provide long lasting weather tight detail

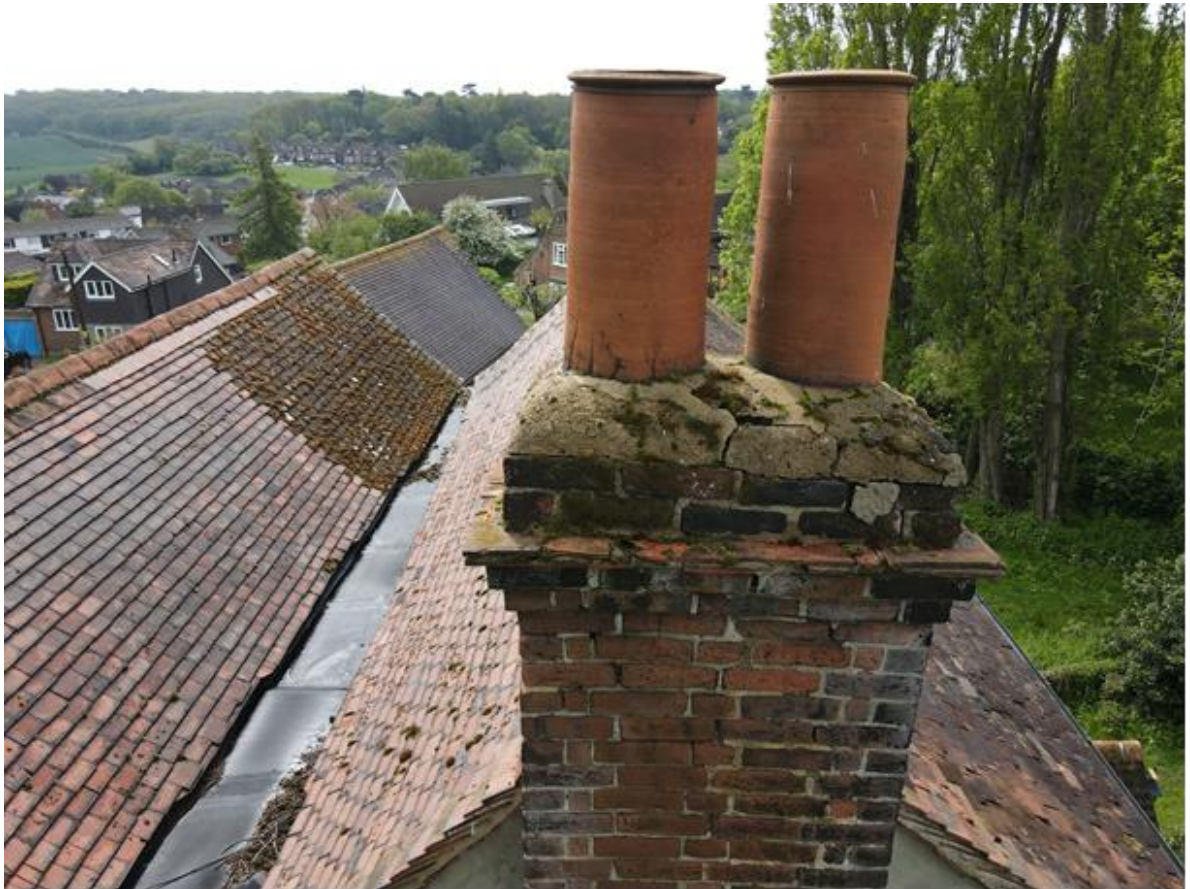
2.16 Chimney 2 – Front

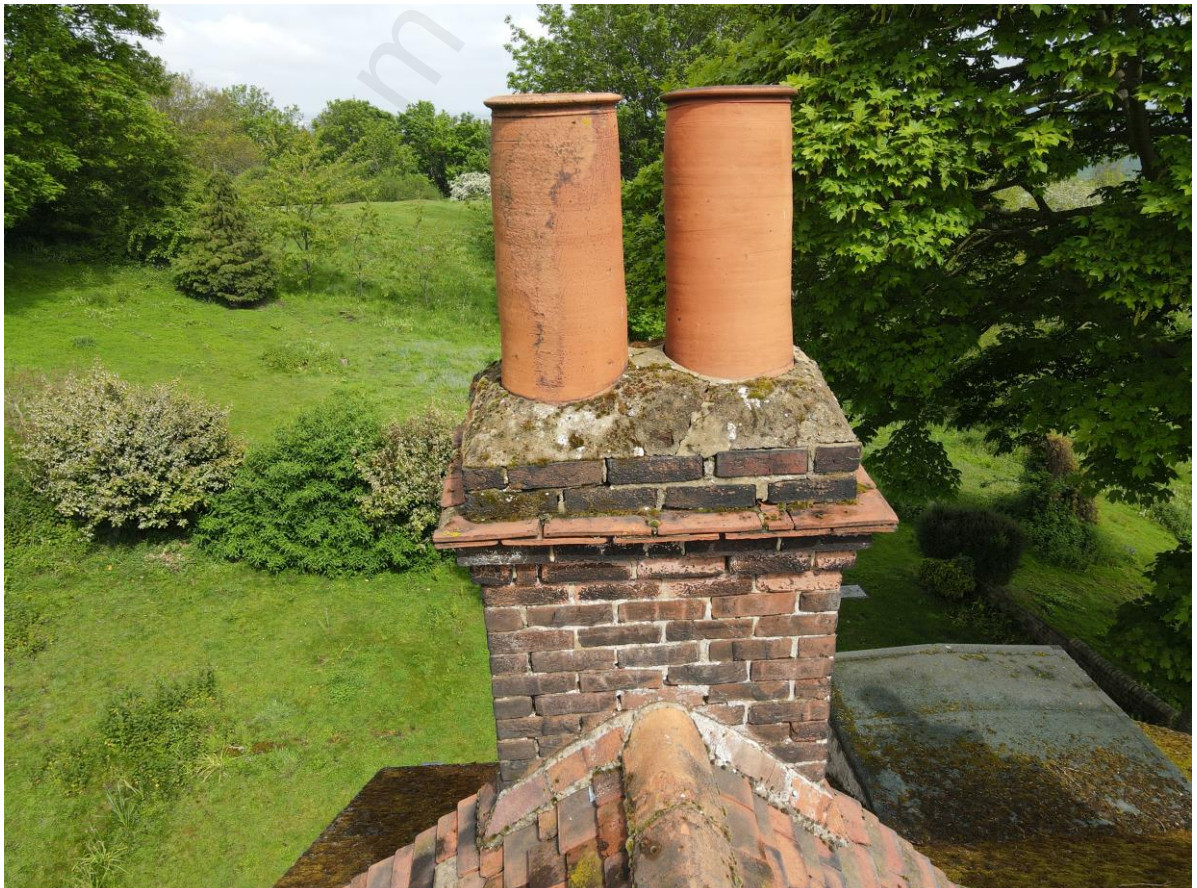
2.17 Chimney 2 - Rear showing bedded tile flashing detail

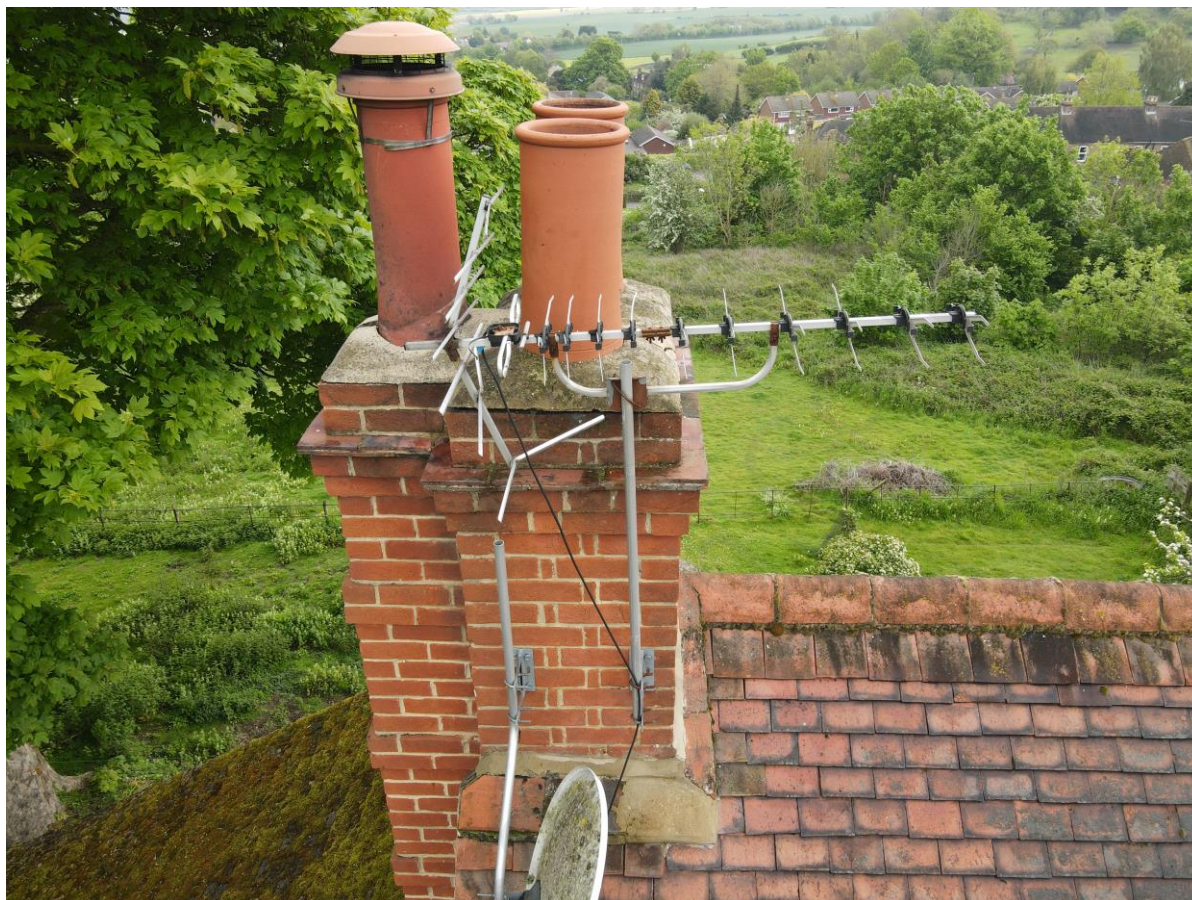
2.17 Chimney 3 – Side

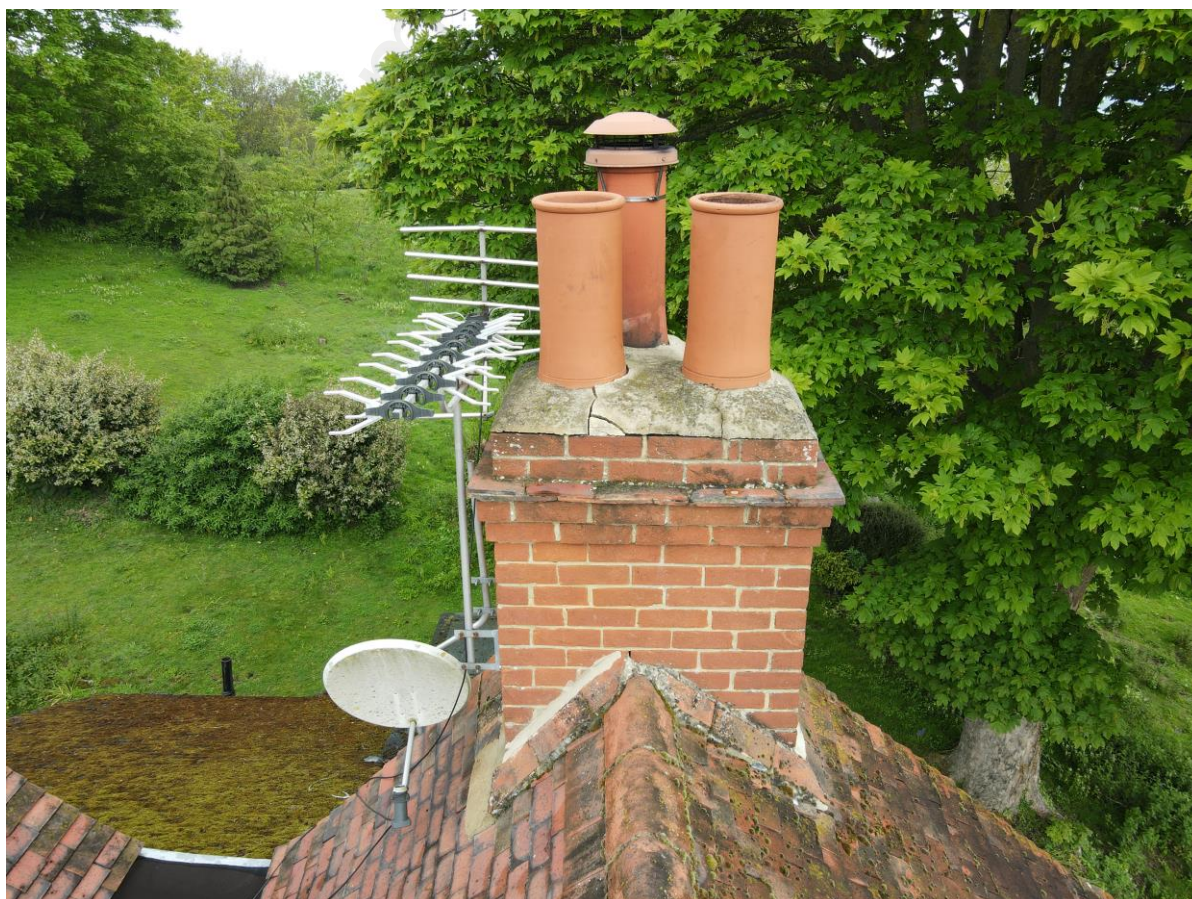
2.17 Chimney 3 – Rear showing bedded tile flashing detail
