# Listed Building Application for site investigation work

## Brief Heritage Statement

Gad's Hill School, Gravesend Road, Rochester ME3 7PA

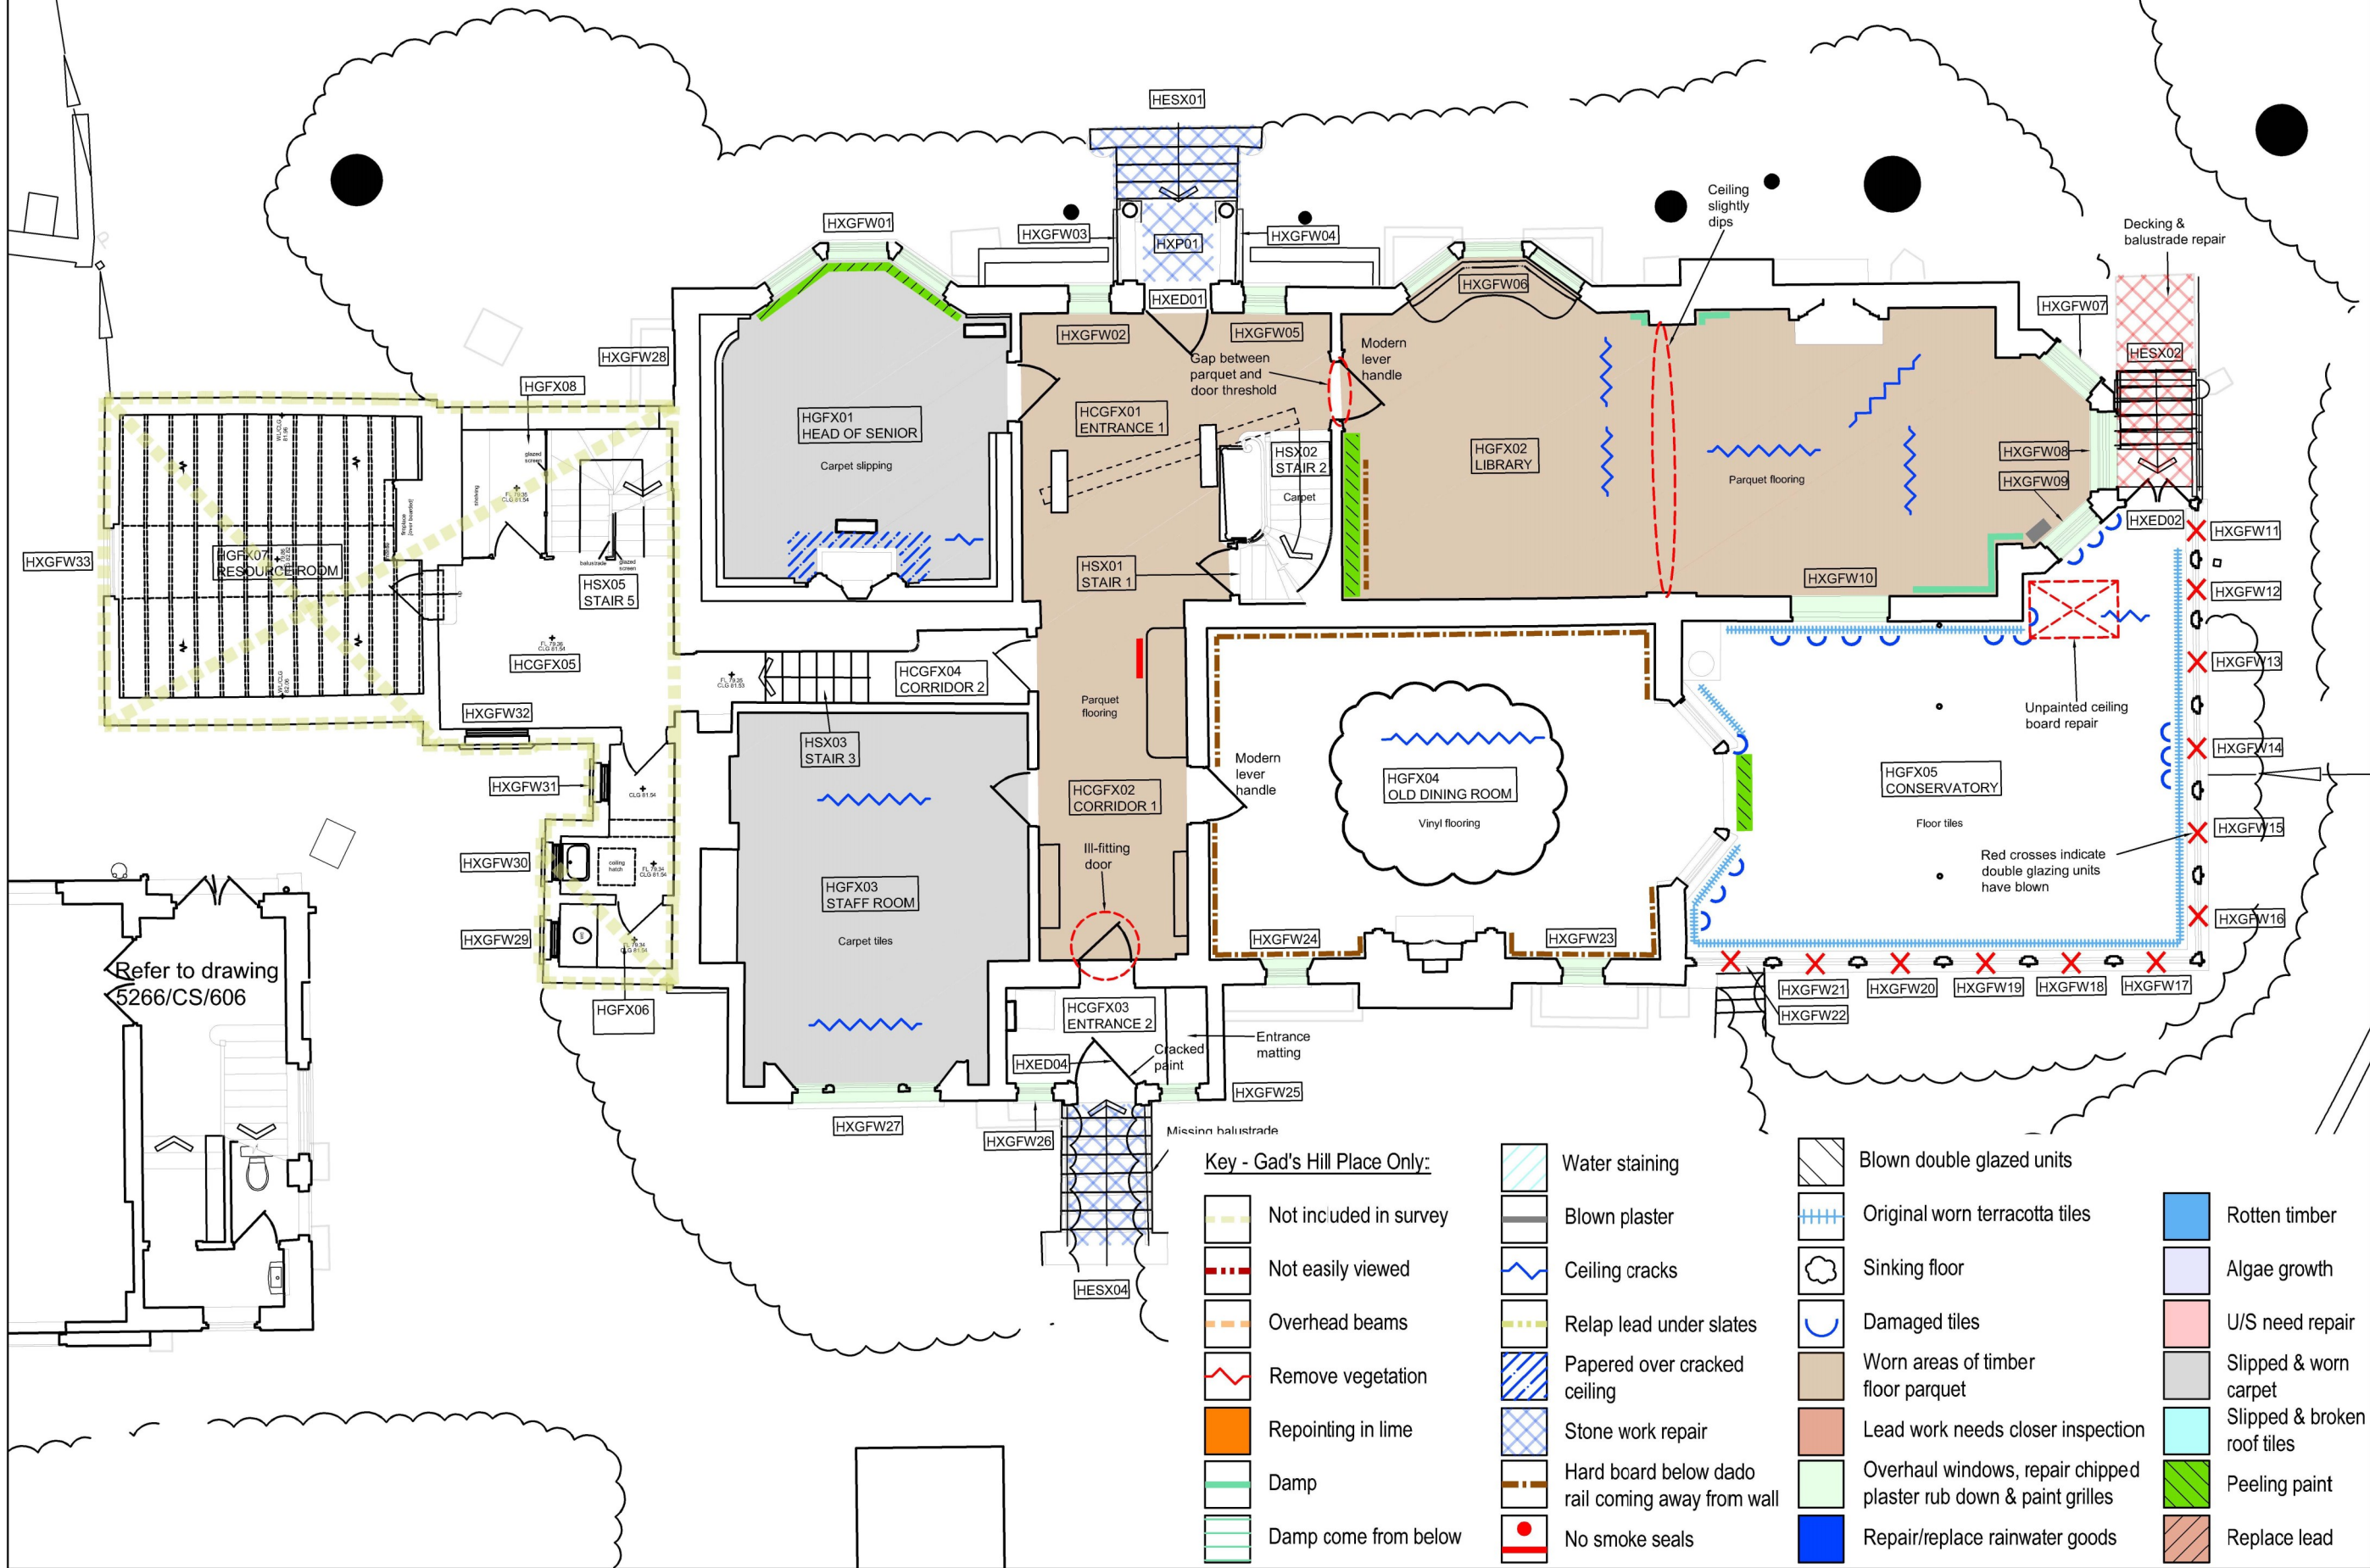
Title  
Gad's Hill Place (H)  
Existing Ground Floor Plan  
Drawing No. 5266/CS/614

The principal issue raised by the survey is that, in its current role as a school building, the mansion is severely overused, with students imposing loads on the building that it was never designed or built for. The floors, ceilings and central staircase are generally in a poor condition and will deteriorate further if not dealt with by the end of 2027.

This therefore is a Listed Building Application for urgent structural investigations to be carried out to enable the inspection of floor joists and sub-structure and enable the consultant team to develop a proposal to repair and correct the damage the caused to the ground, 1st and 2nd floors over the years.
