**CHESS**Structural  
Consultants Ltd28 Station Road  
Watford  
Hertfordshire  
WD17 1JU  
01923 250050

**Re: Ms Marion Money, 32 Harmer Street, Gravesend, Kent, DA21 2AX**

Thank you for meeting with me this morning at your property to inspect the structural damage caused by the recent vehicle impact to the rear of your office building.

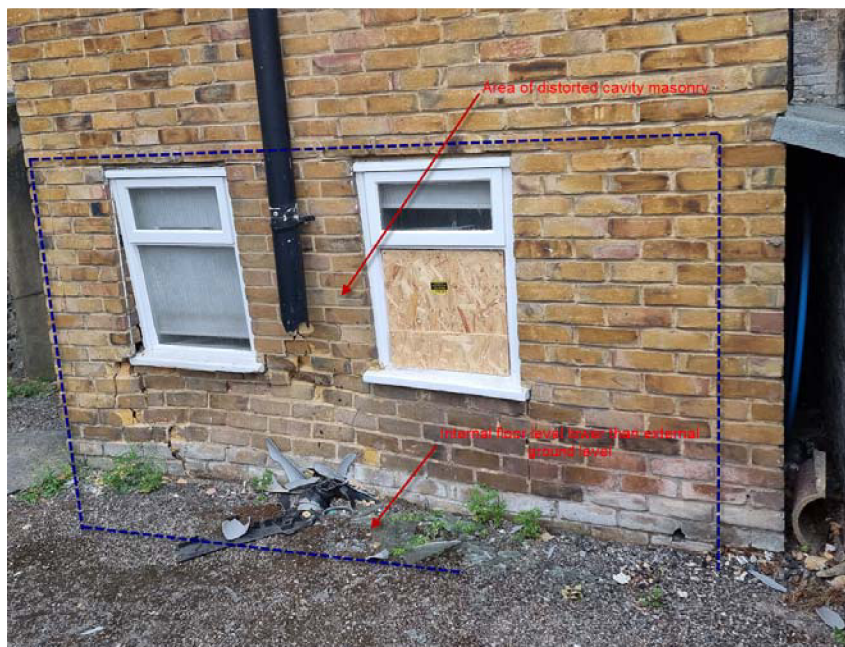
The impact was approximately central to the rear elevation at ground floor level and has distorted the masonry between ground floor window heads and internal ground floor level.

- External damage to rear elevation

It is my recommendation that 4No Strong-Boy Acrow props be installed at ground floor level from the underside of the rear window heads, 2No to each side. Additionally, the RHS (when viewed externally) requires security boarding to be installed internally.

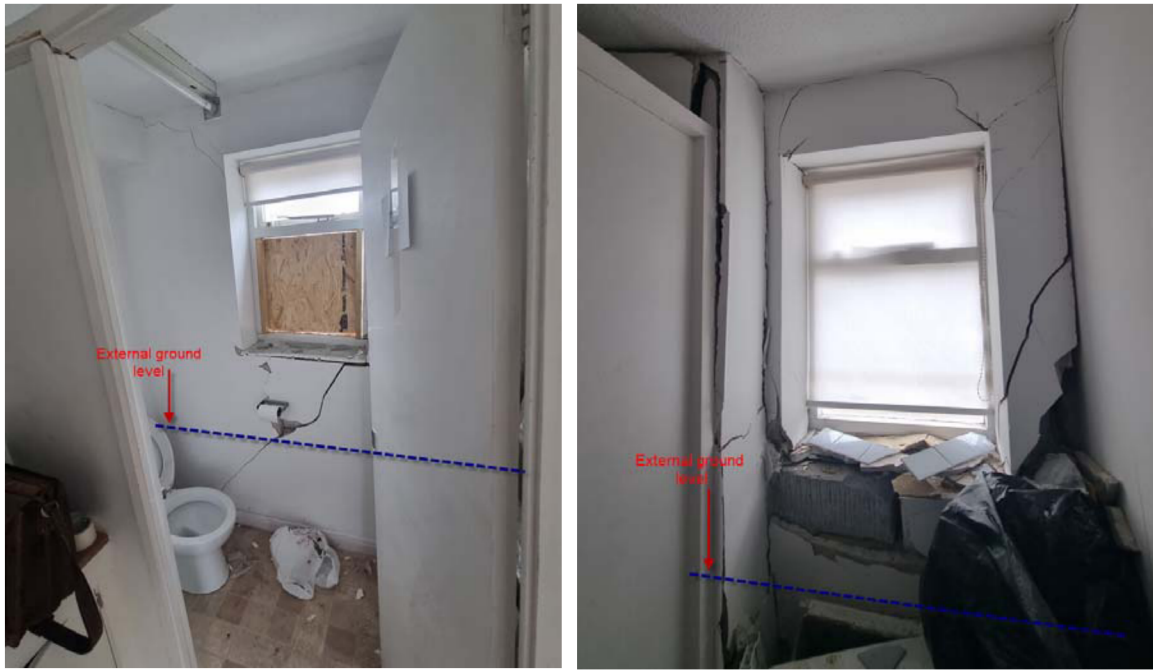
- Internal damage to rear elevation

The vehicle impact has caused significant distortion to the internal and external skins of masonry to the external rear elevation wall at ground floor level. The flank elevations appear to be vertically plumb and free of distortion. Similarly the suspended 1<sup>st</sup> floor timber structure, spanning from side to side, also appears to be undamaged by the impact.
