# Arboricultural Report

SUBSIDENCE INVESTIGATION AT:

**1 Kent Terrace  
Church Street  
Rochester  
Kent  
ME3 7LF**

| Reference No: | SU2302421 |

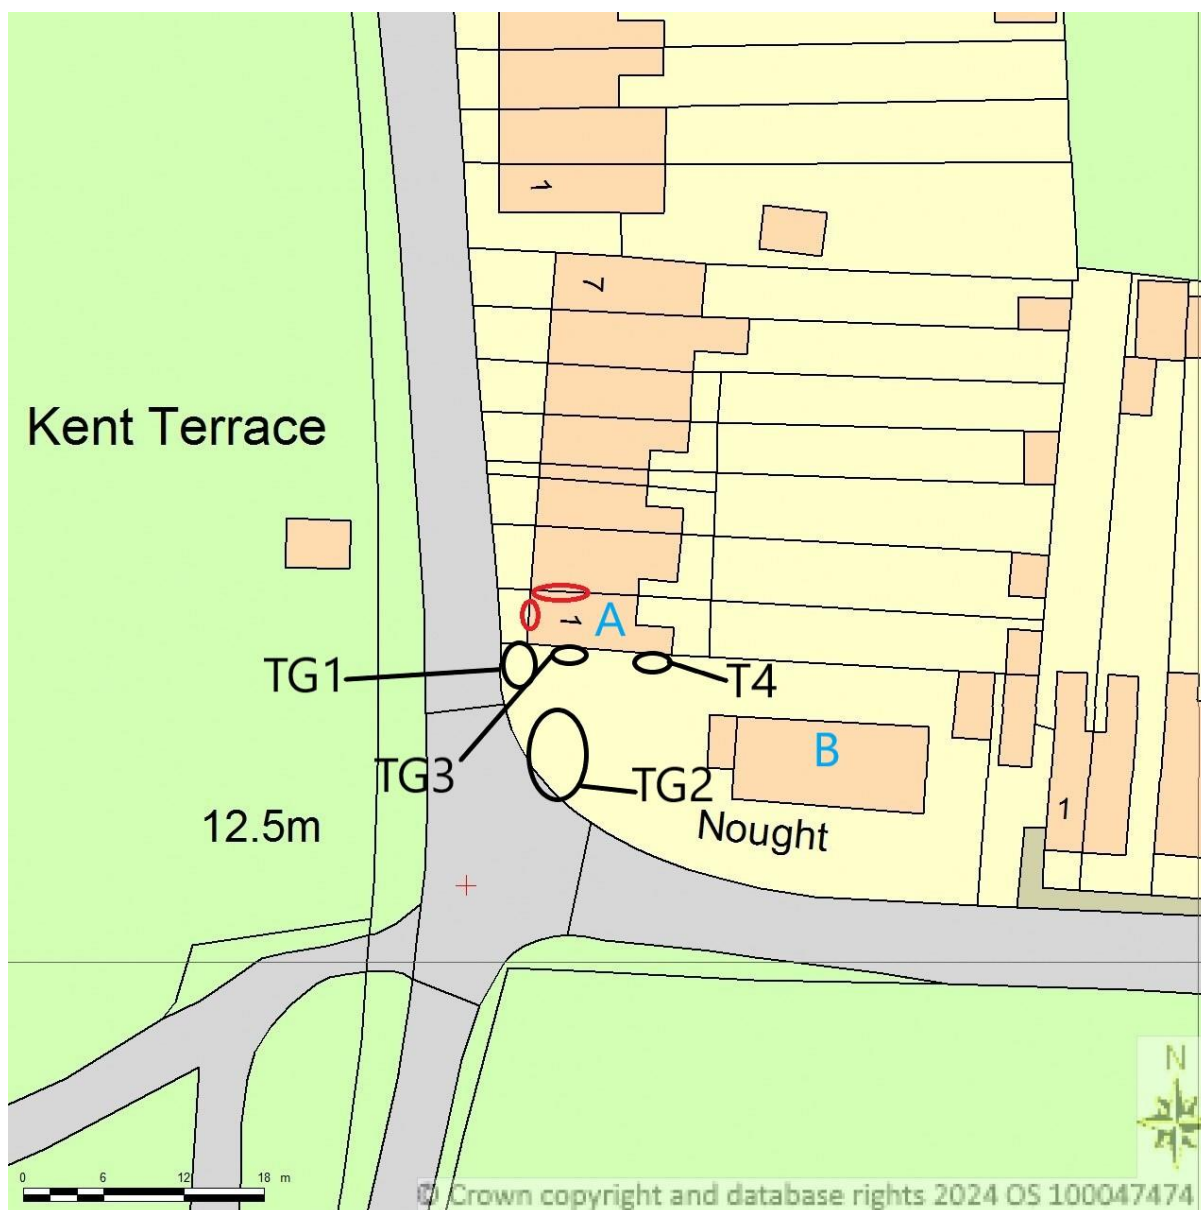
Tree plan showing area of damage with red circle and location of neighbours as detailed below.

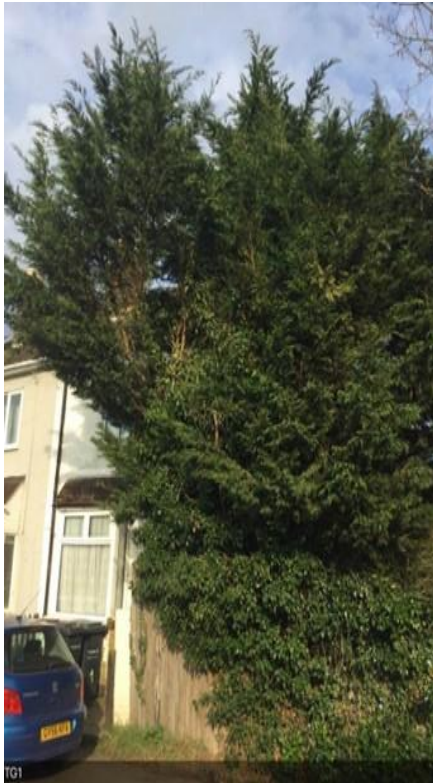
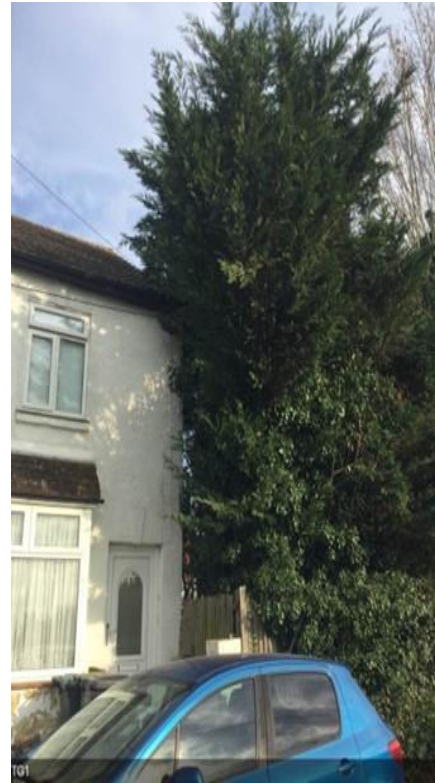
**TG1**

| Ref. | Species | Height (m) | Canopy radius (m) | DBH (cm)<br>No. of stems | Life stage | Age relative to property | Distance to property (m) | Tree owner/ location | Vitality, previous works, comments | TPO/ CA |
|---|---|---|---|---|---|---|---|---|---|---|
| <b>TG1</b> | Leyland cypress | 8 | 3 | 7 | Semi-mature | Younger | 0.6 | Neighbour | Good. Reduced, Target pruned.<br>High-water demand. | CA |

- Leyland cypress (TG1) has a high-water demand and is within the 50% distance for damage in the C&R study. Laboratory analysis of the roots found below foundation depth during the site investigation identified them as Cupressus spp.
- Poplar (TG2) has a high-water demand and is within the 50% distance for damage in the C&R study.
- Elder (TG3) is within 50% of the radius of influence defined by NHBC.
- Elder (T4) is unlikely to be of influence.

| Ref. | Species & age<br>(relative to<br>property) | Height<br>DBH<br>(m) | Dist.<br>to<br>dmg.<br>(m) | Vitality &<br>previous works | Tree owner/<br>location | Recommendation | TPO<br>CA |
|---|---|---|---|---|---|---|---|
| TG1 | Leyland<br>cypress<br>Semi-mature<br>(Younger) | 8<br>(0.07) | 0.6 | Good<br>Reduced, Target<br>pruned | Neighbour<br>(see plan) | Remove close to ground level. | CA |

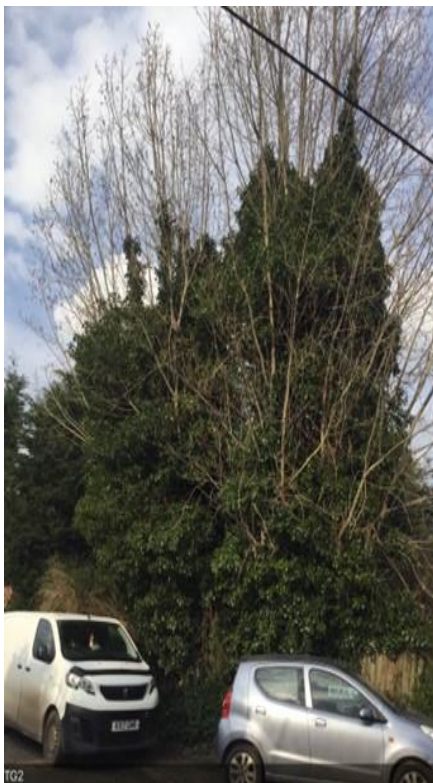
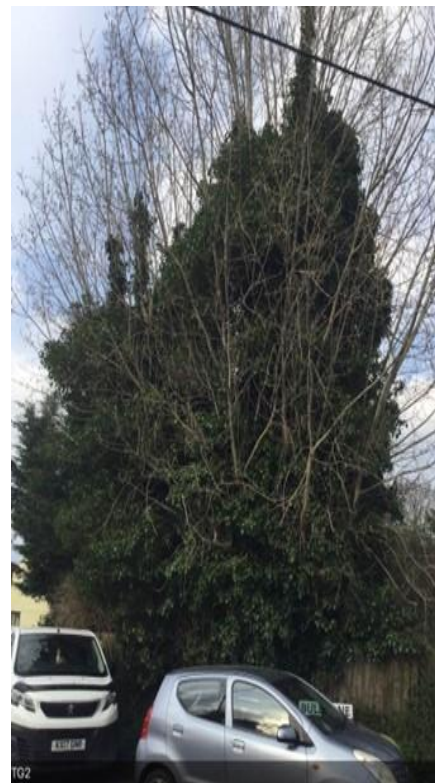
**TG2**

| Ref. | Species | Height (m) | Canopy radius (m) | DBH (cm)<br>No. of stems | Life stage | Age relative to property | Distance to property (m) | Tree owner/ location | Vitality, previous works, comments | TPO/ CA |
|---|---|---|---|---|---|---|---|---|---|---|
| <b>TG2</b> | Poplar | 12 | 3.4 | 23 | Mature | Younger | 8 # | Neighbour | Good. Pollarded.<br>High-water demand. | CA |

| Ref. | Species & age<br>(relative to<br>property) | Height<br>DBH<br>(m) | Dist.<br>to<br>dmg.<br>(m) | Vitality &<br>previous works | Tree owner/<br>location | Recommendation | TPO<br>CA |
|---|---|---|---|---|---|---|---|
| TG2 | Poplar<br>Mature<br>(Younger) | 12<br>(0.23) | 8 # | Good<br>Pollarded | Neighbour<br>(see plan) | Remove close to ground level<br>and treat stumps with herbicide<br>to inhibit regrowth. | CA |

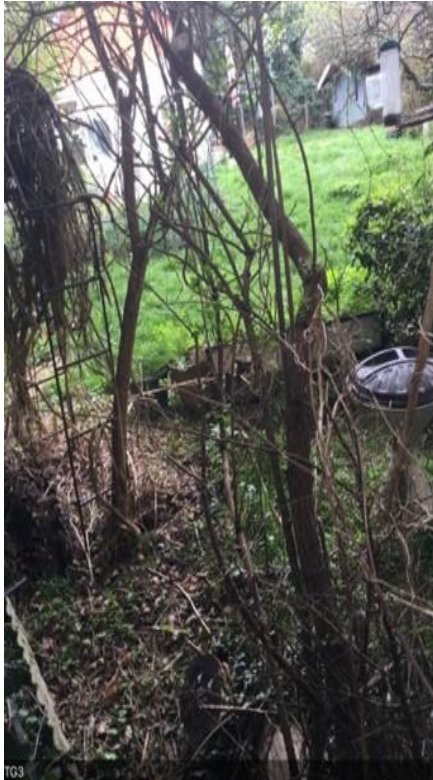
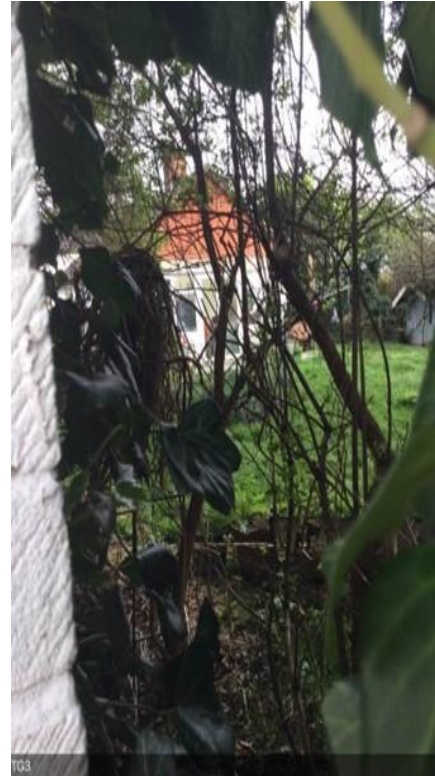
**TG3**

| Ref. | Species | Height (m) | Canopy radius (m) | DBH (cm)<br>No. of stems | Life stage | Age relative to property | Distance to property (m) | Tree owner/ location | Vitality, previous works, comments | TPO/ CA |
|---|---|---|---|---|---|---|---|---|---|---|
| <b>TG3</b> | Elder | 4.5 | 2.5 | 10 # | Young | Younger | 1 # | Neighbour | Good.<br>Low-water demand. | CA |

| Ref. | Species & age<br>(relative to<br>property) | Height<br>DBH<br>(m) | Dist.<br>to<br>dmg.<br>(m) | Vitality &<br>previous works | Tree owner/<br>location | Recommendation | TPO<br>CA |
|---|---|---|---|---|---|---|---|
| TG3 | Elder<br>Young<br>(Younger) | 4.5<br>(0.10) | 1 # | Good | Neighbour<br>(see plan) | Remove close to ground level<br>and treat stumps with herbicide<br>to inhibit regrowth. | CA |

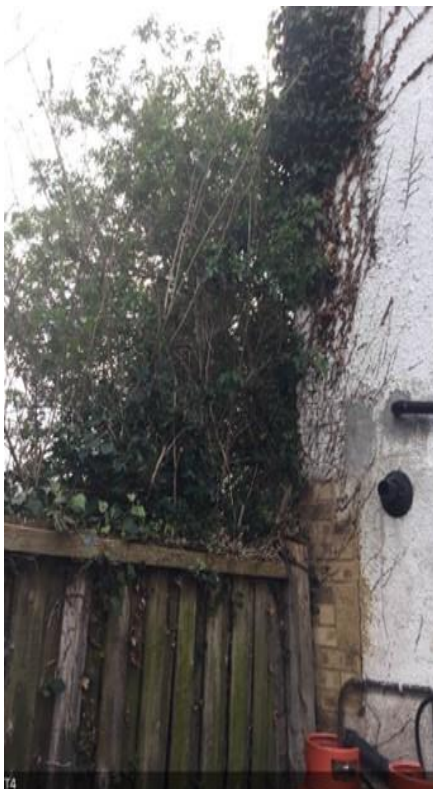
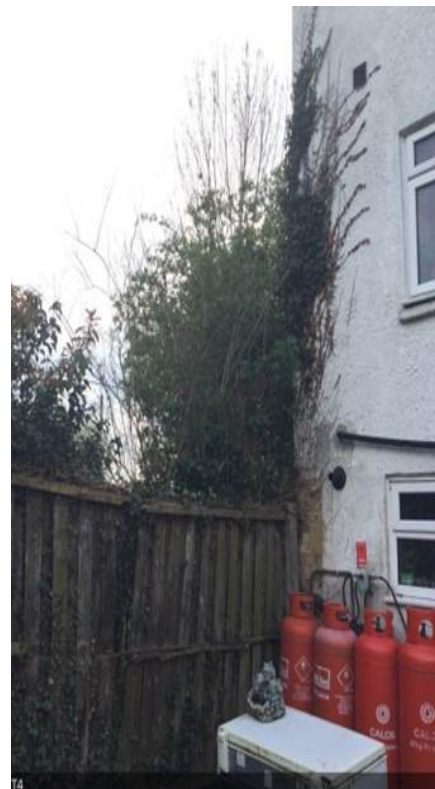
**T4**

| Ref. | Species | Height (m) | Canopy radius (m) | DBH (cm)<br>No. of stems | Life stage | Age relative to property | Distance to property (m) | Tree owner/ location | Vitality, previous works, comments | TPO/ CA |
|---|---|---|---|---|---|---|---|---|---|---|
| <b>T4</b> | Elder | 3 | 1 | 1<br>4 | Young | Younger | 5 # | Neighbour | Fair. Reduced.<br>Low-water demand. | CA |
