## Subsidence Overview Report

Mrs Audrey Osborne  
1 Kent Terrace  
Church Street  
Rochester  
Kent  
ME3 7LF

# Factual Report

## SITE INVESTIGATION AND DRAINAGE REPORT CONTENT

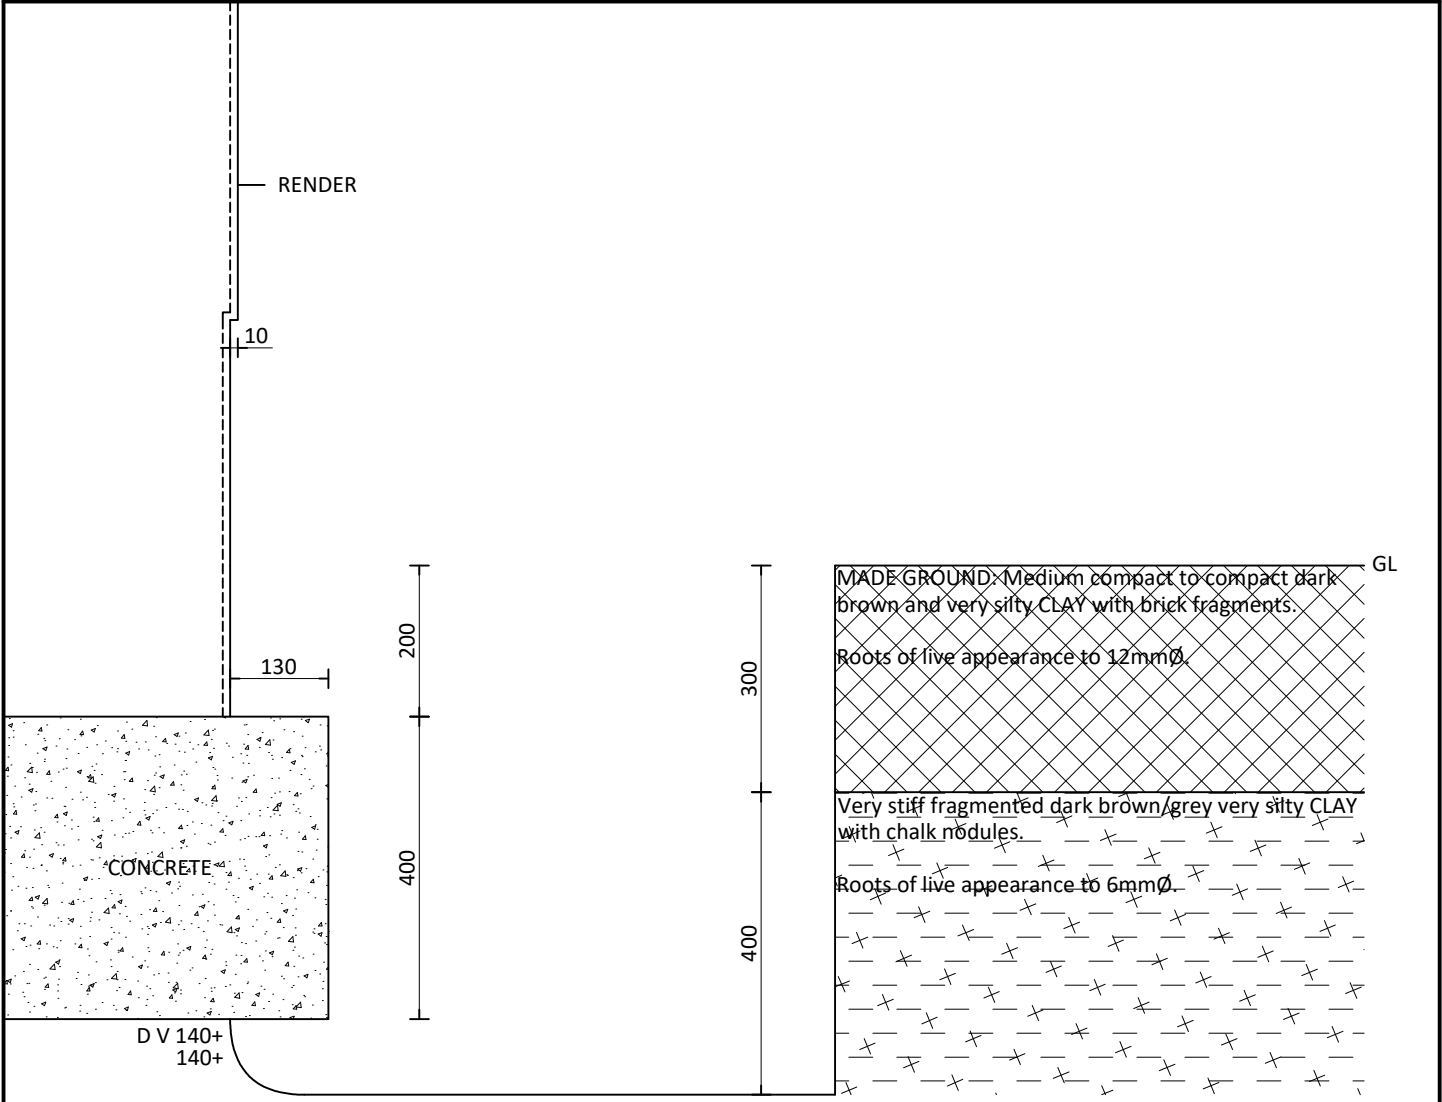
MADE GROUND: Medium compact to compact dark brown and very silty CLAY with brick fragments.  
Roots of live appearance to 12mmØ.

Very stiff fragmented dark brown/grey very silty CLAY with chalk nodules.  
Roots of live appearance to 6mmØ.

TRIAL PIT ENDS AT 700mm  
FOR STRATA BELOW 700mm SEE BOREHOLE 1 LOG

| No water encountered.<br>All dimensions in millimetres. | ND No Data<br>NTS Not to Scale<br>GL Ground Level<br>D Small Disturbed Sample<br>V Pilcon Vane (kPa) |

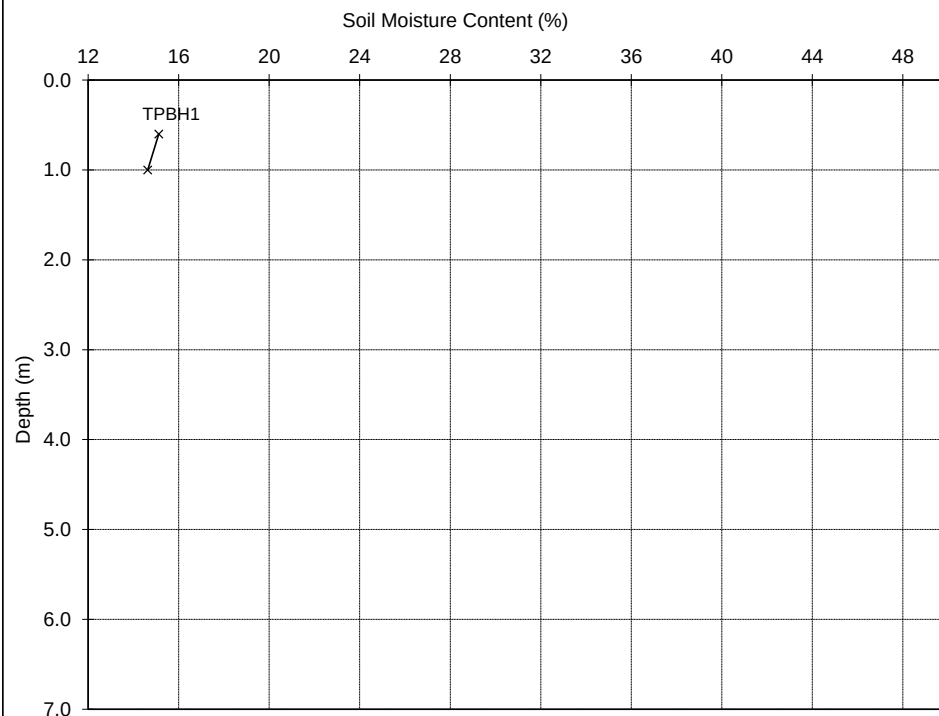
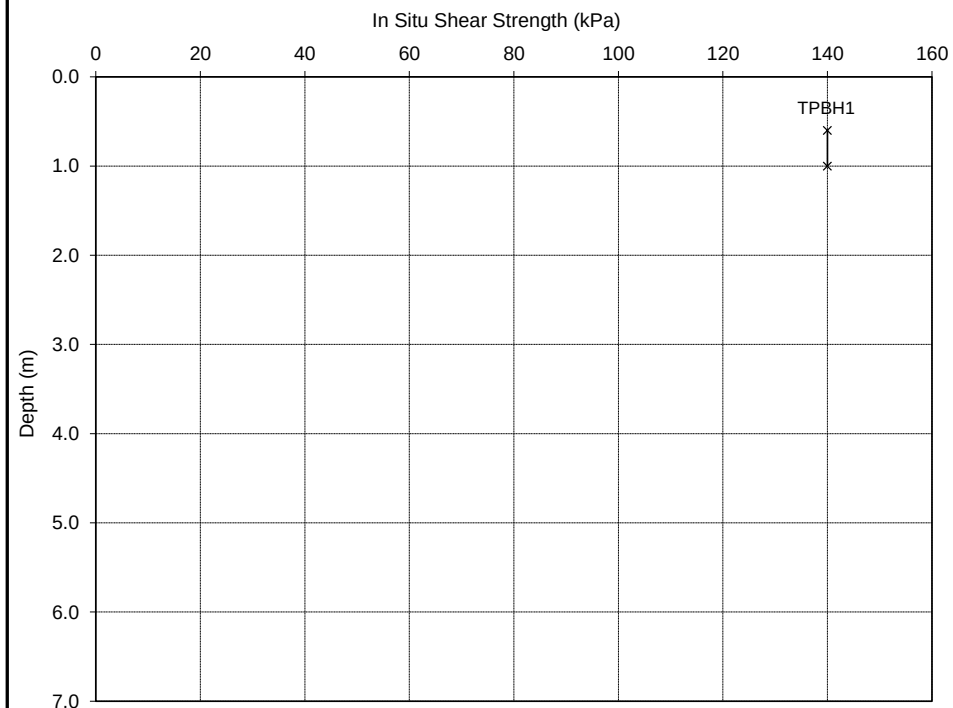
Moisture Content/Shear Strength Profile

Unless otherwise stated, values of Shear Strength were determined in situ using a Pilcon Hand Vane the calibration of which is limited to a maximum reading of 140 kPa. (Not UKAS accredited)

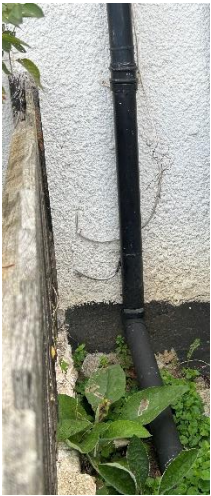
| <b>SURVEY 1:</b> | RWP1 DOWNSTREAM U1: SURFACE | | |

| | Survey abandoned (access) | | |
| Invert Depth: | NA | Structural condition and serviceability: | TBC |

RWP1 & 2 both discharge to surface within the zone of influence. There is insufficient space to install a soakaway. We therefore recommend the insurers diverts them, above ground, away from the zone of influence or installs a water butt.

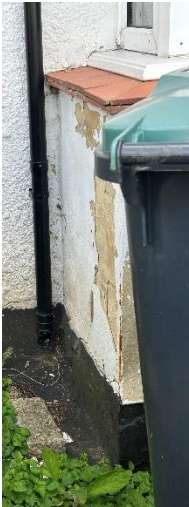
| <b>SURVEY 2:</b> | RWP2 DOWNSTREAM U2: SURFACE | | |

| | Survey abandoned (access) | | |
| Invert Depth: | NA | Structural condition and serviceability: | TBC |
