**Ref: 3825/20**

**PROPOSED REDEVELOPMENT AT  
THE YARD, LOWER RANGE ROAD,  
GRAVESEND, KENT DA12 2QL**

**PHASE 1 GEO ENVIRONMENTAL DESK STUDY AND  
PHASE 2 REPORT ON SUBSOIL INVESTIGATIONS**

**December 2020**

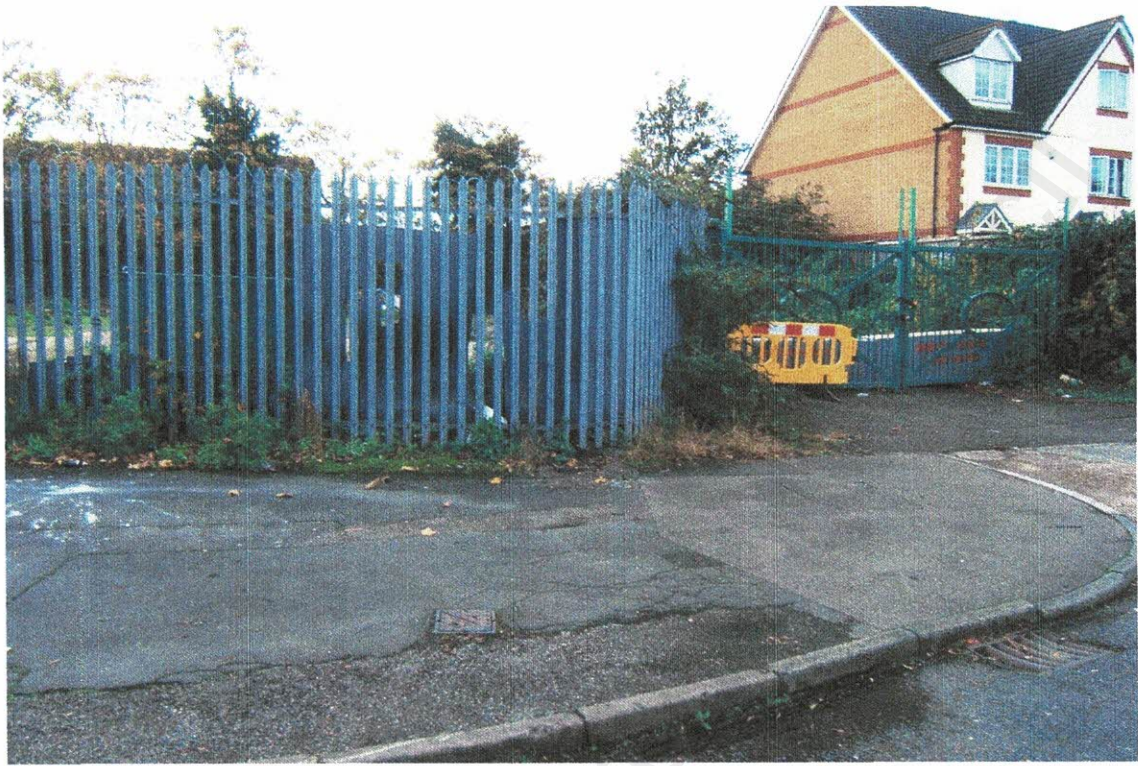
**Plate 1**

- 7.3 The site comprised an irregular area of relatively level ground enclosed on its north and east sides by steel railings (Plates 1). Padlocked steel gates and concrete blocks secured the entrance into the site from its northwest corner. A narrow tarmac road which had been blocked with fly-tipped rubbish passed alongside the north boundary of the site. The south and west boundaries of the site consisted of panelled timber fencing which had partially collapsed along the south boundary.

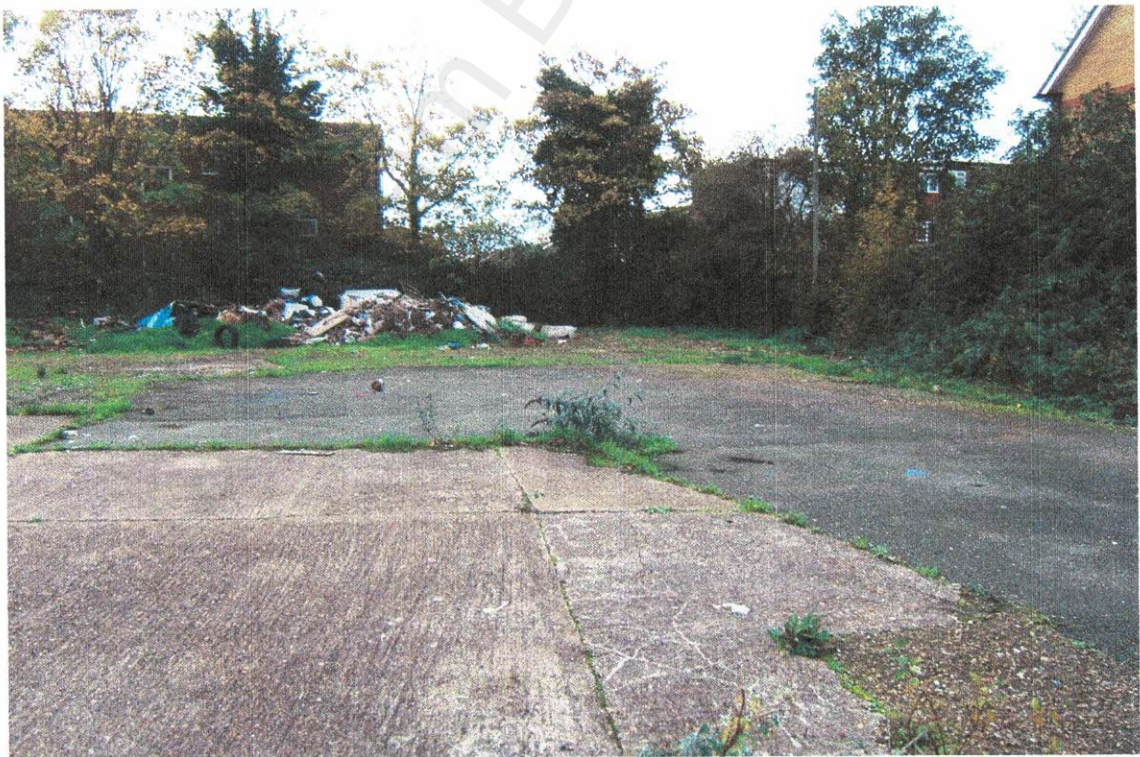
**Plate 2**

- 7.4 The site surface comprised part concrete, part tarmac with an area of unsurfaced gravelly soil in its central area. Large mounds of fly-tipped timber and domestic rubbish were present at the south end of the site and in its southeast corner (Plate 2 and Plate 3).

- 12.7 In the first instance it will be necessary to remove all fly-tipped rubbish from the site to an appropriately licensed waste facility.
- 12.8 It is recommended that areas of proposed garden or landscaping should be excavated to a depth of 600mm below finished ground surface and replaced by clean, imported soil including a capping of at least 300mm topsoil which has been independently tested in order to ensure that it is free from contamination and suitable for use on the site.

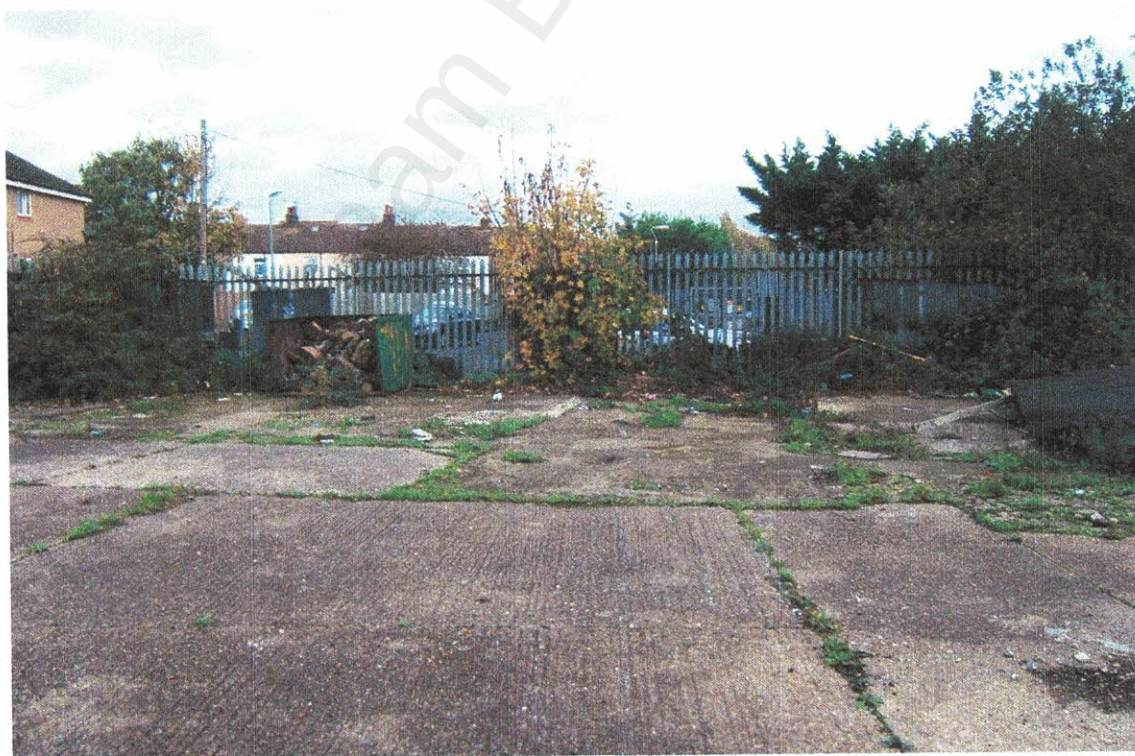
**Plate 4**

- 7.5 An open-ended skip containing brick rubble was located next to the site's north boundary (Plate 4), adjacent to the remains of a small timber building which appeared to have been destroyed by fire (Plate 5).

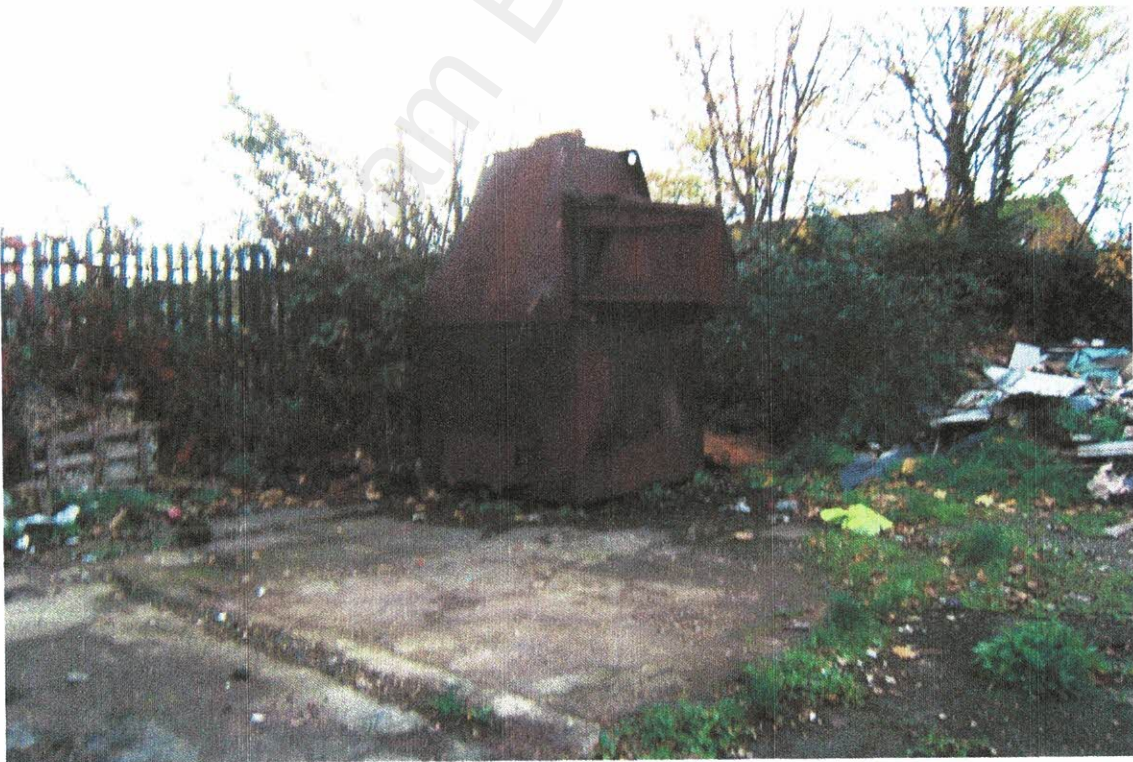
**Plate 6**

- 7.6 A steel incinerator was situated alongside the east boundary of the site (Plate 6).
- 7.7 Deciduous trees and bushes surrounded the east, south and west sides of the site, houses of relatively recent construction being present within the adjacent site to the west (Plate 7). A block of apartments occupied neighbouring land to the south.
