**GILES FARM, HIGHAM**

**STRUCTURAL VISUAL INSPECTION REPORT  
OF EXISTING BUILDINGS 3 & 4**

**6078-CON-XX-XX-RP-S-0001-S2-P01**

**MARCH 2024**

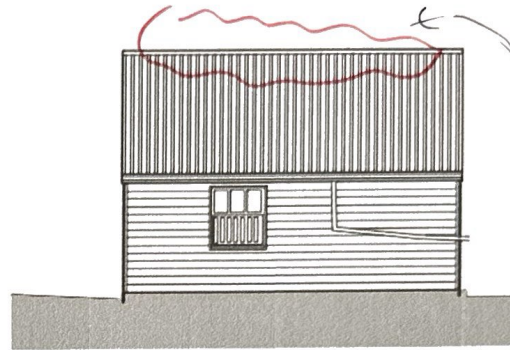
side elevation

Roof has  
dropped  
significantly.

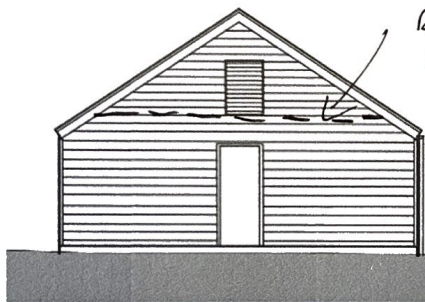
Building 3 front elevation

RAISED COWAL  
LINE  
INTEGRALLY.

DRAINAGE  
NOT  
CONNECTED.

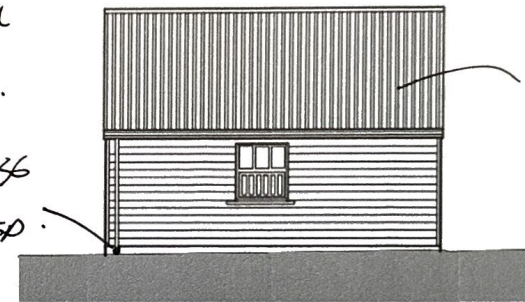
side elevation

PROFILES METAL  
DECK ROOF

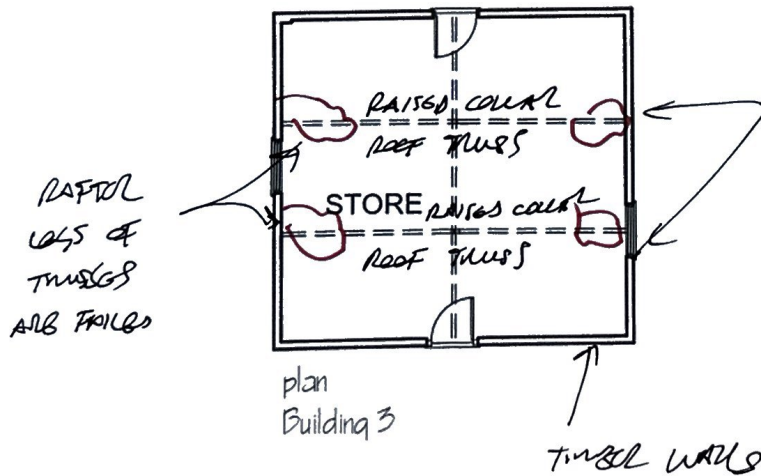
plan  
Building 3

- The substructure is exposed at the perimeter and would appear to be a concrete slab/raft. The presence or details of any reinforcement is not known at this stage.
- The ridge has dropped significantly.
- The two internal timber roof trusses have failed at the connection of the raised collar and the lower rafter leg. The timbers have fractured, and have caused the truss to drop, and the roof structure supported by them has dropped as a result.
- There is no positive rainwater drainage.

TIMBER WALLS

RAFTER LOSS  
OF TRUSSES  
ALL FAILED.

The findings of the survey are that generally the load bearing elements of the two buildings are in a reasonable state of repair, although some local repairs will be required to the roof trusses of building 3, together with relevening of the ridge.
