# Photographic Schedule of Condition

Reference: HC1636

Unit 23, Apex  
Business Park  
Queens Farm Road,  
Shorne  
Gravesend  
Kent  
DA12 3HU

**January  
5th 2024**

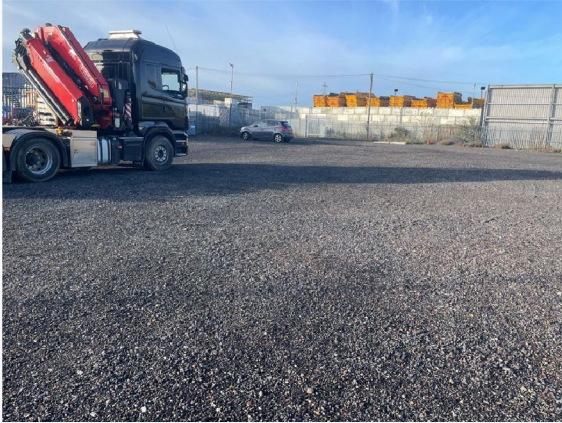
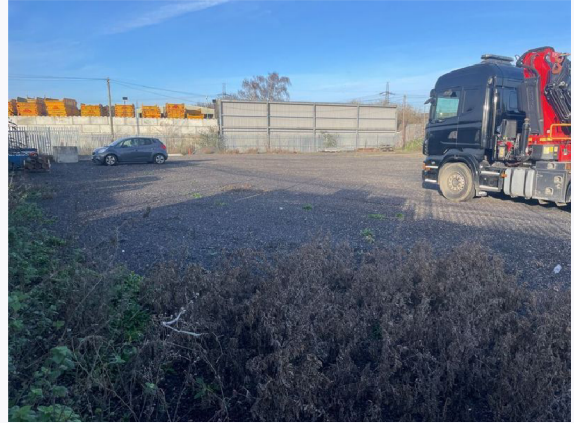
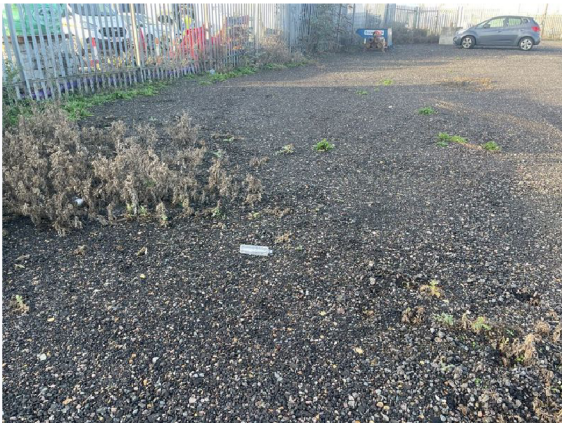
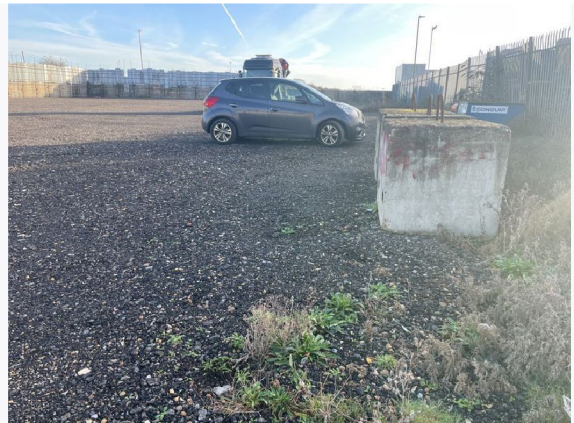
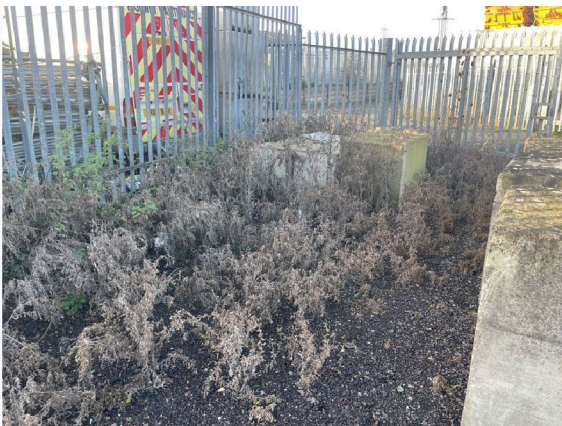
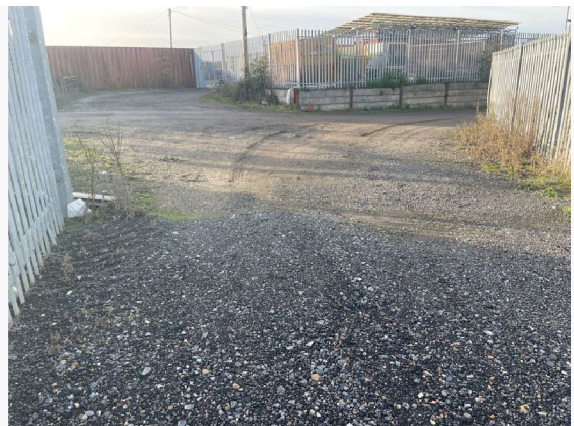
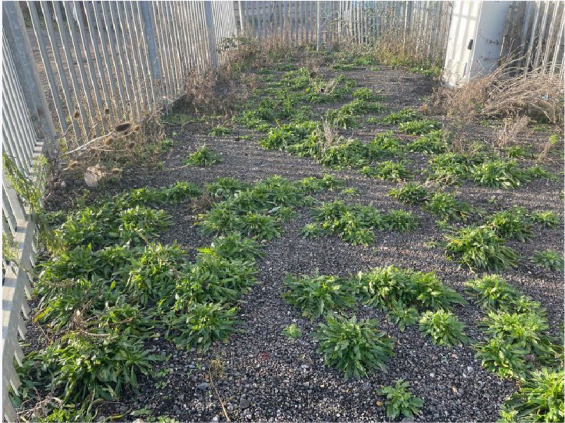
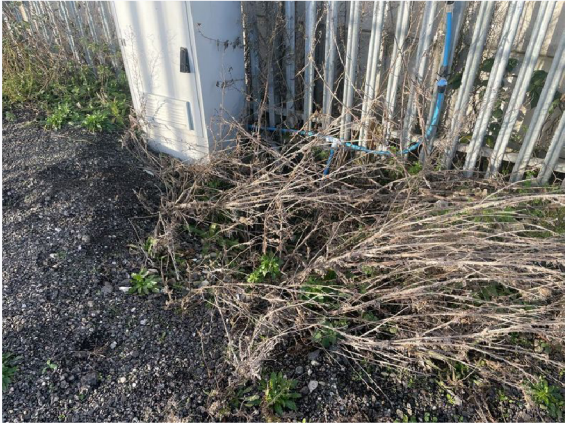
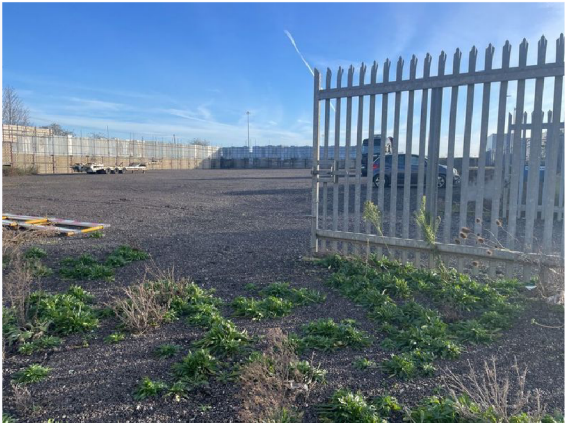
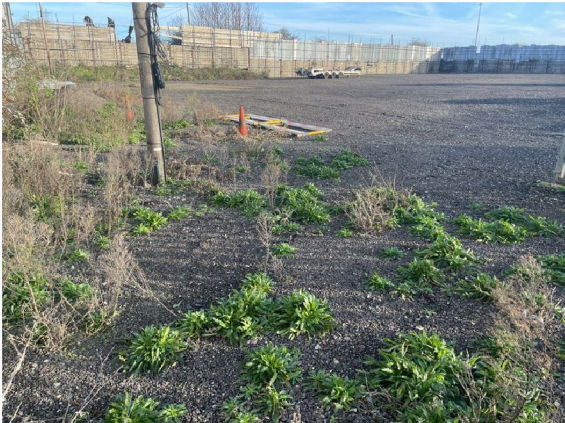
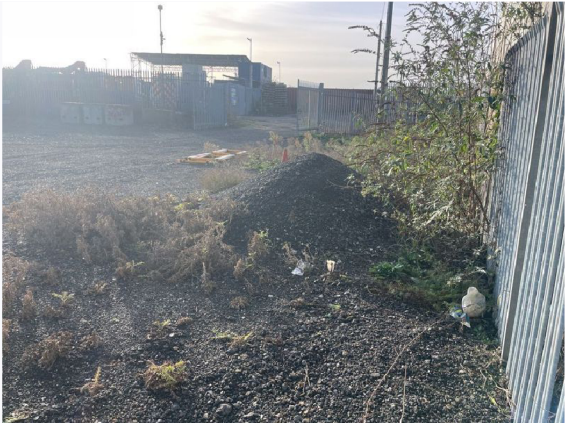
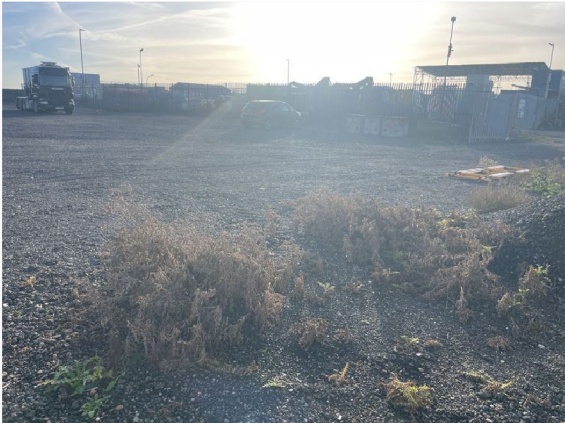
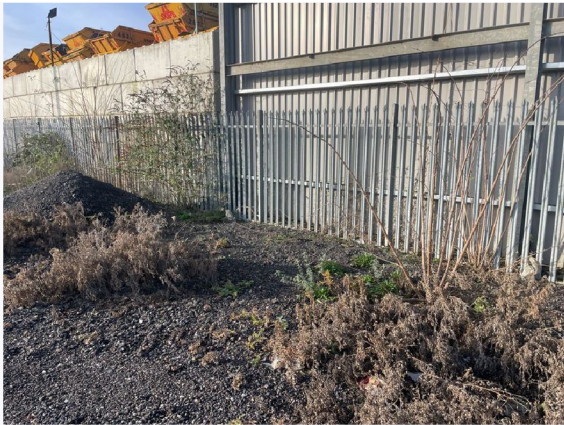
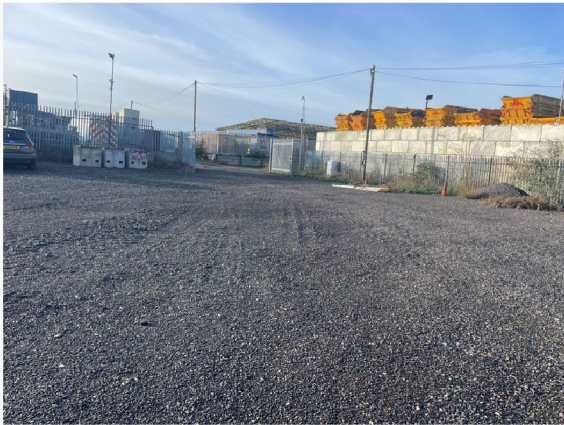
| 1. SOUTH WEST QUADRANT | | | |
|---|---|---|---|
| 1.1 | Grounds | Grounds are laid with gravel. | <p>Grounds are largely in fair condition with the following notable defects:</p> <ul style="list-style-type: none"> <li>- In the south west corner to the right of the electrical box there is a large hole in the ground (approx. 2sq.m), partially obscured with vegetation growth;</li> <li>- Gravel is sparse at the entrance gate;</li> <li>- Some unevenness to the grounds throughout;</li> <li>- Heaped gravel near the west boundary;</li> <li>- Significant vegetation growth to the perimeters;</li> <li>- Minor occasional vegetation growth more centrally within the gravel;</li> <li>- Occasional litter and debris.</li> </ul> |

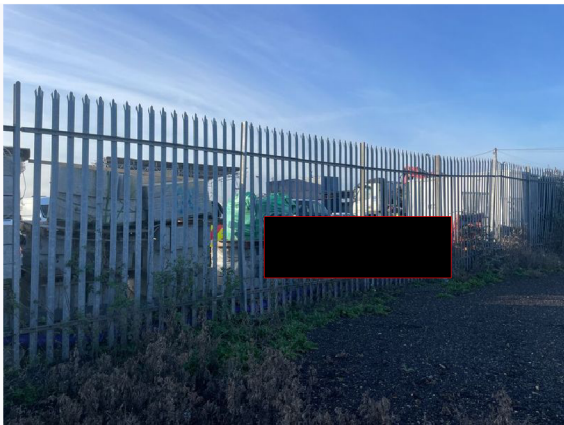
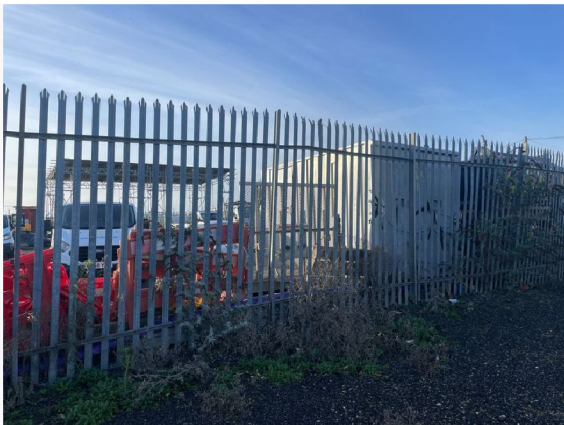
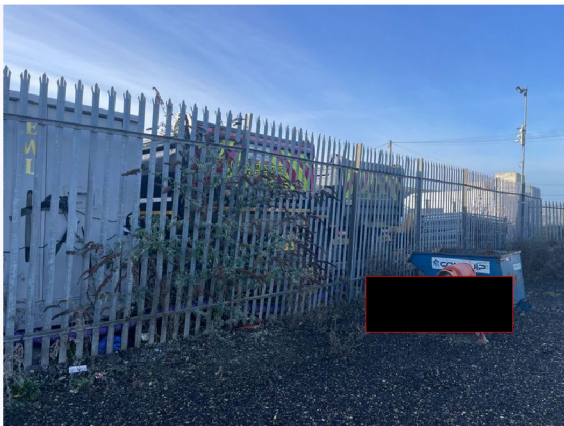
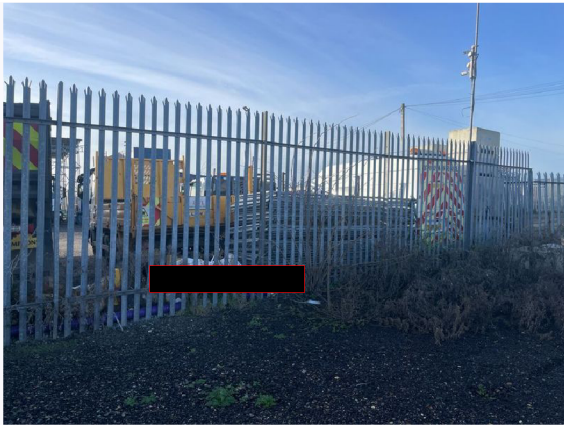
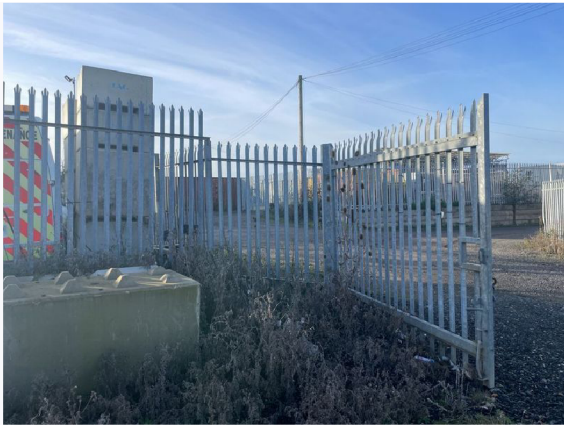
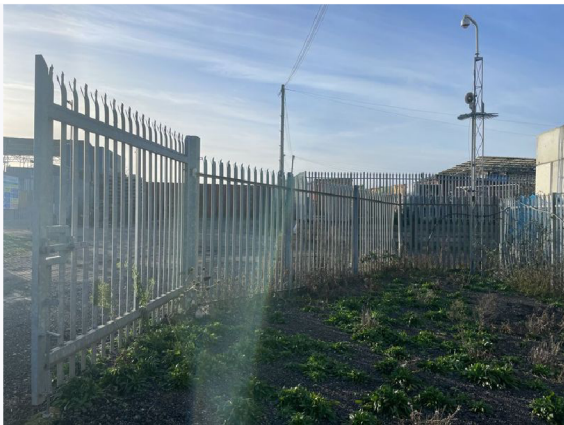
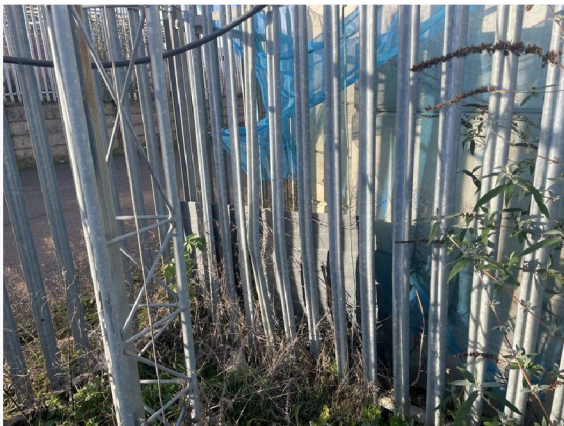
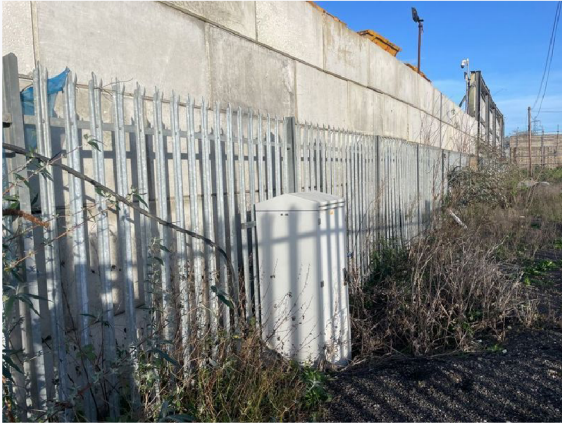
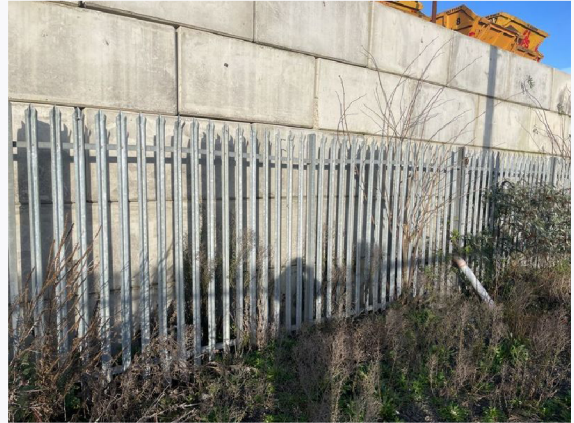
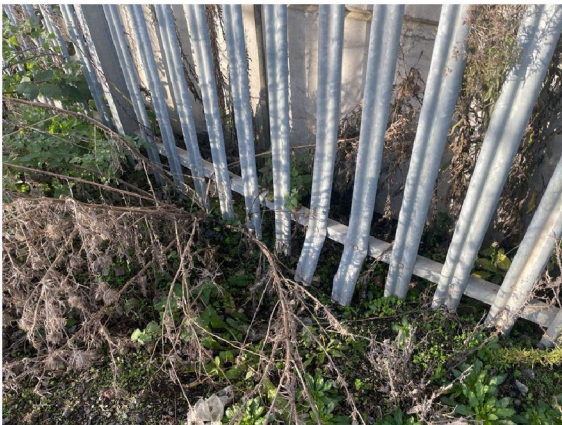
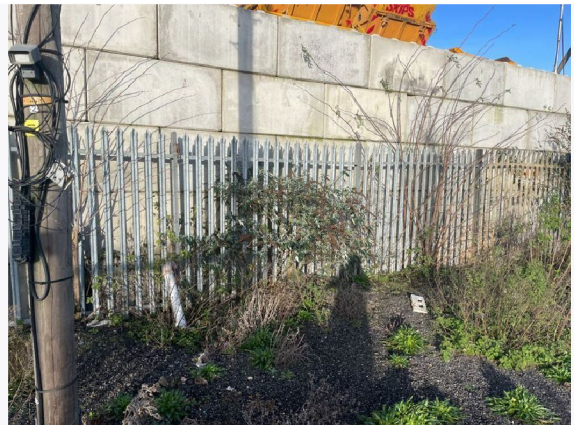
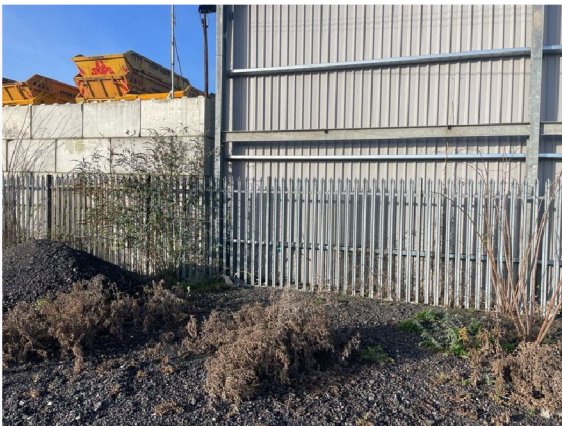
| 1. SOUTH WEST QUADRANT | | | |
|---|---|---|---|
| 1.2 | Boundaries | <p>The south and west boundaries are of palisade fencing.</p> <p>There is also a palisade entrance gate in the south corner.</p> | <p>Fencing is in fair condition overall save for the following defects:</p> <ul style="list-style-type: none"> <li>- Numerous isolated areas impact damage;</li> <li>- Particularly notable impact damage to the south boundary of the 6th and 7th fence panels from the entrance gate. A large vehicle in the neighbouring yard was parked against the fence, causing the fence to lean inwards towards the site during the inspection;</li> <li>- Several fence pales are bent/deformed at the top and bottom;</li> <li>- Occasional vegetation growth through the fencing.</li> </ul> <p>The gate is in fair condition save for:</p> <ul style="list-style-type: none"> <li>- Occasional areas of rust (particularly to the lock area and hinges);</li> <li>- 1 no. gate binds on the ground. There is minor bending to the base of the gate where it binds.</li> </ul> |

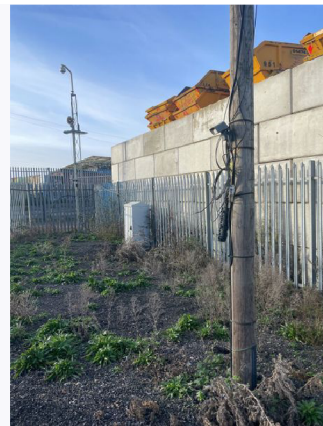
Ref # 1.3

| 1. SOUTH WEST QUADRANT | | | |
|---|---|---|---|
| 1.3 | Miscellaneous | <p>South west corner:</p> <ul style="list-style-type: none"> <li>- Metal pole/column with audio and security camera fit out items;</li> <li>- Metal electrical box.</li> </ul> <p>- Telephone pole approximately central near the west boundary;</p> <p>- Drainage pipe protruding the ground (south end of west boundary);</p> <p>- Previous tenant chattels.</p> | <p>The metal pole/column (with fitout) and electrical box appear to be in fair condition overall. A large electrical cable protrudes from the box and wraps around the perimeter fence loosely before going into the ground near the pole. No electrical items were tested as part of this inspection.</p> <p>No notable defects to the telephone pole save for age related weathering.</p> <p>The piping is in poor condition. It appears to be disconnected and is loosely fitted near the ground.</p> <p>The previous tenant's chattels remain including a rack of canisters and several large cement blocks/ barricades.</p> |

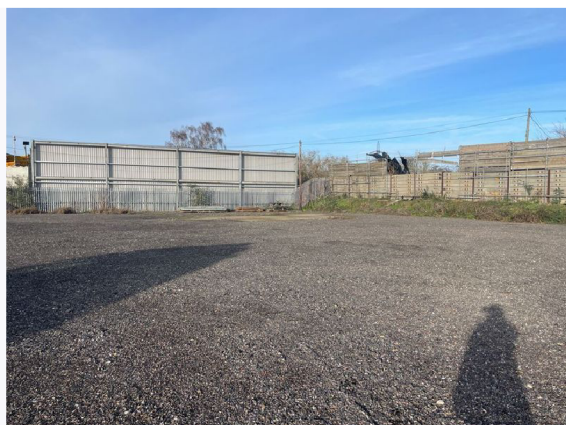
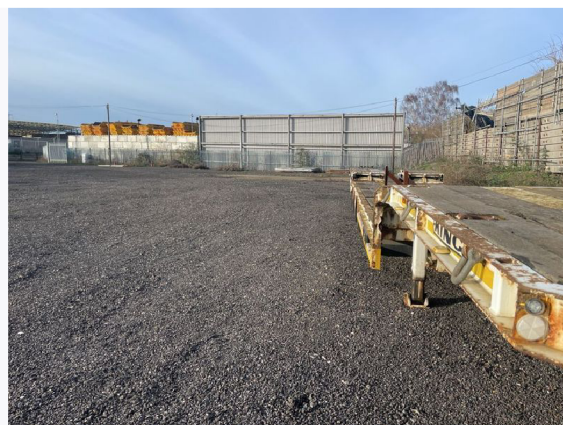
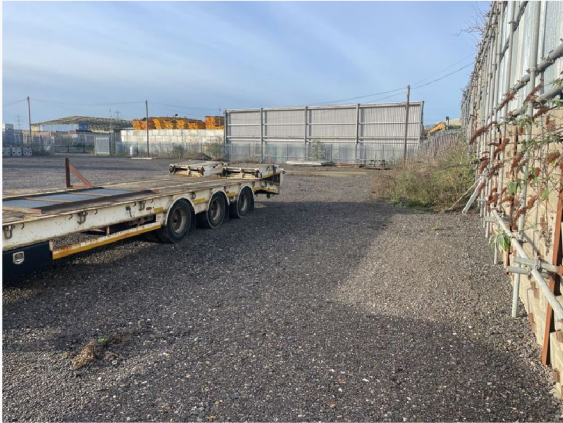
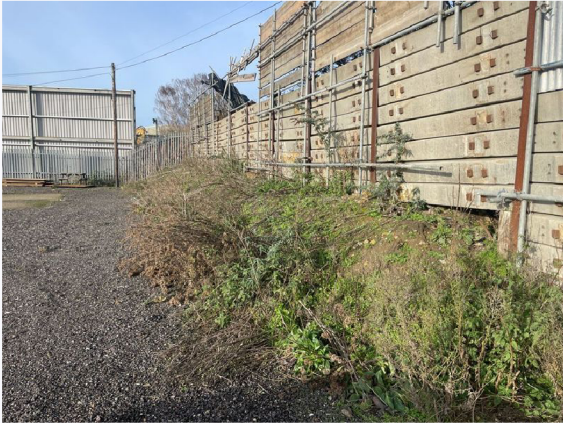
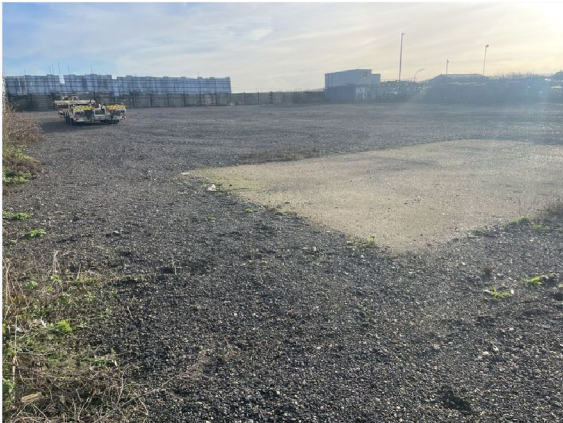
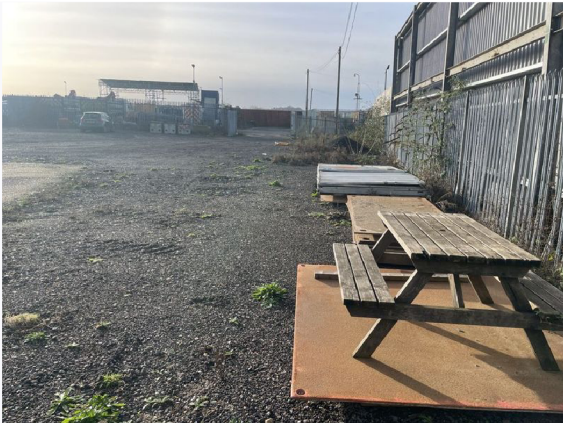
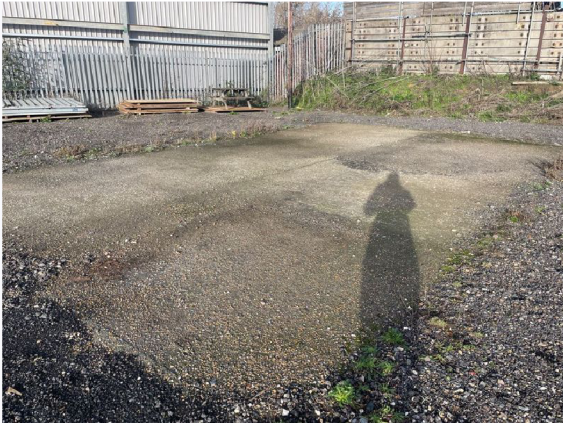
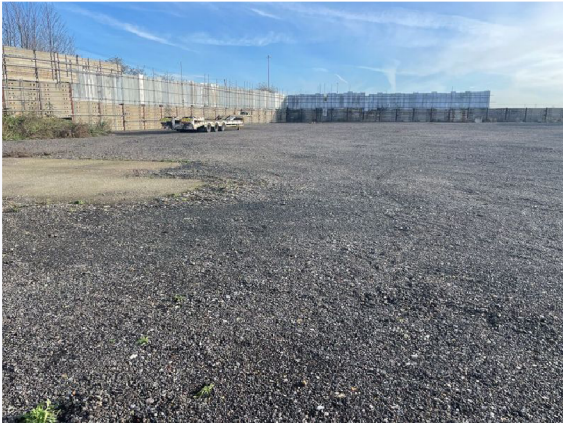
| Ref | Name | Description | Condition |
|---|---|---|---|
| 2.1 | Grounds | <p>Grounds are mostly laid to gravel, save for an area of concrete hardstanding in the north west corner.</p> <p>Along the north boundary there is a mound of soil with vegetation.</p> | <p>Grounds are largely in fair condition with the following notable defects:</p> <ul style="list-style-type: none"> <li>- Some unevenness to the grounds throughout;</li> <li>- Significant vegetation growth to the perimeters;</li> <li>- Minor occasional vegetation growth more centrally within the gravel;</li> <li>- Occasional litter and debris.</li> </ul> <p>The concrete appears to be in fair condition, save for algae growth in some areas and some vegetation growth to the perimeters.</p> <p>The soil/ vegetation area near the north boundary is overgrown and untidy with litter and several parts of the broken boundary fence within the vegetation.</p> |

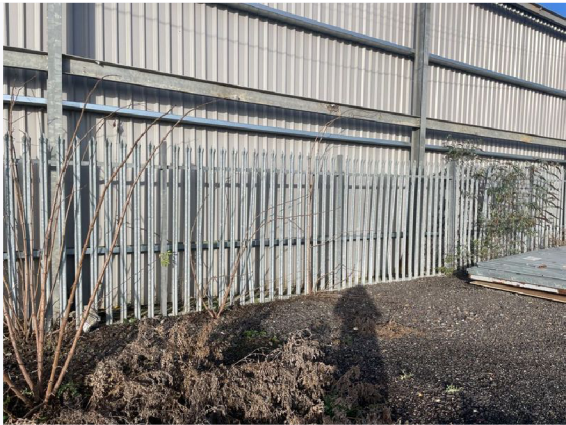
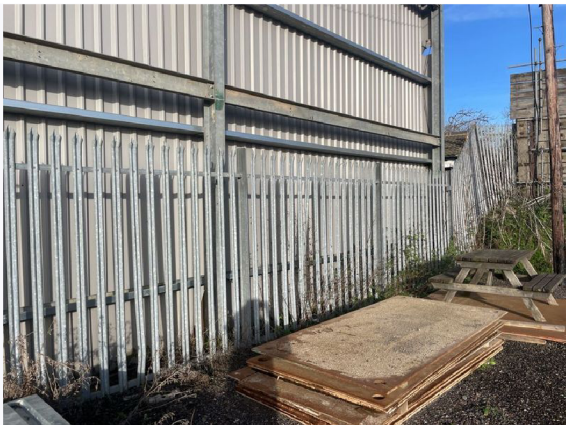
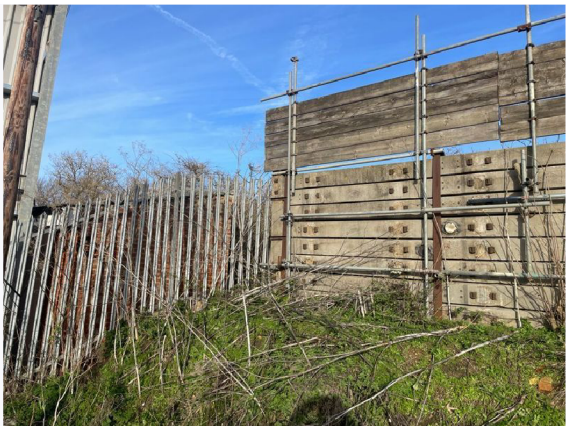
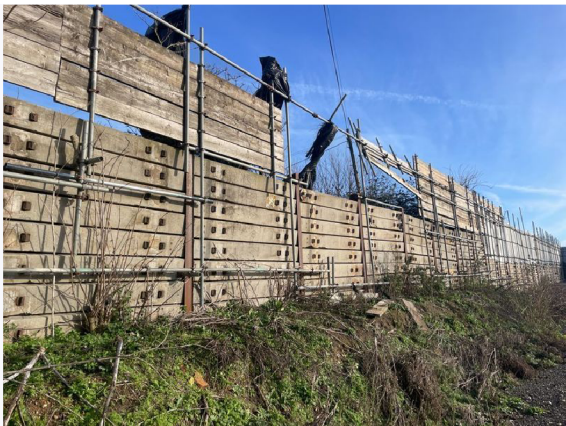
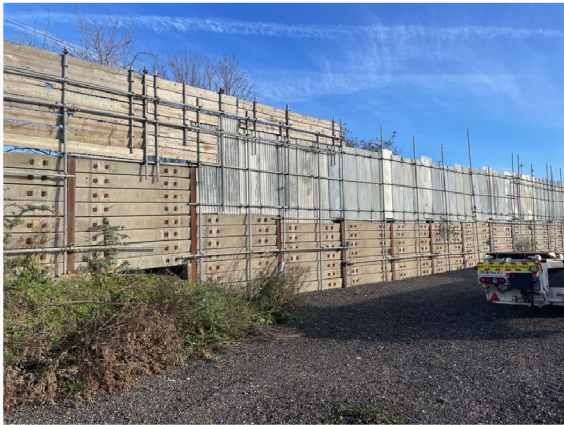
| Ref | Name | Description | Condition |
|---|---|---|---|
| 2.2 | Boundaries | <p>The west boundary is palisade fencing.</p> <p>The north boundary is constructed with a combination of scaffold poles and boards, cement blocks within steel beam fence posts and corrugated metal sheets.</p> | <p>The palisade fencing is in fair condition overall, save for the following defects:</p> <ul style="list-style-type: none"> <li>- Occasional impact damage;</li> <li>- Several fence pales are bent/deformed at the top and bottom;</li> <li>- 1 no. fence pale detached;</li> <li>- Occasional vegetation growth through the fencing.</li> </ul> <p>The north boundary fence is in poor condition overall with the following defects:</p> <ul style="list-style-type: none"> <li>- Several scaffold boards and poles are displaced, damaged or missing;</li> <li>- Scaffold fixings are heavily rusted;</li> <li>- Steel fence posts and fixings to concrete infills are heavily corroded;</li> <li>- Several concrete inserts are displaced or damaged;</li> <li>- Several of the metal corrugated sheets are damaged or corroded.</li> </ul> |

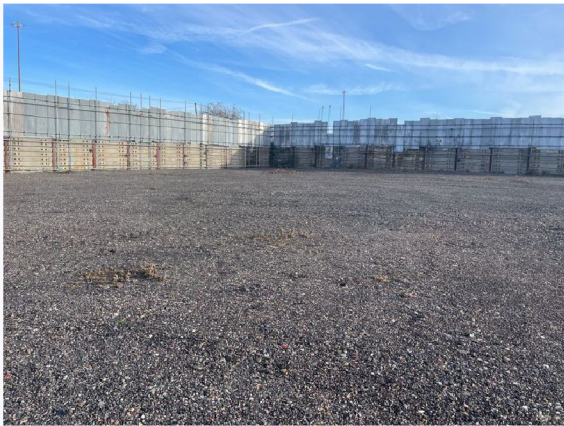
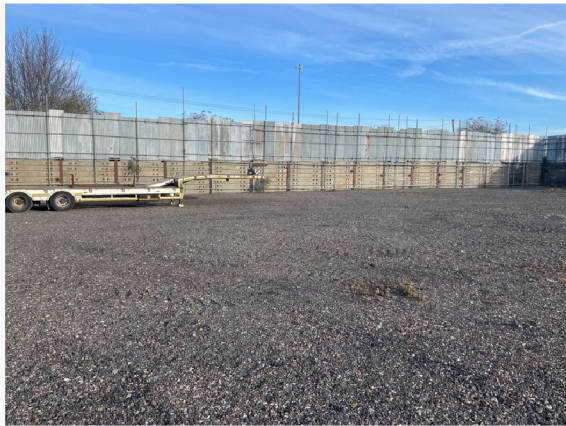
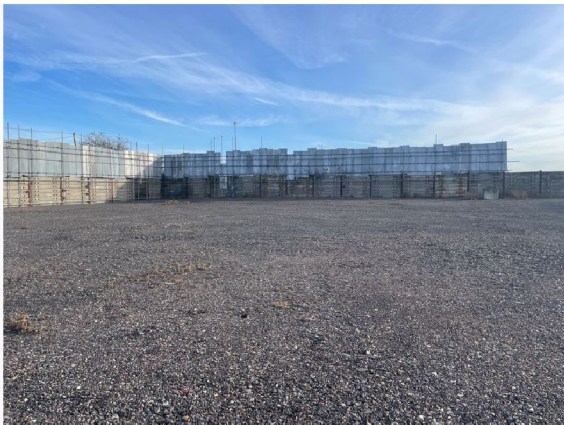
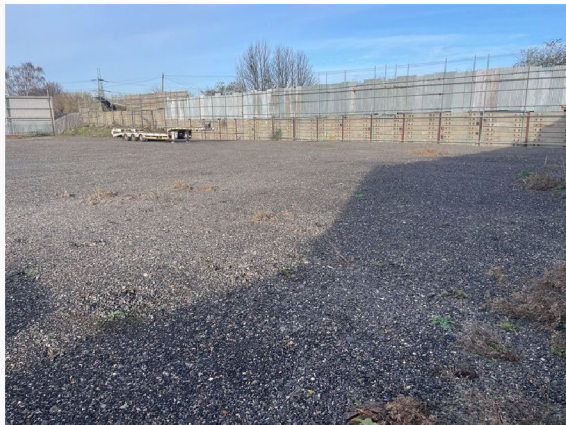
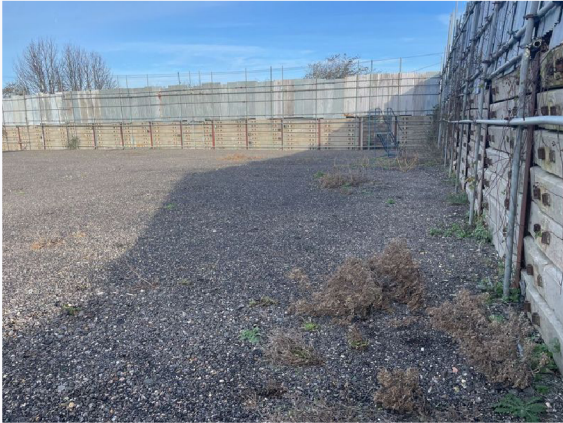
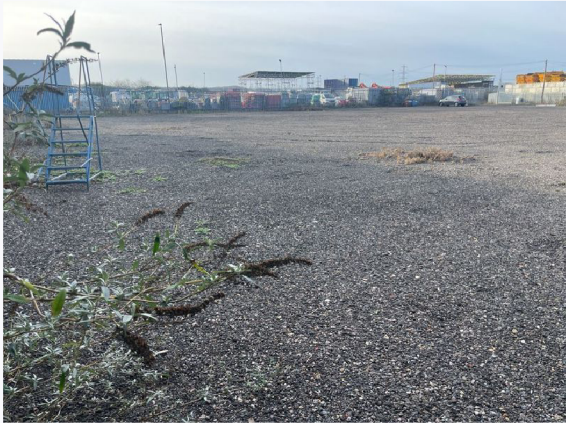
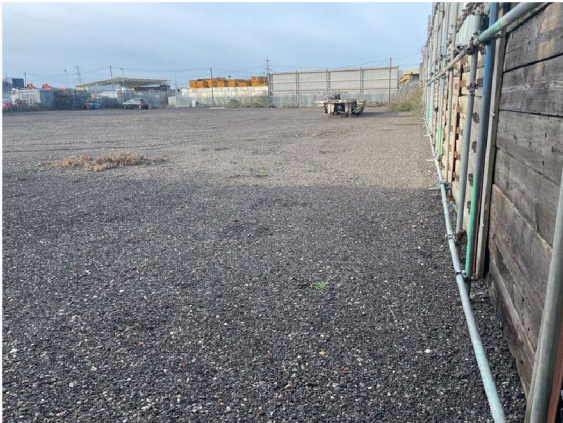
| 3. NORTH EAST QUADRANT | | | |
|---|---|---|---|
| 3.1 | Grounds | Grounds are laid with gravel. | Grounds are largely in fair condition with the following notable defects: <ul style="list-style-type: none"><li>- Some unevenness to the grounds;</li><li>- Some areas of significant vegetation growth near the east boundary;</li><li>- Minor occasional vegetation growth more centrally within the gravel;</li><li>- Occasional litter and debris;</li><li>- Occasional minor pitting towards the east end.</li></ul> |

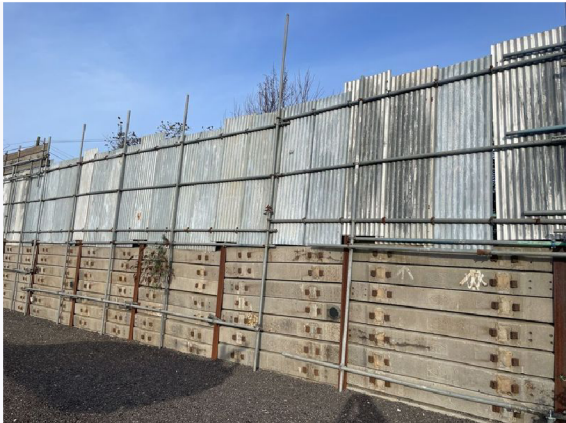
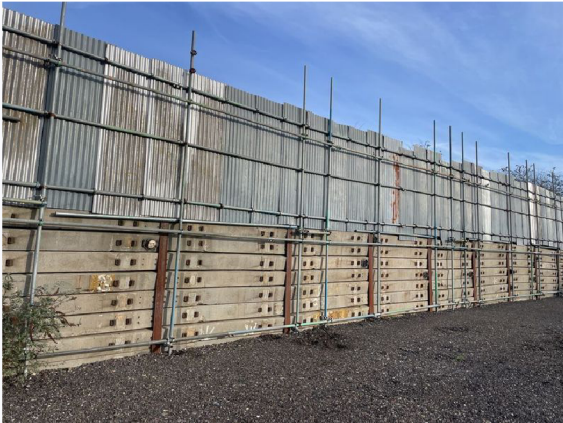
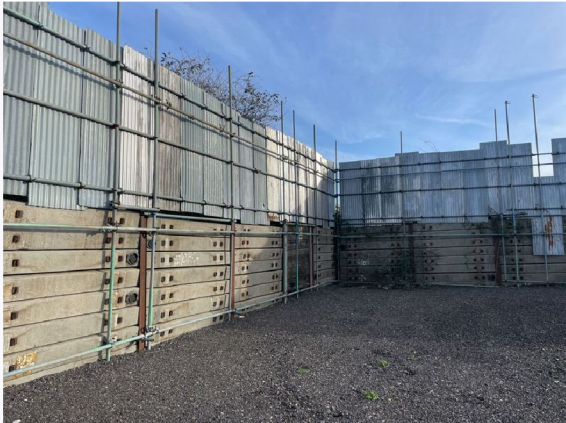
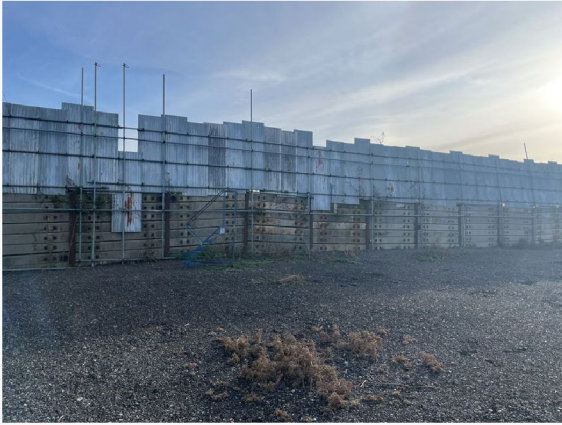
| 3. NORTH EAST QUADRANT | | | |
|---|---|---|---|
| 3.2 | Boundaries | The north and east boundaries are constructed with a combination of scaffold poles and corrugated metal sheets above cement blocks and railway sleepers within steel beam fence posts. | The boundary fencing is in poor condition overall with the following defects: <ul style="list-style-type: none"><li>- Scaffold fixings are heavily rusted;</li><li>- Steel fence posts and fixings to concrete infills are heavily corroded;</li><li>- Several concrete inserts are displaced or damaged;</li><li>- Several of the metal corrugated sheets are damaged or corroded. Several have also become displaced, particularly to the east boundary.</li></ul> |

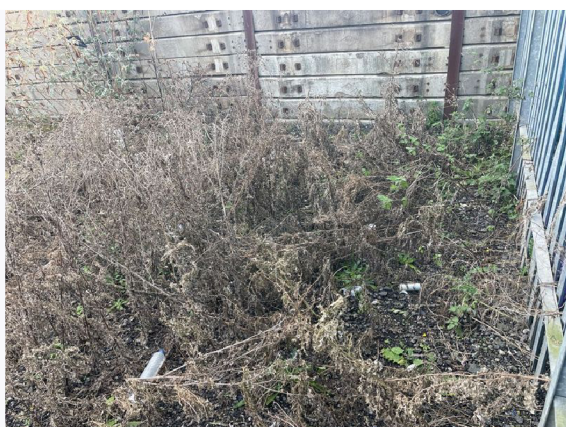
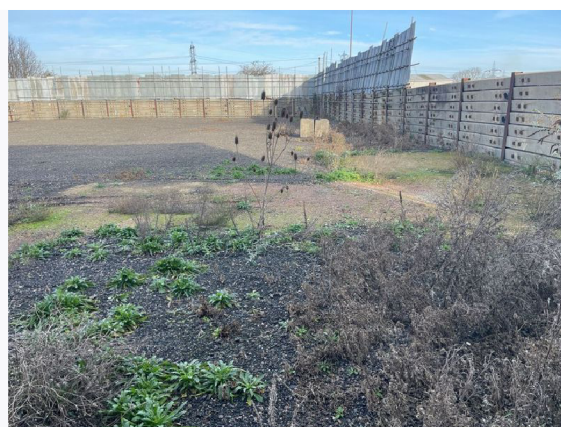
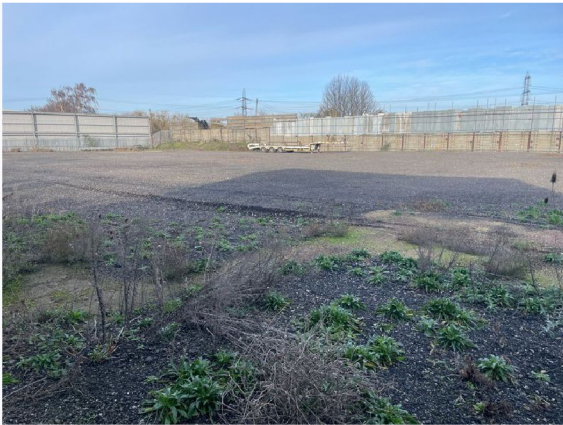
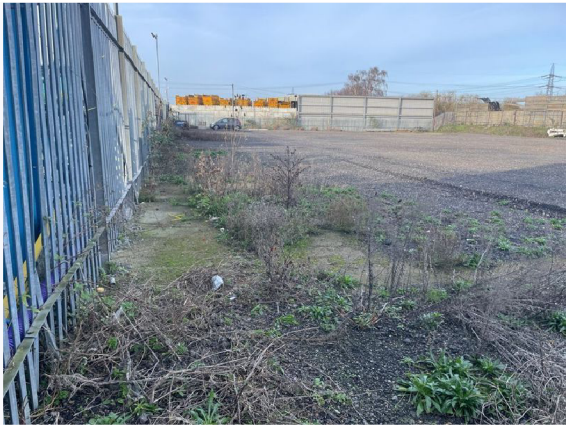
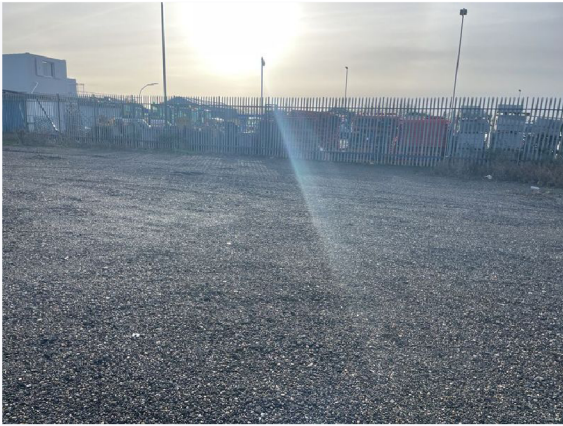
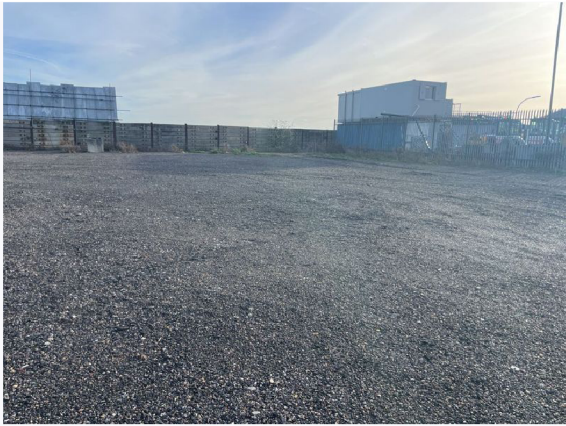
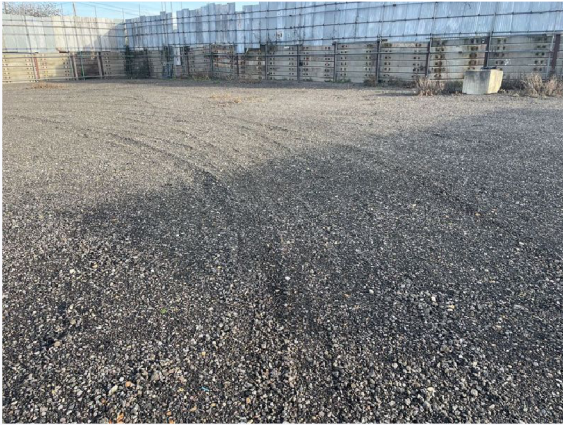
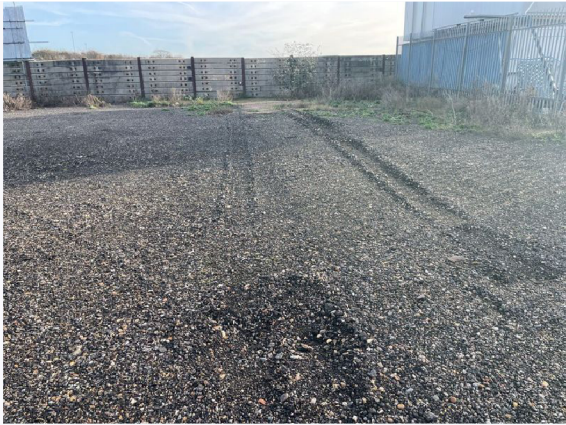
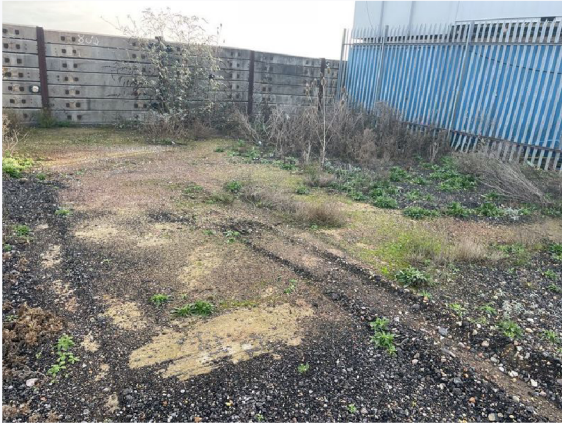
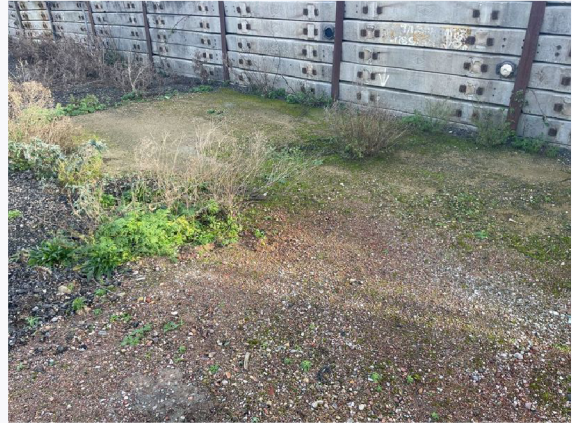
| Ref | Name | Description | Condition |
|---|---|---|---|
| 4.1 | Grounds | Grounds are mostly laid to gravel, save for an area of concrete hardstanding in the south east corner. | <p>Grounds are largely in fair condition with the following notable defects:</p> <ul style="list-style-type: none"> <li>- Some unevenness to the grounds;</li> <li>- Significant vegetation growth to the perimeters, particularly in the south east corner;</li> <li>- Minor occasional vegetation growth more centrally within the gravel;</li> <li>- Occasional litter and debris;</li> <li>- Significant tire track grooves leading up to the hardstanding as well as several large pitted areas nearby;</li> <li>- Occasional minor pitting;</li> </ul> <p>Hardstanding is in poor condition with gravel, overlaying large sections, occasional patch repairs and heavy vegetation growth.</p> |

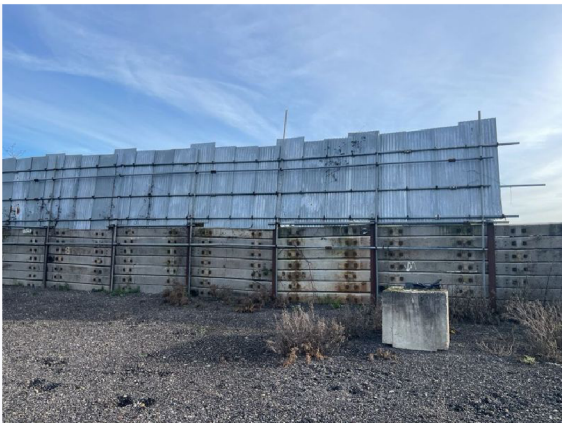
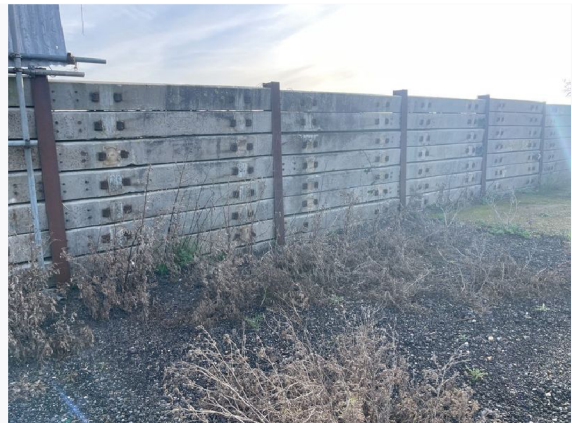
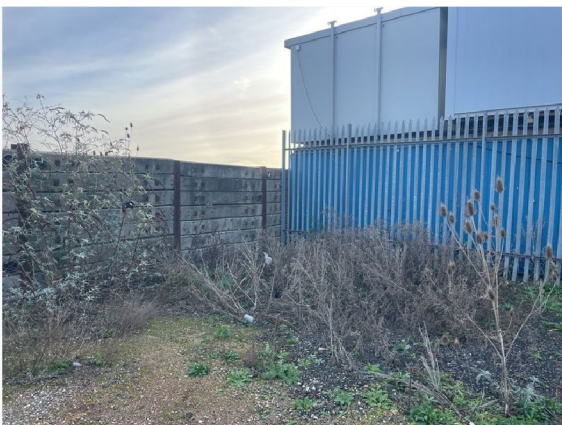
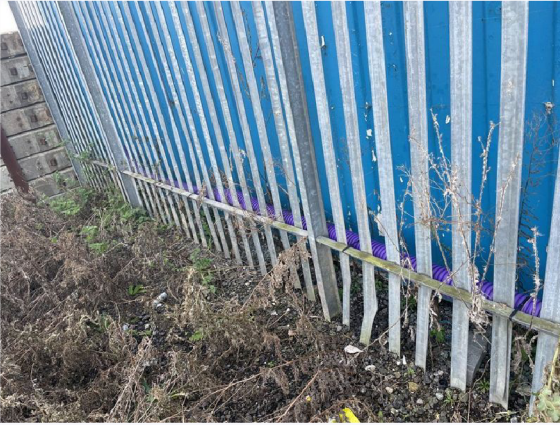
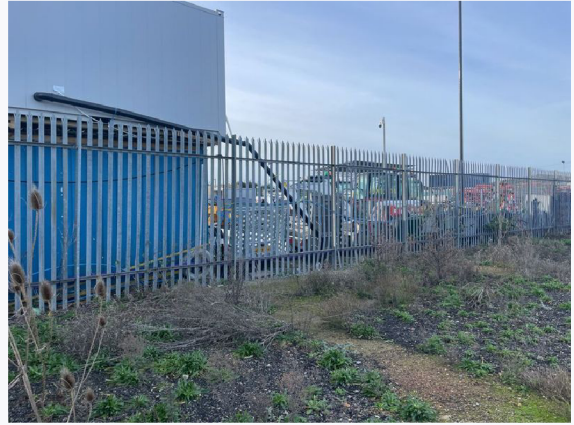
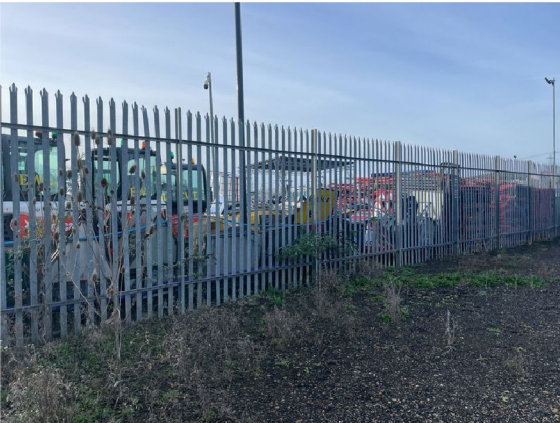
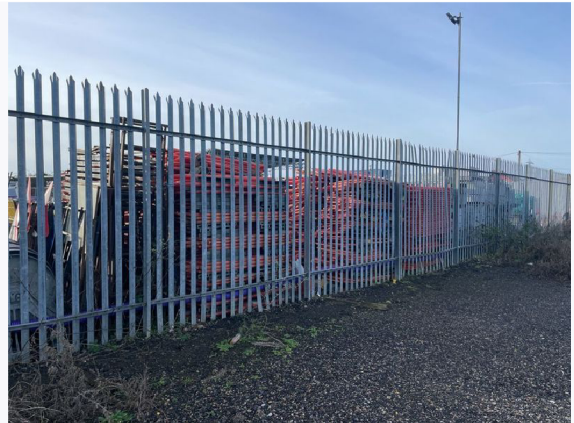
| Ref | Name | Description | Condition |
|---|---|---|---|
| 4.2 | Boundaries | <p>The south boundary is of palisade fencing.</p> <p>East boundary is constructed with a combination of scaffold poles and corrugated metal sheets above cement blocks and railway sleepers within steel beam fence posts.</p> | <p>The palisade fencing is a fair condition overall, save for the following defects:</p> <ul style="list-style-type: none"> <li>- Occasional minor impact damage;</li> <li>- Several fence pales are bent/deformed at the top and bottom;</li> </ul> <p>The east boundary fencing is in poor condition overall with the following defects:</p> <ul style="list-style-type: none"> <li>- Scaffold fixings are heavily rusted;</li> <li>- Steel fence posts and fixings to concrete infills are heavily corroded;</li> <li>- Several concrete inserts are displaced or damaged;</li> <li>- Several of the metal corrugated sheets are damaged or corroded. Most are also leaning significantly.</li> </ul> |
