# **R. CARR GEOTECHNICAL SERVICES**

**THE RAVENS, RHODODENDRON AVENUE,  
CULVERSTONE, KENT DA13 0TT.**

## **PHASE I GEO ENVIRONMENTAL DESK STUDY AND PRELIMINARY RISK ASSESSMENT**

**October 2023**

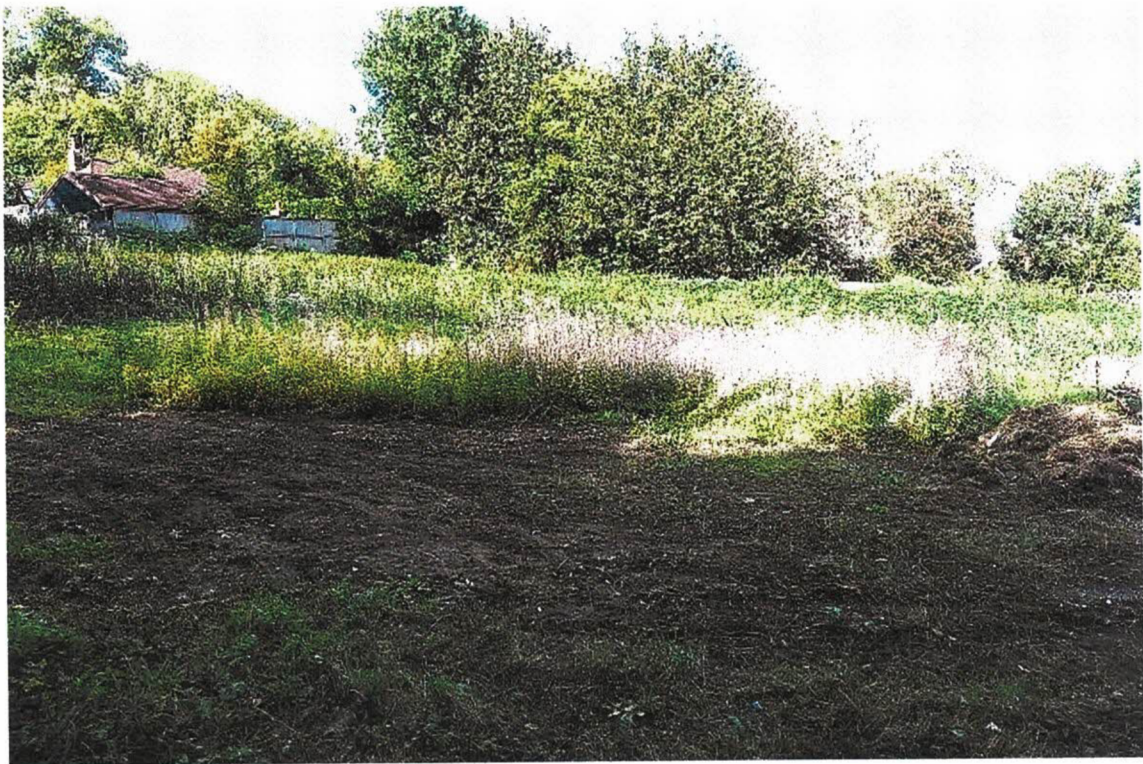
**Plate 1**

- 7.4 The site comprised a disused paddock and exercise area for horses, its west section consisting of an area of sloping land overgrown with stinging nettles and other weeds (Plate 1).

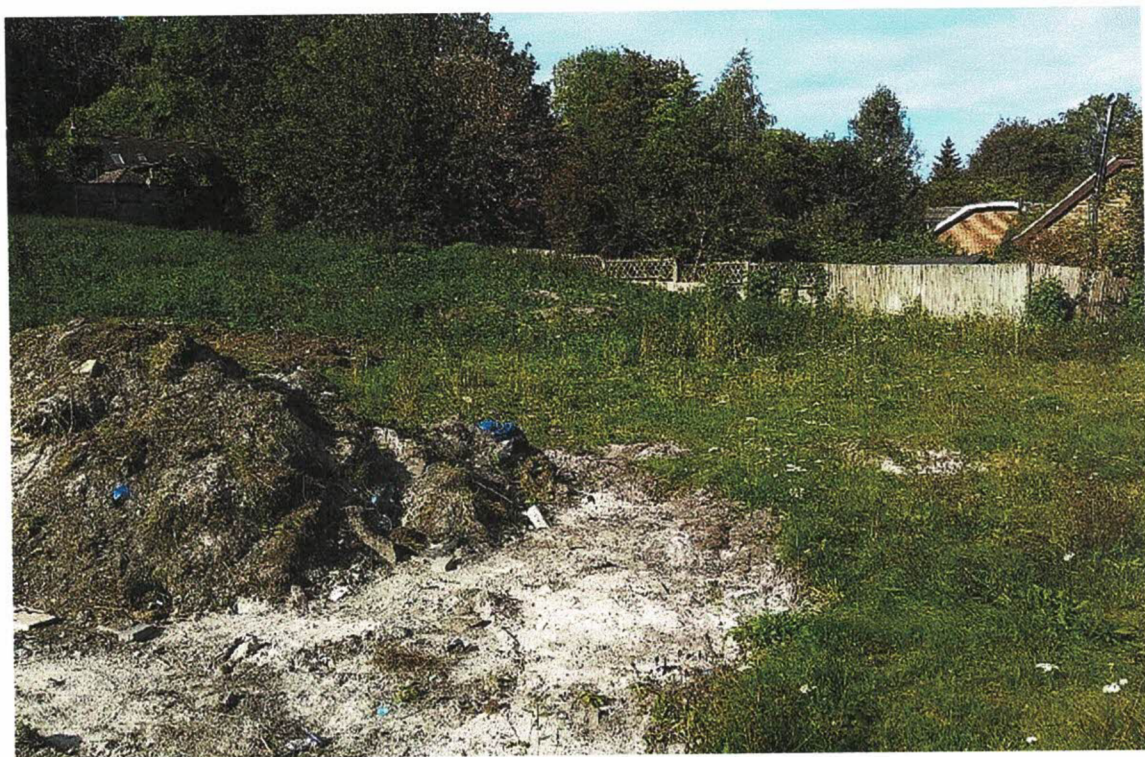
**Plate 2**

- 7.5 The site's eastern section consisted of relatively level ground with patches of overgrown grass and exposed soil. A mound of sand and soil derived from an excavated manege was present in its central area (Plate 2 and Plate 3).

- 10.5 Further action is therefore considered unnecessary, other than a general clear-up of the site to include the removal of excavated soil and subsequent demolition materials to appropriately licensed waste facilities.

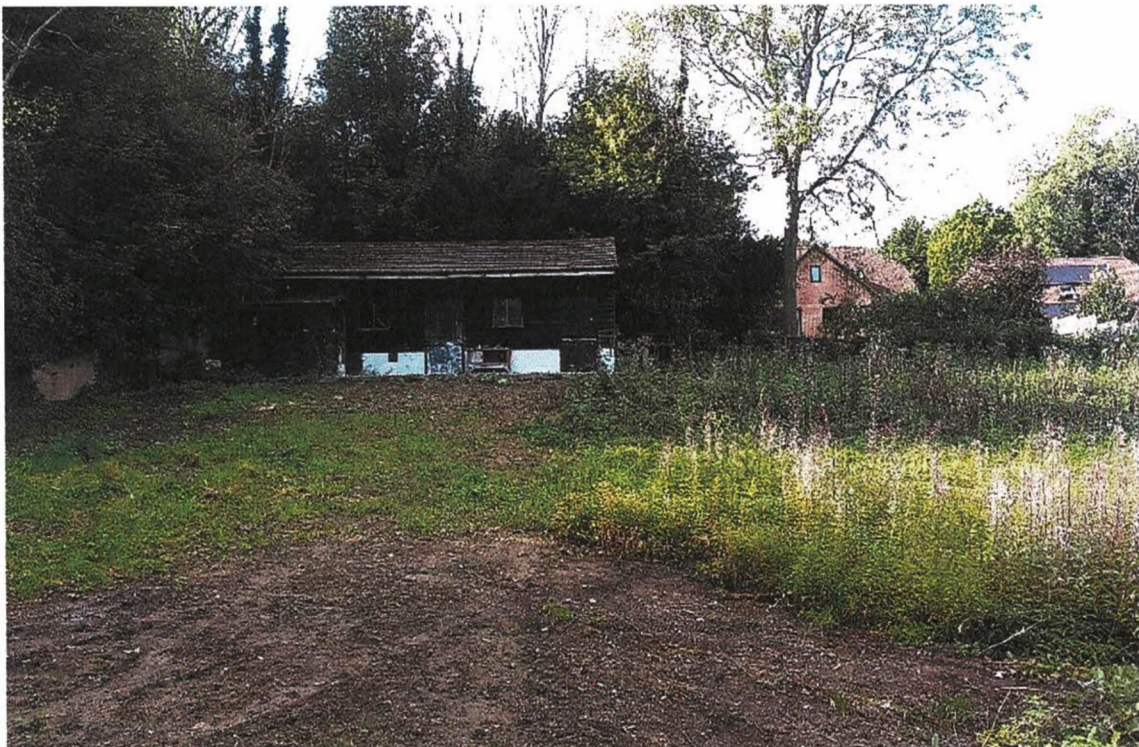
**Plate 4**

- 7.6 A rectangular stable block of timber construction under a tiled roof was present in the southwest corner of the site (Plate 4), a granular track leading from the site entrance up to the building. The stable was underlain by a concrete slab which protruded beyond the front of the structure to form a small patio. An empty rabbit hutch was present on the patio, together with items of rubbish and a section of plastic pipe (Plate 5).

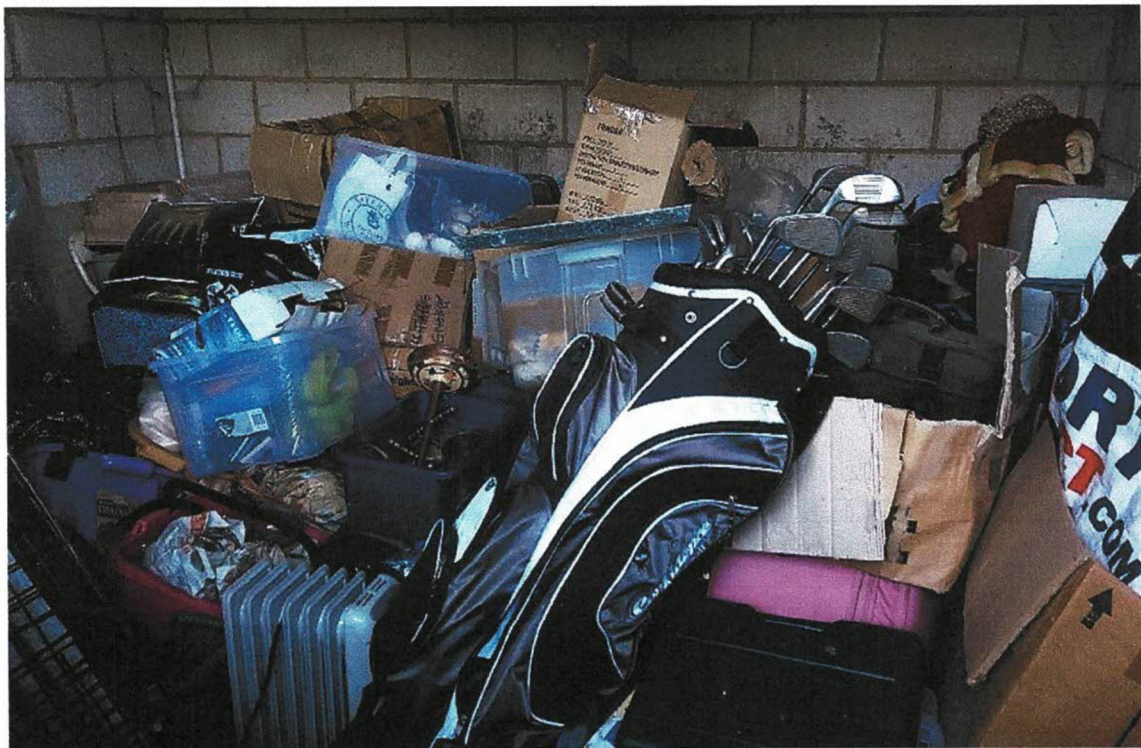
Plate 6

- 7.7 The stable was divided into three compartments, two of which contained stored recreational equipment and domestic furniture (Plate 6 and Plate 7) whereas the third section of the building was in use as a store for hand tools and aluminium ladders (Plate 8).
