**RE: Tree Inspection, Luddesdown Rectory, DA13 0XE,**

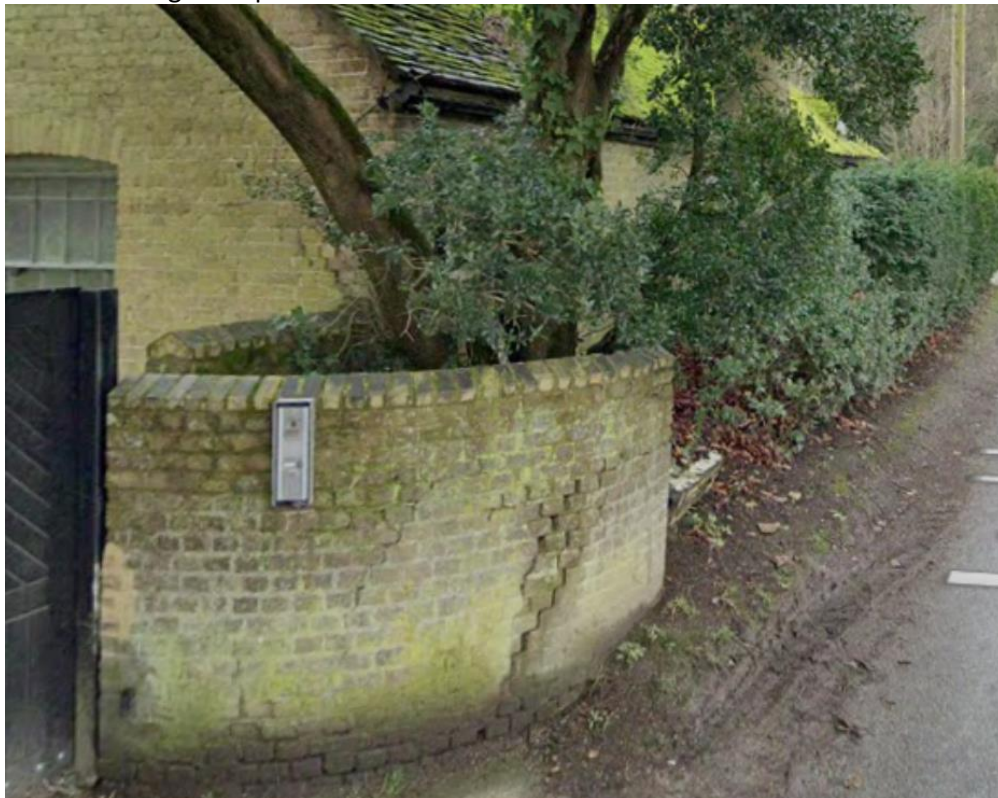
T1 Holm Oak – is a twin stemmed tree, forking just above ground level and has very poor form, being suppressed by the adjacent beech, T2. The T1 tree is causing visible cracking to the wall, which wraps round three sides of the tree, to the right of the gate (see photo below). It will continue to cause damage to the wall and destabilise it as it grows. As it is so close to the wall there are no pruning options to prevent further damage to the masonry and removal is advised.

T1 Wall damage and poor form

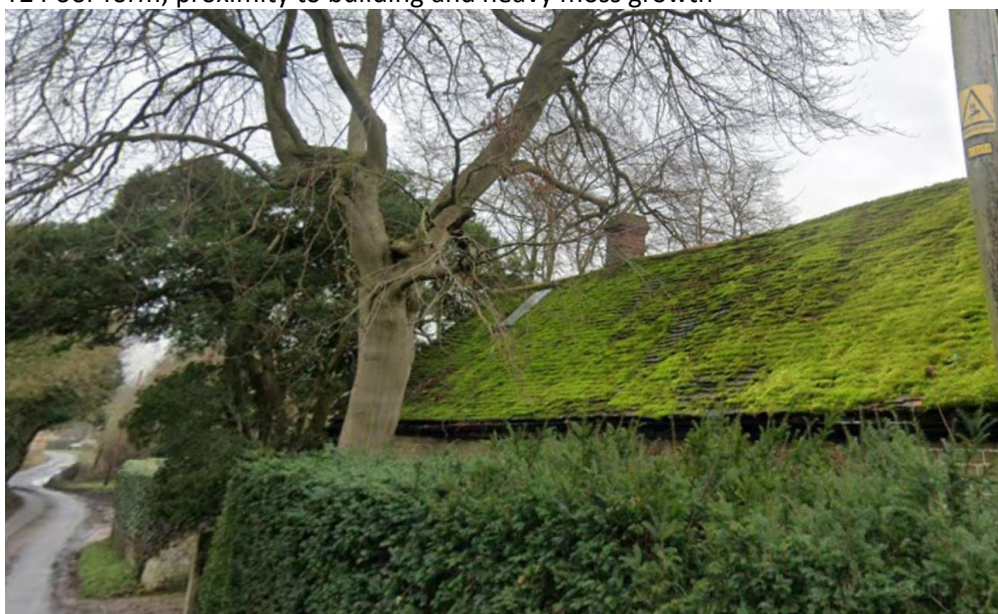
T2, a medium sized beech tree is just to the south of T1. It grows within a few inches of the building wall to the east. The tree also has poor form as it bifurcates into two trunks at approx. 15ft and has power lines running through it. The building roof is damp and heavily covered in moss due to the overshadowing of the trees. Whilst there is no visible structural damage to the building currently, the close proximity of the tree is highly likely to cause damage in the future. As a preventative measure I would also advise that this tree is removed.

T2 Poor form, proximity to building and heavy moss growth

To mitigate the loss of the two trees I would suggest that two replacement trees are planted to the north of the gate by the boundary wall but far enough away so as not to damage the wall as they grow. These trees will be near to the road so highly visible and provide good amenity for passing members of the public. The trees should be minimum 12-14cm girth and suggested species are Copper Beech and Pin Oak.
