# LISTED BUILDING APPLICATION FOR EMERGENCY REPAIRS: Proposed ceiling and roof repairs to classroom H1 at Gad's Hill School, Gravesend Road, Higham, Rochester, Kent ME3 7PA

**clay** architecture

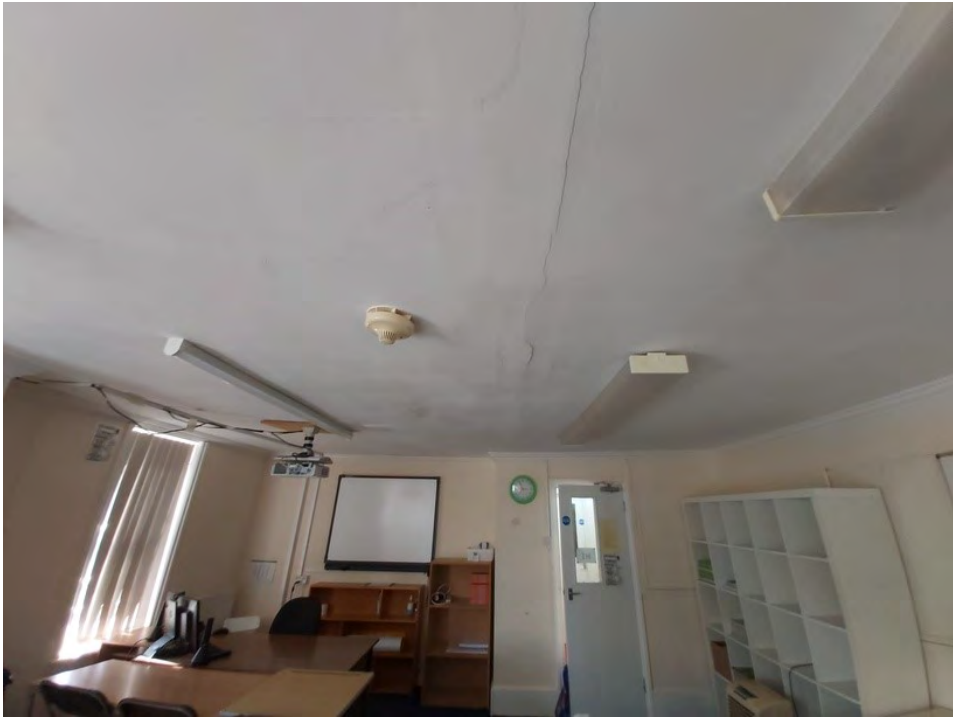
Ceiling of HSFX06 H1 classroom looking west  
Ceiling shows signs of cracking , sagging and previous repairs.  
Photograph taken 01/08/2022 by CP

The immediate priority, and the subject of this LBA, is to carry out necessary repairs to the slate tiled roof to the rear, and to reinstate the lathe and plaster ceiling where it has failed.

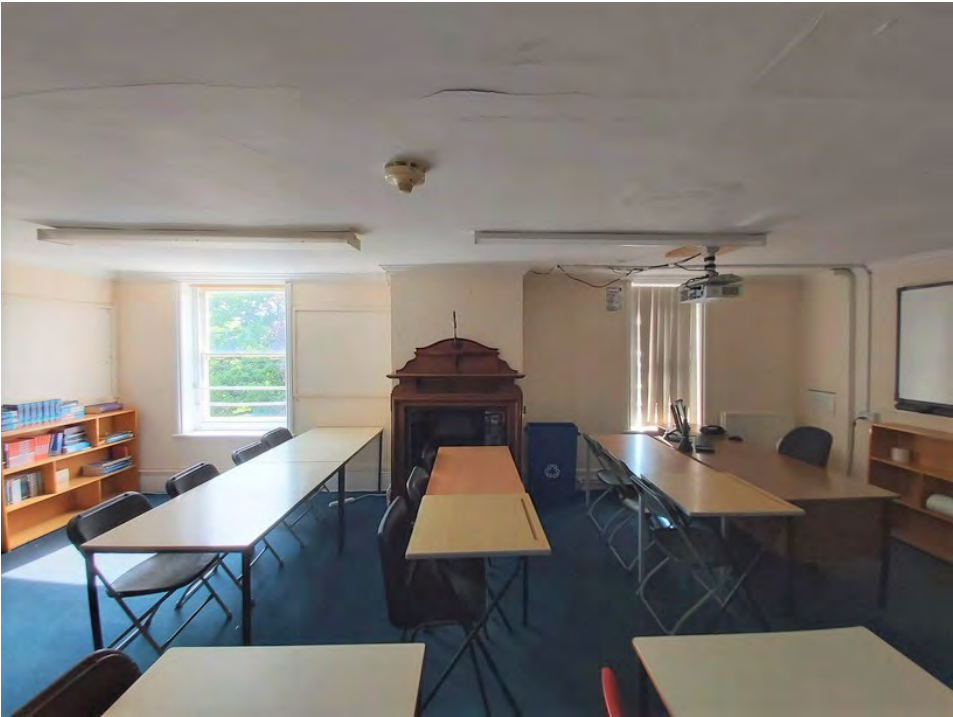
Ceiling of HSFX06 H1 classroom looking east  
Photograph taken 01/08/2022 by CP

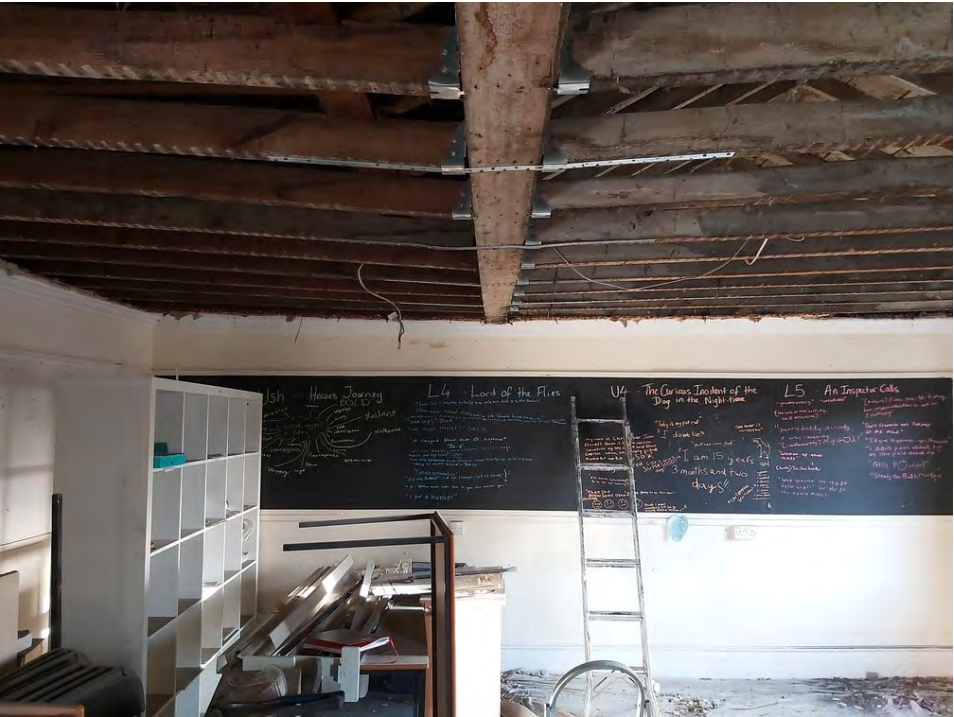
Ceiling of HSFX06 H1 classroom looking east  
After ceiling came down on the advice of the SE straps were fixed to underside of main beam.  
Photograph taken 23/11/2022 by CP

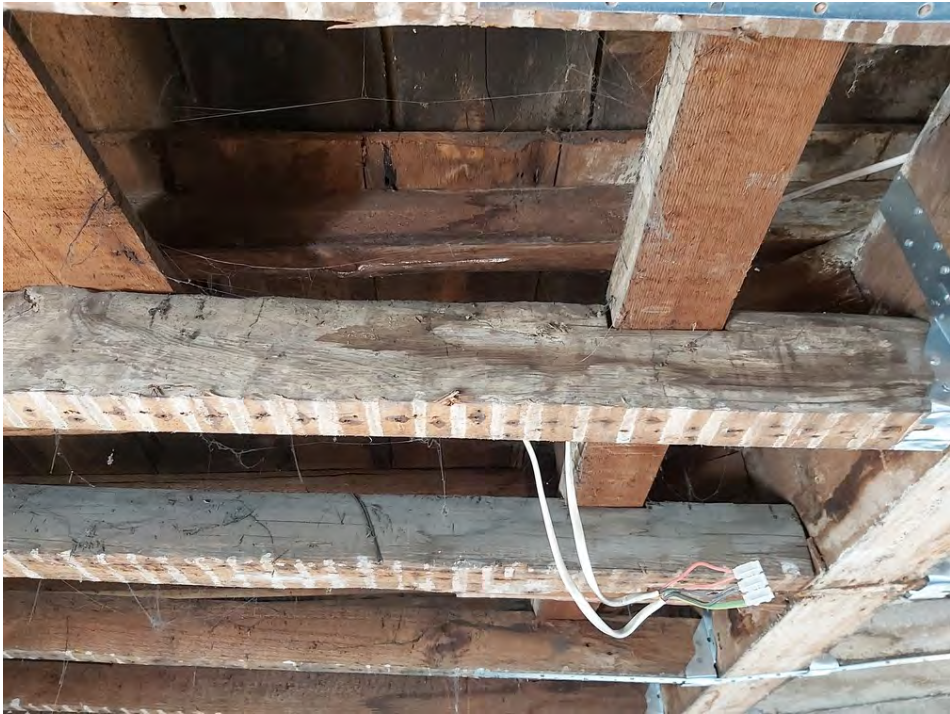
Ceiling of HSF06 H1 classroom looking north  
Underside of lead roof RFX03.  
Photograph taken 23/11/2022 by CP

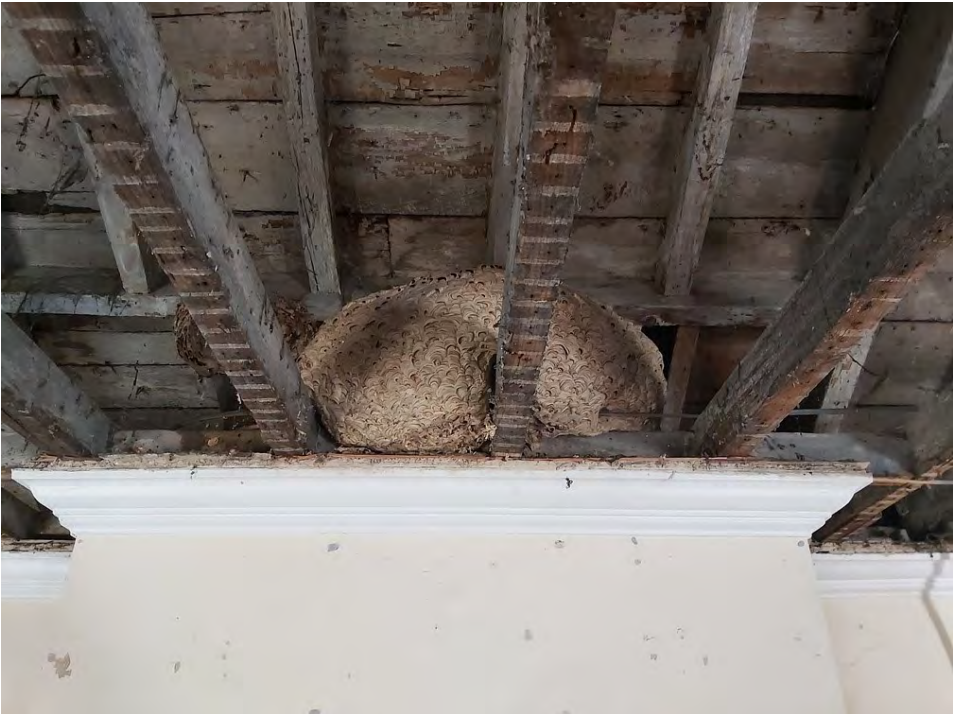
Ceiling of HSF06 H1 Classroom looking south  
Bee/ wasps nest above fireplace.  
Photograph taken 23/11/2022 by CP

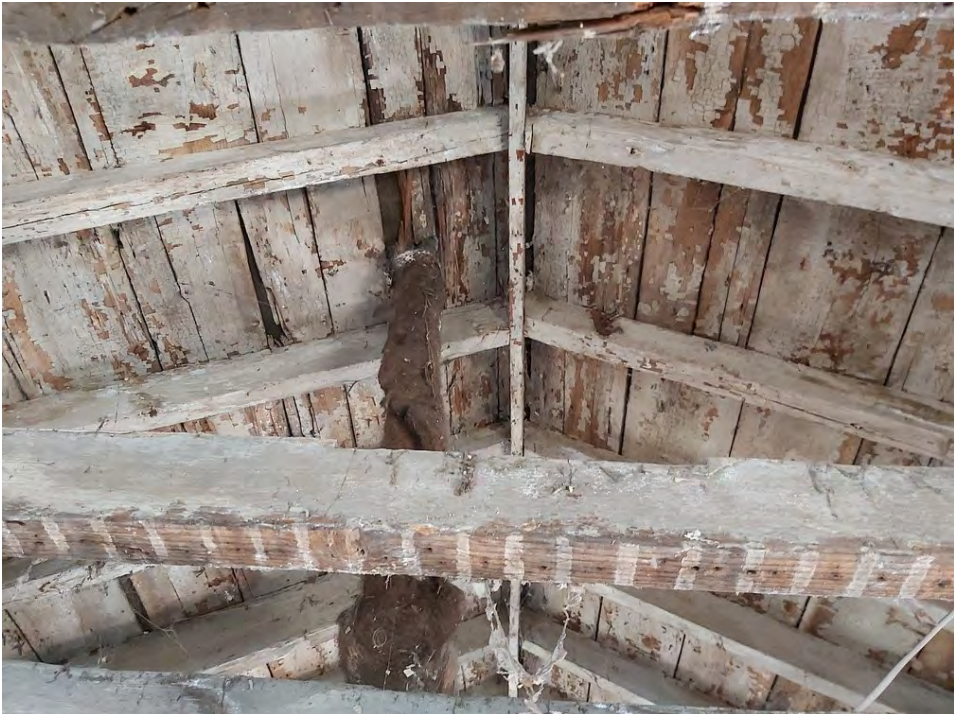
Ceiling of HSF06 H1 classroom looking east west  
Underside of roof RFX02. Gaps between sarking boards. Some are rotten and damp coming in from above.  
Photograph taken 23/11/2022 by CP

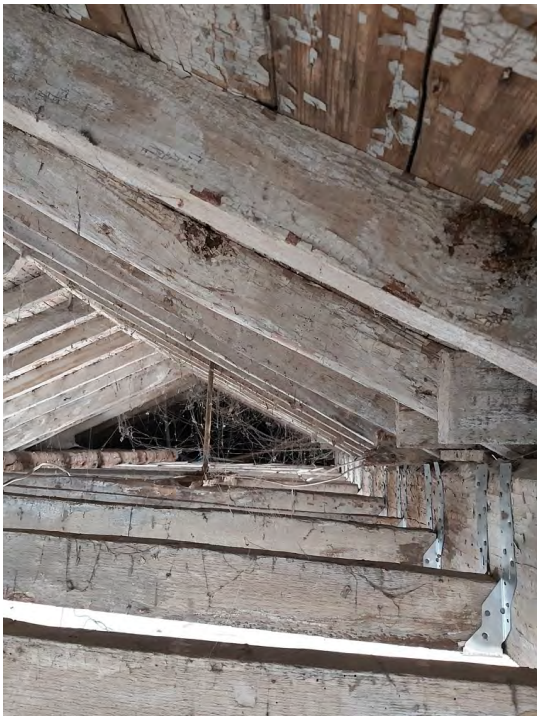
**Ceiling of HSFX06 H1 classroom looking east west**  
**Sarking boards have been lime washed . Some boards are showing signs of damp ingress**  
**Photograph taken 23/11/2022 by CP**

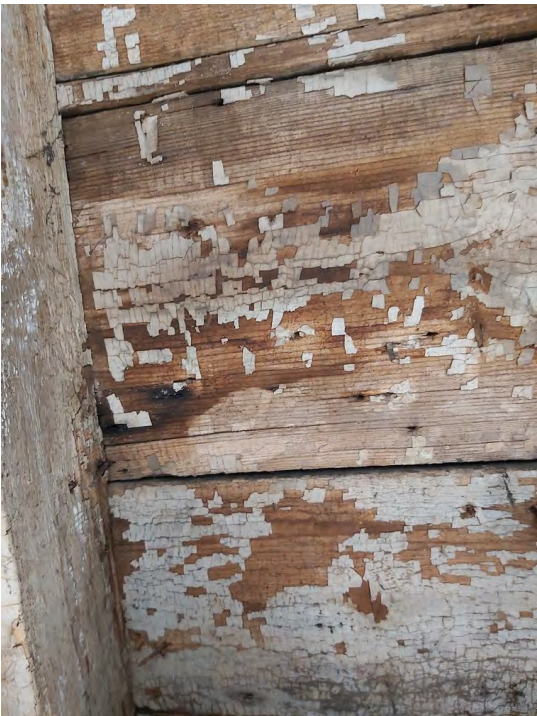
**Underside of roof HRFX02 of HSFX06 H1 classroom looking at the sarking boards.**  
**Sarking boards showing signs of water ingress coming in from above.**  
**Photograph taken 23/11/2022 by CP**
