# CCTV Drainage Survey Report

Former St Johns Ambulance Site,  
Armoury Drive,  
Gravesend,  
Kent DA12 1CT

## u07467 Gravesend - CCTV Survey Report : 16/03/22

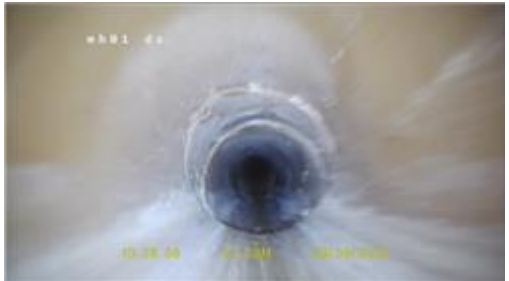
| Pos | Video Ref | Code | Cont. | Description | Image |
|---|---|---|---|---|---|
| 12.5m | 0:00:38 | FM | | Fracture multiple from 12 o'clock to 12 o'clock - Severity 4 | Image Provided - Ref: 0_2<br> |

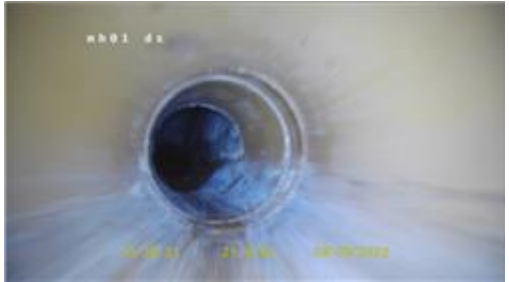
| Pos | Video Ref | Code | Cont. | Description | Image |
|---|---|---|---|---|---|
| 21.7m | 0:01:02 | LL | | Line of drain/sewer deviates left | Image Provided - Ref: 0_3<br> |

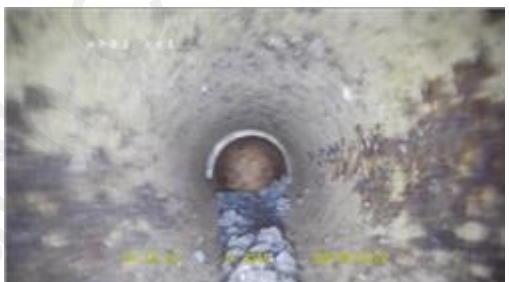
| Pos | Video Ref | Code | Cont. | Description | Image |
|---|---|---|---|---|---|
| 00.3m | 0:00:08 | DES | | Settled deposits fine: 5% cross-sectional area loss - Severity 2 | Image Provided - Ref: 2_1<br> |

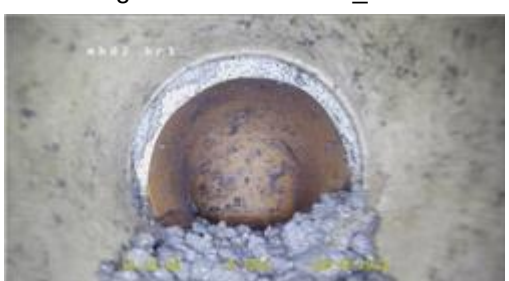
| Pos | Video Ref | Code | Cont. | Description | Image |
|---|---|---|---|---|---|
| 00.8m | 0:00:11 | JDM | | Joint displaced medium - Severity 2 | Image Provided - Ref: 2_2<br> |

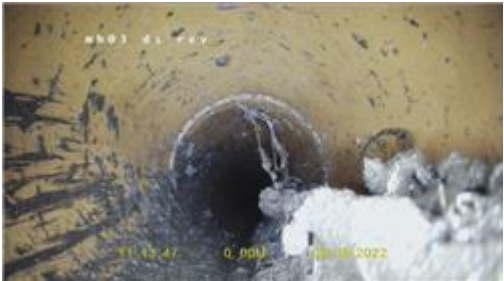
| Pos | Video Ref | Code | Cont. | Description | Image |
|---|---|---|---|---|---|
| 00.4m | 0:02:41 | RF | | Roots fine at joint - Severity 1 | Image Provided - Ref: 5_4<br> |

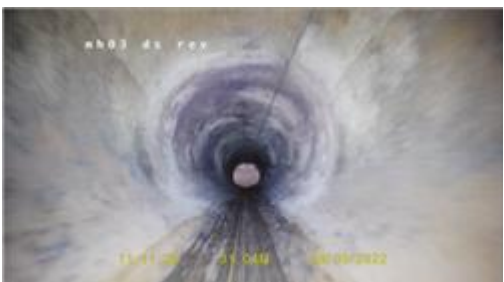
| Pos | Video Ref | Code | Cont. | Description | Image |
|---|---|---|---|---|---|
| 31.0m | 0:00:21 | CL | S1 | Crack, longitudinal 31m - 32m at 01 o'clock - Severity 2 | Image Provided - Ref: 5_1<br> |

| Pos | Video Ref | Code | Cont. | Description | Image |
|---|---|---|---|---|---|
| 32.0m | 0:00:21 | CL | F1 | Crack, longitudinal Defect End at 01 o'clock - Severity 2 | |

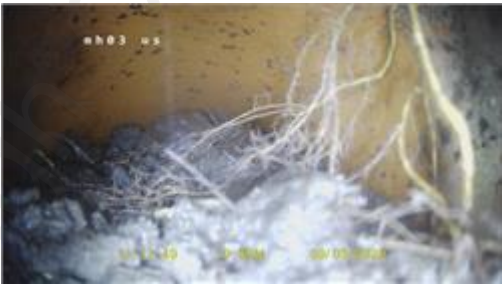
| Pos | Video Ref | Code | Cont. | Description | Image |
|---|---|---|---|---|---|
| 00.0m | 0:00:00 | RF | | Roots fine - Severity 1 | Image Provided - Ref: 6_1<br> |

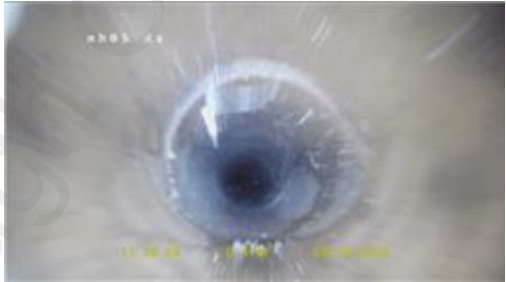
| Pos | Video Ref | Code | Cont. | Description | Image |
|---|---|---|---|---|---|
| 00.5m | 0:00:06 | FC | | Fracture circumferential from 12 o'clock to 12 o'clock - Severity 3 | Image Provided - Ref: 10_1<br> |

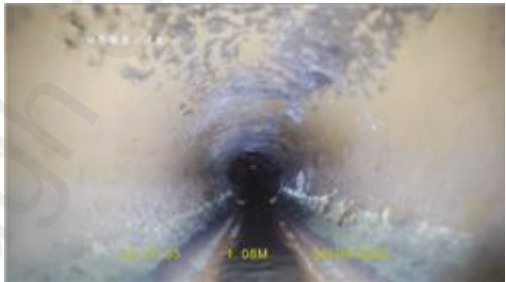
| Pos | Video Ref | Code | Cont. | Description | Image |
|---|---|---|---|---|---|
| 01.0m | 0:00:07 | DEF | S1 | Attached deposits, fouling 1m - 11.8m from 04 o'clock to 08 o'clock: 5% cross-sectional area loss - Severity 2 | Image Provided - Ref: 14_1<br> |

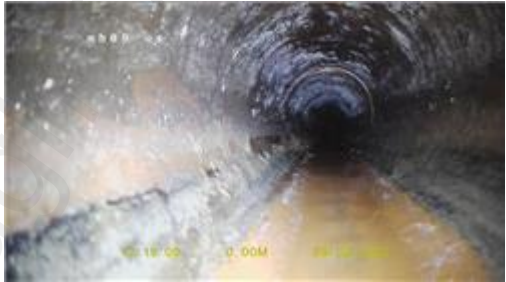
| Pos | Video Ref | Code | Cont. | Description | Image |
|---|---|---|---|---|---|
| 00.0m | 0:00:00 | DEF | S1 | Attached deposits, fouling 0m - 2.2m from 04 o'clock to 08 o'clock: 5% cross-sectional area loss - Severity 2 | Image Provided - Ref: 15_1<br> |

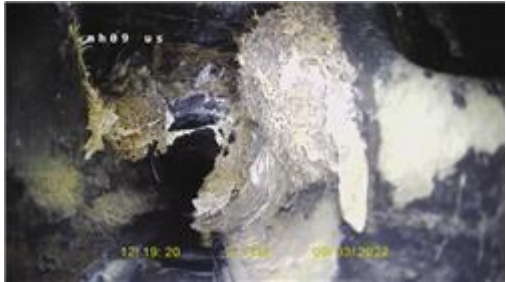
| Pos | Video Ref | Code | Cont. | Description | Image |
|---|---|---|---|---|---|
| 02.2m | 0:00:14 | REM | | General remark<br>Root Mass In Manhole | Image Provided - Ref: 15_3<br> |

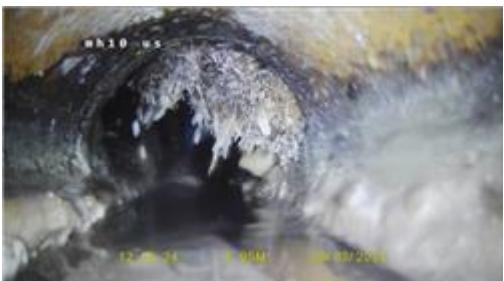
| Pos | Video Ref | Code | Cont. | Description | Image |
|---|---|---|---|---|---|
| 05.1m | 0:00:27 | REM | | General remark<br>Pushed Through Manhole | Image Provided - Ref: 16_3<br> |

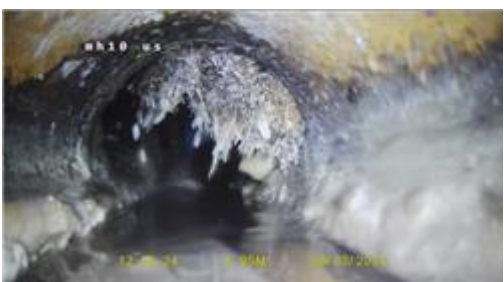
| Pos | Video Ref | Code | Cont. | Description | Image |
|---|---|---|---|---|---|
| 05.1m | 0:00:27 | RM | | Roots mass: 10% cross-sectional area loss - Severity 4<br>Root Mass In Manhole | Image Provided - Ref: 16_4<br> |

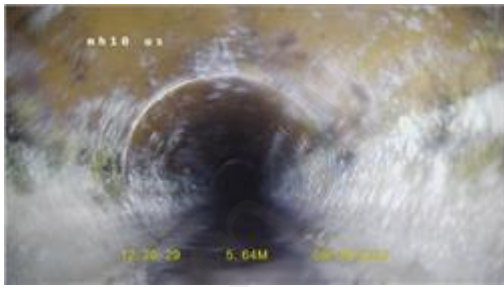
| Pos | Video Ref | Code | Cont. | Description | Image |
|---|---|---|---|---|---|
| 05.6m | 0:00:32 | WL | S2 | Water level 5.6m - 7.5m: 10% Height/Diameter | Image Provided - Ref: 16_5<br> |

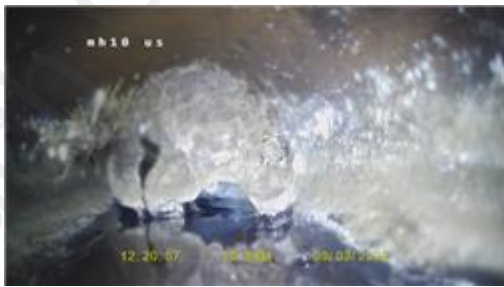
| Pos | Video Ref | Code | Cont. | Description | Image |
|---|---|---|---|---|---|
| 11.0m | 0:01:01 | RM | | Roots mass: 90% cross-sectional area loss - Severity 4 | Image Provided - Ref: 16_6<br> |

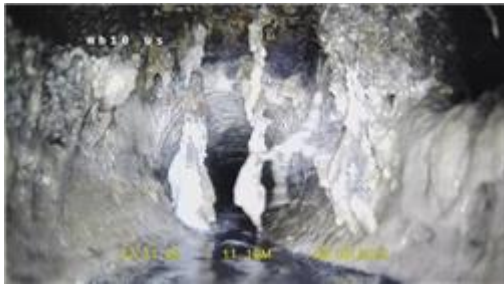
| Pos | Video Ref | Code | Cont. | Description | Image |
|---|---|---|---|---|---|
| 11.2m | 0:01:12 | REM | | General remark<br>Root Mass In Manhole | Image Provided - Ref: 16_7<br> |

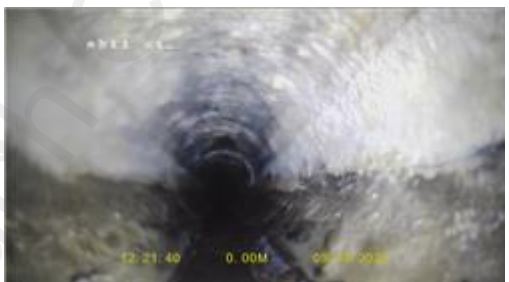
| Pos | Video Ref | Code | Cont. | Description | Image |
|---|---|---|---|---|---|
| 00.0m | 0:00:00 | DEF | S1 | Attached deposits, fouling 0m - 3.9m from 07 o'clock to 05 o'clock: 5% cross-sectional area loss - Severity 2 | Image Provided - Ref: 17_1<br> |

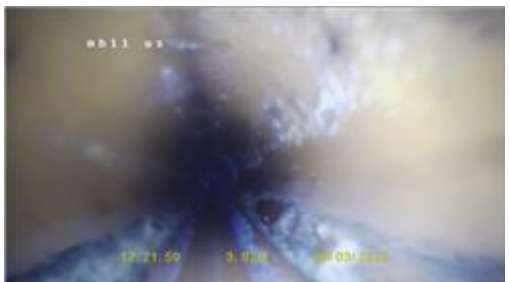
| Pos | Video Ref | Code | Cont. | Description | Image |
|---|---|---|---|---|---|
| 03.9m | 0:00:18 | DEF | S2 | Attached deposits, fouling 3.9m - 5.8m from 05 o'clock to 07 o'clock: 5% cross-sectional area loss - Severity 2 | Image Provided - Ref: 17_2<br> |

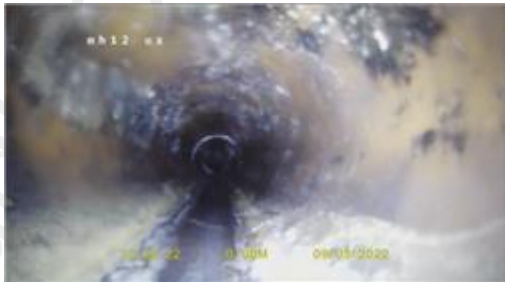
| Pos | Video Ref | Code | Cont. | Description | Image |
|---|---|---|---|---|---|
| 00.0m | 0:00:00 | DEF | S1 | Attached deposits, fouling 0m - 6.1m from 05 o'clock to 07 o'clock: 5% cross-sectional area loss - Severity 2 | Image Provided - Ref: 18_1<br> |

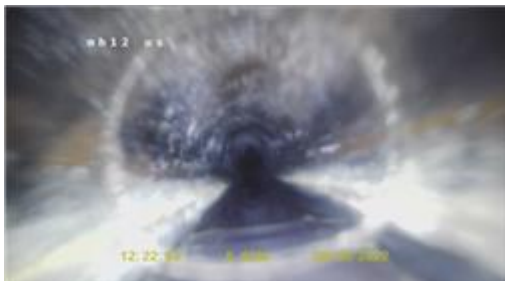
| Pos | Video Ref | Code | Cont. | Description | Image |
|---|---|---|---|---|---|
| 05.5m | 0:00:30 | WL | | Water level: 10% Height/Diameter | Image Provided - Ref: 18_2<br> |

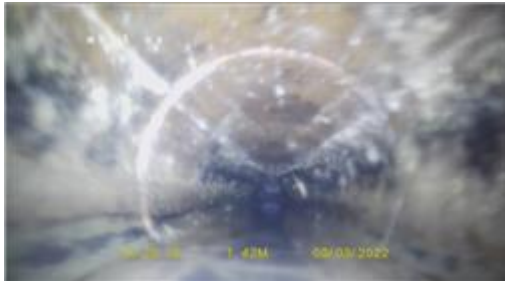
| Pos | Video Ref | Code | Cont. | Description | Image |
|---|---|---|---|---|---|
| 01.5m | 0:00:07 | WL | S2 | Water level 1.5m - 3m: 10% Height/Diameter | Image Provided - Ref: 19_2<br> |
