**INTERMEDIATE STRUCTURAL  
PLANNING SURVEY**

Rutherford Stables  
r/o Hilary Cottage  
Hermitage Road  
Higham  
Kent  
ME3 7NE

On Behalf Of: Mr Paul Rutherford

**REPORT NUMBER** FC2015/209

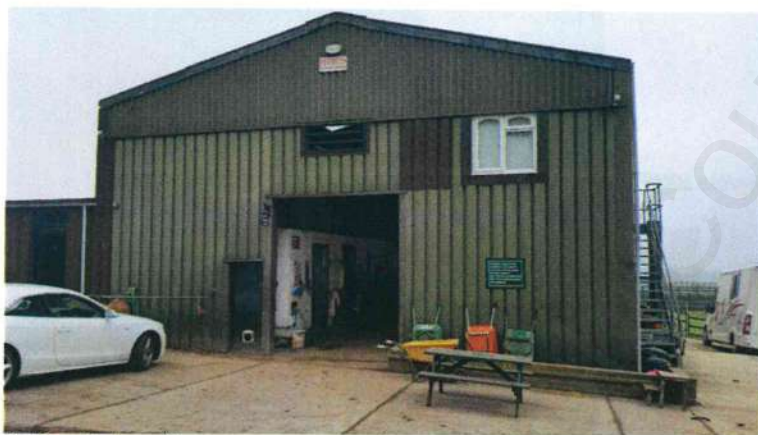
1. Front elevation.

The premises are generally as previously described, being a steel portal frame agricultural style shed, used as a stabling building with ancillary services and tack rooms and mezzanine accommodation. The building is clad with fibre cement sheet over the roof and single skin metal profile sheet to external walls on a masonry sub-structure. The building is approximately 25.5 metres long x 15.6 metres wide being approximately 7.2 metres to ridge and 5.5 metres to eaves. Fig.1.

External examination indicates the building to be of good line and level, showing no deviation in horizontal or vertical alignment to suggest any neither recent nor past settlement or subsidence effects.

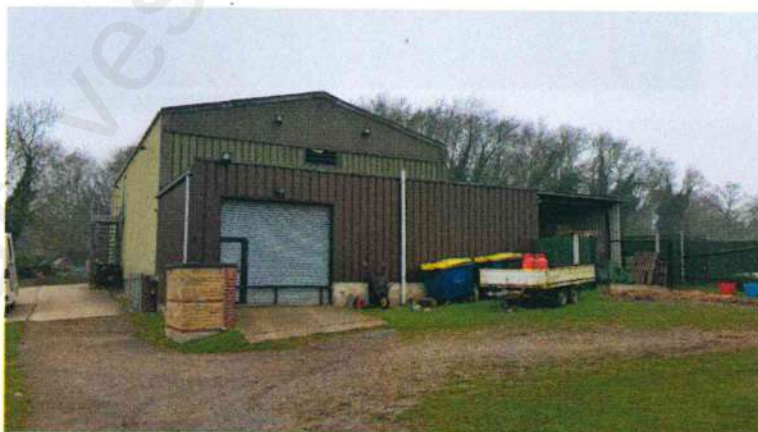
3. Rear elevation.

The property has a number of timber personnel doors and hand operated roller shutter door serving the main stabling area. The rear extension is partially open and also fitted with galvanised roller shutter door all in good order. Fig 3 The PVC rainwater goods are generally found to be in satisfactory condition and windows are serviceable.

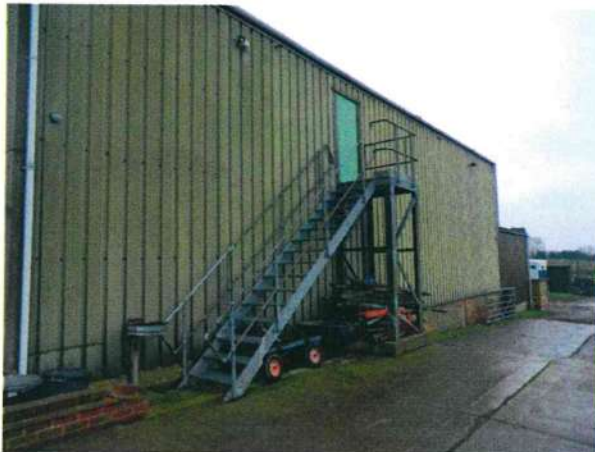
4. Right elevation and access stair

The structure has a number of windows at high level with numerous personnel and large access doors with galvanised steel fire escape serving the mezzanine level off the right-hand elevation. Fig.4.

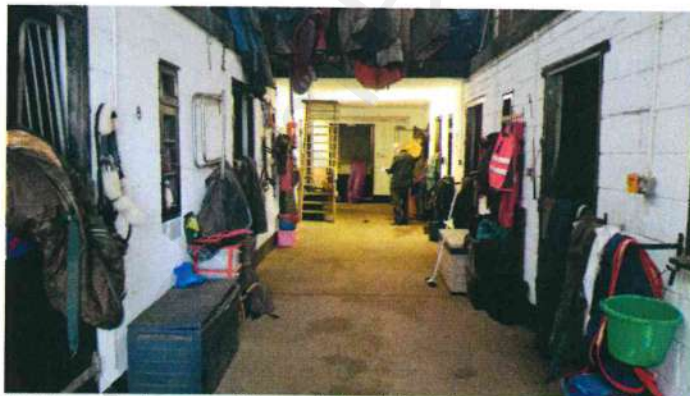
6. Internal at ground floor stable block level.

Internal walls generally comprise 140mm dense concrete blockwork which were found to be of good line and level and these support the mezzanine timber deck which was found to be structurally adequate. The unit has an in situ concrete floor slab which again is of acceptable line and level and appears structurally sound. Fig.6. The floor steps in alignment between the side offshot and main stabling area.

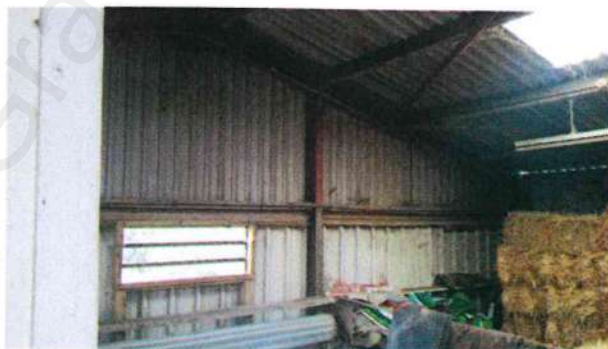
7. Typical steel frame.

Internal examination confirms a series of steel portal frames at approximately 3.6 metre centres comprising 254mm x 146mm UB columns with 178mm x 102mm UB rafter sections in turn carrying five timber purlins per roof slope and frame braced by 76mm diameter steel tubing within the end bay. The roof accommodates eight translucent roof lights. Fig.7.

Examination of the structural steelwork shows no evidence of significant corrosion to cause loss of metal or weakness within the frame with some areas displaying minor surface corrosion in need of simple mechanical cleaning and localised repainting.
