# R. G. Croudace Glass

Project St. Andrew's Art Centre, Royal Pier Road, Gravesend, Kent, DA12 2BD  
C/O Stuart James Associates, Shelly Lafferty- Director, Head of Architecture  
Email shelleylafferty@stuartjamesassociates.co.uk  
Telephone 020 7228 8522

## STAINED GLASS CONDITION REPORT

This document details findings of an onsite inspection of the stained glass and leaded light windows at the old Mission Church (built 1871) at Royal Pier Road, Gravesend. The church building is, now known as St. Andrew's Art Centre. Proposed repairs, methods and costs for each stained glass and leaded light location are presented.

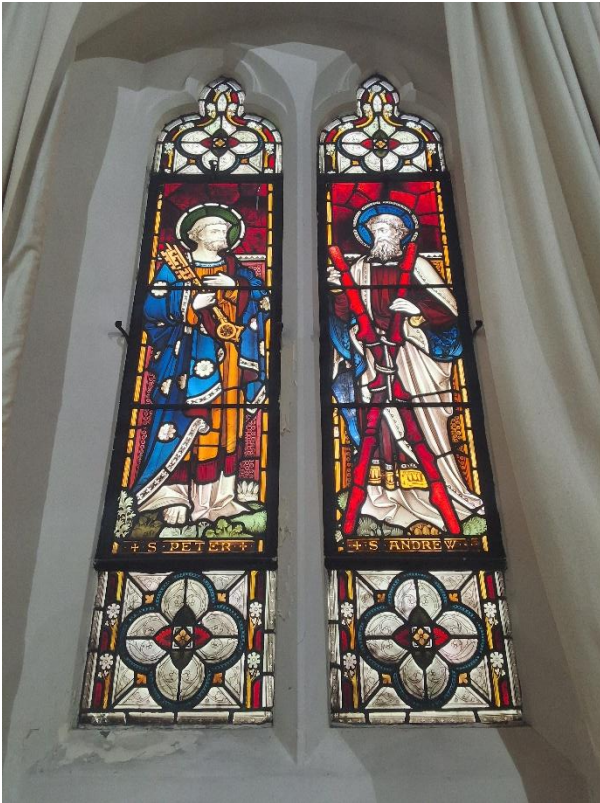
NAVE WEST AISLE: WINDOW 1. ST. PETER AND ST. ANDREW

- Two stained glass windows depicting St. Peter and St. Andrew.
- Metal openers are located at the base of each window.
- Slight bow to the lead work in the header panel of St. Andrew.
- Slight bows to both St. Peter and St. Andrew panels at the bases.
- Various minor and moderate glass breaks to central and border glass pieces. Some affect the appearance of the painted images whilst others less so.
- St. Peter- hand painted glass damage:
  - Glass damage with a hole within the blue gown.
  - Hole in red flash glass above head.
- St. Andrew- hand painted glass damage:
  - Paint loss to amber glass
  - In situ glass repairs are possible to selected glass breaks
  - Cracks to glass in bottom panel.
- Up close inspection of the protective external glazing and fittings was not possible.

- The bows in the panels could be left and monitored over time. **Optional:** Remove the panels now from the window frame for studio repairs. This work would remove the bow entirely. Happy to discuss the pros, cons and costs.
- **Optional:** Return metal opening window frames to operational standard. This includes removing the metal frames from the building fabric, sand blasting, priming and painting in marine grade matt or satin black paint.
- Replace heavily damaged hand-painted pieces with hand-painted replicas by Flora Jamieson.
- These damaged hand-painted pieces will be removed, replacement glass cut to fit onsite and then painted by F. J. Suitable temporary glass will be cut to shape, fitted and weather sealed into the leaded panel whilst painting offsite is made. New hand-painted glass fitted into lead on return visit.

- Strap minor and selected moderate glass breaks with lead came strapping to stabilize glass and mask damage (see process description below). Both internal and external faces of breaks will be strapped where access is possible.
- In situ glass replacement of selected broken glass (see process description below).
- Replace any failed or missing weather sealing leaded light cement in between glass and lead comes as found on both sides of leaded panels.
- Replace any failing or missing external perimeter border weather sealing material in between leaded panels and building fabric using appropriate material e.g. lime putty.

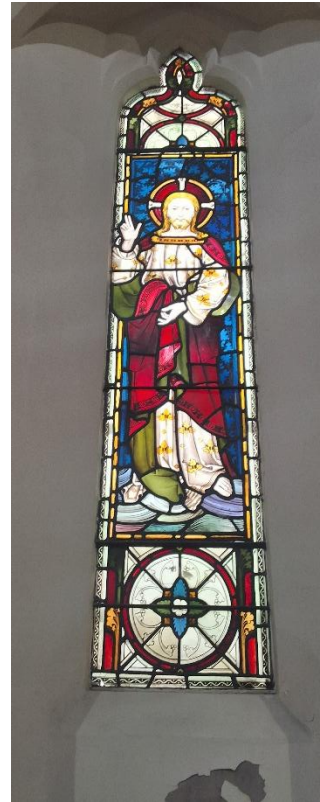
NAVE WEST AISLE: WINDOW 2

- Single stained glass window.
- The lower section of the window panel is bowing inwards.
- Bottom left side- hole in painted glass piece.
- Bottom left side- repaint damaged glass.
- Wall or ceiling paint can be seen on the lead comes.
- Up close inspection of the protective external glazing and fittings was not possible.

- The bow in the lower section of the panel could be left and monitored over time. Optional: The panel removed now from the window frame for studio repairs. This work would remove the bow entirely. Happy to discuss the pros, cons and costs.

- Replace heavily damaged hand-painted pieces with hand-painted replicas by Flora Jamieson.
- These damaged hand-painted pieces will be removed, replacement glass cut to fit onsite, and then painted by F. J. Suitable temporary glass will be cut to shape, fitted and weather sealed into the leaded panel whilst painting offsite is made. New hand-painted glass fitted into lead on return visit.

- Strap minor and selected moderate glass breaks with lead came strapping to stabilize glass and mask damage (see process description below). Both internal and external faces of breaks will be strapped where access is possible.

- Remove paint from lead comes by hand.
- Lightly buff lead to remove traces of cleaning process.
- Replace any failed or missing weather sealing leaded light cement in between glass and lead comes as found on both sides of leaded panels.

- Replace any failing or missing external perimeter border weather sealing material in between leaded panels and building fabric using appropriate material e.g. lime putty.

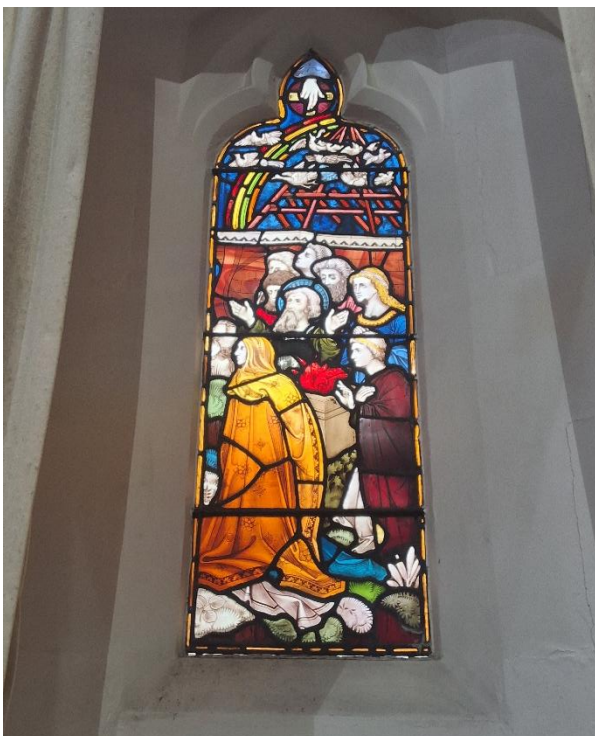
NAIVE WEST AISLE: WINDOW 3

- Wall or ceiling paint can be seen on the lead comes.

- Remove paint from lead comes by hand.
- Lightly buff lead to remove traces of cleaning process.
- Replace any failed or missing weather sealing leaded light cement in between glass and lead comes as found on both sides of leaded panels.
- Replace any failing or missing external perimeter border weather sealing material in between leaded panels and building fabric using appropriate material e.g. lime putty.
- Up close inspection of the protective external glazing and fittings was not possible.

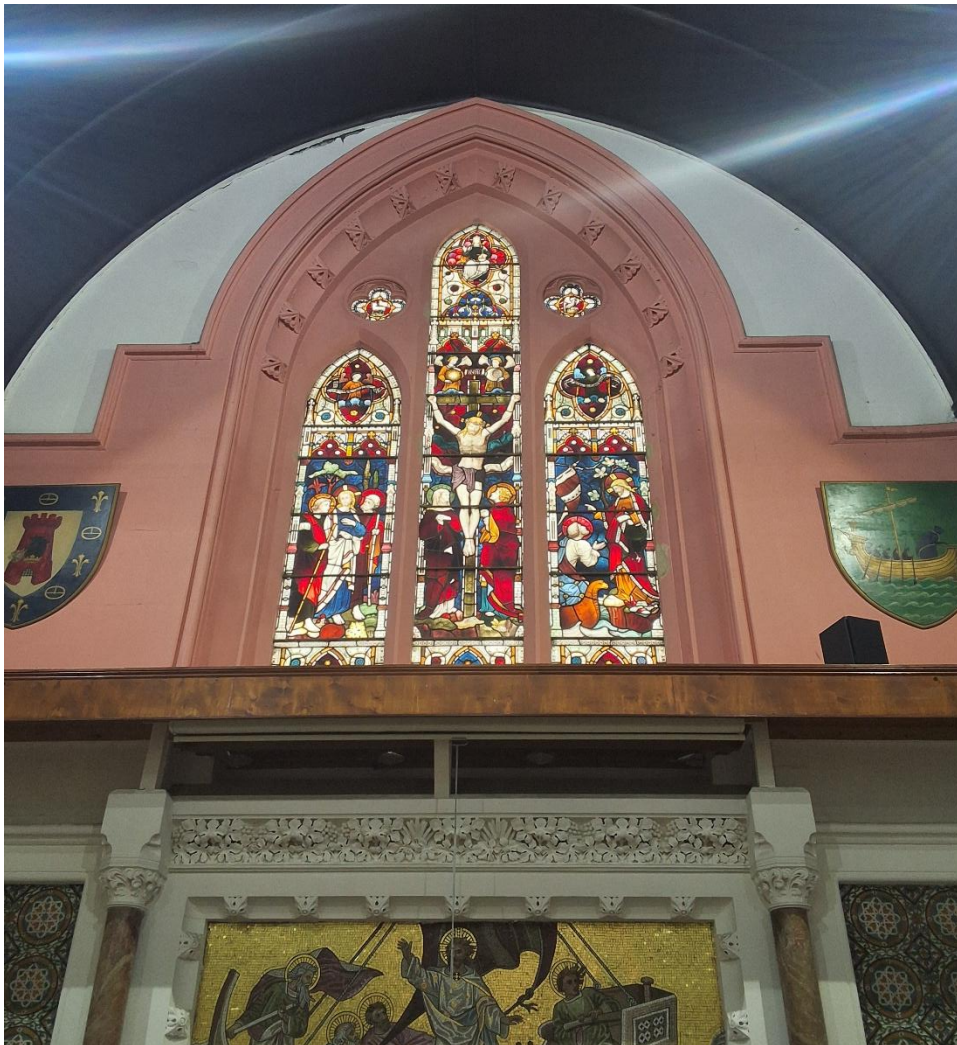
ALTAR

- Overall, the majority of saddle bar ties appear to be in position and still tied. These ties are soldered to the leaded panel and wrapped around the horizontal metal bars located into the tracery stonework. These ties are very important to help brace and support the leaded panels in position from movement, principally by the wind and weather.

- Horizontal metal saddle support bars- some ends located into the building fabric appear to have jacked the stone.
- Possible Portland cement traces can be seen on lead and glass, especially around Jesus' left hand and on the side perimeter border lead.

- Minor crack in hand-painted glass to one figure's red gown.
- Right side window- Hand-painted glass replacement of red glass in Jesus' gown required. Water staining is evident on the glass beneath the hole..

- Either wall or ceiling paint or bird faeces on lead comes.
- Wall or ceiling paint can be seen on the lead comes of numerous panels.
- Minor glass breaks across all panels.

- Missing glass in hand-painted glass piece- a hole is evident in a green tree canopy piece.
- Hole in amber perimeter border glass of quatre foil leaded panel.

- Possible stone decay or loose dust underneath the pink wall paint along the top three curves in both quatre foil panels.
- Up close inspection of the protective external glazing and fittings was not possible.

- Strap minor and selected moderate glass breaks with lead came strapping to stabilize glass and mask damage (see process description below). Both internal and external faces of breaks will be strapped where access is possible.

- In situ glass replacement of selected broken glass (see process description below).
- Replace heavily damaged hand-painted pieces with hand-painted replicas by Flora Jamieson.

- These damaged hand-painted pieces will be removed, replacement glass cut to fit onsite, and then painted by F. J. Suitable temporary glass will be cut to shape, fitted and weather sealed into the leaded panel whilst painting offsite is made. New hand-painted glass fitted into lead on return visit.

- Remove paint from lead comes by hand.
- Solder replacement saddle bar ties in place.
- Light removal of dust from all panels.
- Remove paint from lead comes by hand.

- Lightly buff lead to remove traces of cleaning process.
- Replace any failed or missing weather sealing leaded light cement in between glass and lead comes as found on both sides of leaded panels.

- Replace any failing or missing external perimeter border weather sealing material in between leaded panels and building fabric using appropriate material e.g. lime putty.

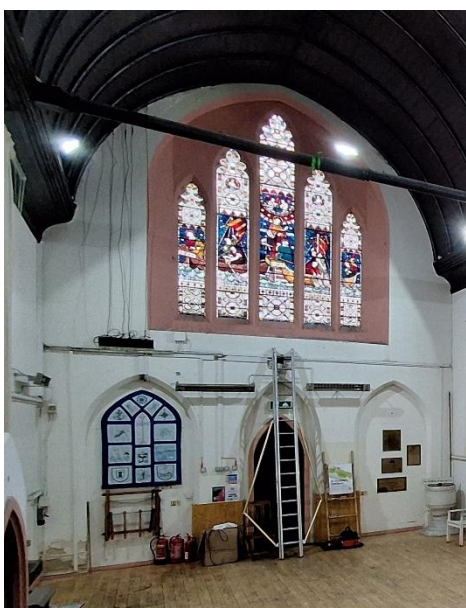
NAVE

- Saddle support bars appear satisfactory and in position.
- The metal saddle bars themselves look satisfactory.
- Possible stone decay or loose dust underneath saddle bar ends where they fit into the walls.
- Wall or ceiling paint can be seen in a few places on lead comes.
- External protective glazing sheeting looks satisfactory, albeit aged by weather and sunlight exposure. Fittings not inspected.
- Cracks to clear perimeter border glass.
- Crack to hand-painted ship hull piece.
- Minor cracks in surrounding border glass, and to a lower decorative leaded panel.
- Hole in glass in hand-painted blue sky (to the left of the ship's sail). Cracked blue glass beneath this piece, clear glass to the side broken, and clear perimeter border glass cracked.
- Up close inspection of the protective external glazing and fittings was not possible.

- Light removal of dust from all panels.
- Replace heavily damaged hand-painted pieces with hand-painted replicas by Flora Jamieson.

- These damaged hand-painted pieces will be removed, replacement glass cut to fit onsite, and then painted by F. J. Suitable temporary glass will be cut to shape, fitted and weather sealed into the leaded panel whilst painting offsite is made. New hand-painted glass fitted into lead on return visit.
- Remove paint from lead comes by hand.
- Solder replacement saddle bar ties in place.
- Remove paint from lead comes by hand.
- Lightly buff lead to remove traces of cleaning process.
- Replace any failed or missing weather sealing leaded light cement in between glass and lead comes as found on both sides of leaded panels.
- Replace any failing or missing external perimeter border weather sealing material in between leaded panels and building fabric using appropriate material e.g. lime putty.

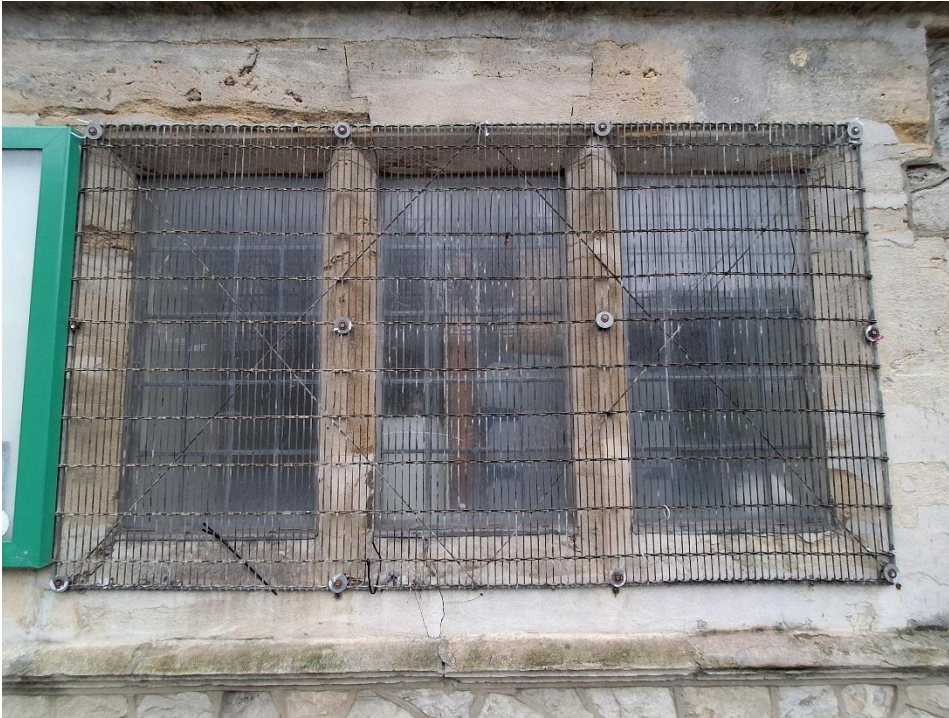
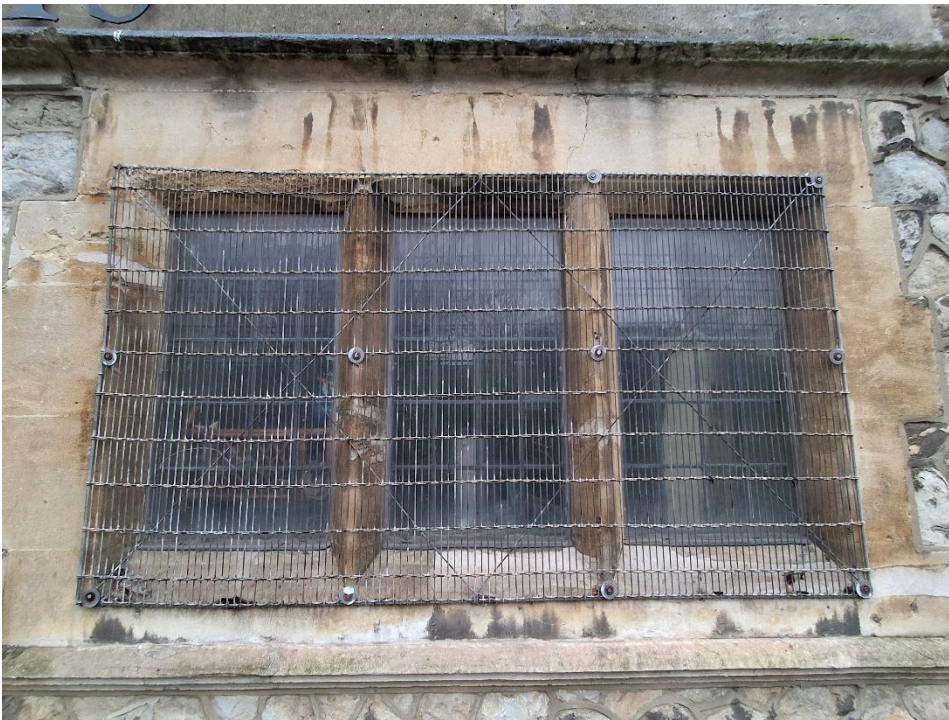
NARTHEX

- Six rectangular quarried leaded lights- three in toilet area, three in staff room.
- One in situ clear textured glass repair required.
- Overall the leaded lights appear in good condition.
- External metal protective grilles fixed in position across both sets of windows.
- Protective external glazing siliconed into position with vent holes in silicone.
- Paint on some glass.

- Light removal of dust from all panels.
- Replace any failed or missing weather sealing leaded light cement in between glass and lead comes as found on both sides of leaded panels.
- Replace any failing or missing external perimeter border weather sealing material in between leaded panels and building fabric using appropriate material e.g. lime putty.
- Remove external metal protection grilles. Clean metal work (sandblast off site or hand clean onsite). Paint metal work with marine grade paint to resist water side location and weather. Install grilles into same locations.
- Leave external silicone glazing in situ.
