# Phase I Geo-Environmental Desk Study

Huggens College,  
College Road,  
Northfleet,  
Kent,  
DA11 9DL

Andrew Firebrace  
Partnership Ltd

Ref: 5618 23 10 31 Rpt 01 Rev A JH AFP

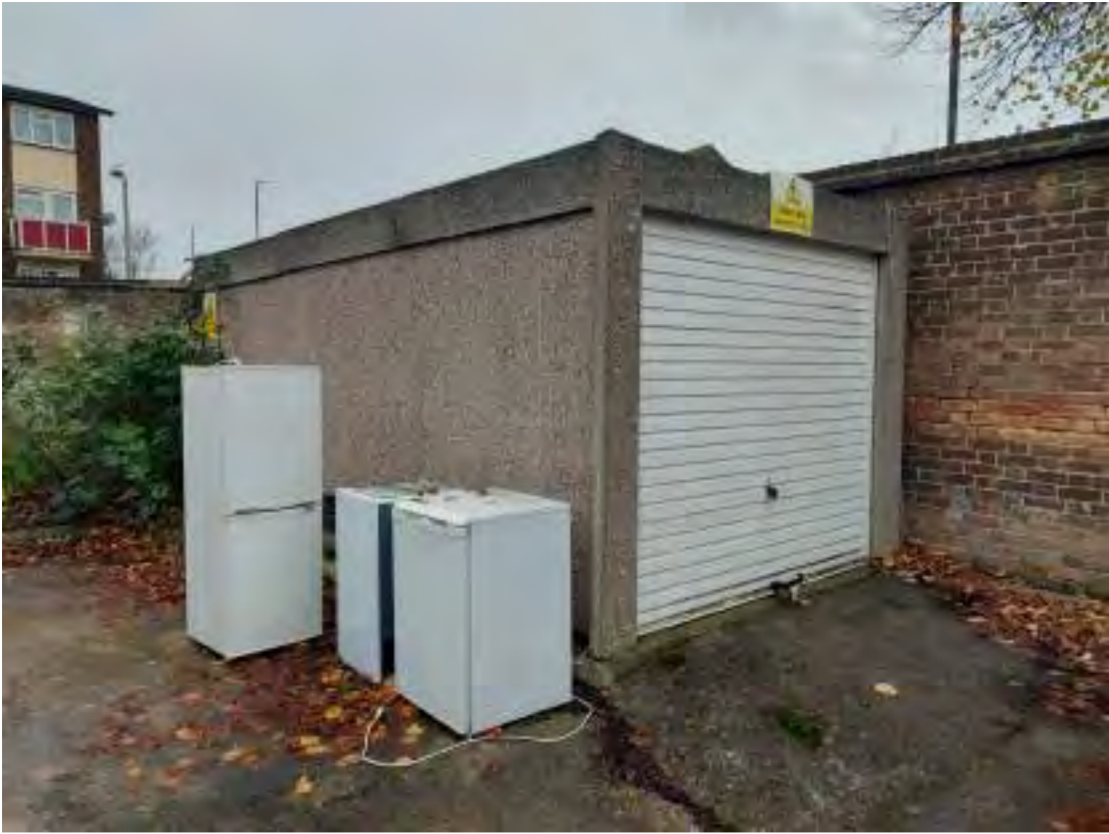
Photo 9—Garage with asbestos roof and stockpile of kitchen appliances

- Presumed asbestos chimneys and panels behind the chimneys were noted on the properties as well as the roof of the garage located to the southeast of the site. To begin compliance with the Control of Asbestos Regulations 2012, a Pre-Demolition/Major Refurbishment Asbestos Survey should be conducted prior to any disturbance to the existing structures;

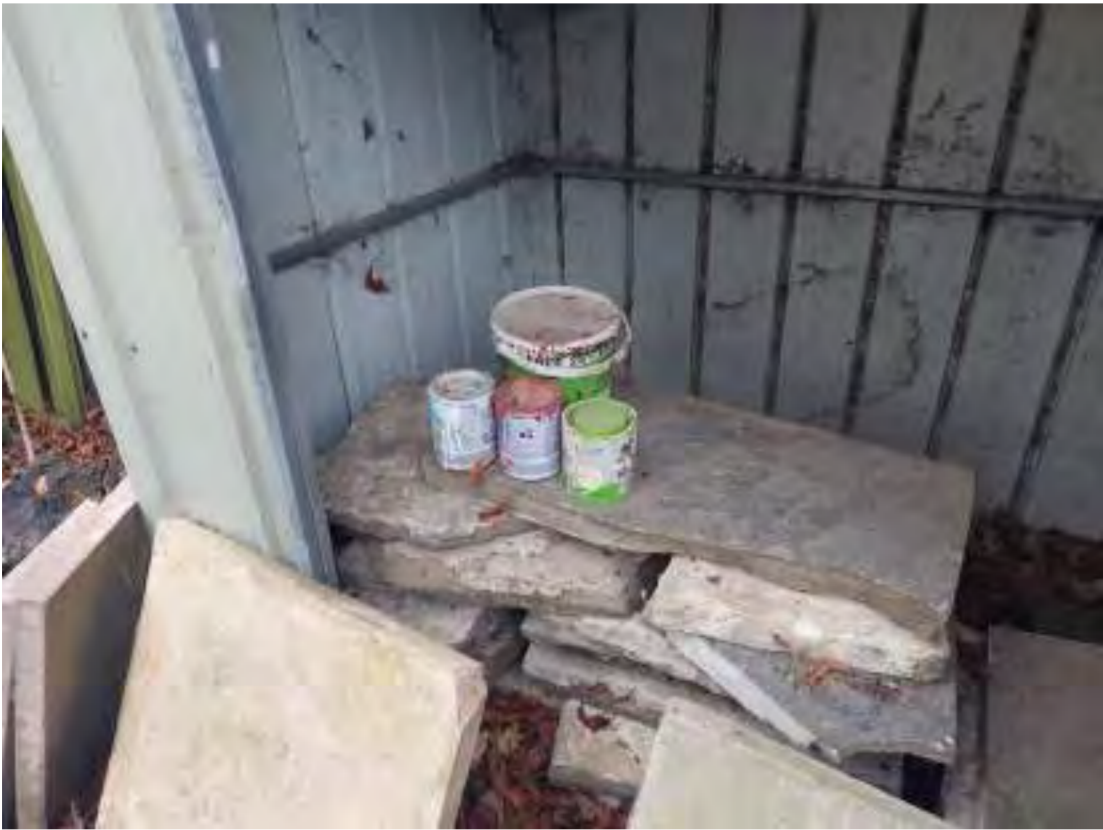
Photo 10—Metal shed with concrete slabs and paint cans

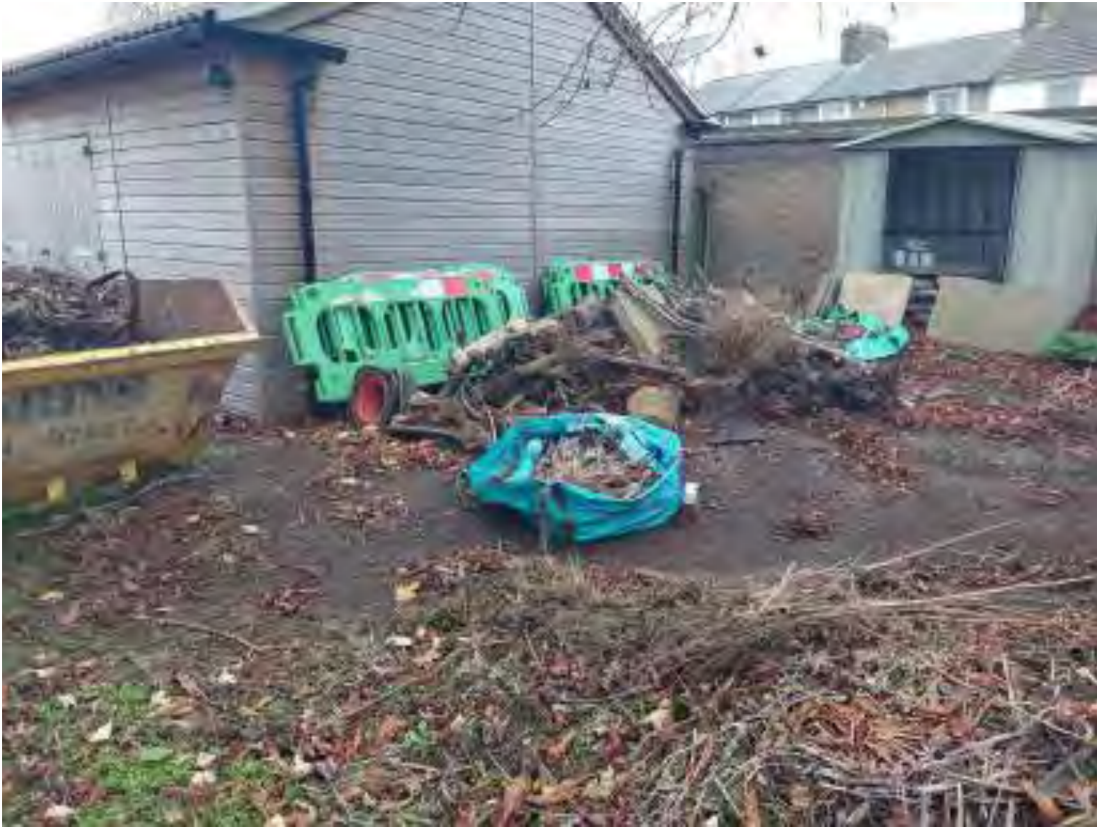
Photo 11—skip comprising rubble and organic matter such as bark, soil and wood. Barriers and cones, and a stockpile of wood, bark, and soil was noted adjacent to the skip

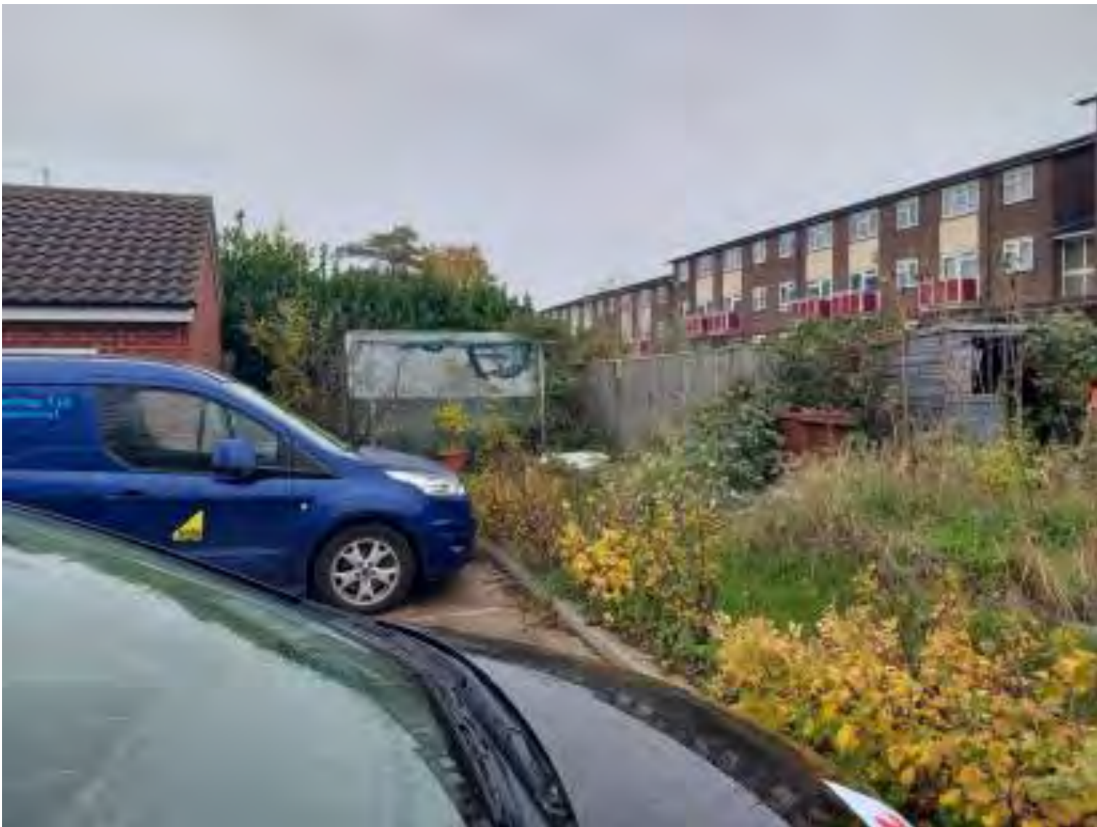
Photo 12—small gardening area, greenhouse and substation (behind wooden fence) on the southeastern side of the site.

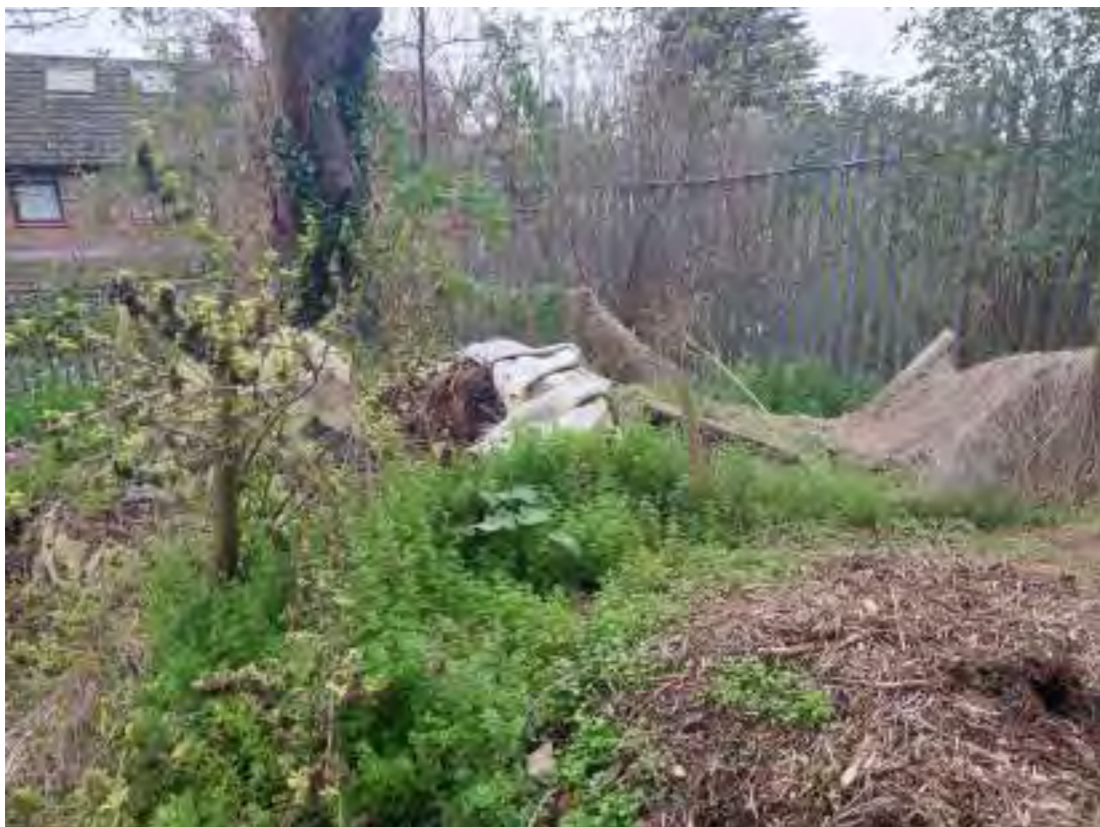
To the southwestern corner of the site was a stockpile of carpet, overgrown grass cuttings, bark, soil, and potential rubber. Along the eastern and northern boundaries behind the residential gardens was soft landscaping and trees.

Photo 13—Stockpile of carpet, overgrown grass cuttings, bark, soil, and potential rubber on the southwestern side of the site

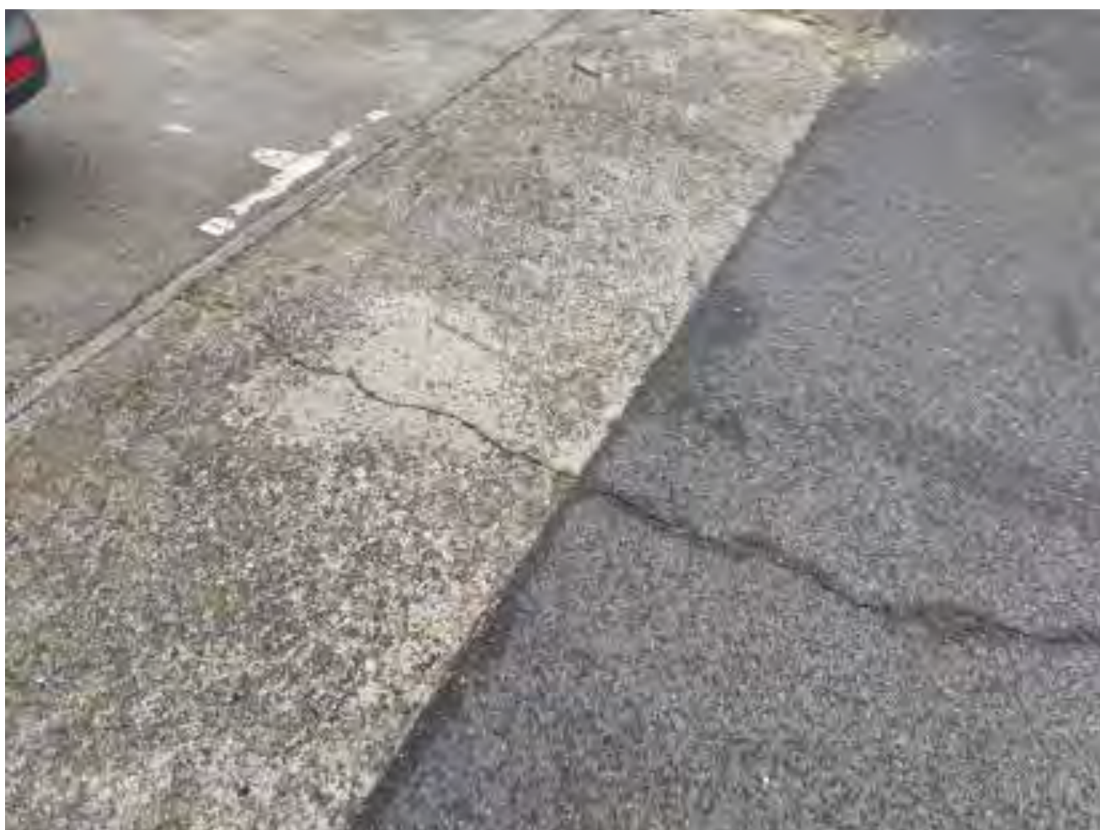
Photo 14—Evidence of cracked concrete in the visitor car parking area
