# **LISTED BUILDING APPLICATION FOR EMERGENCY REPAIRS:**

**Proposed repairs at Gad's Hill School, Gravesend Road, Higham, Rochester, Kent  
ME3 7PA**

**clay** architecture

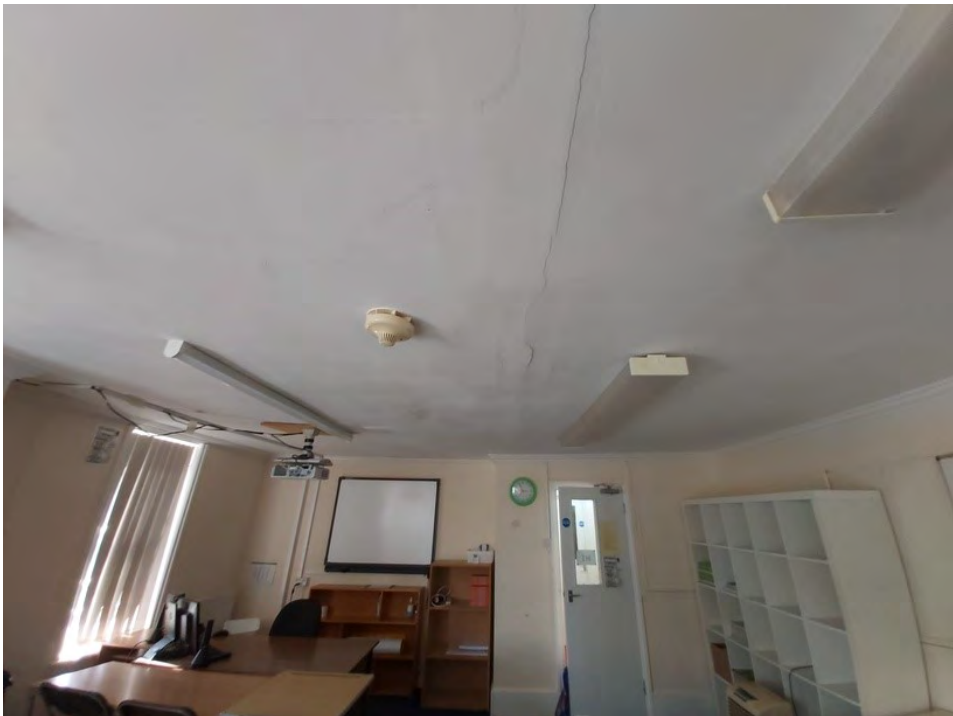
- 1) The roof of Gad's Hill Place is in poor condition, having suffered water ingress over some years, which have weakened the lathe and plaster ceilings on the second floor. The ceilings to one of the second-floor classrooms failed last winter.

ceiling ( room H1 ) failed in November 2022.

1) Ceiling of HSFX06 H1 classroom looking west  
Ceiling shows signs of cracking , sagging and previous repairs.  
Photograph taken 01/08/2022 by CP

- 1.00 Classroom H1 on the second floor and the roofs above it. The slate tiled roof to the rear, and to reinstate the lathe and plaster ceiling where it has failed.

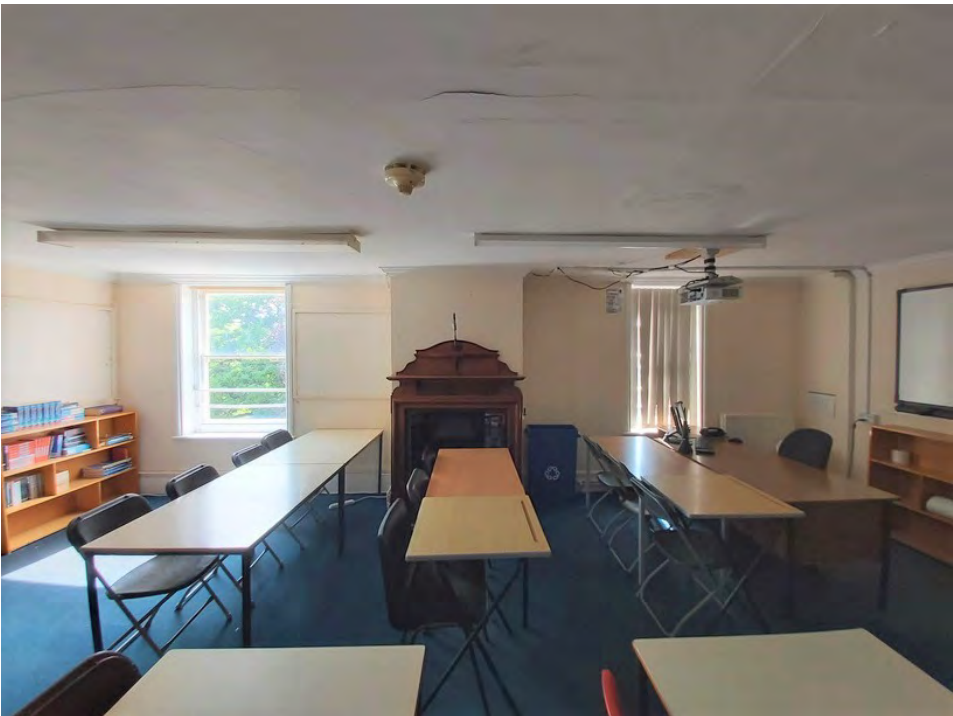
1) Ceiling of HSFX06 H1 classroom looking east  
Photograph taken 01/08/2022 by CP

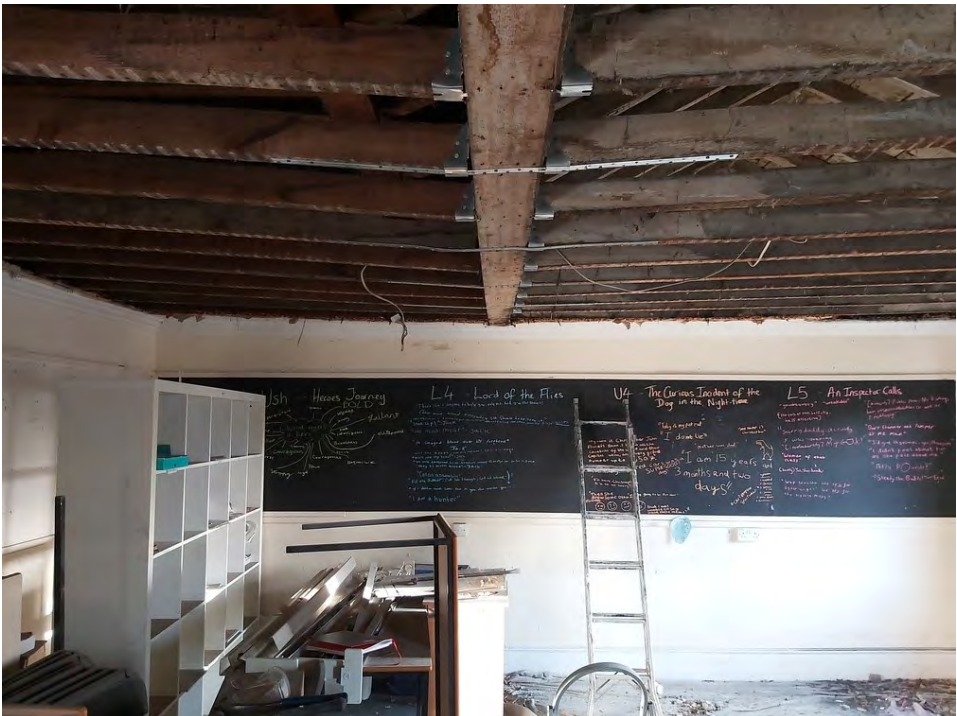
1) Ceiling of HSFX06 H1 classroom looking east  
After ceiling came down on the advice of the SE straps were fixed to underside of main beam.  
Photograph taken 23/11/2022 by CP

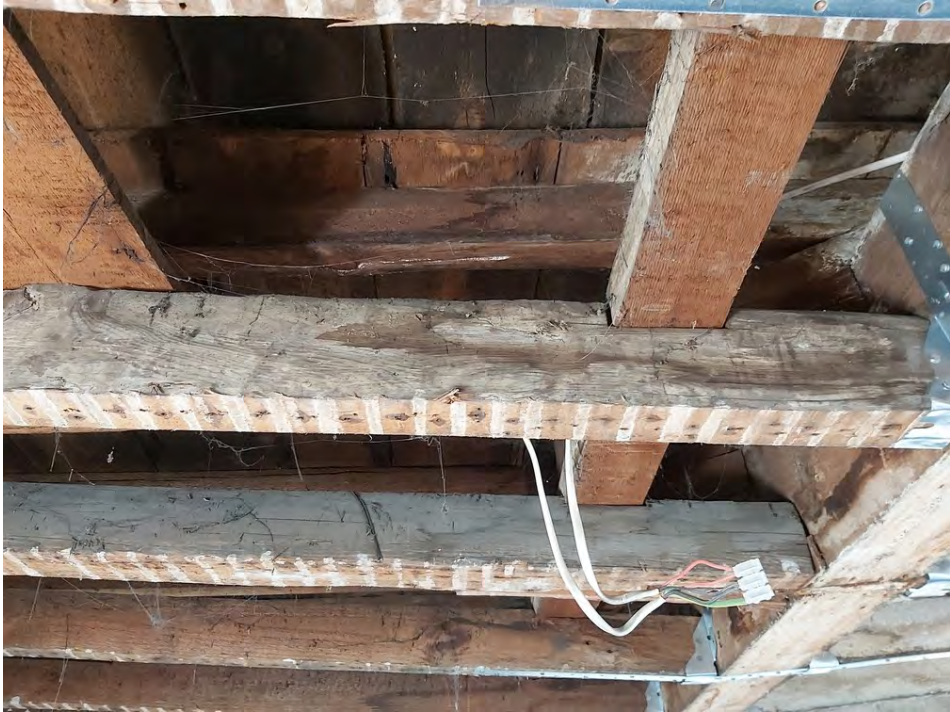
1) Ceiling of HSF06 H1 classroom looking north  
Underside of lead roof RFX03.  
Photograph taken 23/11/2022 by CP

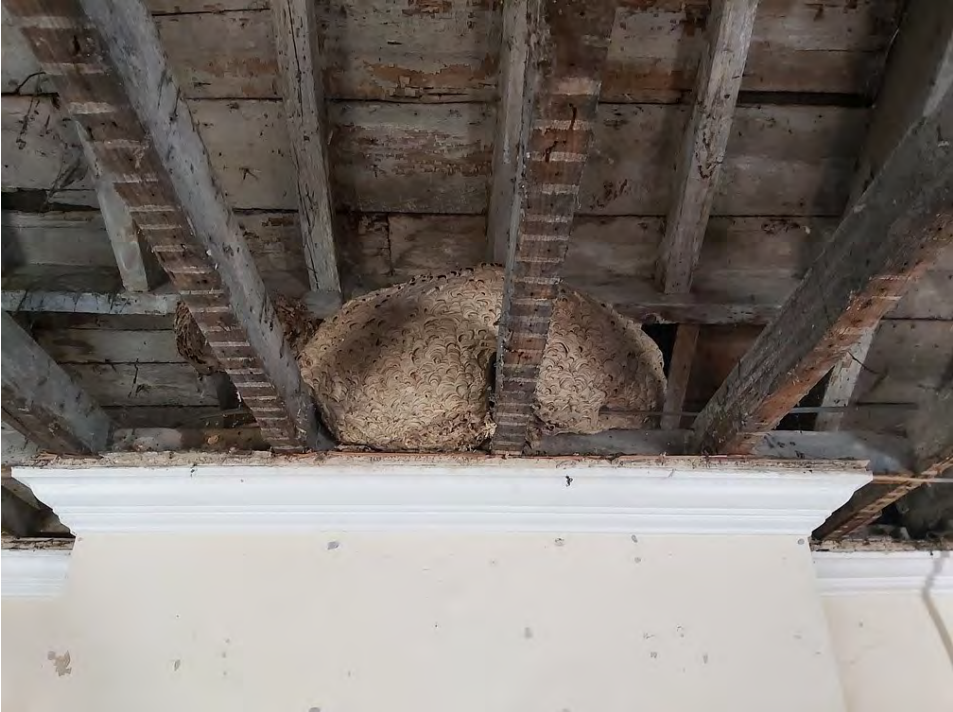
1) Ceiling of HSF06 H1 Classroom looking south  
Bee/ wasps nest above fireplace.  
Photograph taken 23/11/2022 by CP

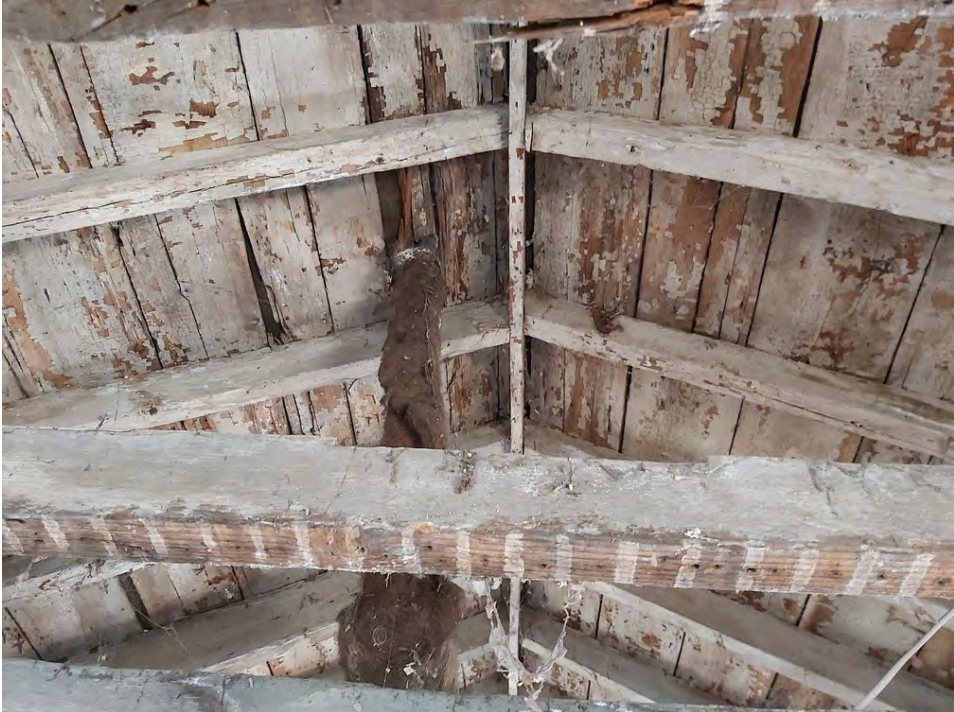
1) Ceiling of HSF06 H1 classroom looking east west  
Underside of roof RFX02. Gaps between sarking boards. Some are rotten and damp coming in from above.  
Photograph taken 23/11/2022 by CP

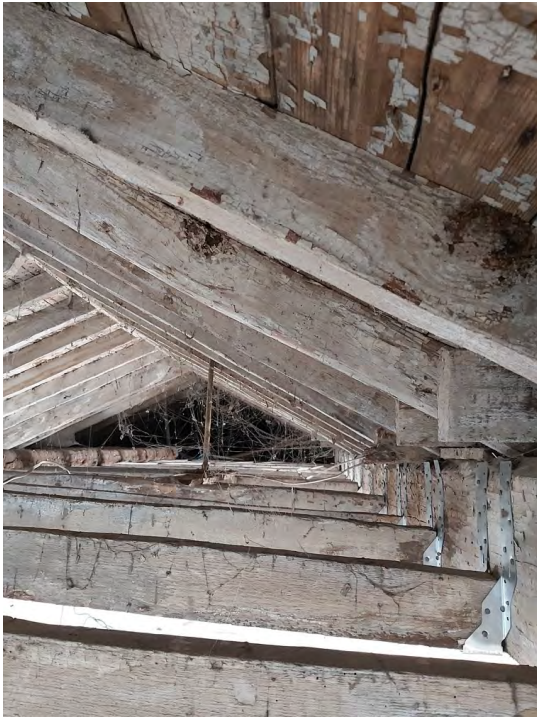
1) Ceiling of HSF06 H1 classroom looking east west  
Sarking boards have been lime washed . Some boards are showing signs of damp ingress  
Photograph taken 23/11/2022 by CP

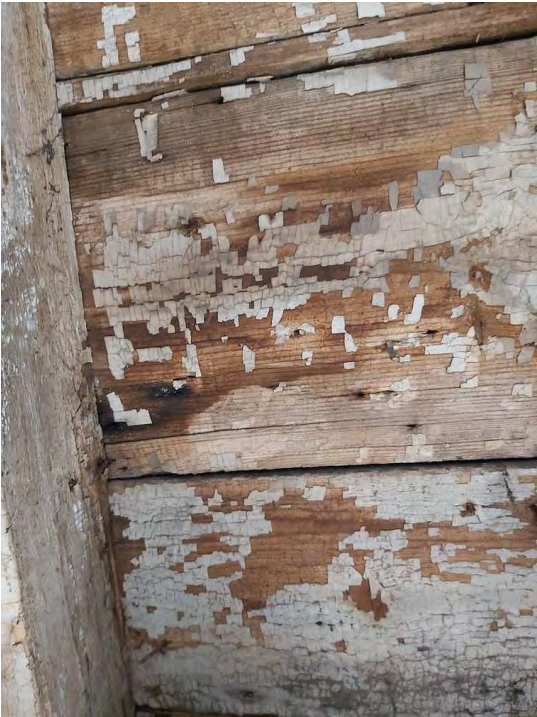
1) Underside of roof HRF02 of HSF06 H1 class-room looking at the sarking boards.  
Sarking boards showing signs of water ingress coming in from above.  
Photograph taken 23/11/2022 by CP

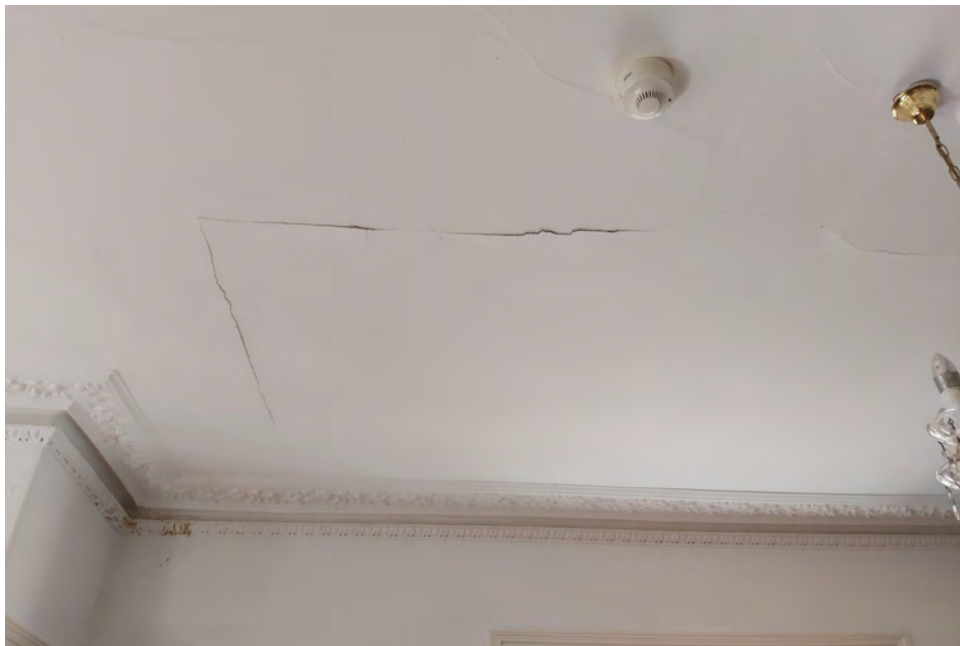
- 2) The roof of the Library extension has holes in the lead flashing that is allowing water ingress. This has caused the previously repaired plasterboard ceiling below to crack and slightly sag. A temporary repair has taken place to prevent the ceiling collapsing as agreed on site with the Conservation Officer.

2) Ceiling of HGFX0X Library extension looking east west  
Cracks appearing around the plasterboard ceiling  
Photograph taken 04/05/2023 by CP

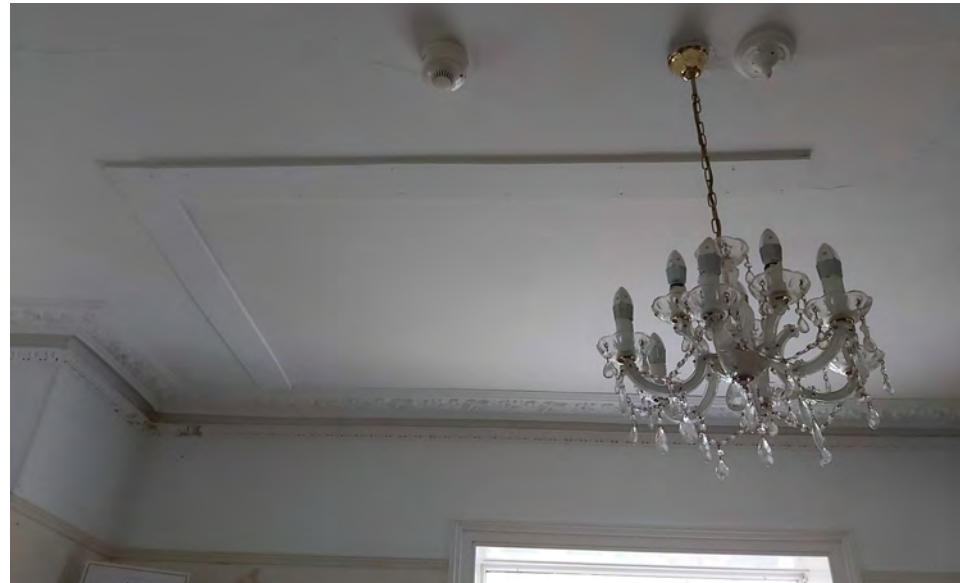
2) Ceiling of HGFX0X Library extension looking east west  
Temporary repair has been carried out.  
Photograph taken 04/08/2023 by CP

- 2.02 The ceiling of the Library extension has had a temporary repair carried out along the line of the cracked plasterboard with a strip of plywood fixed through to the ceiling joists above.

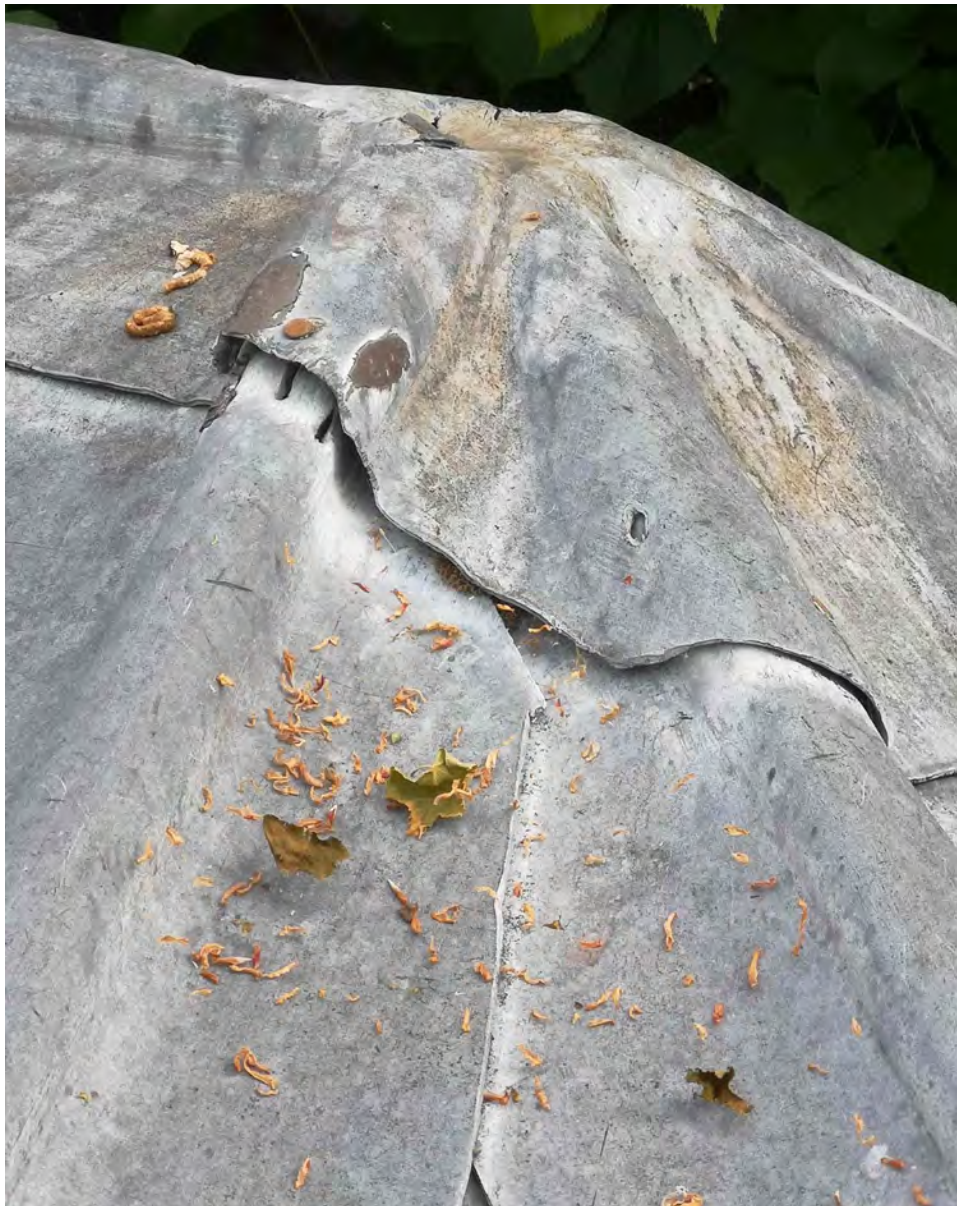
- 1.02 Enclosed are quick outline sketch proposals for the repair works to discuss with the Conservation Officer.
- 2.00 Ground Floor Library extension ceiling and roof above. The slate roof has been battered by overhanging roof branches and squirrels have been nibbling the lead ridges. The lead work is in poor condition and has not been flashed in properly. There are also a number of cracked and slipped slates. This roof is not insulated and there is no access to the roof void. The ceiling below has been repaired with plasterboard fixed through the lathe and plaster ceiling above. Due to water ingress the ceiling has cracked and is showing signs of sagging.

2) Top of roof HRFX07 of HGF0X Library extension looking at the lead ridges.  
Holes in leadwork where it had been knocked by tree branches over time.  
Photograph taken 23/05/2023 by BG

- 2.01 Until funds are properly earmarked, as a temporary measure the intention is once the lime tree has had it's lower branches removed, to flash tape the lead work. In the meantime the detailed work of removing , insulating, vented and reinstate the slate roof can be done when funds are found.

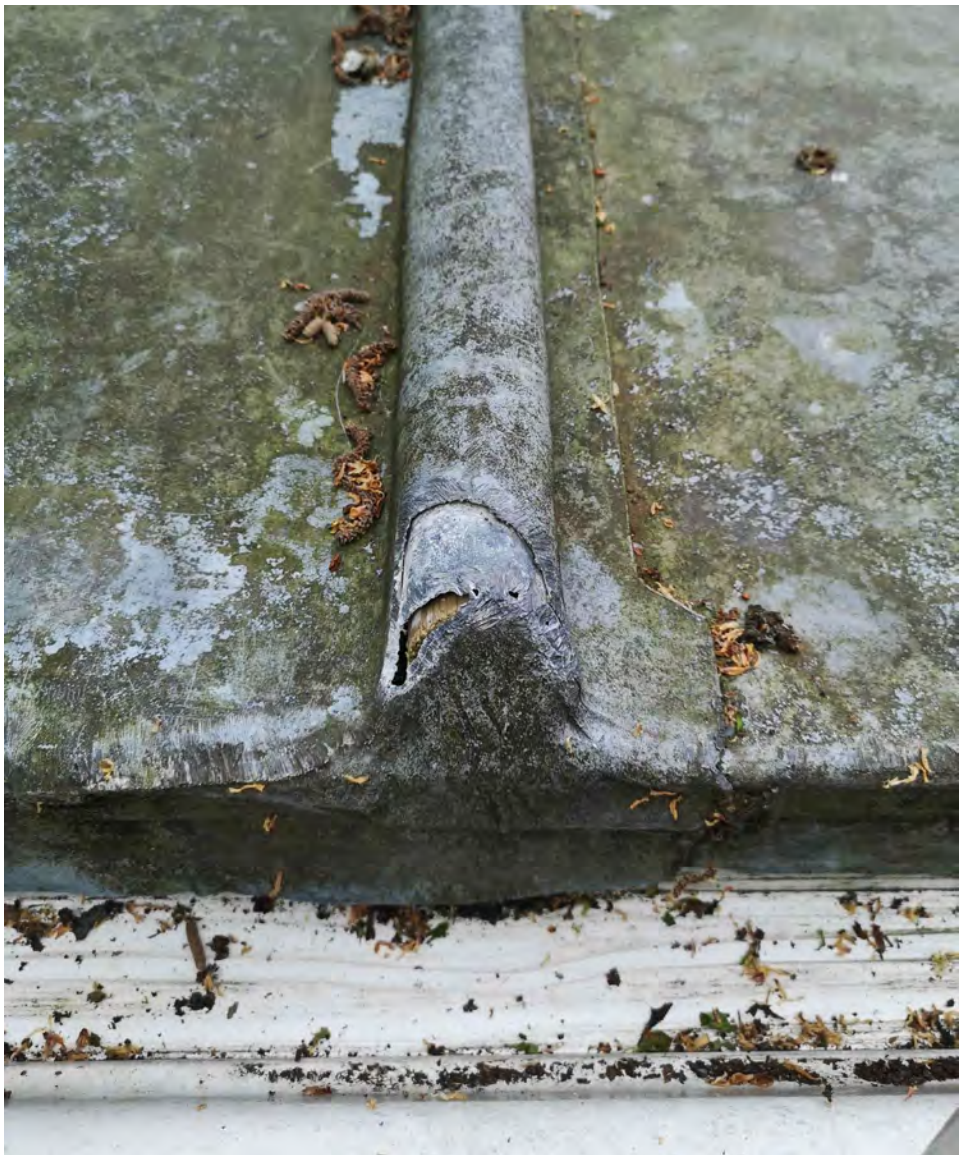
2) Roof HRFX08 Library extension looking east west  
Lead roof has been nibbled by squirrels  
Photograph taken 23/05/2023 by BG

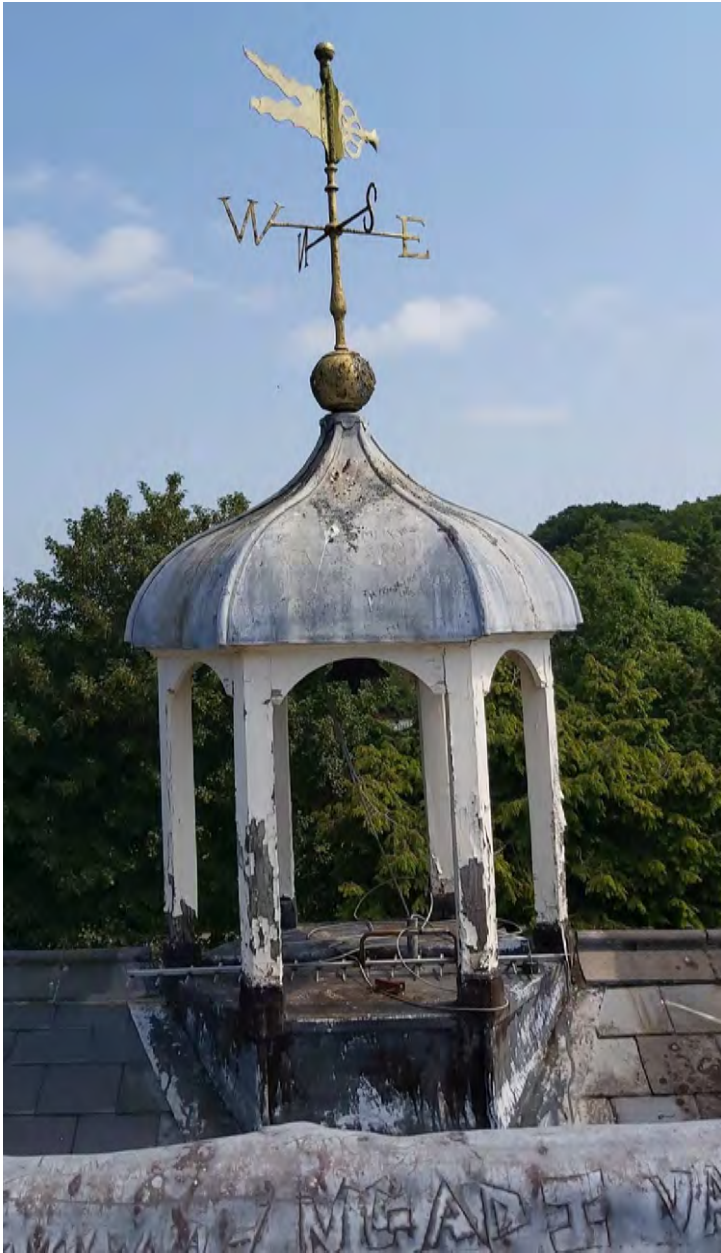
- 3.00 The structural stability of the cupola has become a more urgent concern. A year ago the Structural Engineer had given it 18 months before it needed to be taken down and repaired. In August, this year the time was reduced to 3 months. Sited in an exposed position and due to the strong winds since August last year the cupola has moved and slightly twisted off it's axis.

3) Cupola HCPX01 looking north.  
Some of the posts are rotten, paintwork has cracked allowing water ingress. Cupola has twisted.  
Photograph taken 09/06/2023 by CP

- 3.02 Opening up works have been carried out. From our investigation, the Structural Engineer advises that in-situ repairs will last another 5 years, while removing the cupola for full off-site repairs will last another 30 years. Subject to cost and the school's preference is for a full off-site repair.

- 3.03 Meanwhile, while left in situ the cupola urgently needs to be temporarily stabilised. This will be done by fixing plywood gussets top and bottom of each post on 3 sides to help brace and stop it from twisting further. This is only a temporary measure and will only be good for a couple of months.

- 3.04 The advice is to remove the cupola for repair as a matter of urgency. The bracing in 3.03 plus additional cross bracing will be needed to lift the cupola off the roof with a crane.

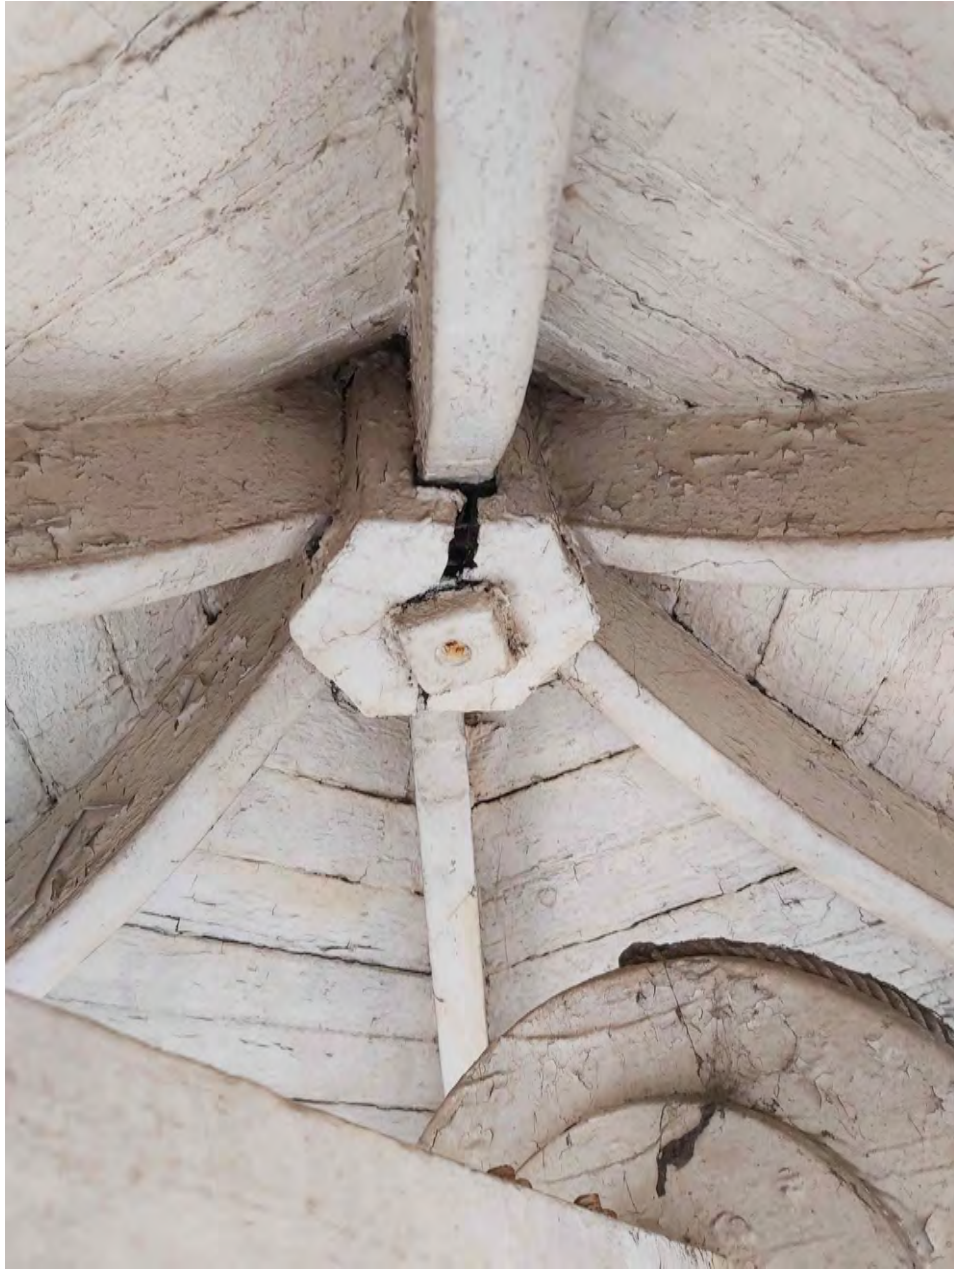
3) Underside of cupola HCPX01.  
Photograph taken 17/08/2023 by CP

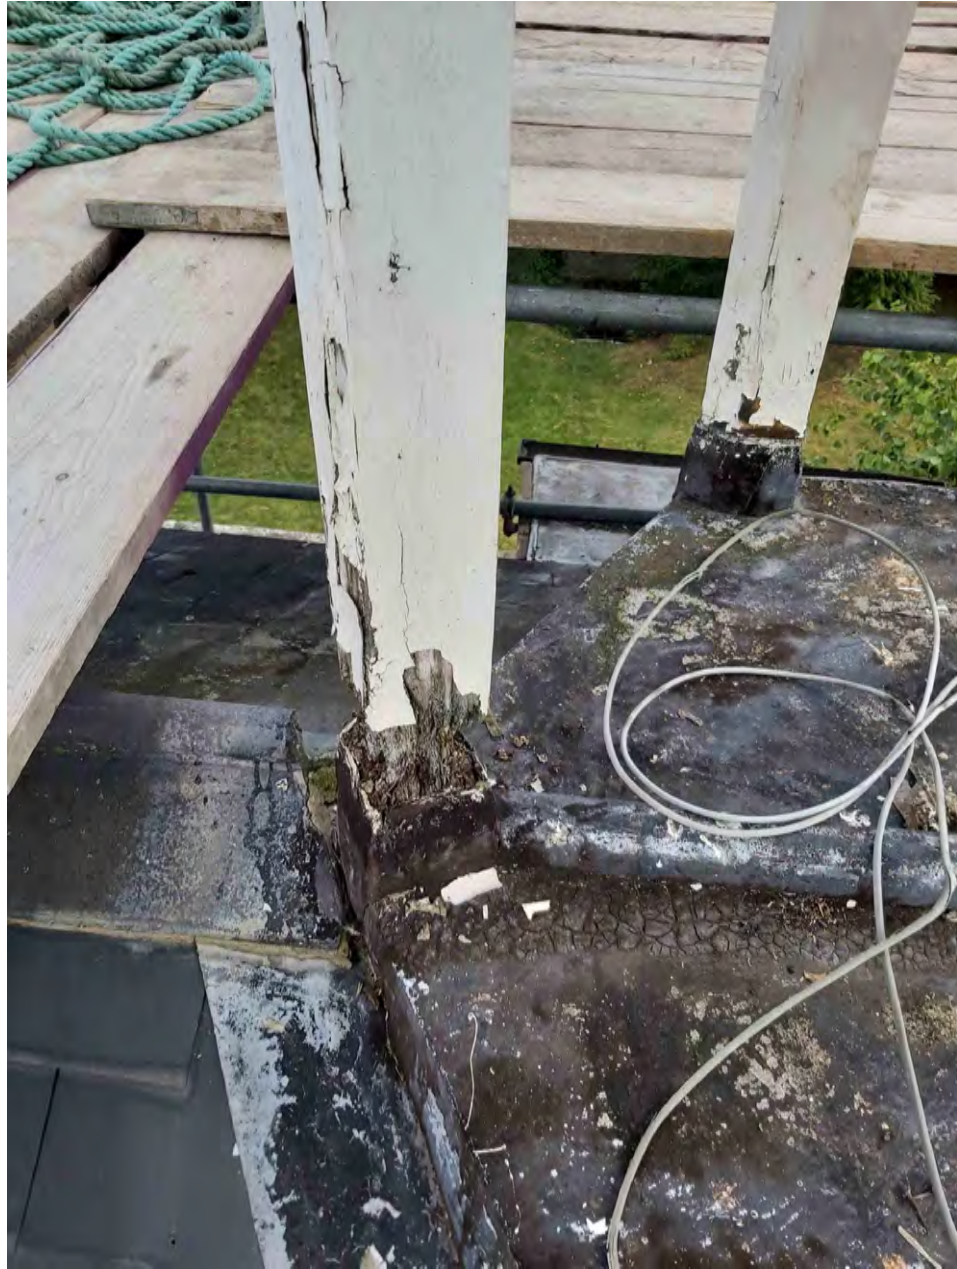
3) Base of cupola post by roof HRFX04.  
Post is rotten and needs to be replaced.  
Photograph taken 17/08/2023 by CP

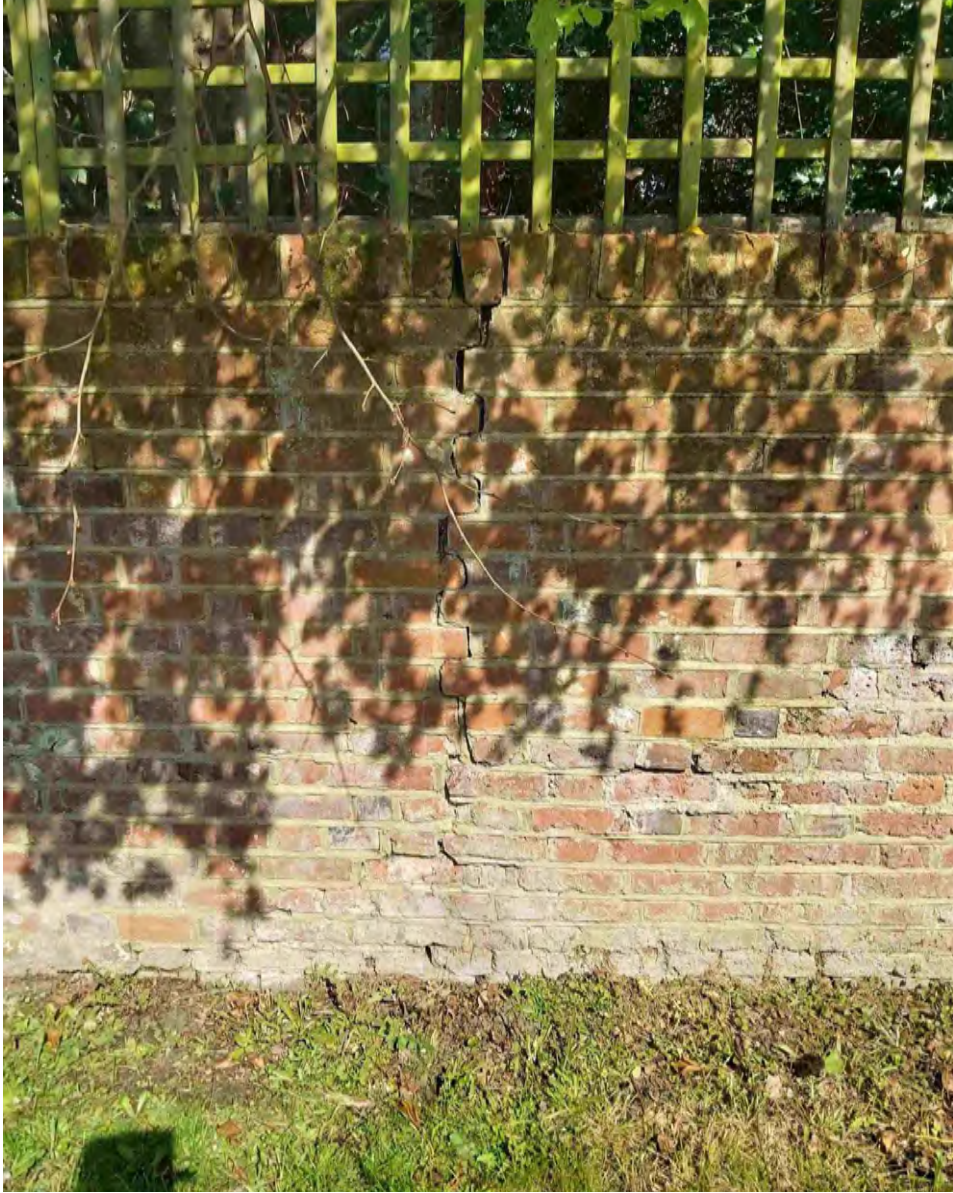
- 3.05 At the time of writing, we are still trying to confirm dates for a visit by Gravesham Officers.
- 4.00 The curved garden wall between the front drive and the lower orchard area that forms part of the nursery outside area is bulging and has cracks in it. The wall has been repointed with cementitious cement, that makes it inflexible. The wall also suffers from pressures from the west due to the amount of self sown trees and debris that has built up behind it over the years.

4) Garden wall between front drive and orchard. With multiple trees behind.  
Vertical cracks in brickwork. Wall has been repointed with a cementitious mortar some time ago.  
Photograph taken 03/05/2023 by CP

- 4.01 The Structural Engineer has proposed a detailed design to repair the wall that includes putting in buttresses and low level weepholes. This has been enclosed along with this submission.

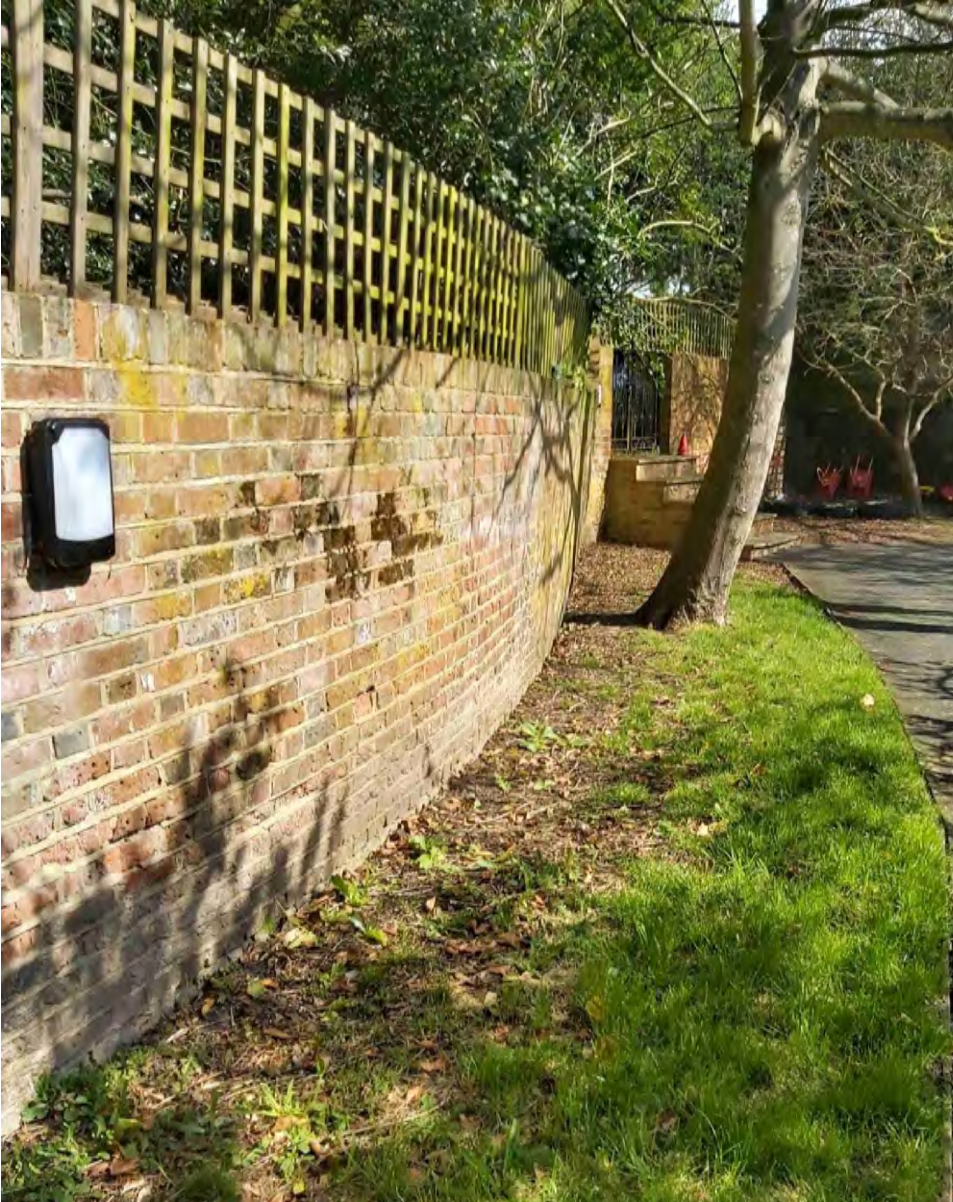
- 4) The garden boundary wall between the front drive and orchard has cracks and is bulging. The wall has been impacted by previous repairs in cementitious mortar and by pressure of the self sown trees and plant debris behind the wall on the drive side (west). The trees recommended for removal are noted in point 8. The Structural Engineer has put forward a proposal to repair the wall.

4) Garden wall between front drive and orchard.  
Wall is bulging.  
Photograph taken 03/05/2023 by CP

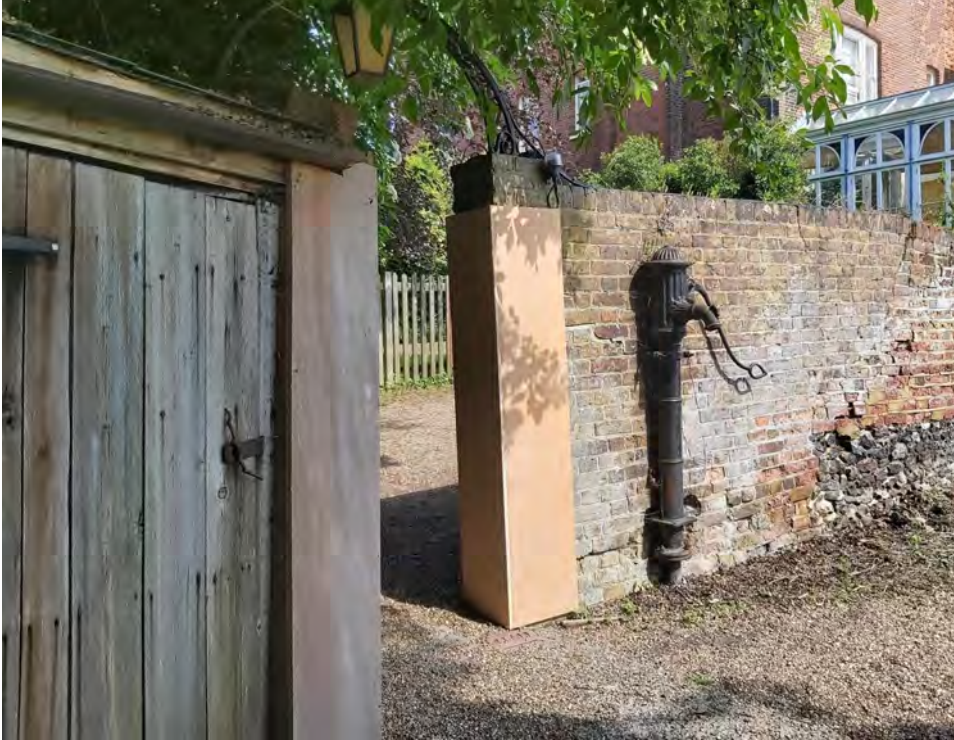
- 5.00 Where the curved garden wall ends there is a section of straight freestanding wall to the south side of the house that is in bad condition. It has been repaired several times over the years with one complete section rebuilt with cementitious mortar. The end of the wall is joined by an wrought iron archway to a small garden shed. The children pass through this archway to get from the main house to the DT Block. Mortar on the end pier has in places come out, either helped or just fallen out. Currently the end of the wall has been temporarily encased in plywood.

5) Garden wall linked to the small shed via a wrought iron archway. Gad's Hill house behind.  
Foundations are sinking. Previously repaired and rebuilt using cementitious mortar that has caused bricks to spall and crack.  
Photograph taken 09/06/2023 by CP

- 5.01 There are 2 options to repair the wall. A light touch option to stabilise it, the other is to take it down completely and put in proper

foundations and rebuild the wall.

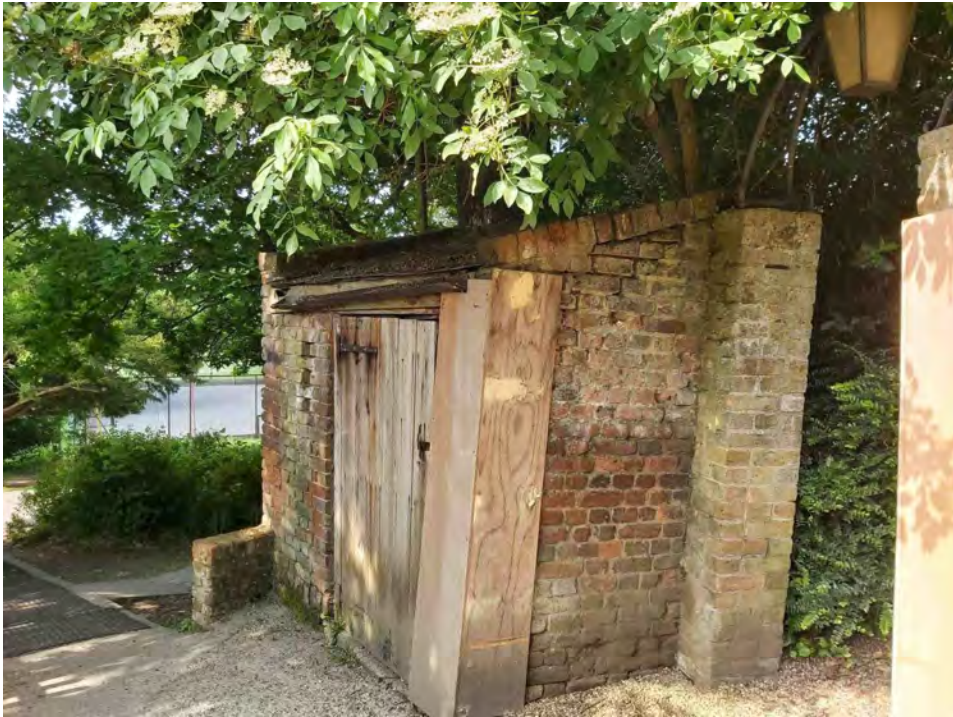
6.00 A small shed that is connected via an archway to the wall mentioned in point 5 has been condemned by the Structural Engineer. There is a very large oak tree behind it that its growth is impacting on the shed. Due to the movement and twisting of the shed it is assumed that there are little to no foundations.

6) Small garden shed in front of the oak tree numbered T71 on Sylvan arb's tree survey plan of the north of the site. The shed is twisting.  
Photograph taken 09/06/2023 by CP

6.01 The proposal is that the shed is surveyed, brick and flint bands are recorded in order that the shed will be rebuilt at a later date with proper foundations when funds allow.

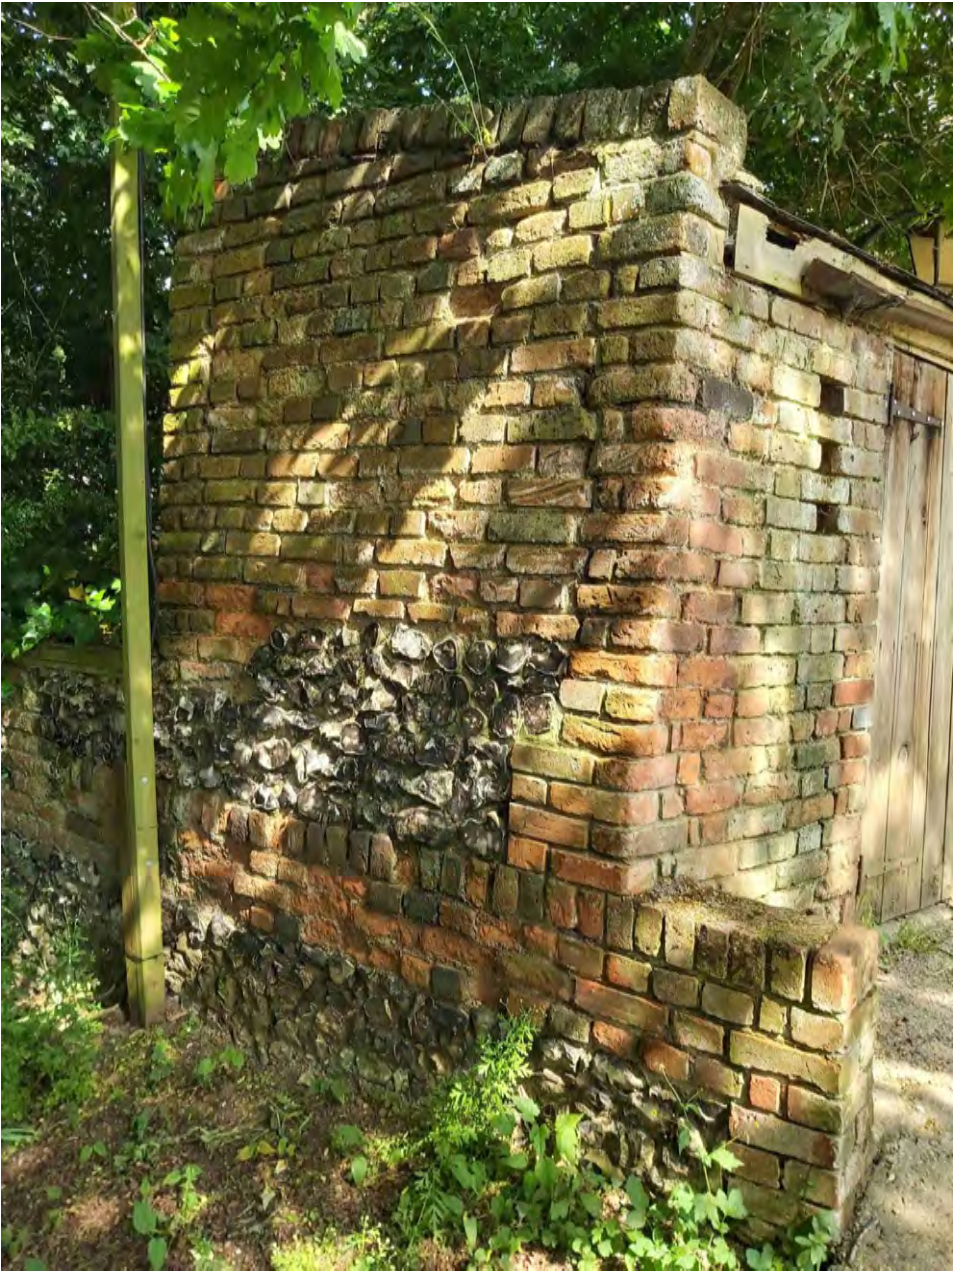
6) The side of the small shed.  
Photograph taken 09/06/2023 by BG

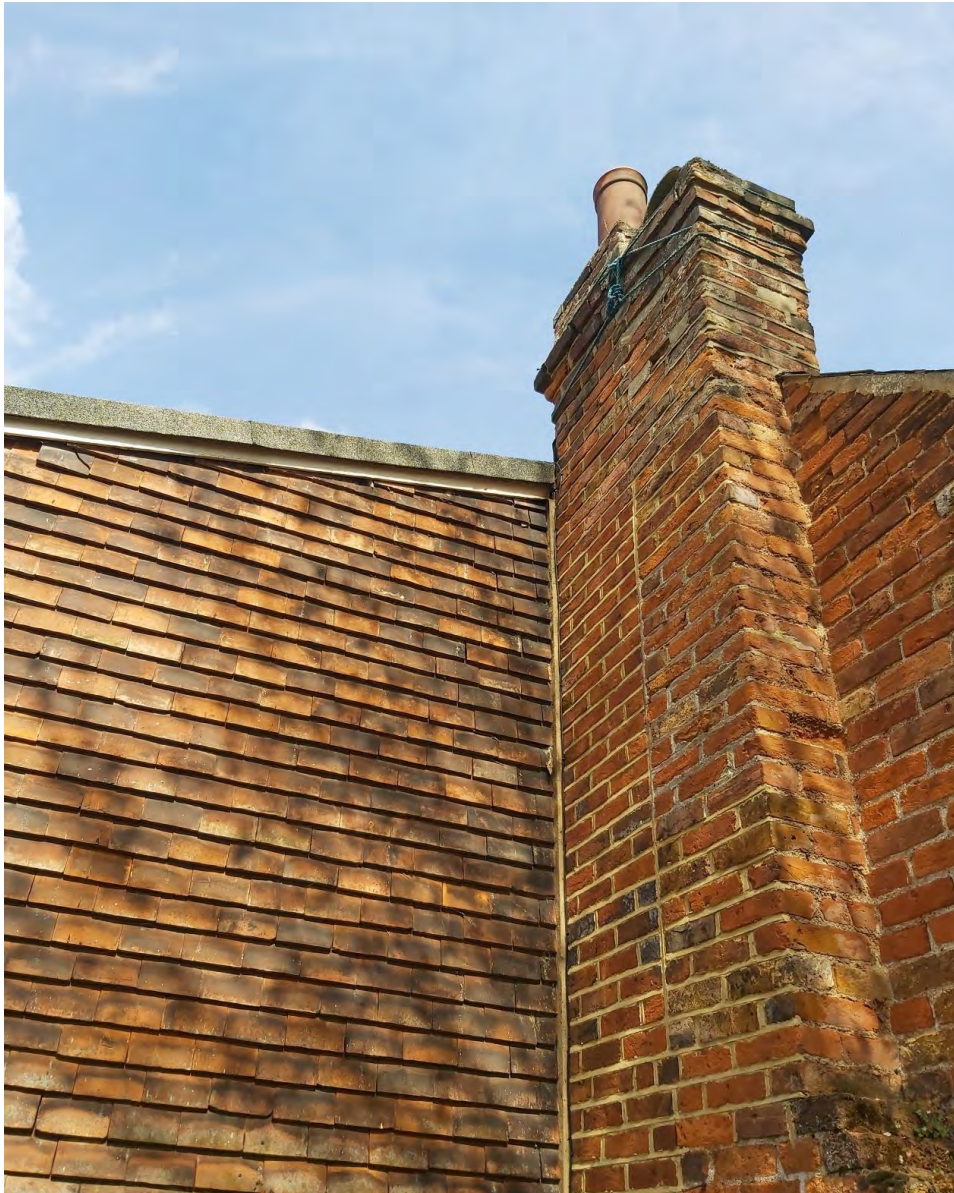
- 7) The Gardeners Cottage Chimney stack CXCH01 has spalled and

cracked bricks, and is in close proximity to an active wasps nest. The ridge of roof CRFX02 has washed out mortar which needs to be temporarily re bedded.

7) Chimney stack CXCH01 to Gardeners cottage  
Spalled bricks and cracking. There is an active honey bee nest in the roof CRFX01. The bees will need to be removed by specialists prior to repairs being carried  
Photograph taken 04/05/2023 by CP

7.00 One of the chimneys to the Gardener's Cottage is in a bad way and needs to be taken down to eaves level and rebuilt with lime mortar. One of the issues complicating the repair work is the presence of wasps that are living in the roof adjacent to it. The ridge of roof CRFX02 needs to be re-bedded as a temporary measure.

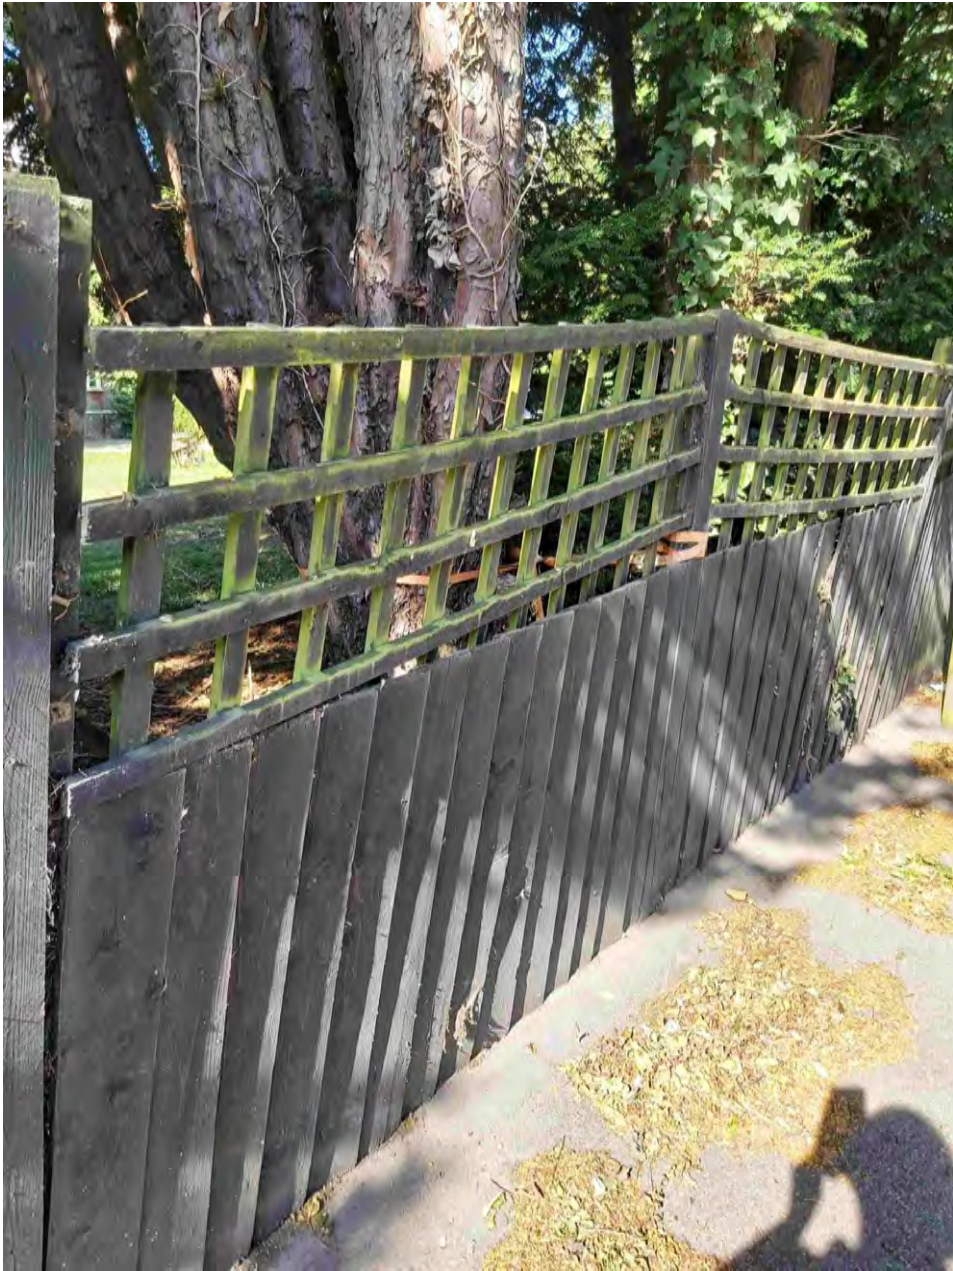
9.01 The fence is fixed in part to the boundary wall. The fence is unstable and is affecting the stability of the boundary wall. It needs to be replaced with a new self-supporting fence.

9) Front boundary fence facing Gravesend Road between driveway gates. Close boarded timber fence with open trellis above. The fence posts are rotting.  
The fence has been fixed down to the top of a low brick wall that straddles the tunnel below.  
Photograph taken 16/08/2023 by CP

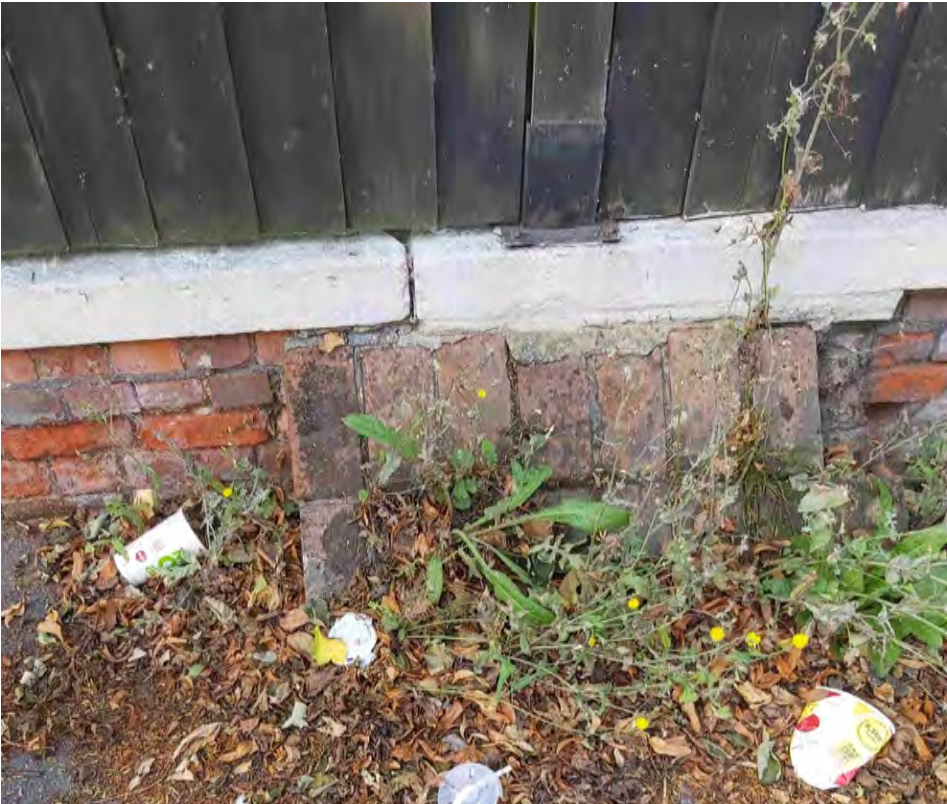
9) Low brick wall straddling the tunnel opening with buttress. Metal post shoe has been fixed to coping.  
Photograph taken 16/08/2023 by CP
