# **LISTED BUILDING APPLICATION FOR EMERGENCY REPAIRS:**

**Proposed repairs at Gad's Hill School, Gravesend Road, Higham, Rochester, Kent  
ME3 7PA**

**clay** architecture

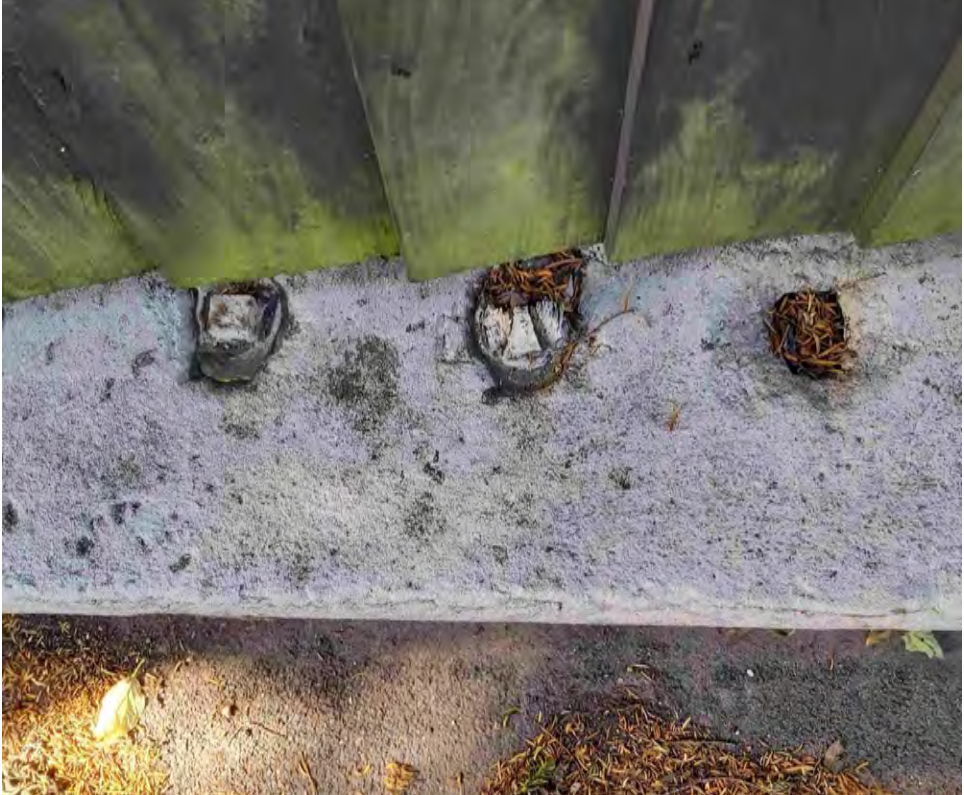
9) Base of railings sawn off railings in coping to low wall below timber fence.  
Photograph taken 16/08/2023 by CP
