Project  
Gad's Hill School

Proposal for repairs to roof and ceiling

Title  
Gad's Hill Place ( H )

Existing Roof Plan

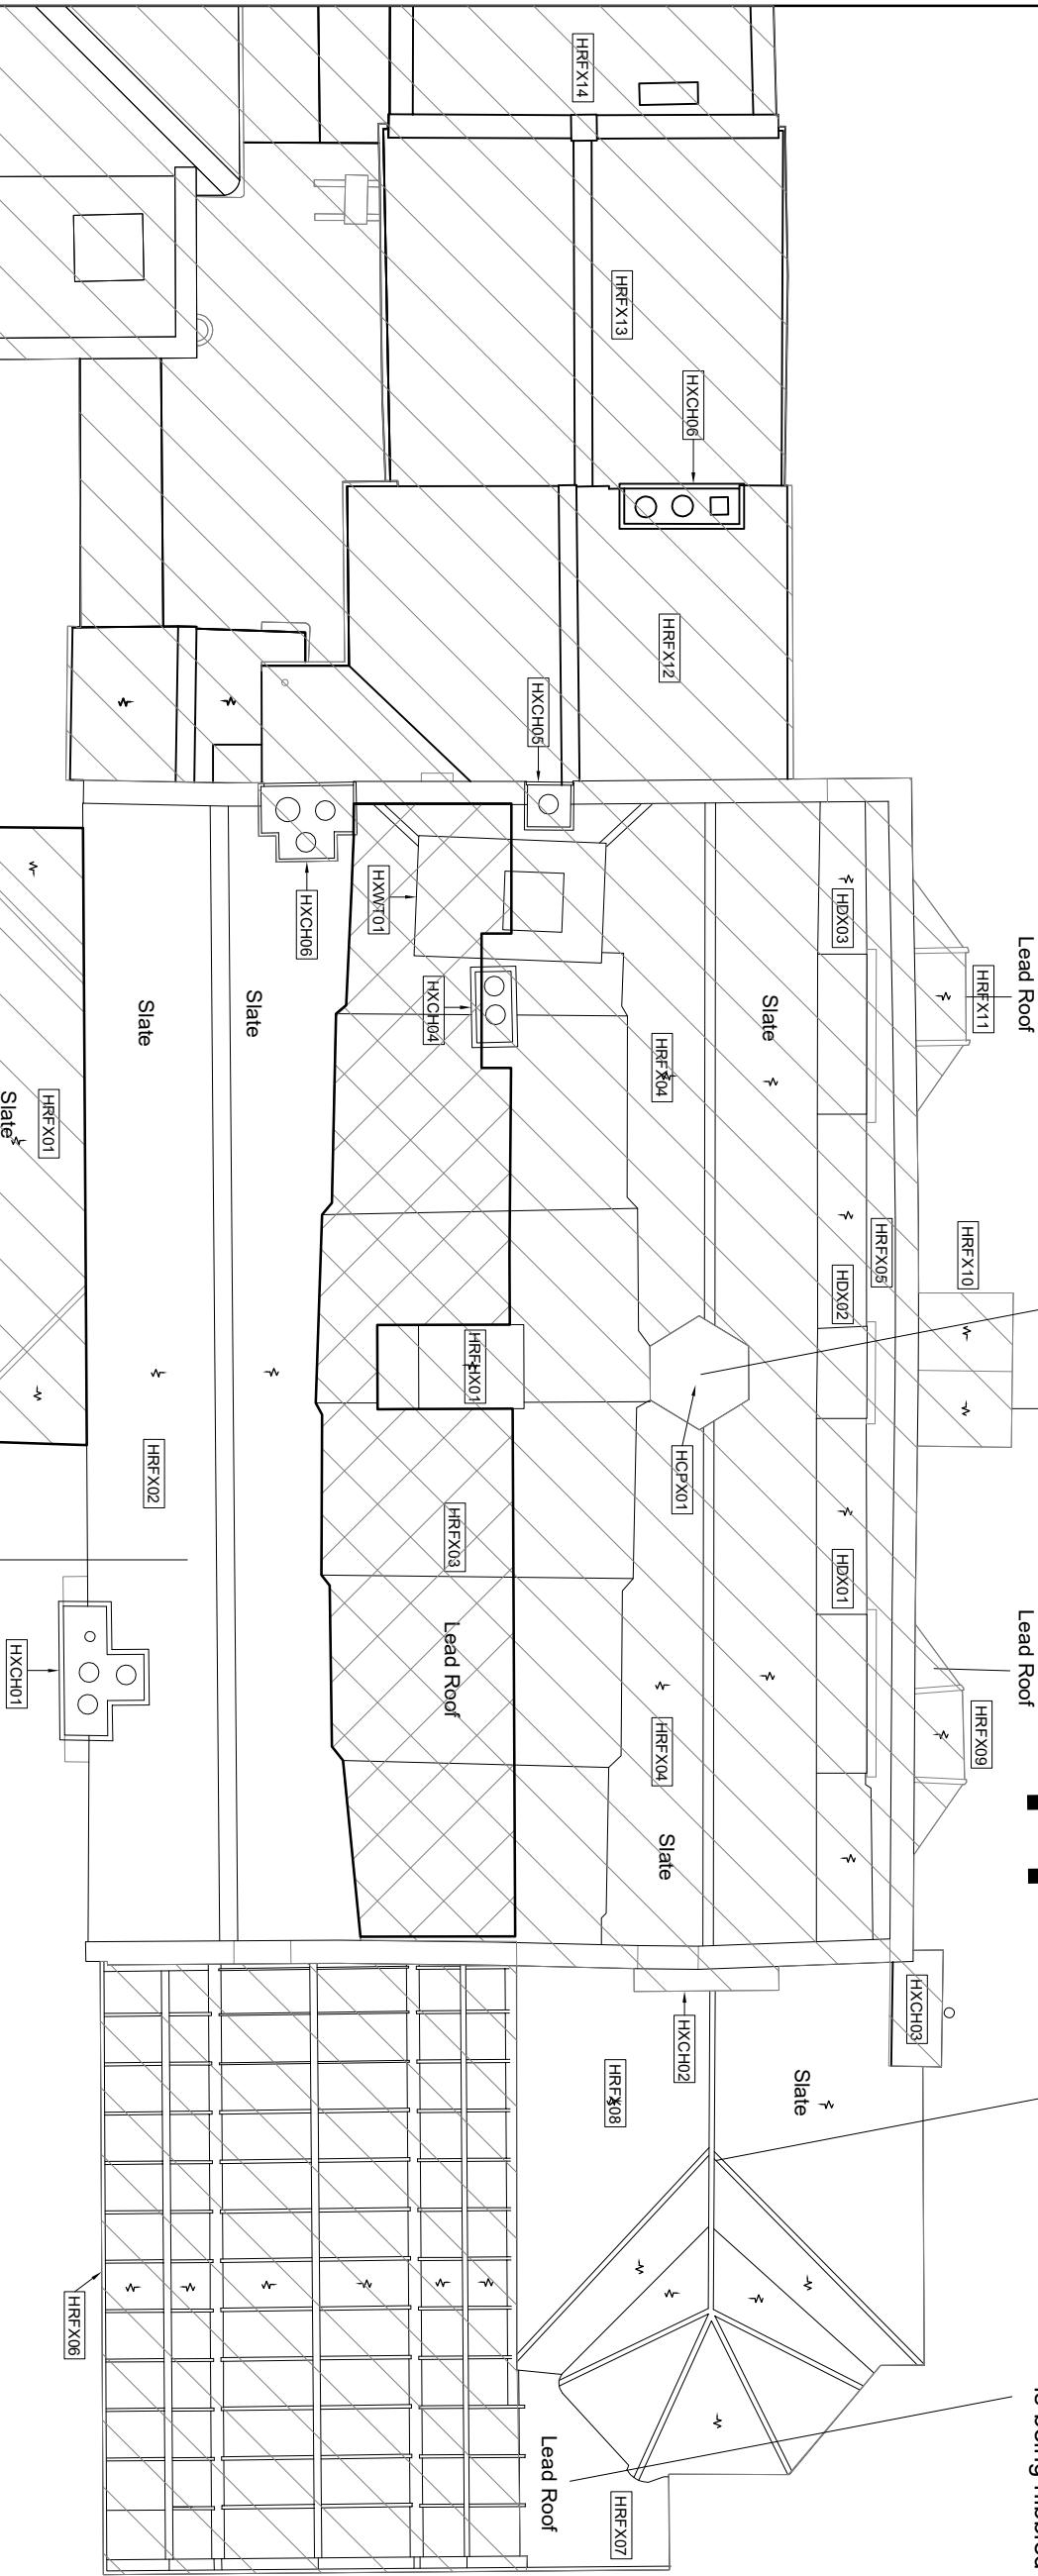
GAD'S HILL PLACE (H) EXISTING ROOF PLAN

Cupola HCFX01 is failing

Roof HRFX08 is failing. Lead flashing has been nibbled by squirrels and in some areas damaged by overhanging branches. Water is getting in and damaging the ceiling below.

Lead work to roof HRFX07 is being nibbled by squirrels

Roof HRFX02 is failing
