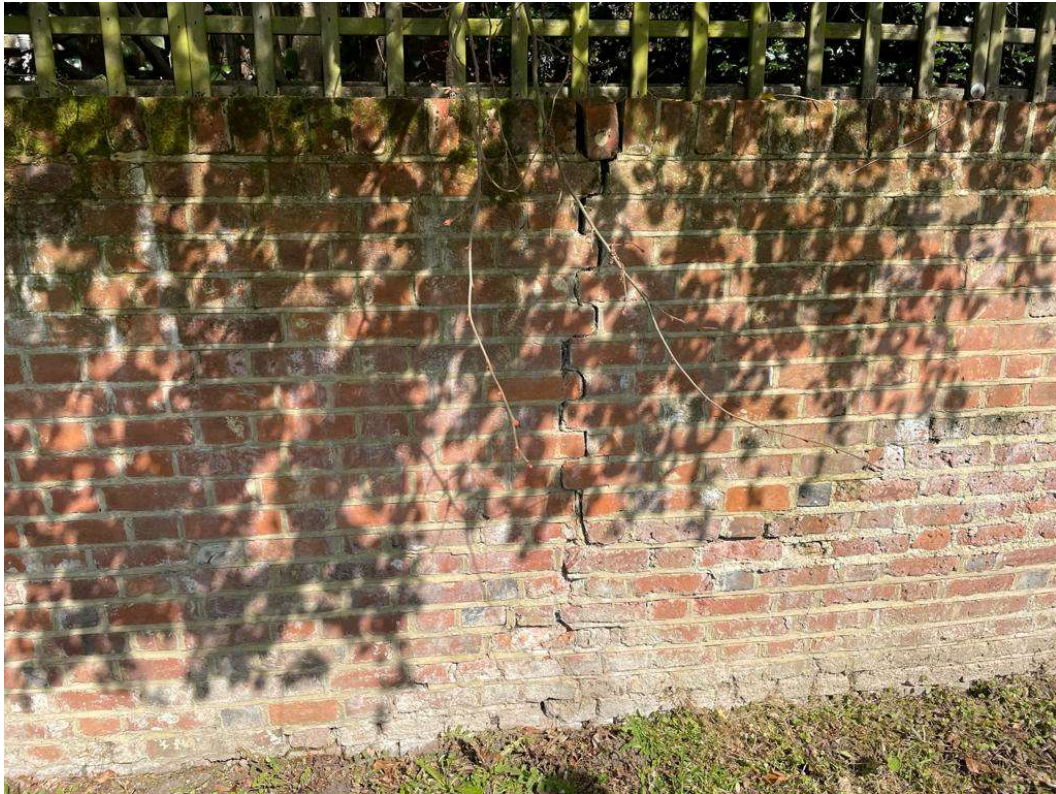
View on tapering vertical crack in retaining wall

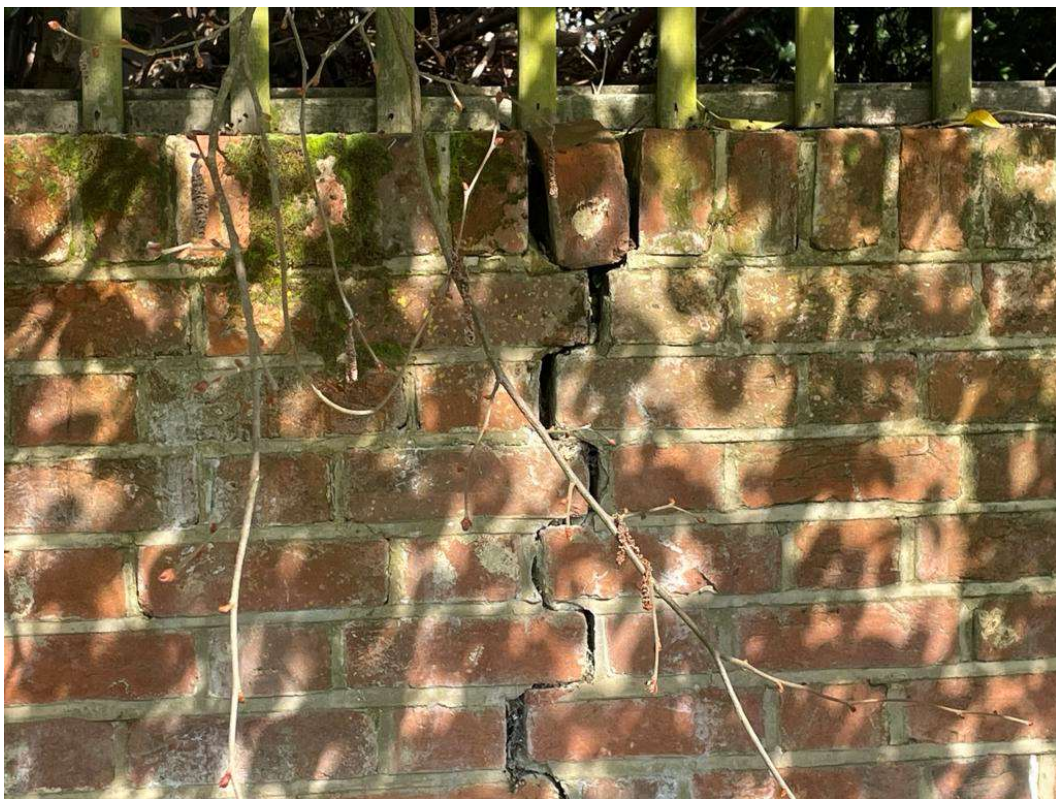
Close-up view on crack

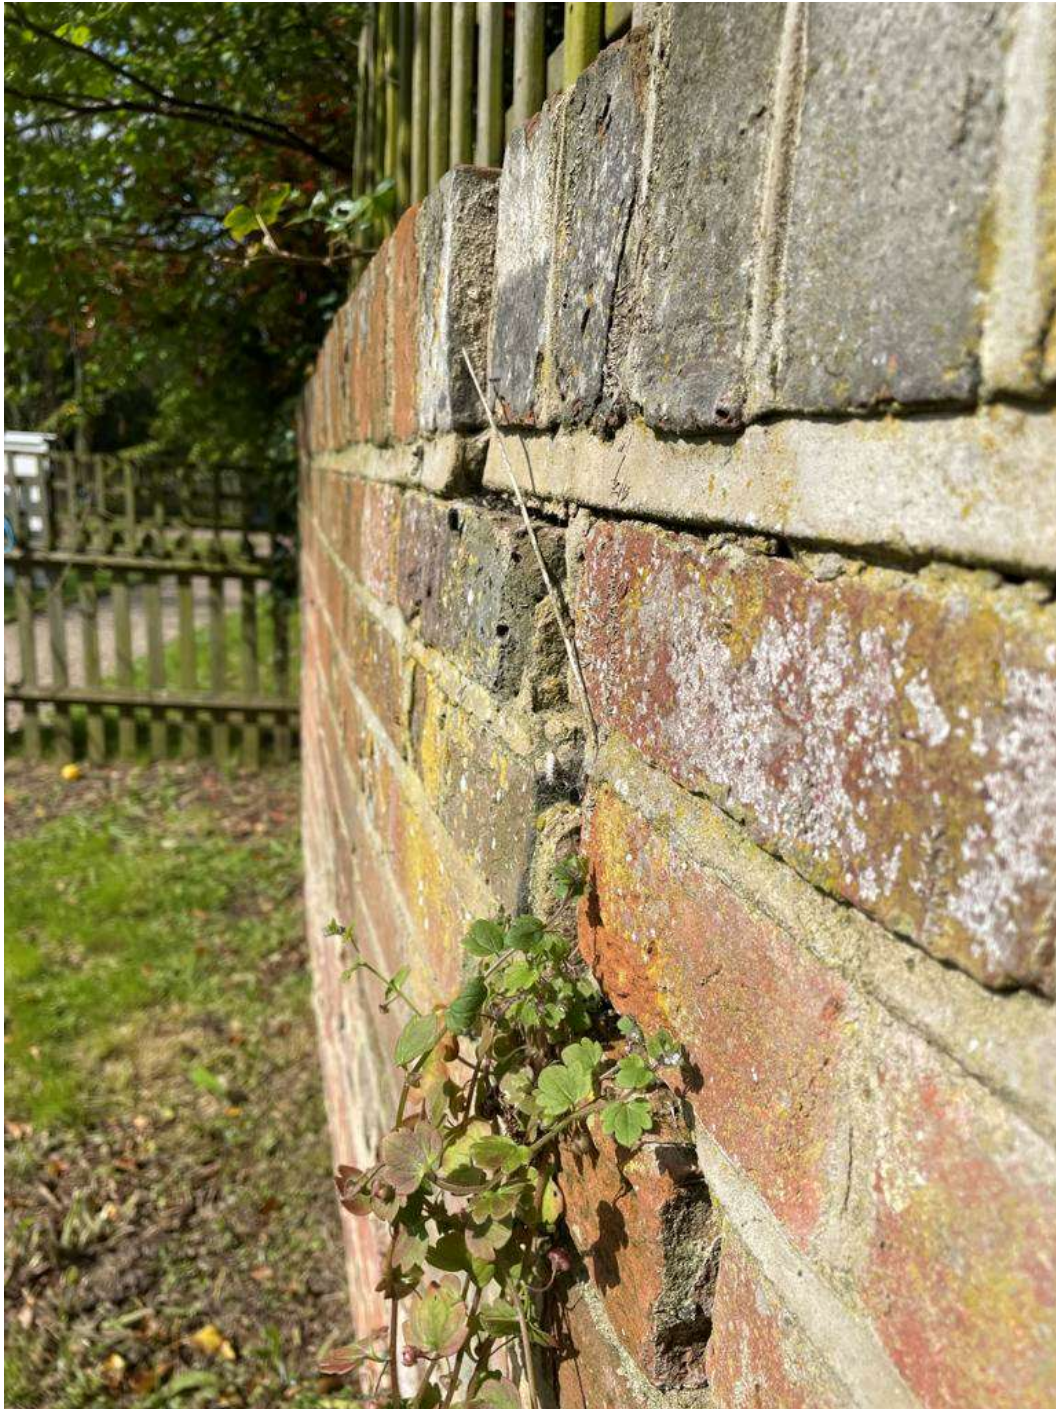
Angled view on wall showing lateral movement at vertical crack

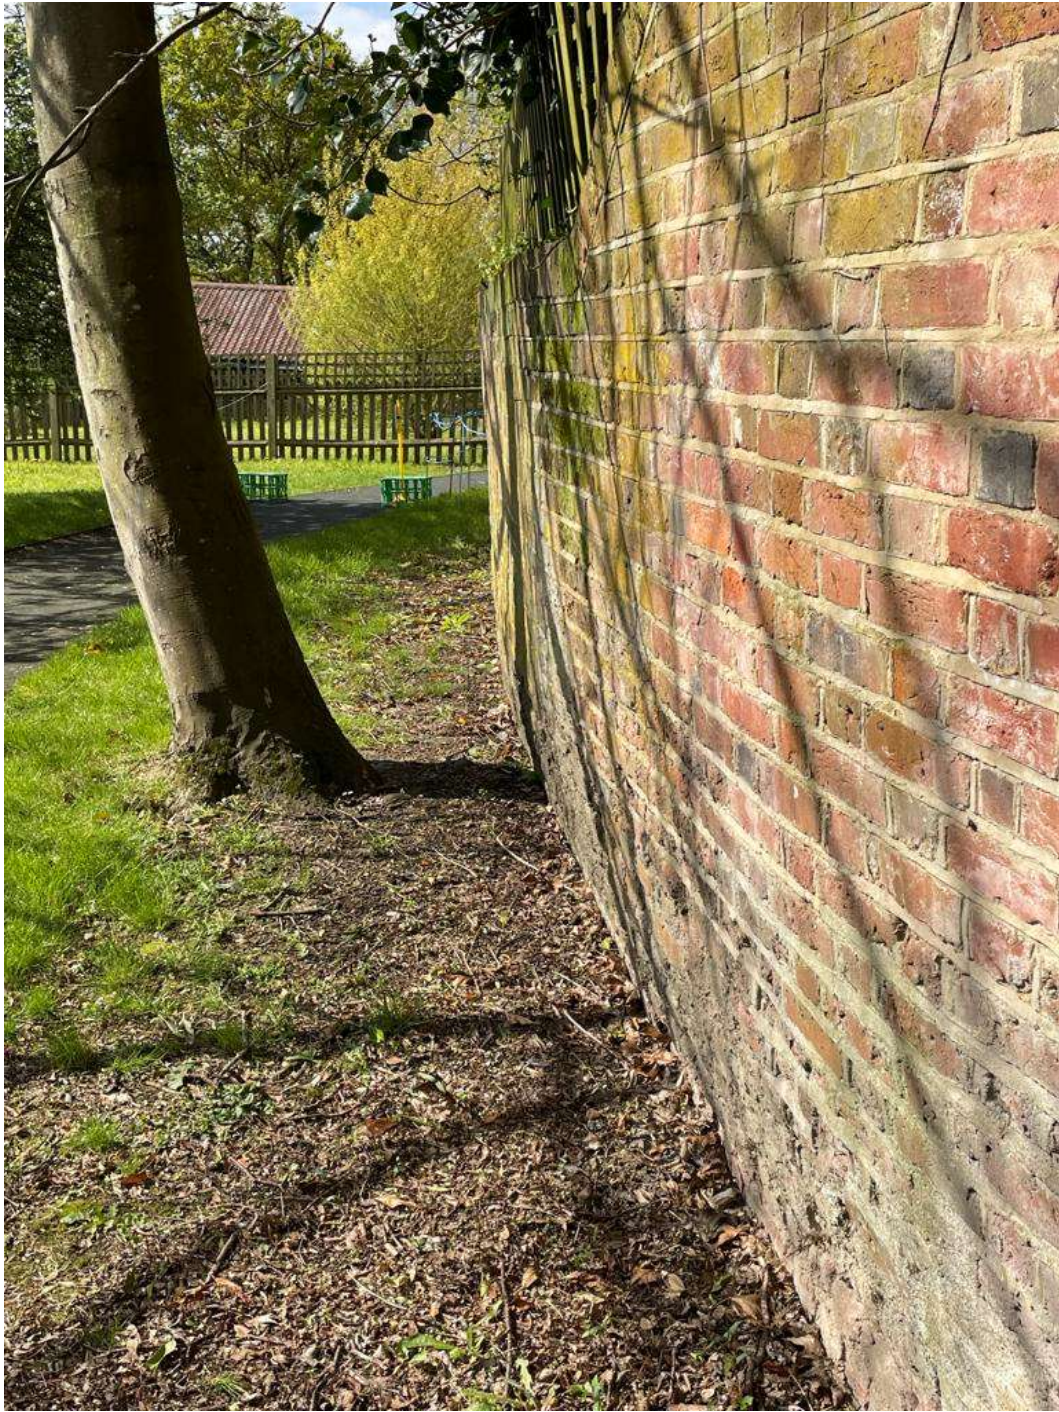
View on wall looking to south showing outward lean to wall

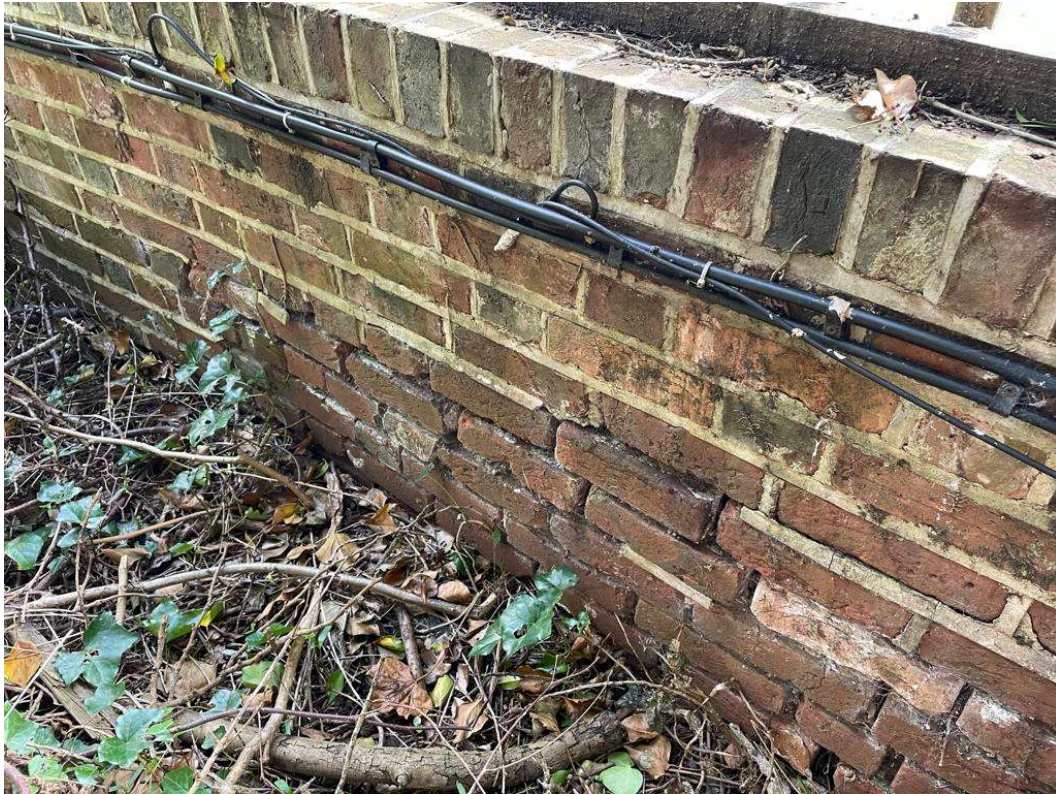
View on mortar loss to rear face of wall near to vertical crack

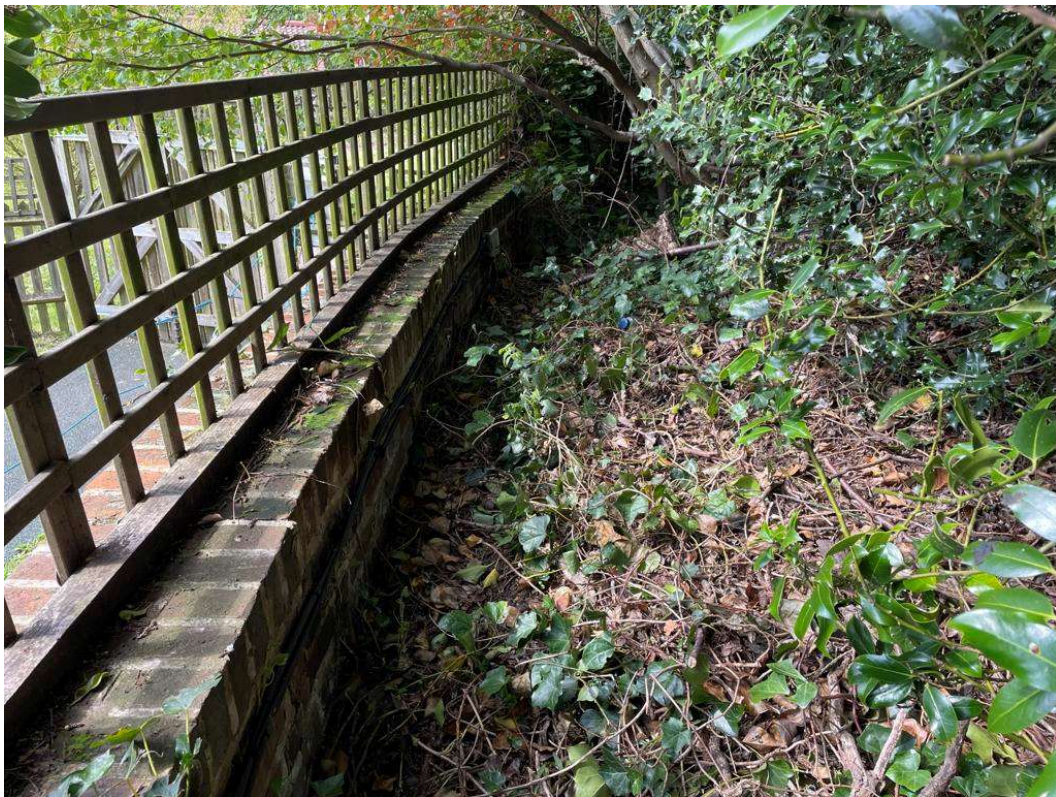
View along top of wall showing proximity of trees and undergrowth
