| EXISTING PHOTOS GROUND FLOOR - PART 1 | | |
| Conversion of Existing Residential Areas to HMO<br>38 Windmill Street<br>Gravesend Kent DA12 1BA<br>for: Mr M Celli | | |
| 1124.WD.104 | | |

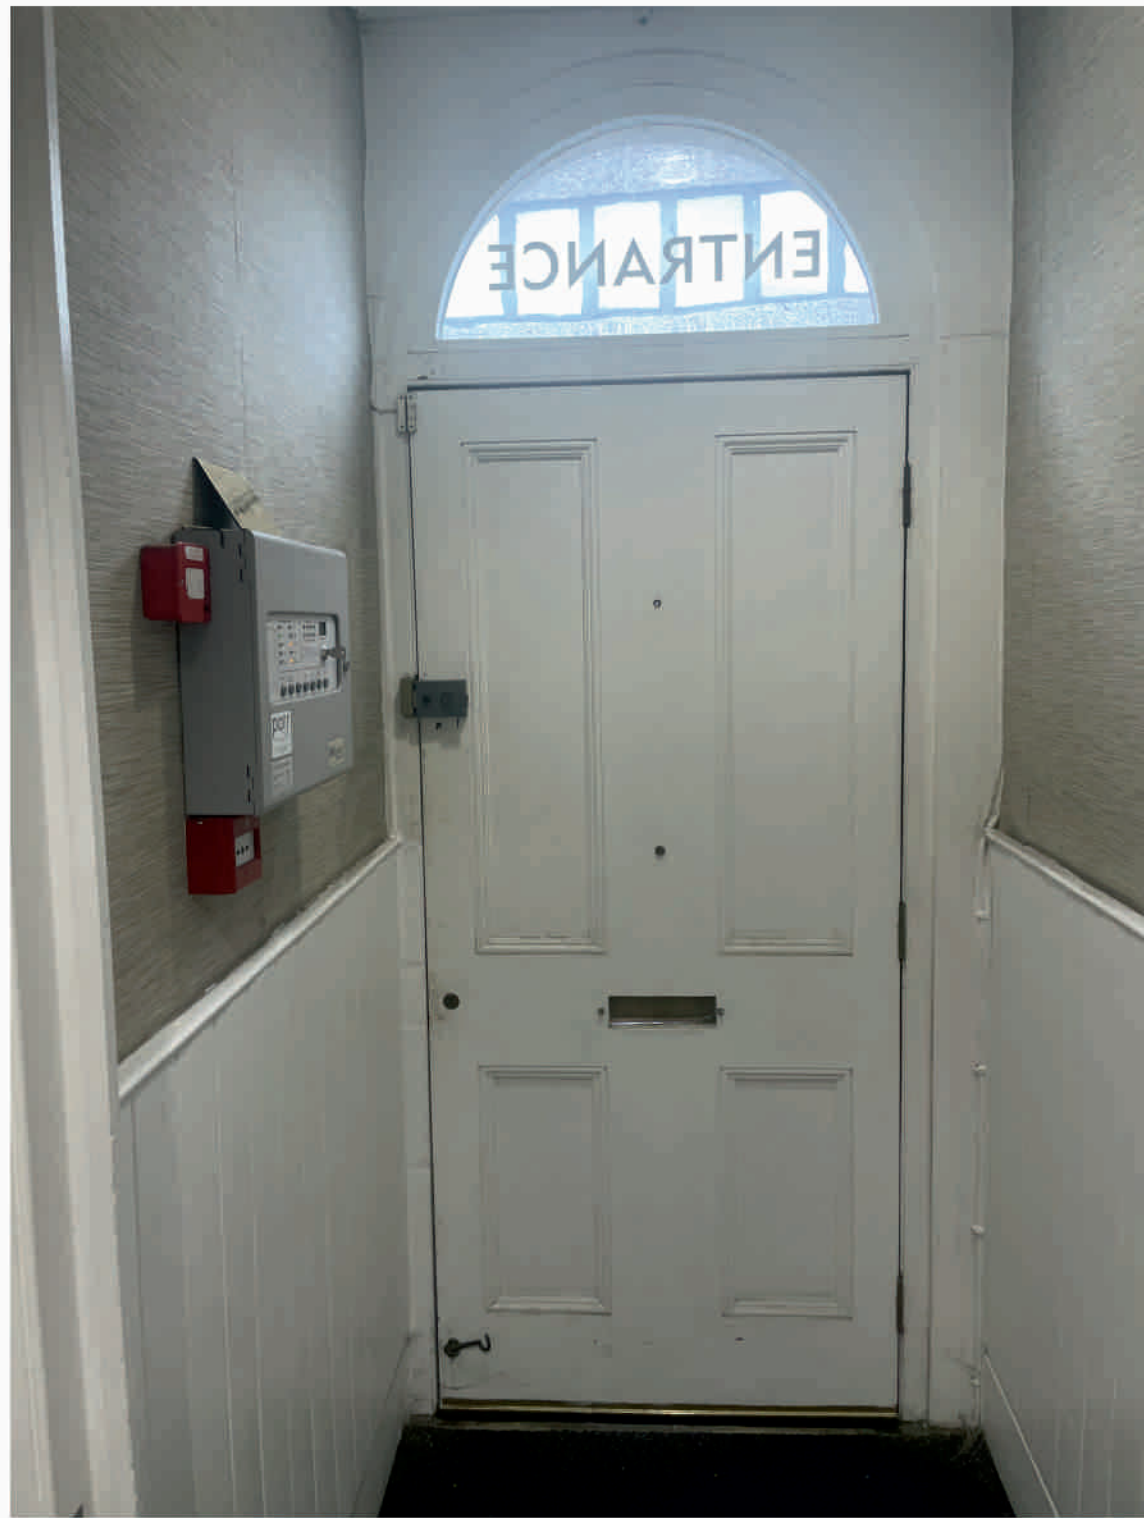
PORCH LOBBY 4 - Looking toward original entrance door curved fanlight and wainscotting all to remain. Note fire alarm control panel

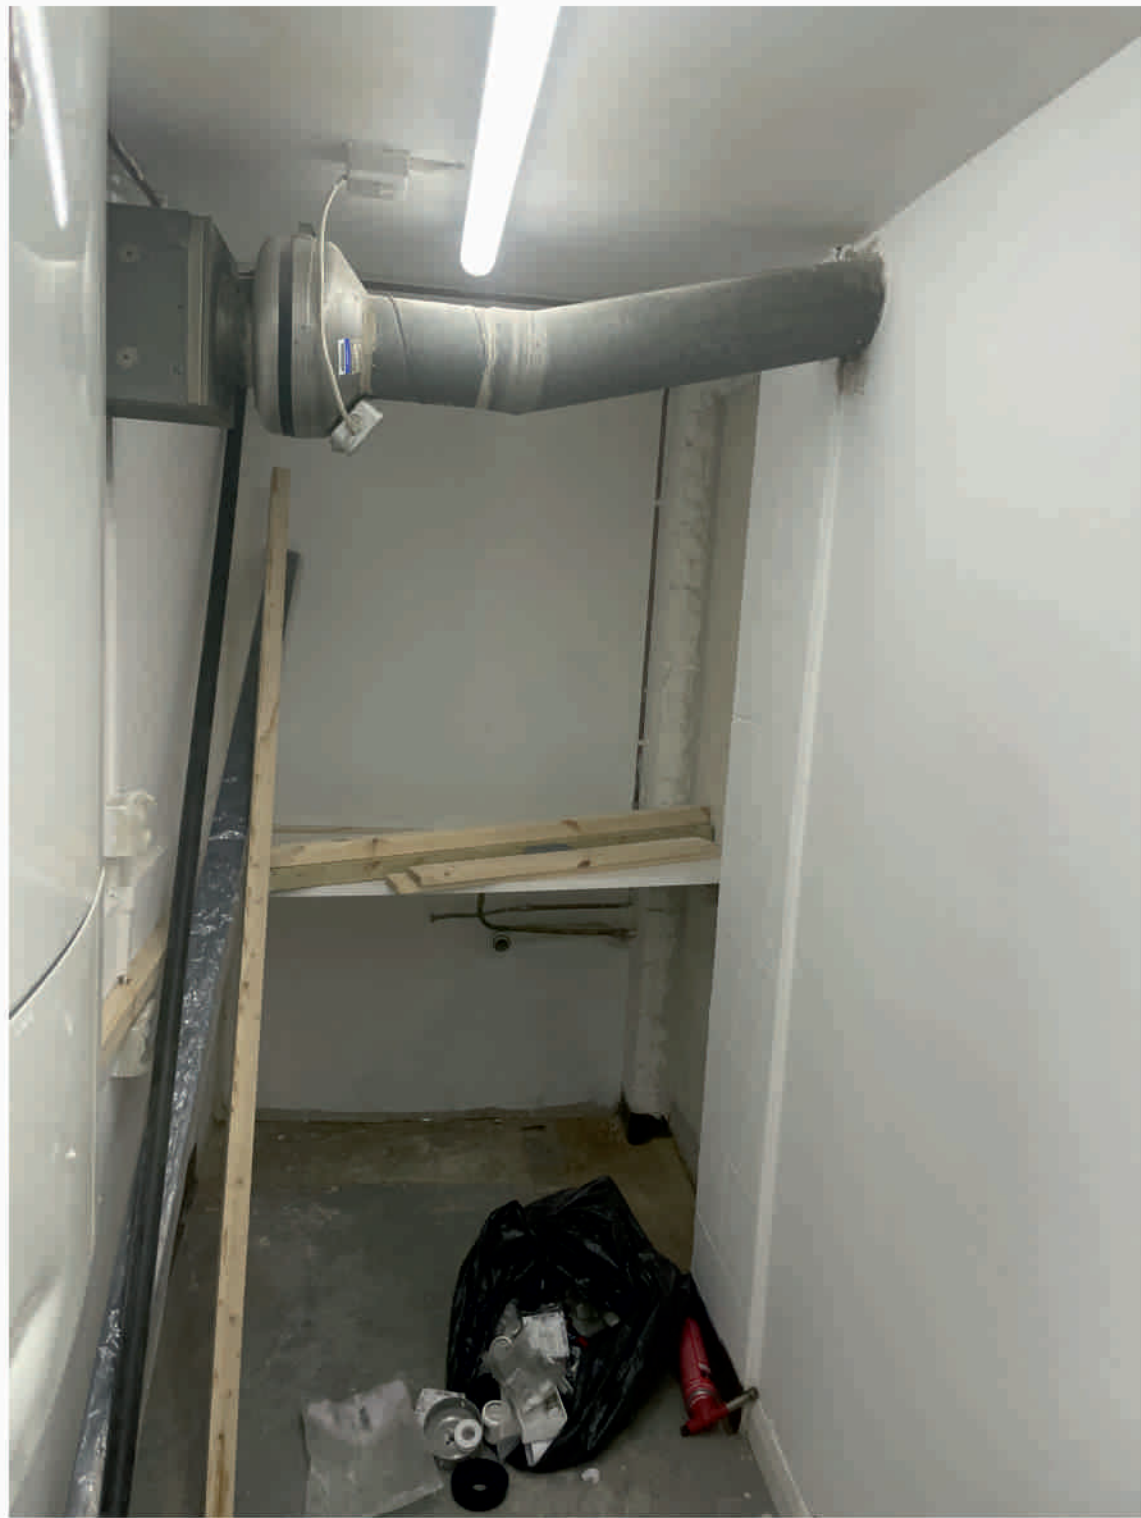
ROOM 7 - Store no original features

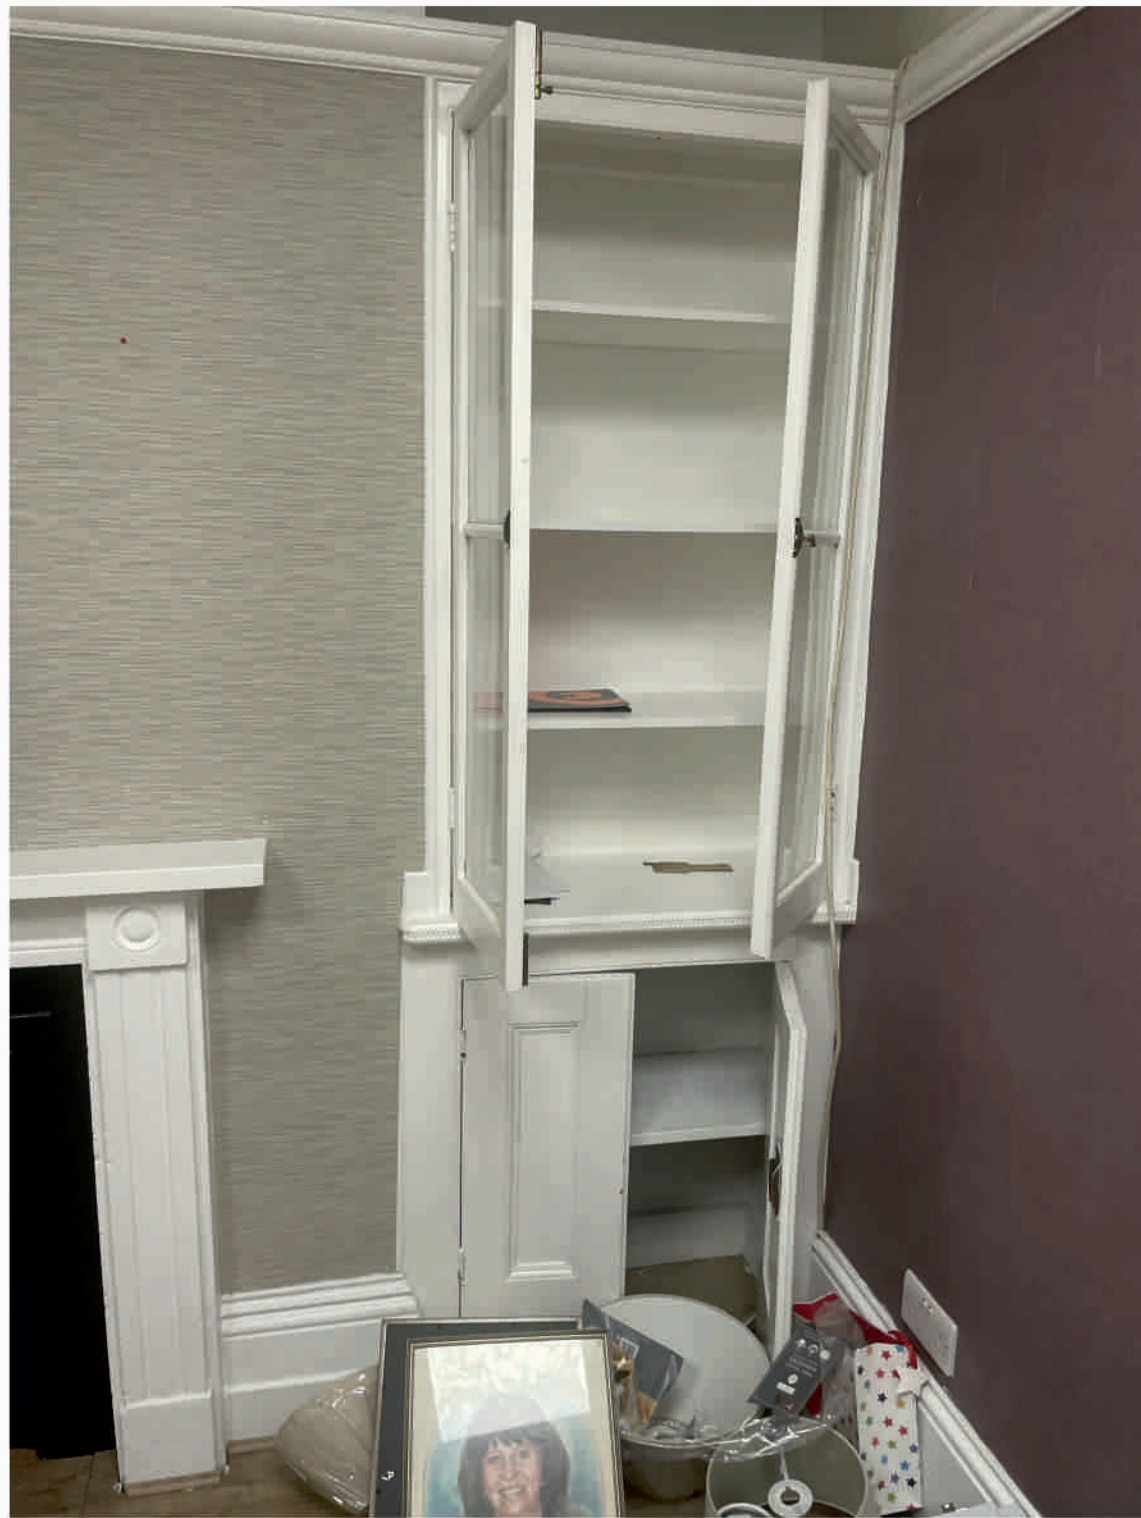
ROOM 6 - Right hand original built in cupboard and display cabinet with original picture rail and skirting

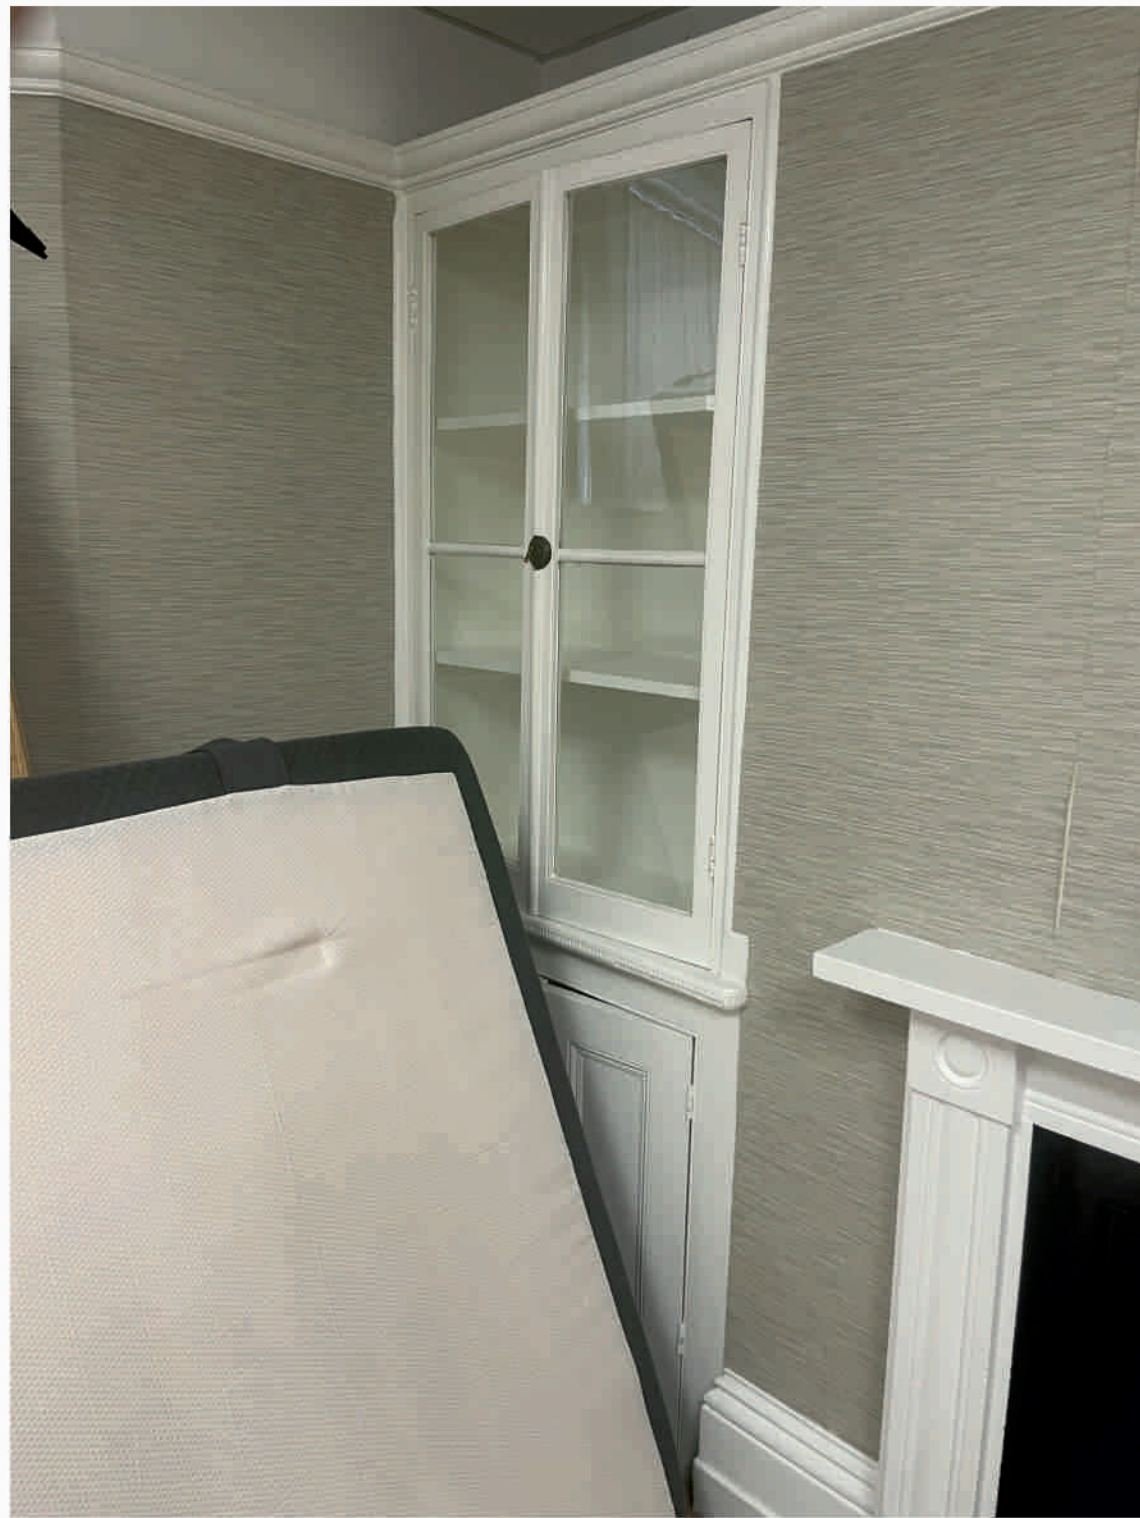
ROOM 6 - Left hand original built in cupboard and display cabinet with original picture rail and skirting

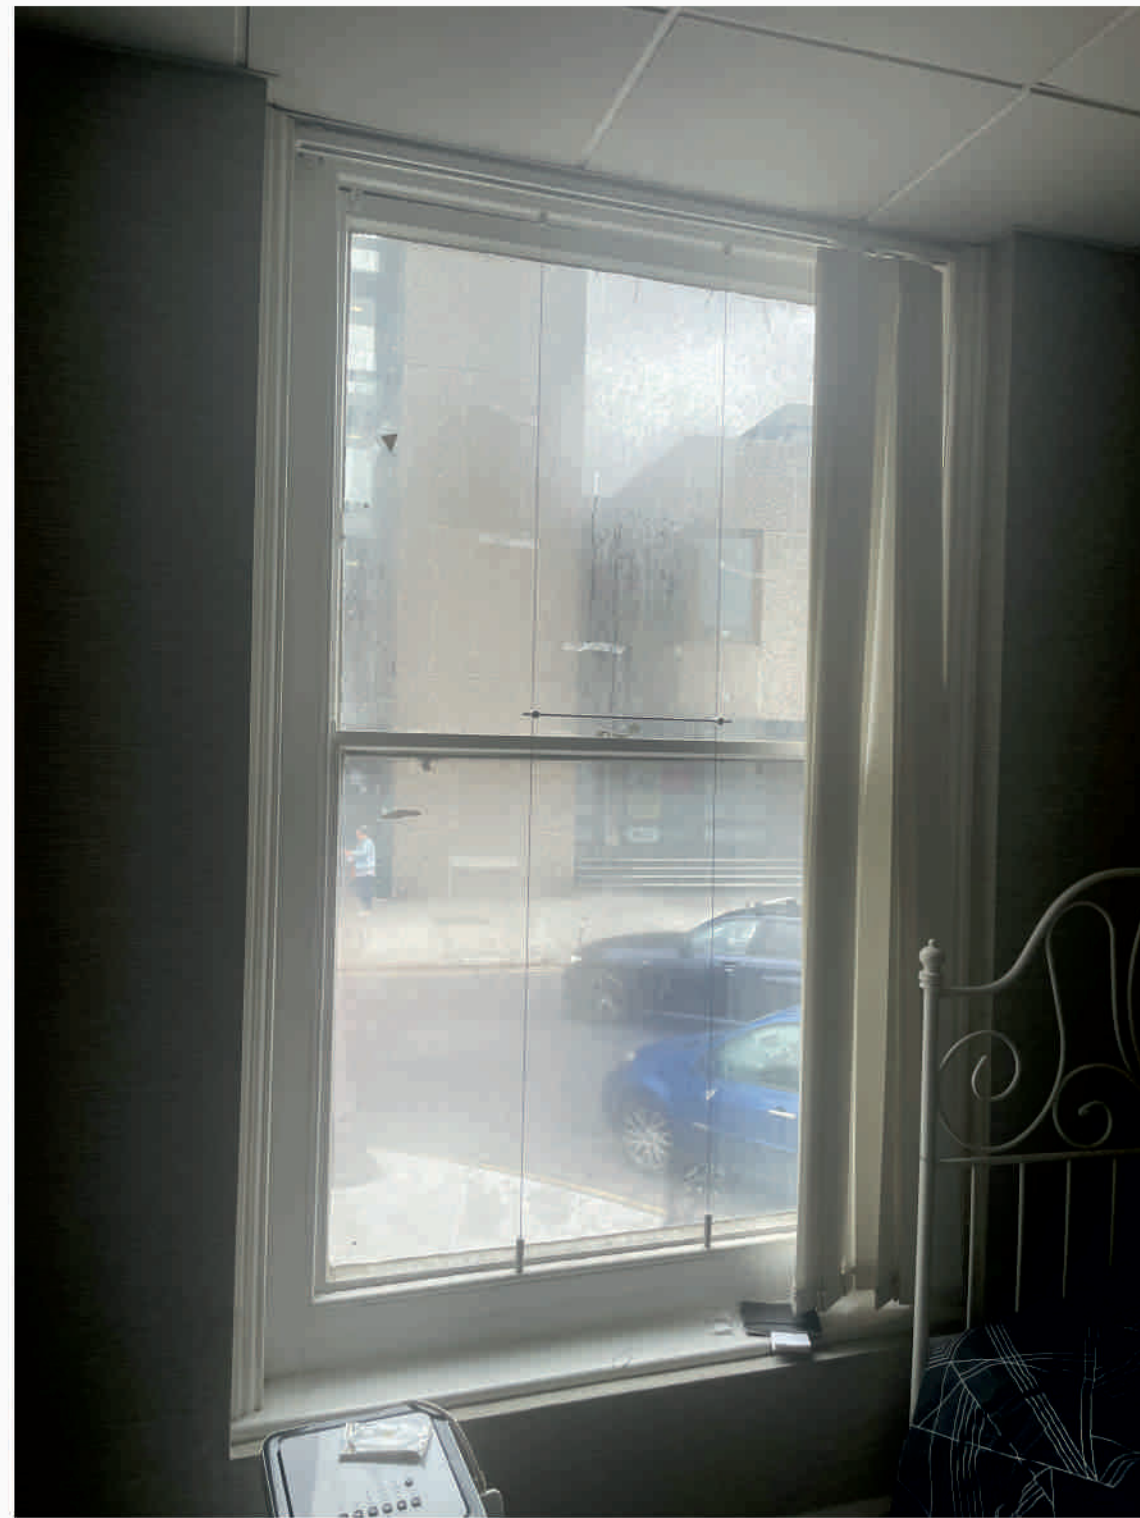
ROOM 2 - Original sash window in good order to be made good. Note there are no window bars and no sign that original bars have been removed, also front wall built out with internal stud work (find out why?).

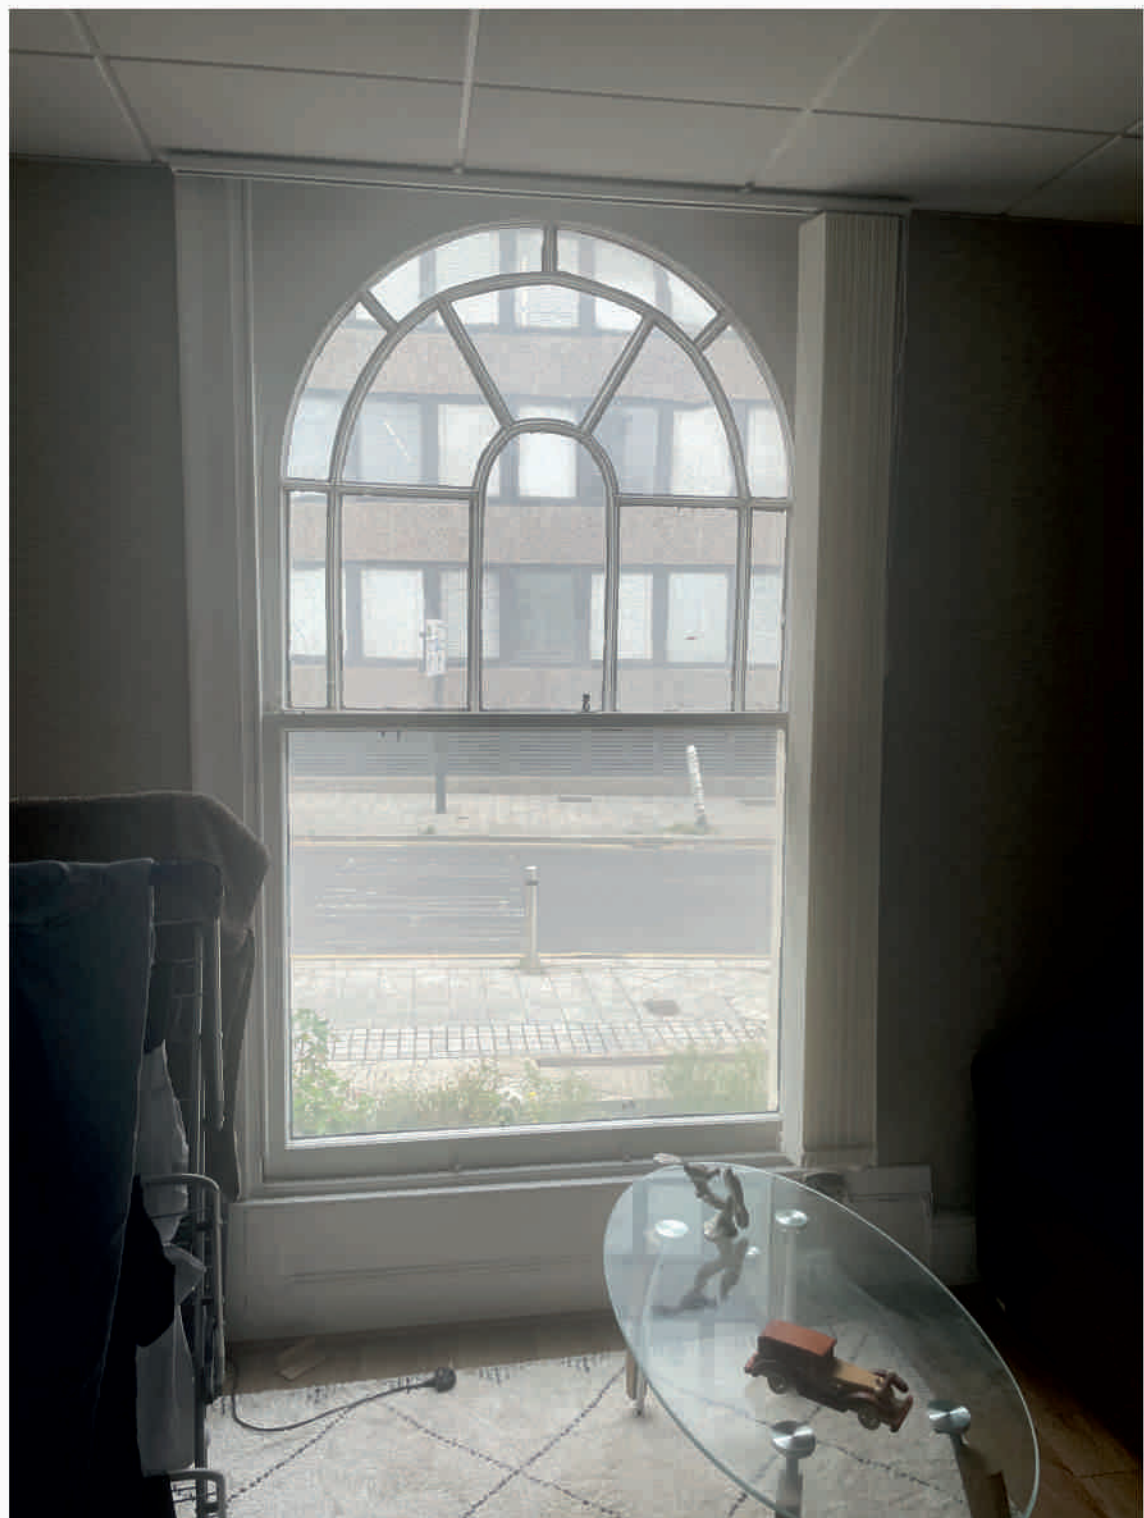
ROOM 1 - Original curved top sash window in good order to be made good. Note there are no window bars in the lower sash. Note suspended ceiling to room 1. Intention is to re bar the lower pane to match existing above and install secondary glazing (including room 2).

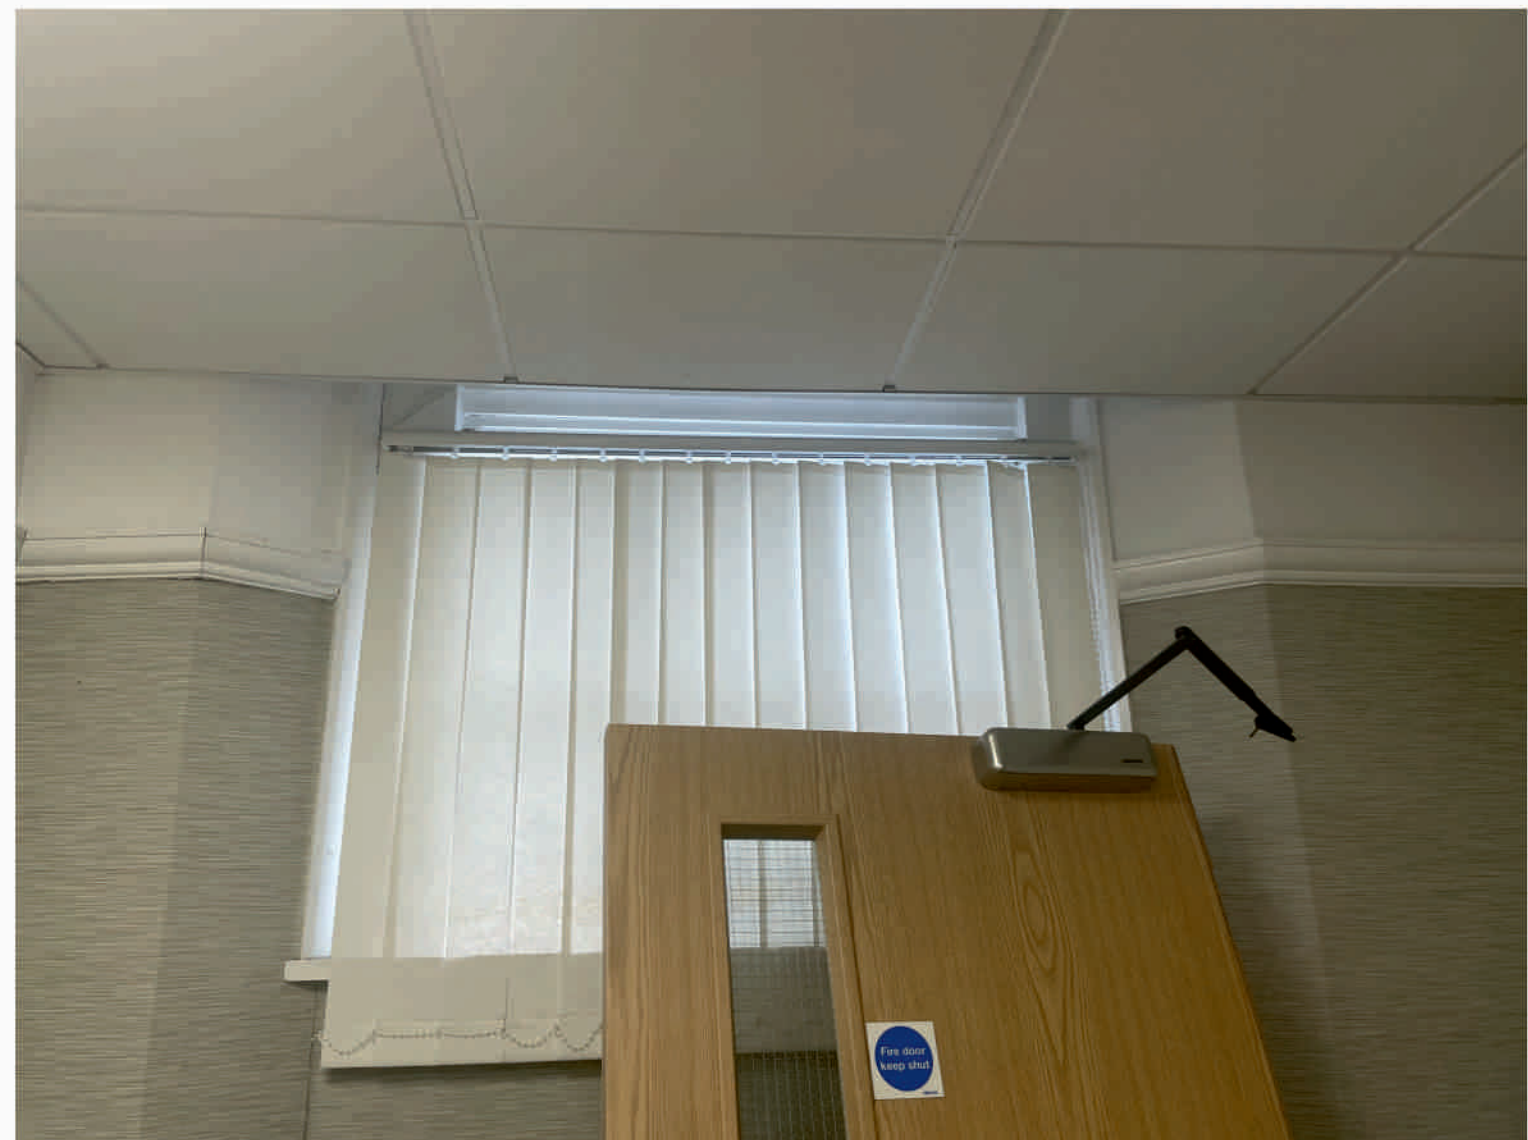
ROOM 6 - Original top hung plain window at high level over roof of lower ground floor level. original picture rail to remain. Not suspended ceiling. Checked void which is used for services cornice damaged.

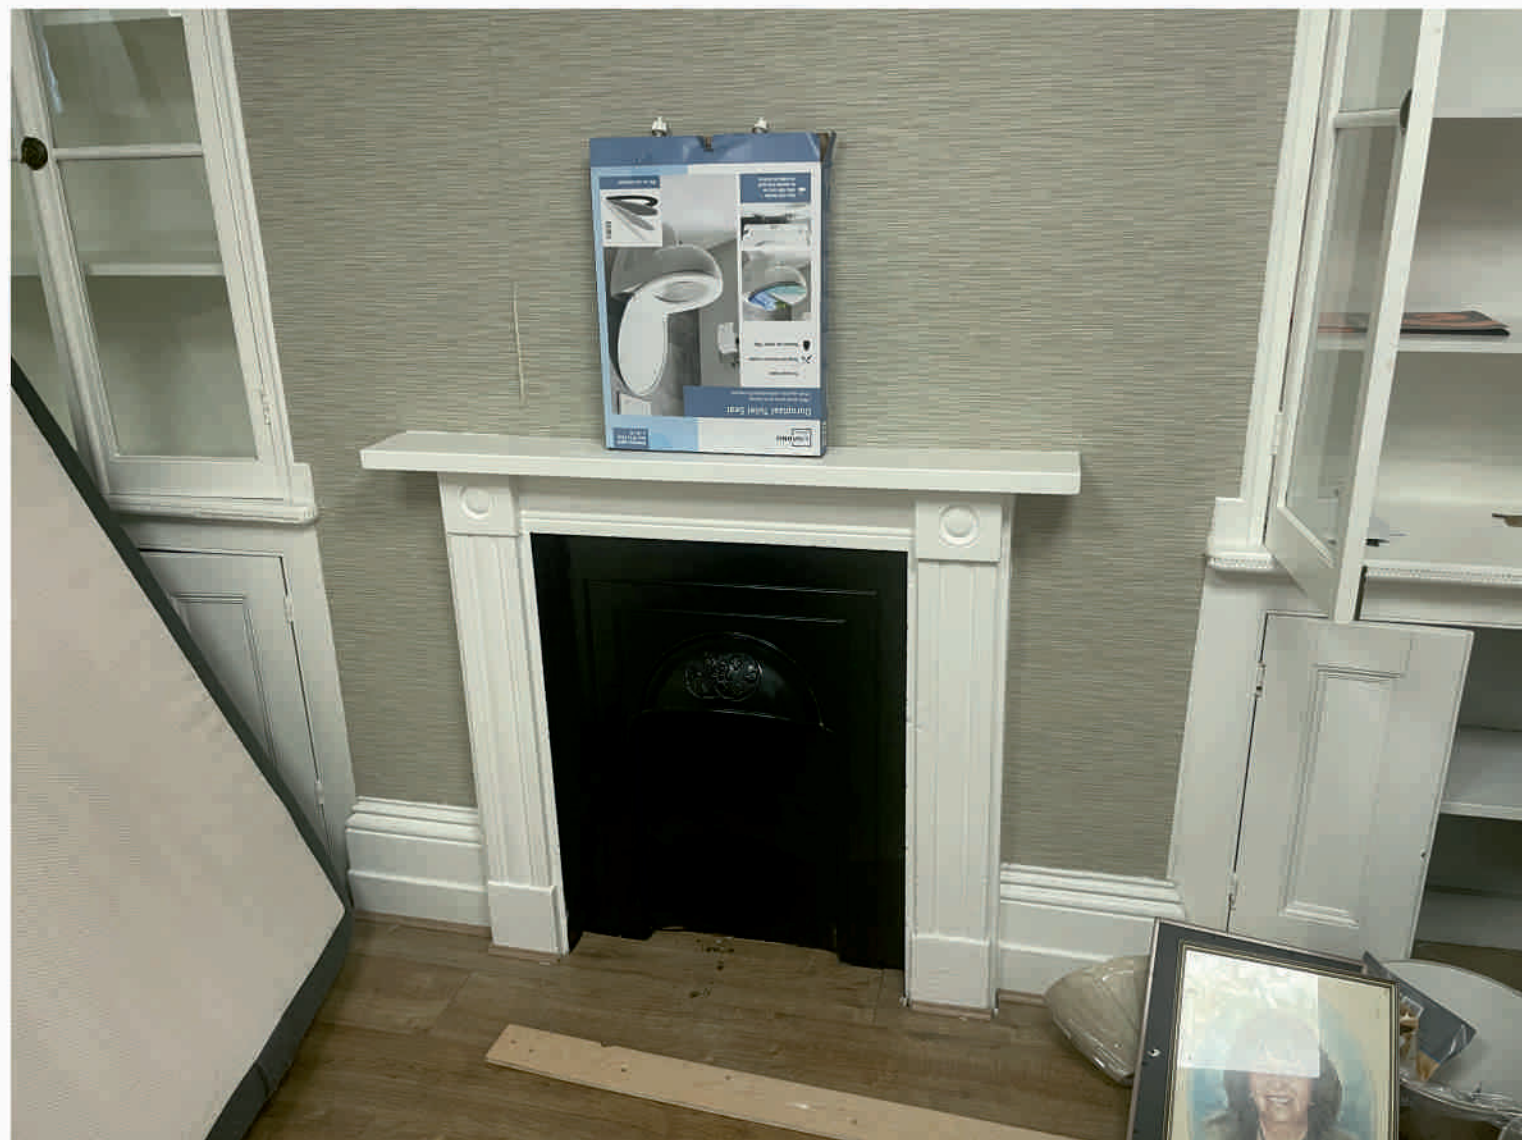
ROOM 6 - Central original fire place and surround to remain intact with original skirting

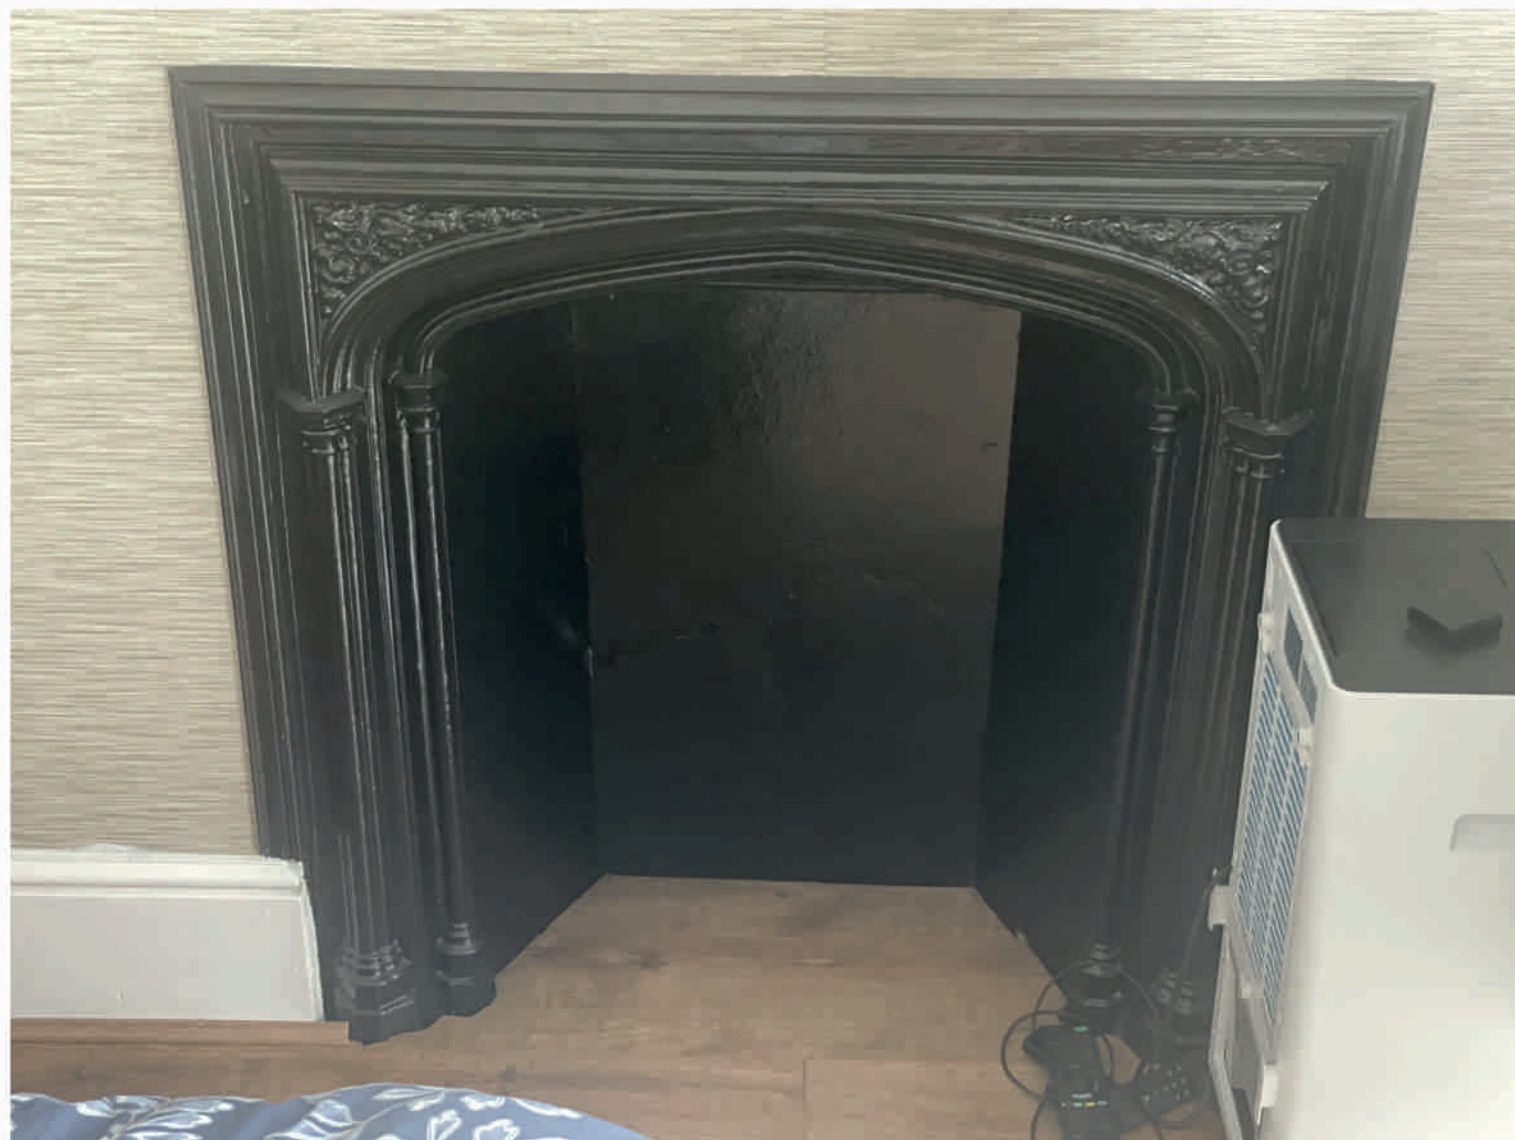
ROOM 1 - Central original fire place and surround to remain intact with replace skirting.
