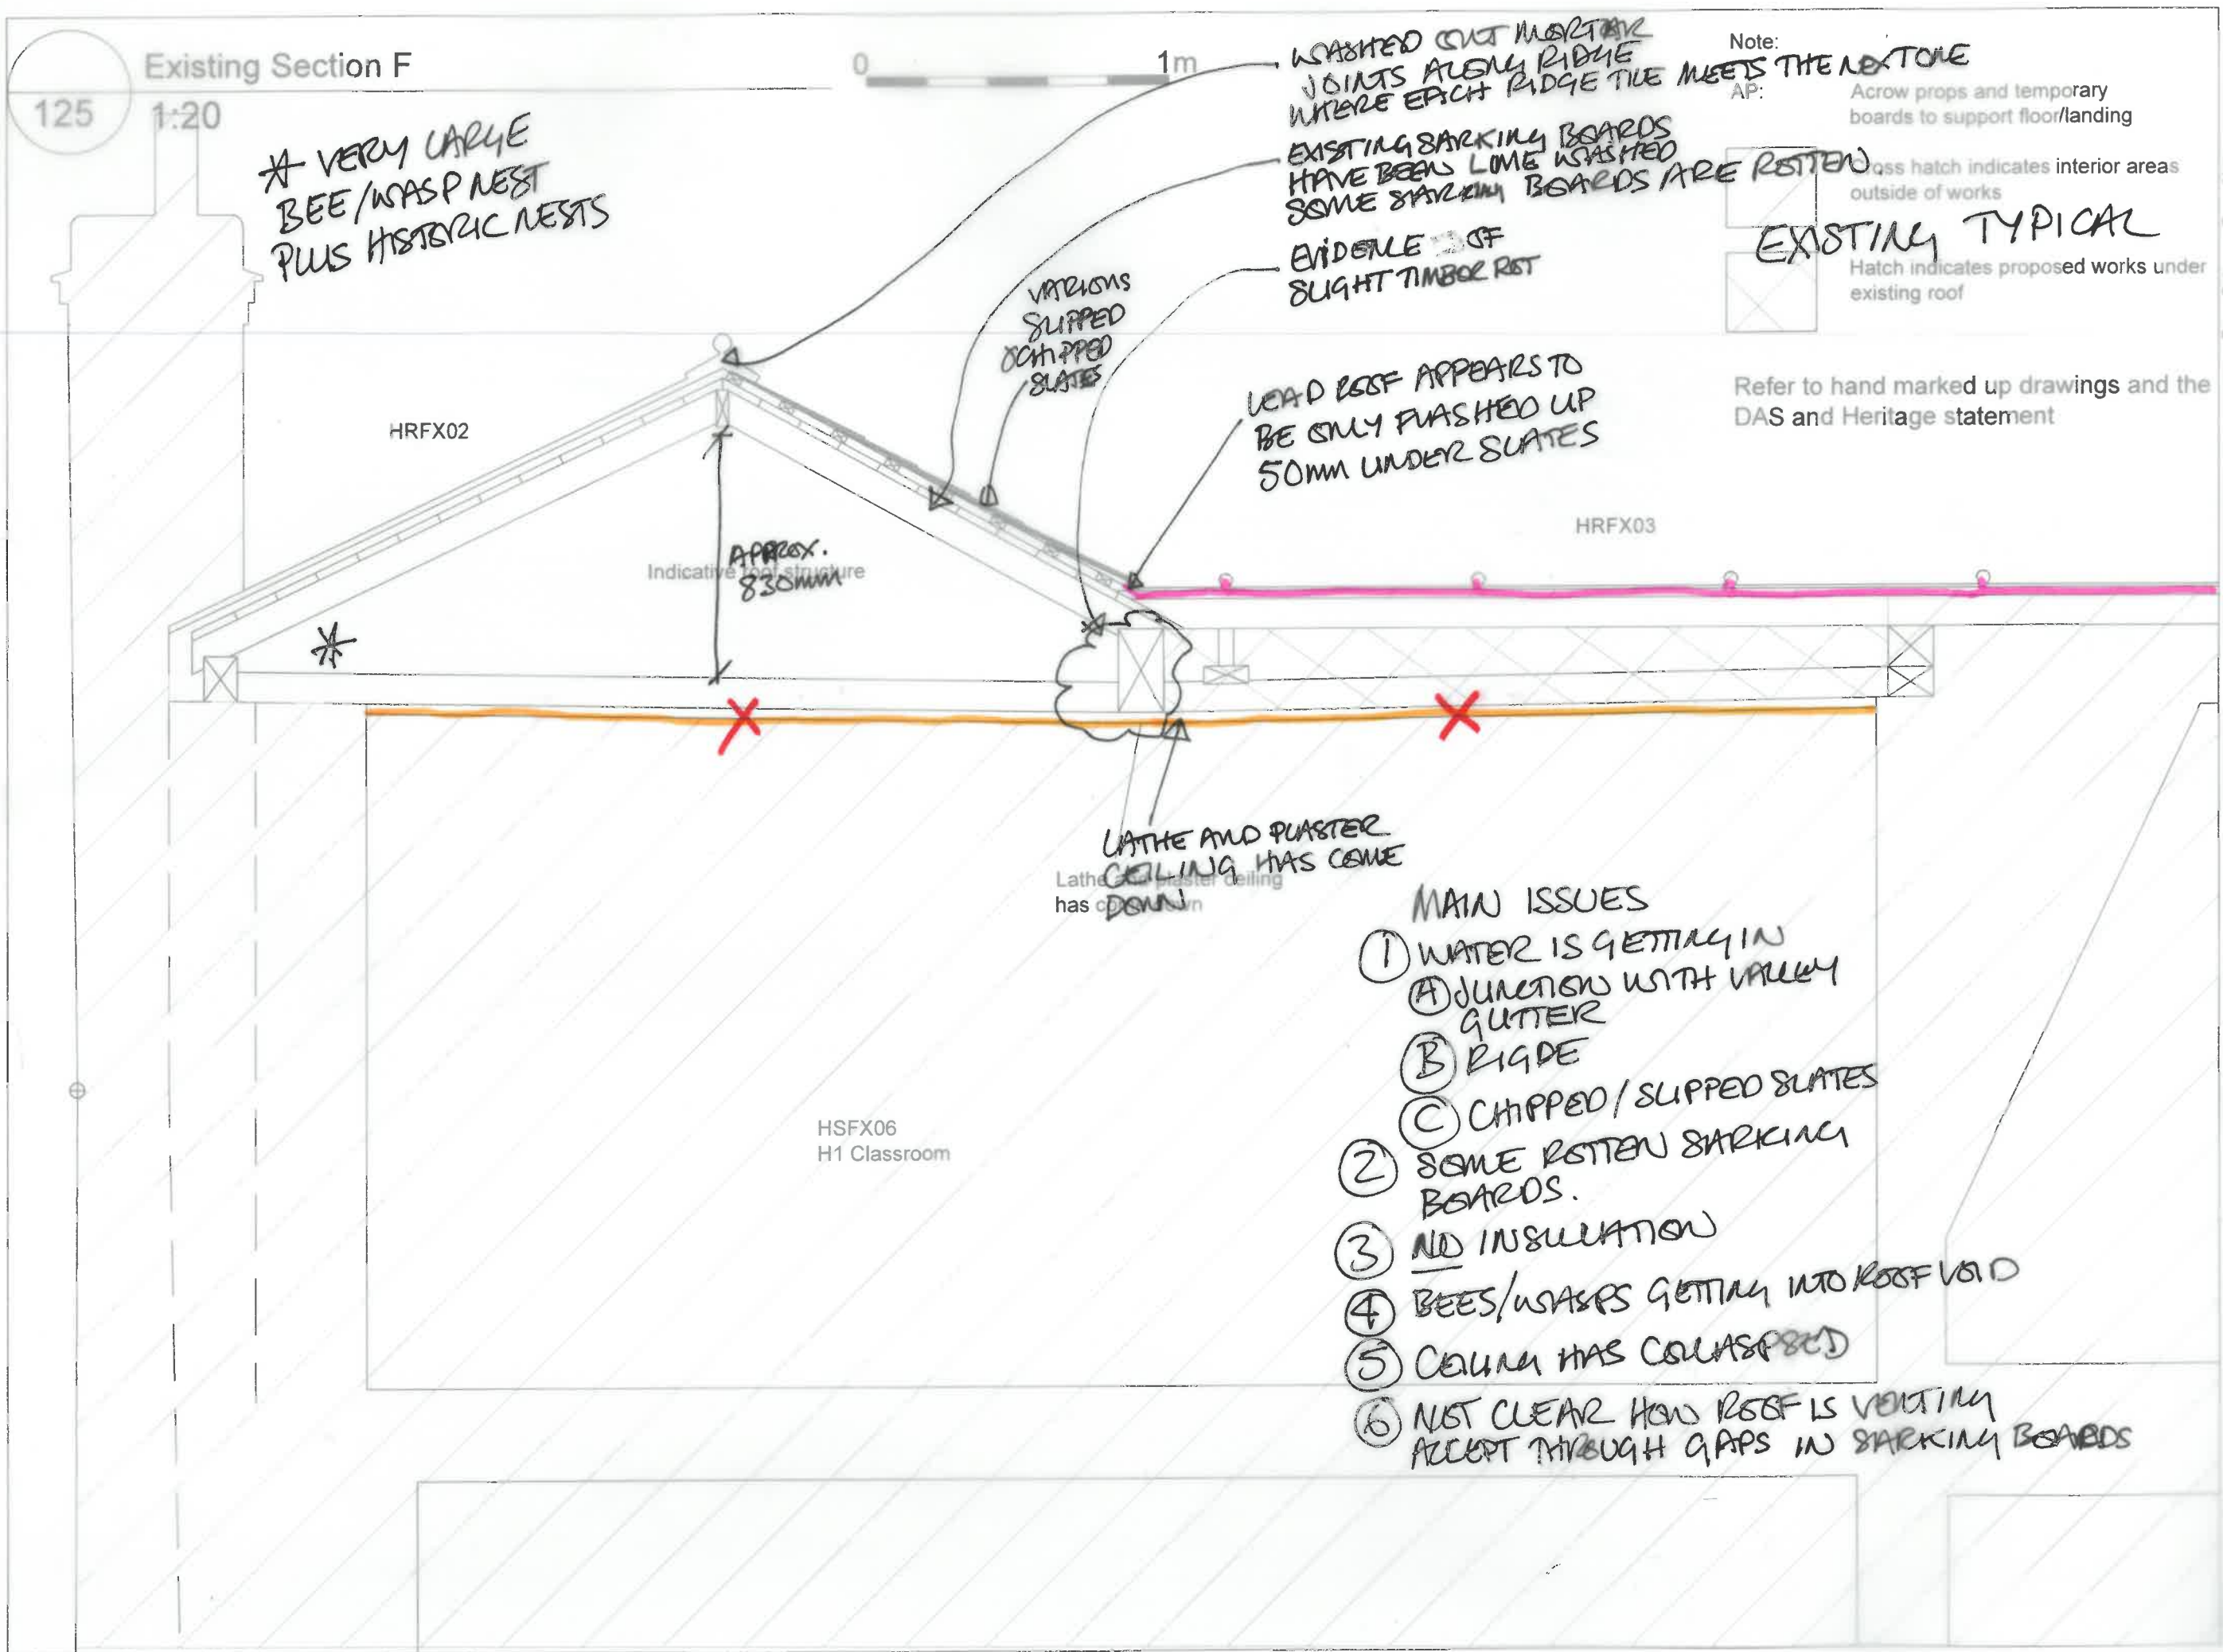
- MAIN ISSUES**
- ① WATER IS GETTING IN
    - A) JUNCTION WITH VALLEY GUTTER
    - B) RIDGE
    - C) CHIPPED / SLIPPED SLATES
  - ② SOME ROTTEN BARKING BOARDS.
  - ③ NO INSULATION
  - ④ BEES/WASPS GETTING INTO ROOF VOID
  - ⑤ CEILING HAS COLLAPSED
  - ⑥ NOT CLEAR HOW ROOF IS VENTILATING ACCEPT THROUGH GAPS IN BARKING BOARDS
