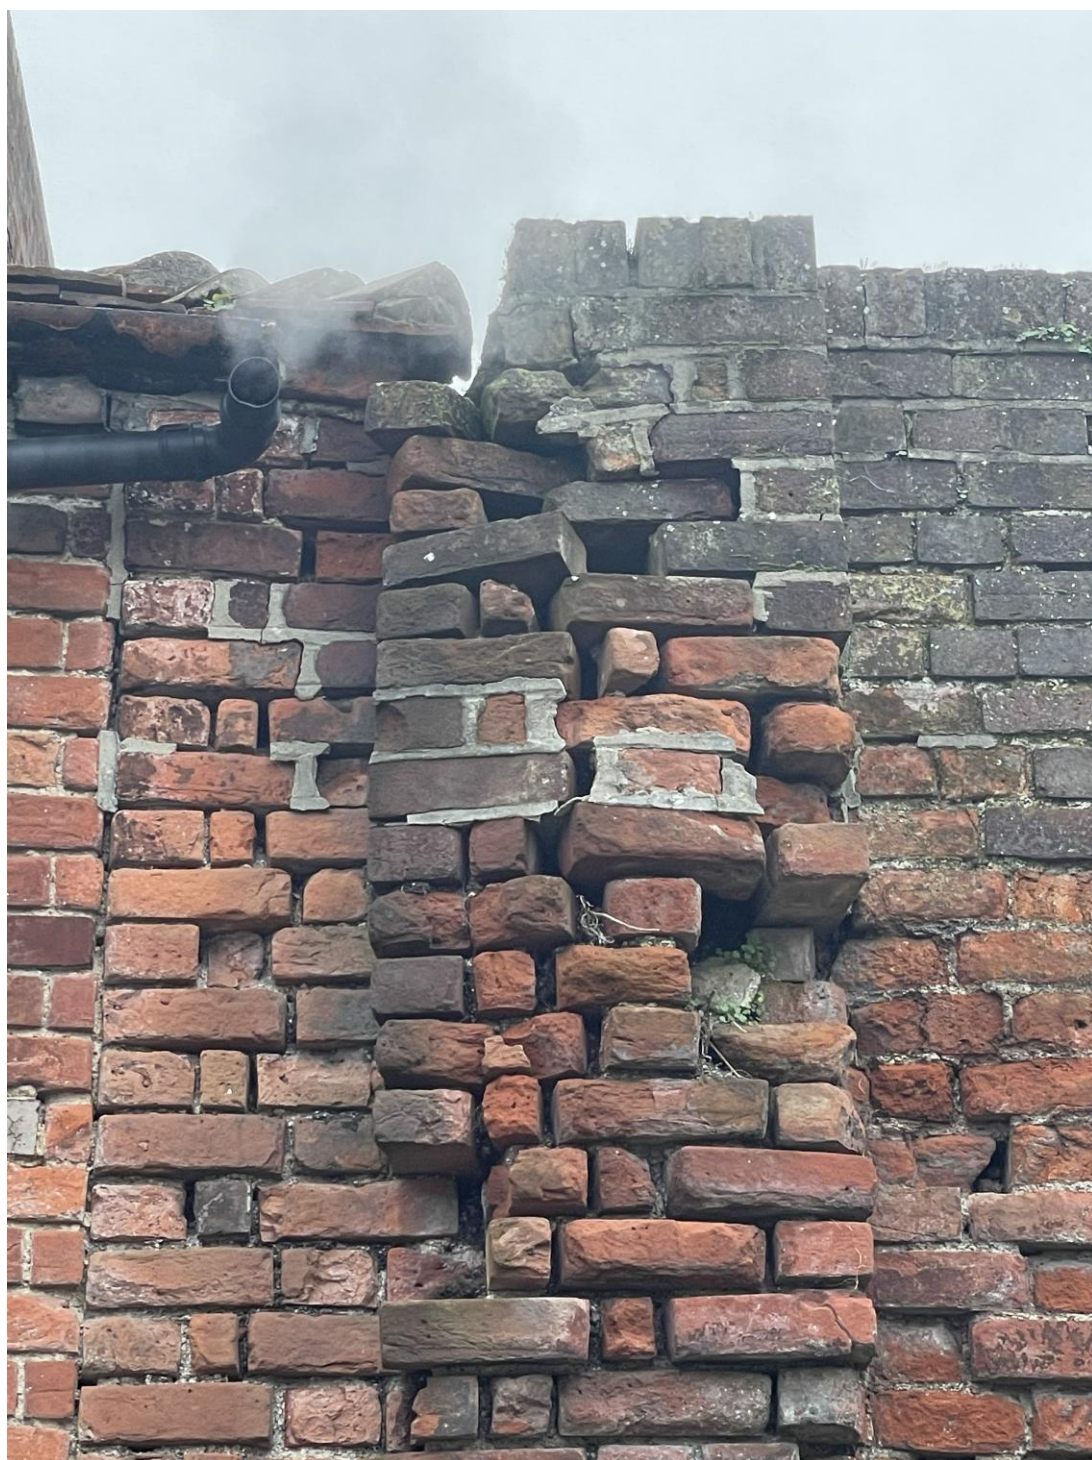
View of existing parapet wall taken from Crutches Lane – several bricks have little or no mortar, the parapet wall has very recently pulled away from the main building (moving to the right on this photo) and a section of brickwork on the left-hand side of the buttress is in imminent danger of collapse

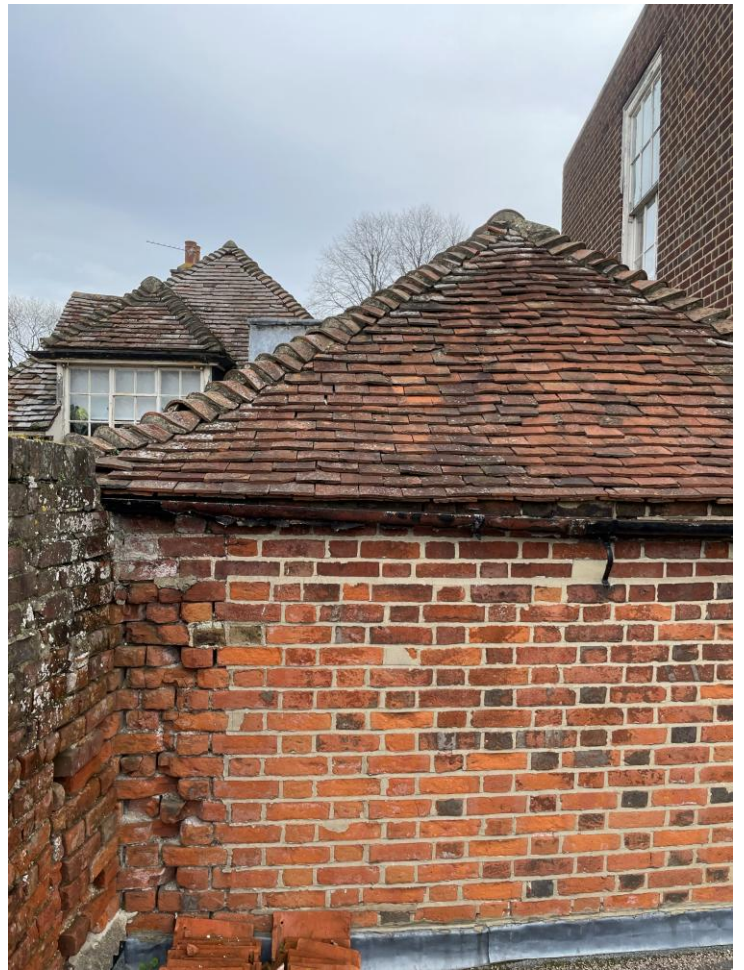
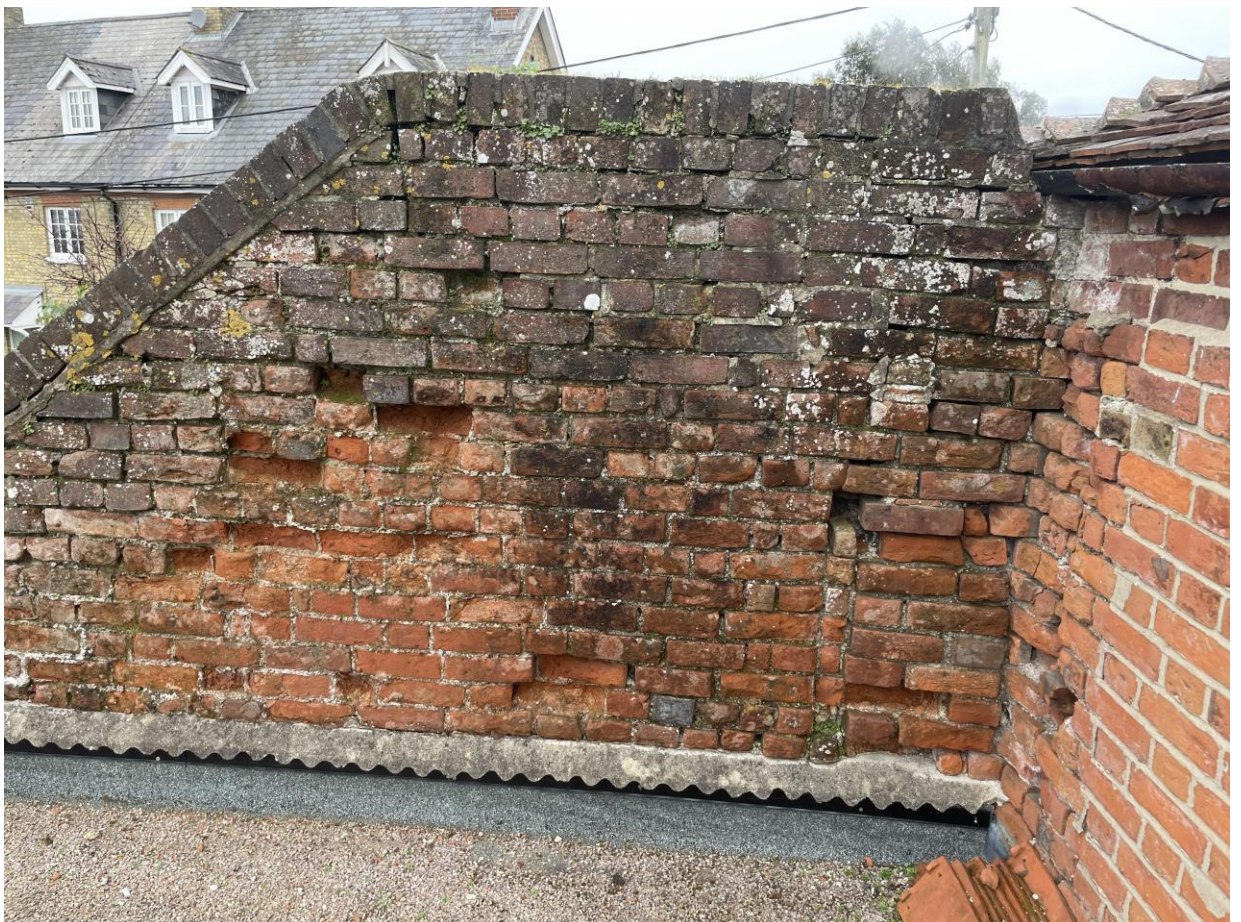
View of parapet wall  
on the school side  
(below) and where it  
joins the main  
building (upper  
photo)  
Note different bricks  
with harder bricks  
upper and brick  
'rubbers' lower. Note  
how many of the  
rubbers have blown  
faces with more than  
half of the depth of the  
bricks missing in  
several locations

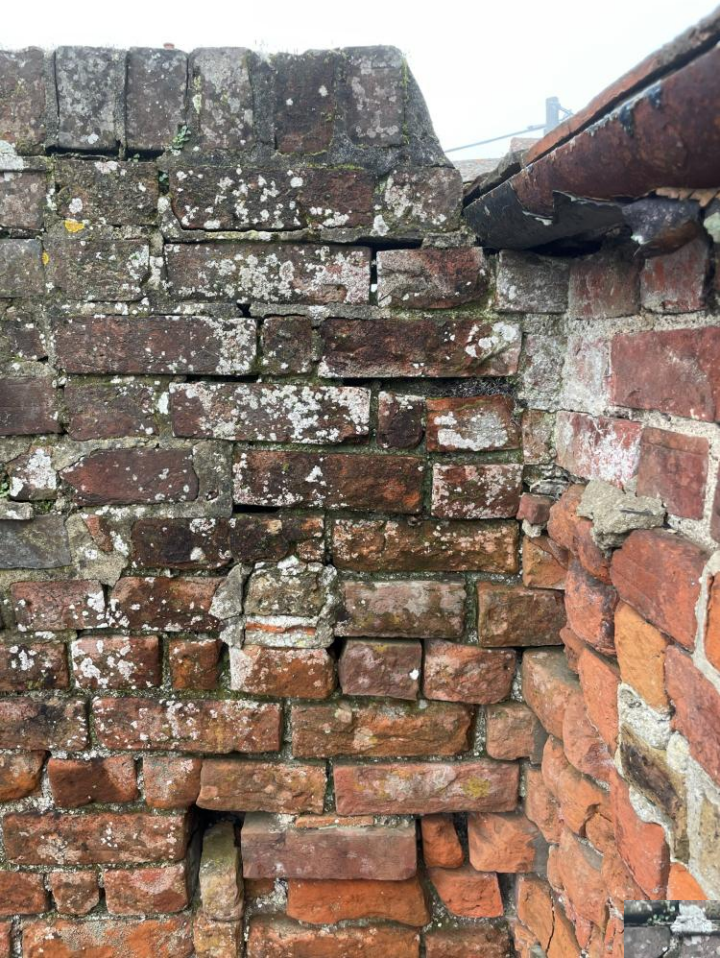
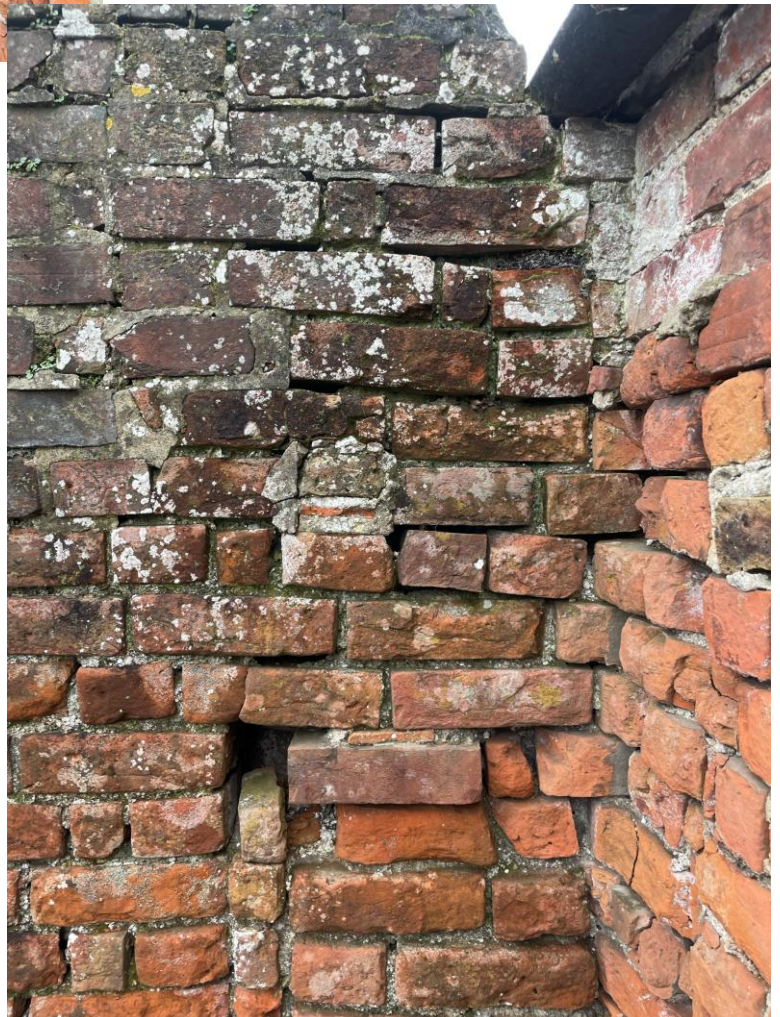
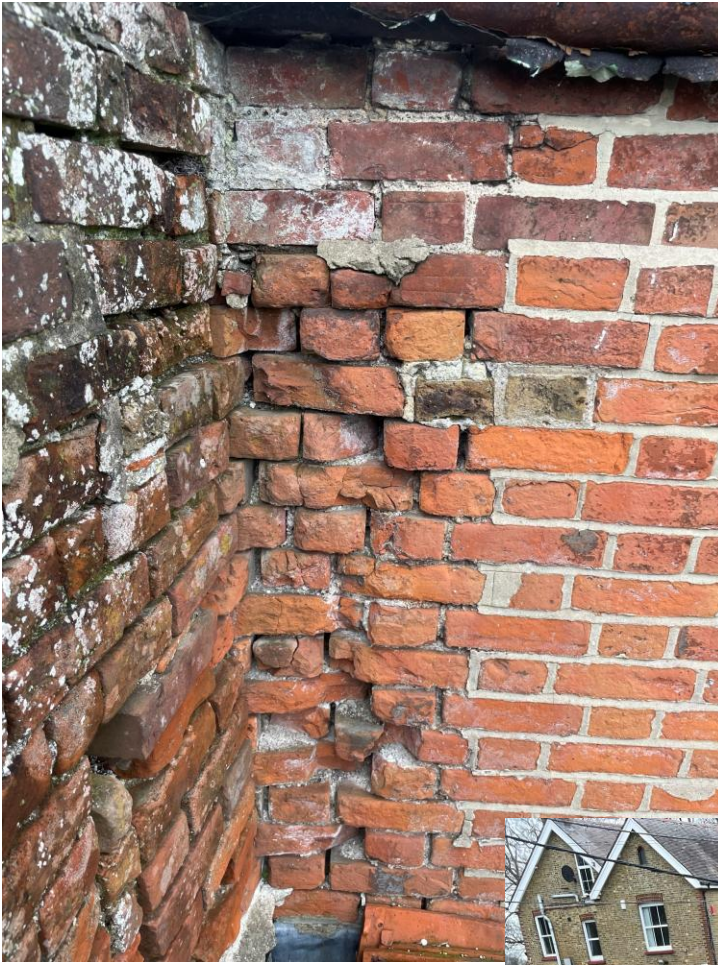
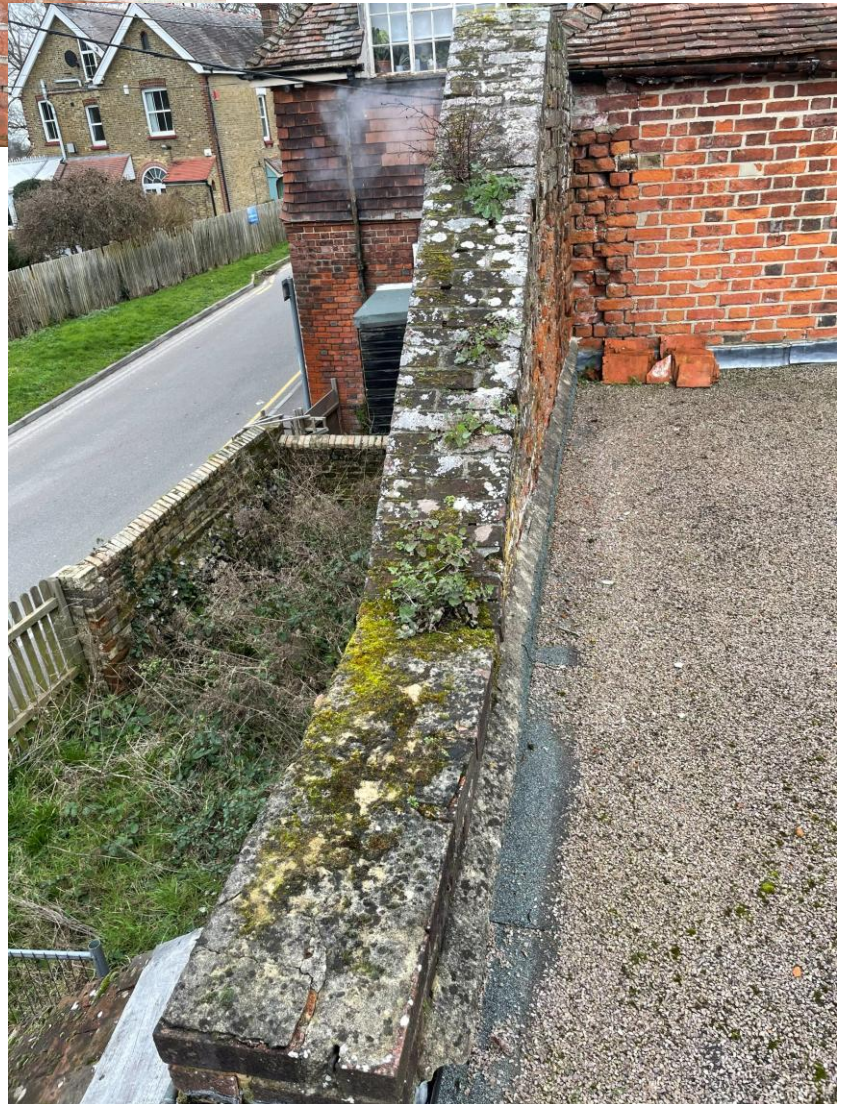
Close ups of parapet wall from school side, it is possible to see daylight straight through this wall in several locations

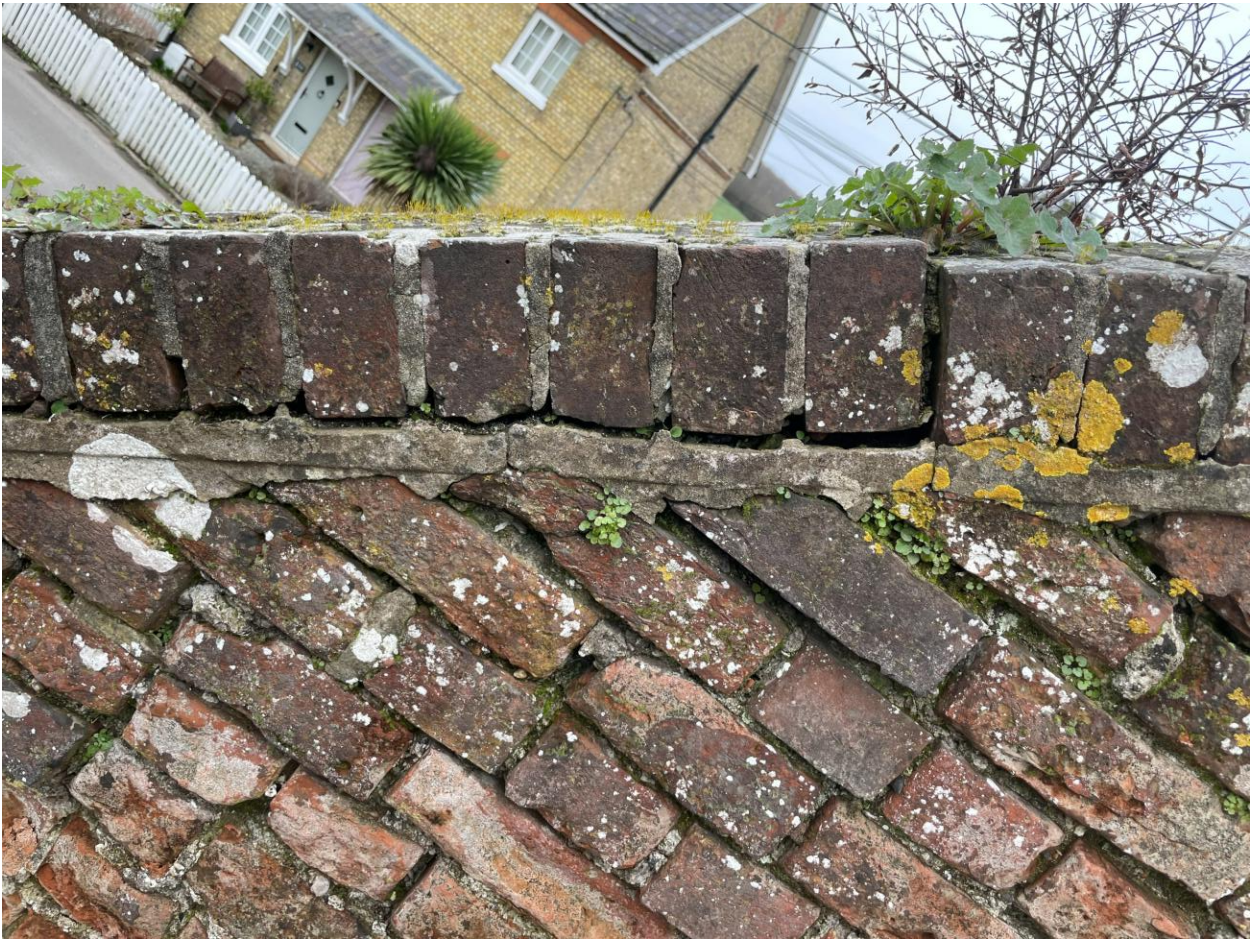
Note very poor coping detail – mortar benching

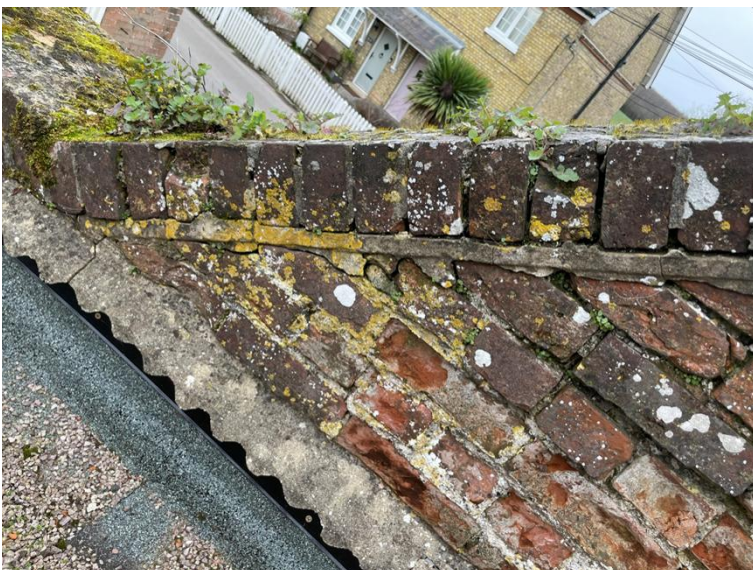
Brick coping detail in cementitious mortar has failed – bricks have lifted and weeds are growing out of the failed brick joints
