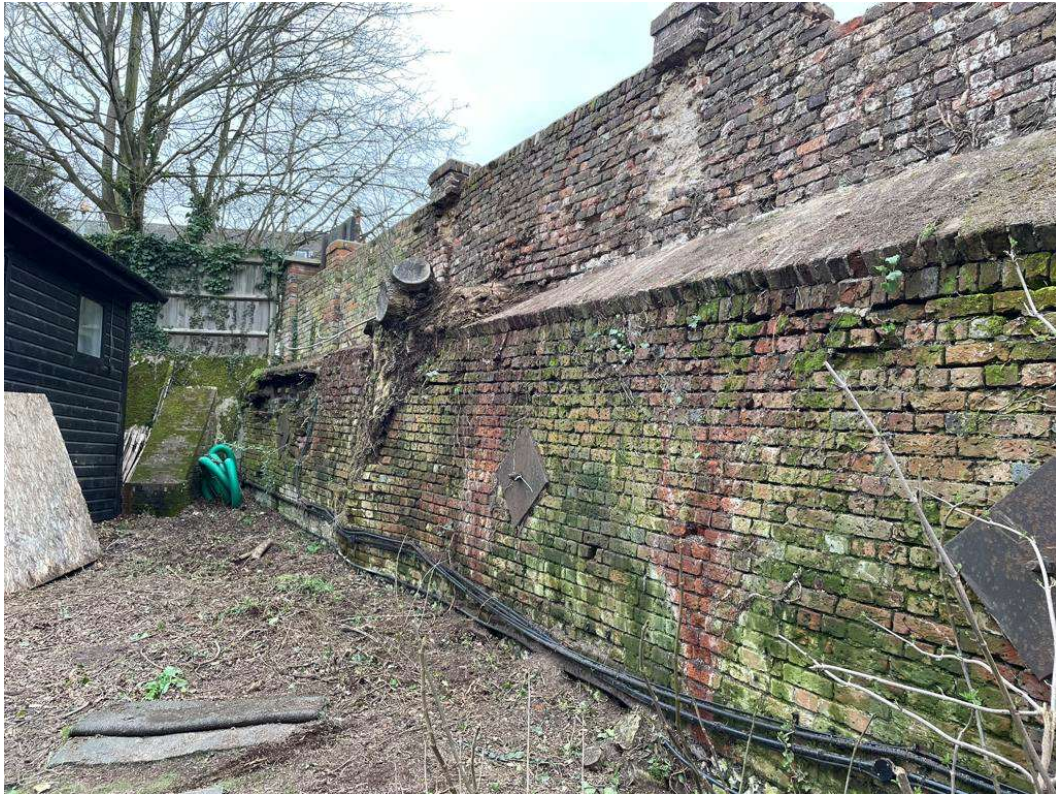
View along eastern wall looking to north showing damage to boundary and retaining walls

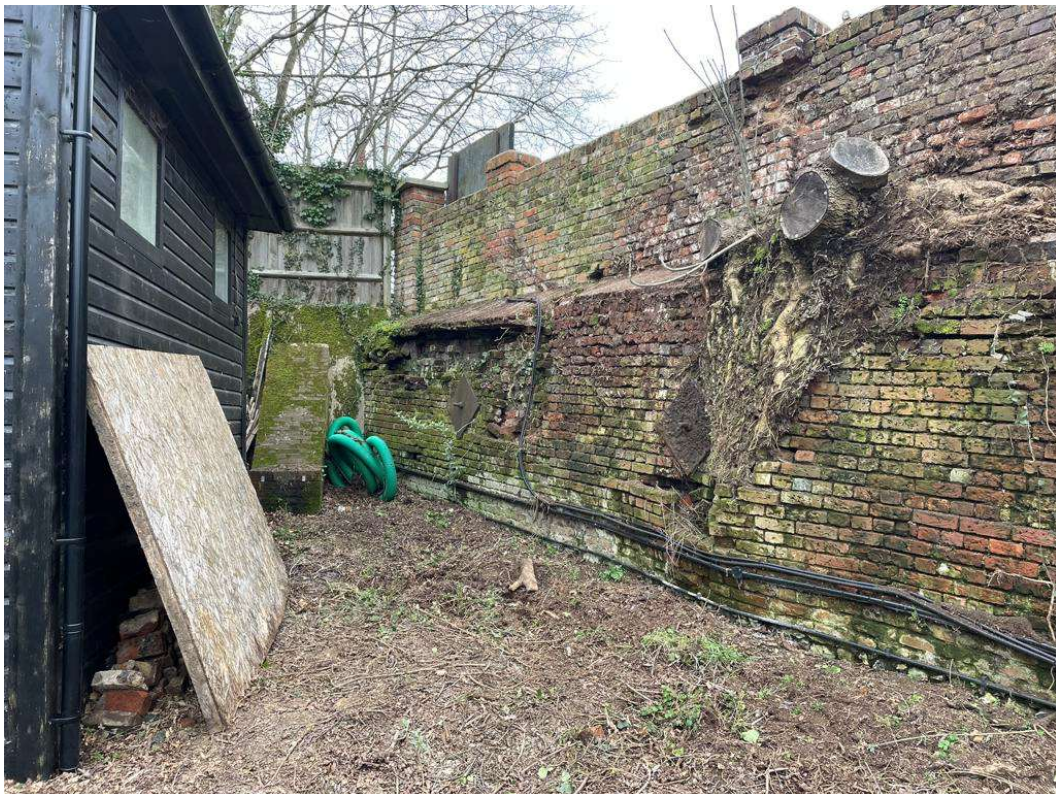
View on northern end of east wall showing proximity to kindergarten, brick loss, sycamore tree roots and damage caused

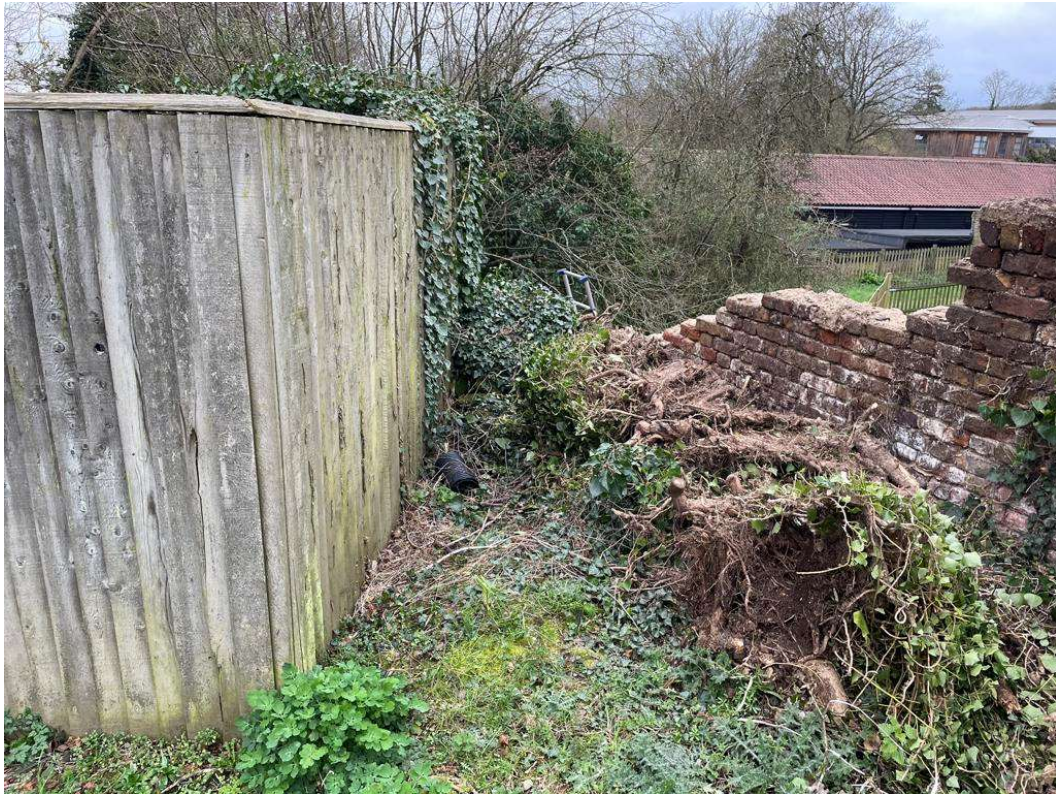
View of failed boundary wall at upper level showing lack of restriction and safety protection to any persons

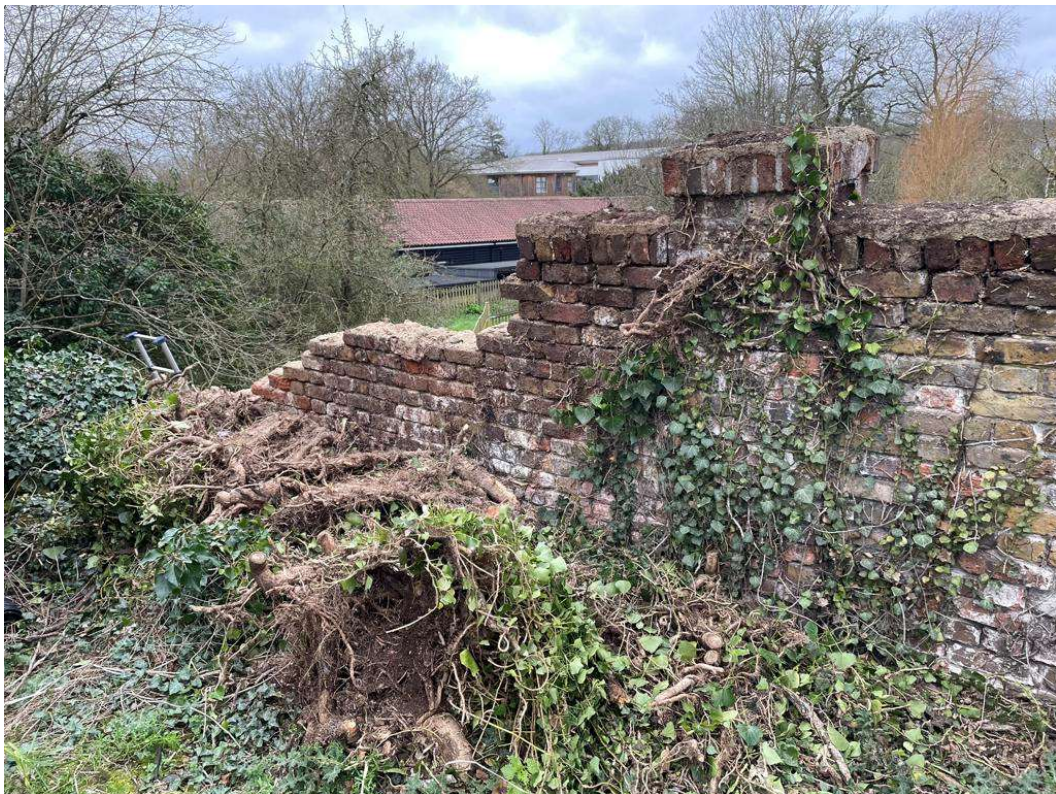
View of failed wall and surviving but weak and unstable boundary wall

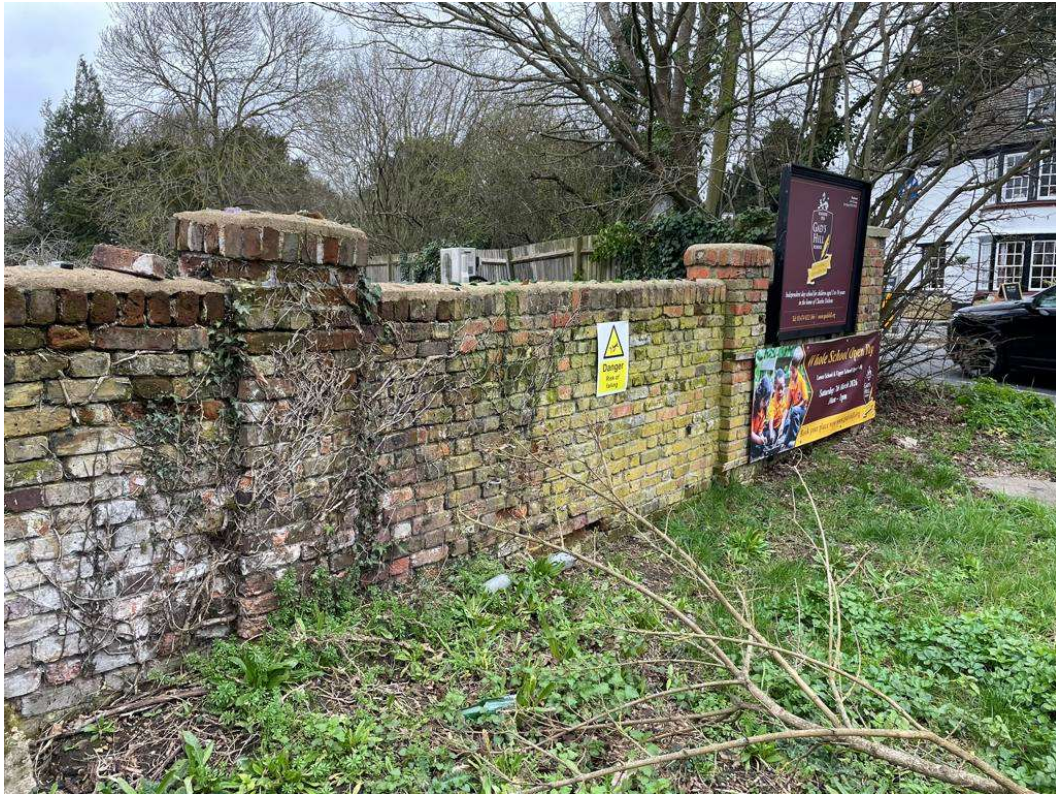
View on upper level boundary wall showing short length of undamaged wall

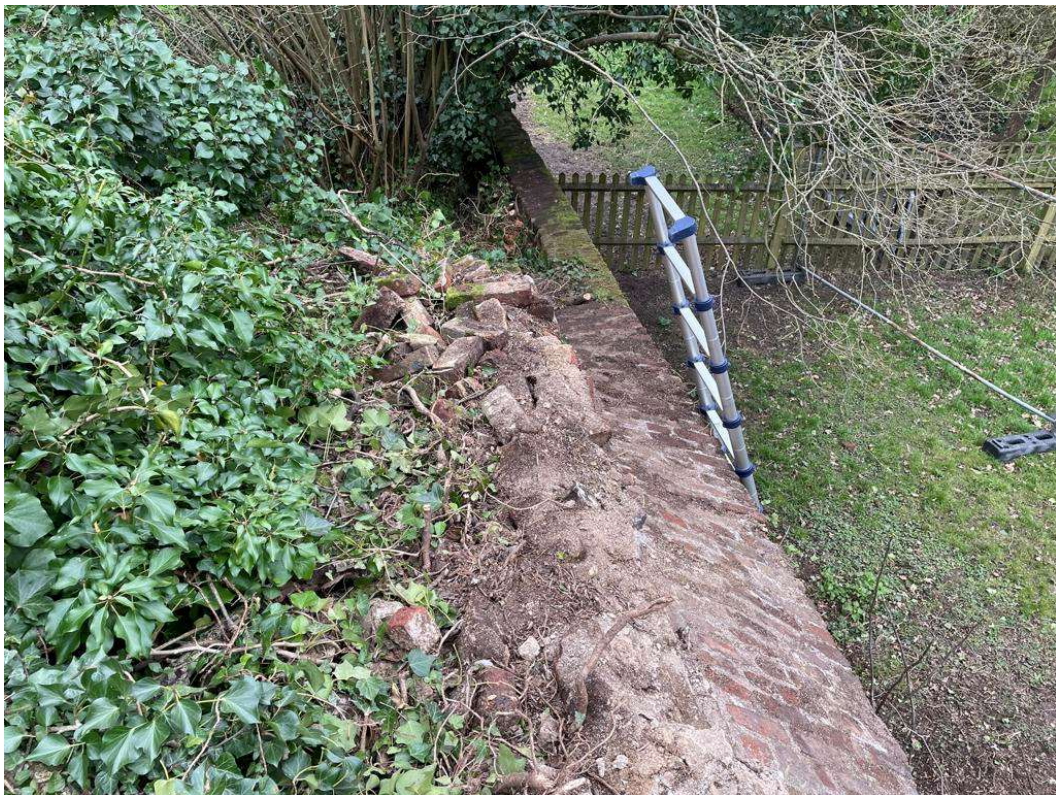
View on unprotected edge where boundary wall has failed

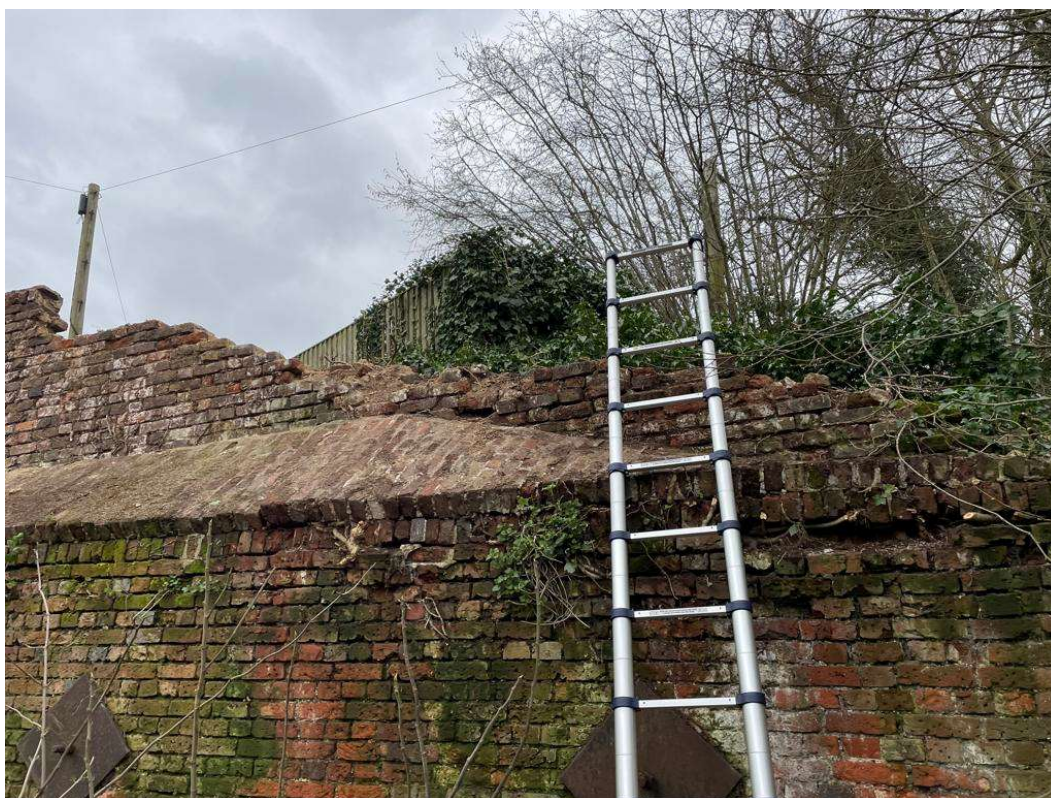
View on unprotected edge from lower ground level

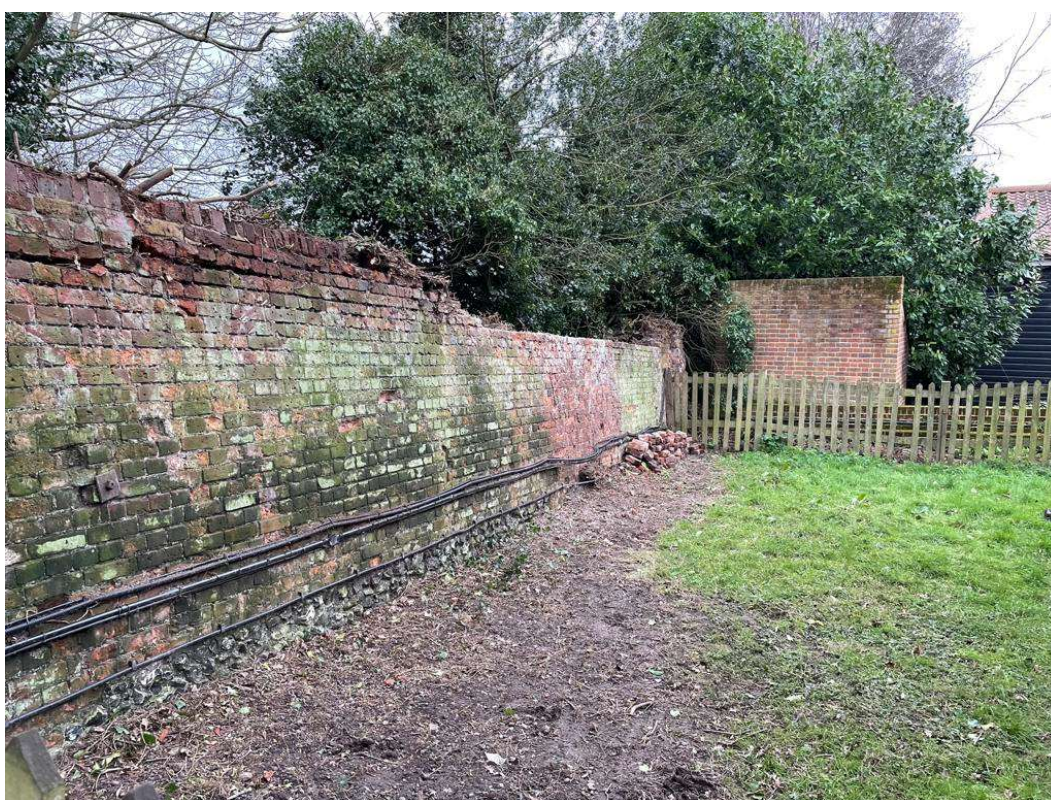
View on length of non-retaining boundary wall at low level towards the Pavillion showing damage to top of wall and outward leaning at mid-distance

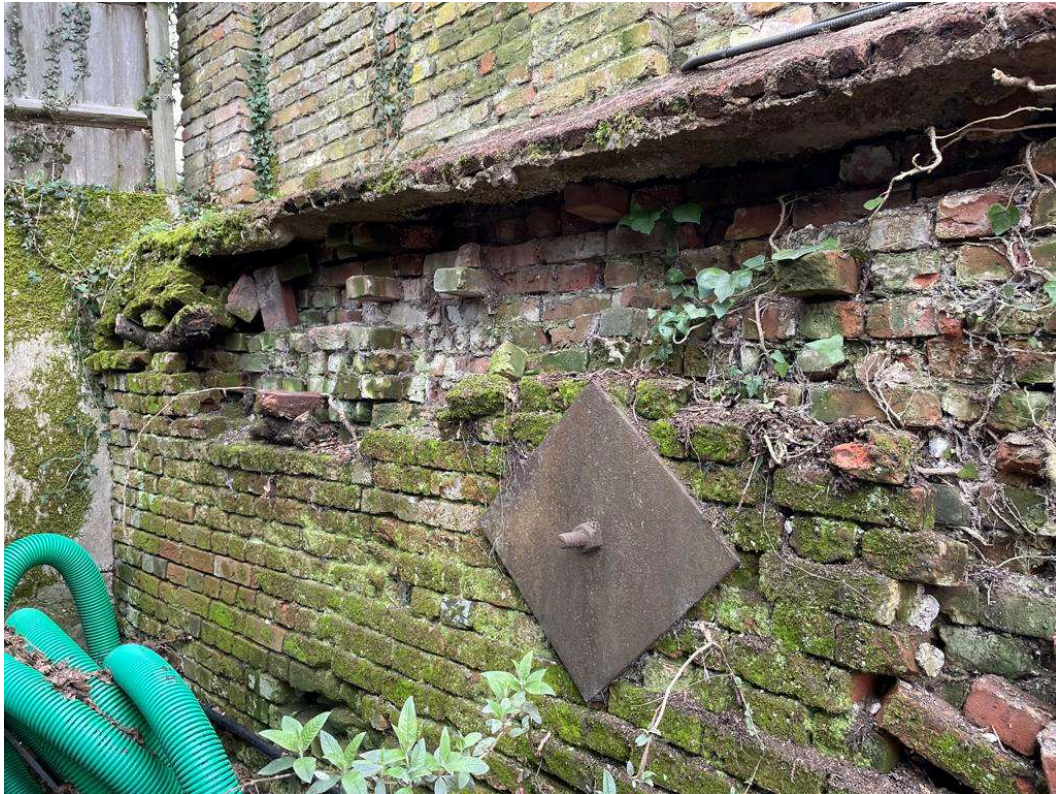
Close up view of failed brickwork also showing ground anchor

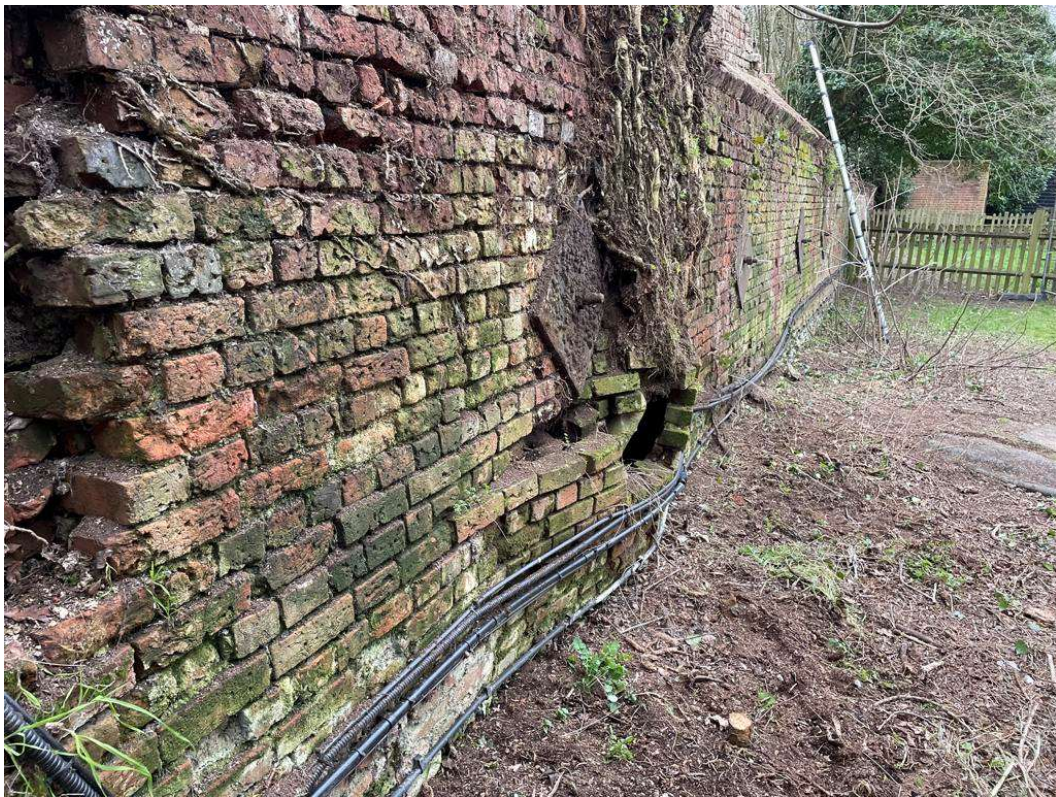
View on lower tree roots showing damage to retaining wall brickwork

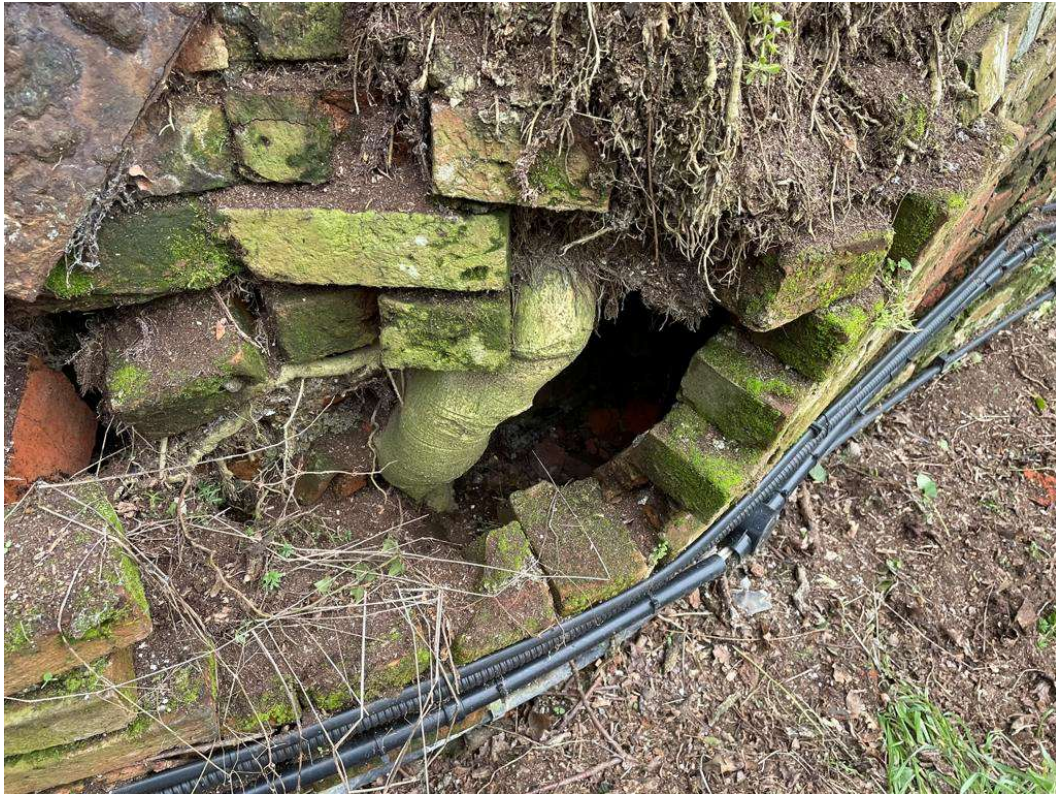
Detailed view on tree root damage and penetration into wall brickwork
