# TREE SURVEY REPORT

**Location:** 24 Beach Mast, Vigo Village, Meopham, DA13 0SX

**Date :** 20/03/2026

## Arboricultural Report – Silver Birch (Betula pendula)

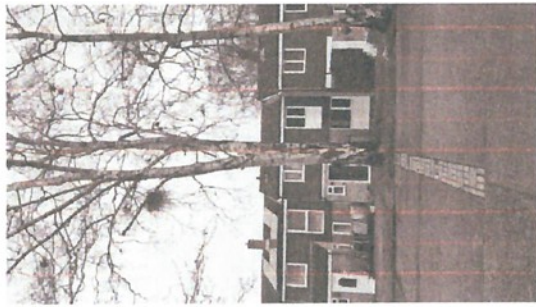
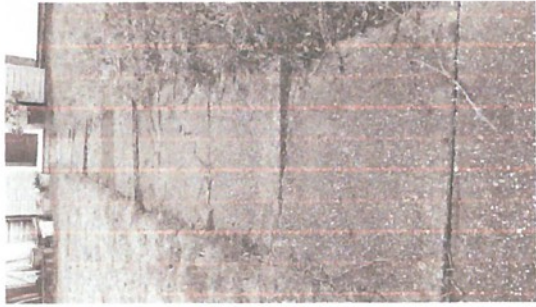
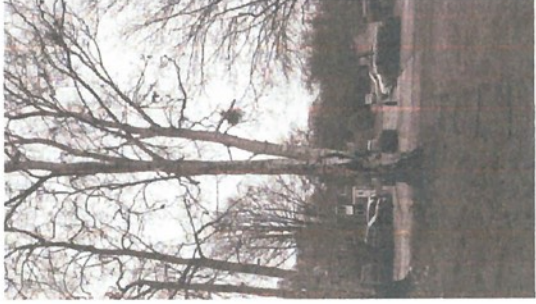
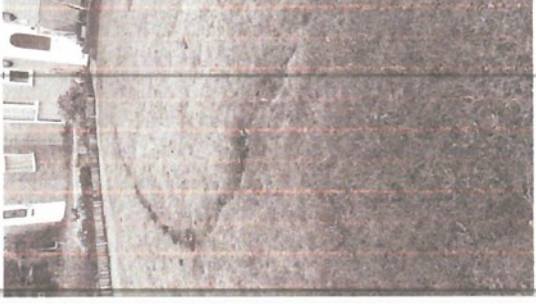
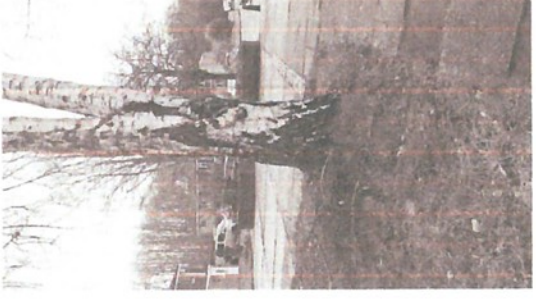
A visual arboricultural inspection has identified **clear indicators of decline and structural compromise**, including the presence of internal decay and associated defects.

The tree demonstrates **pronounced movement under wind loading**, beyond what would be expected for a structurally sound specimen.

The crown contains **dead and dying limbs**, which are brittle and liable to fail without warning, presenting an immediate hazard.

There is clear evidence of **extensive surface root development**, resulting in:

- The tree be **removed in full** due to structural unsuitability
