## **Photo Addendum**

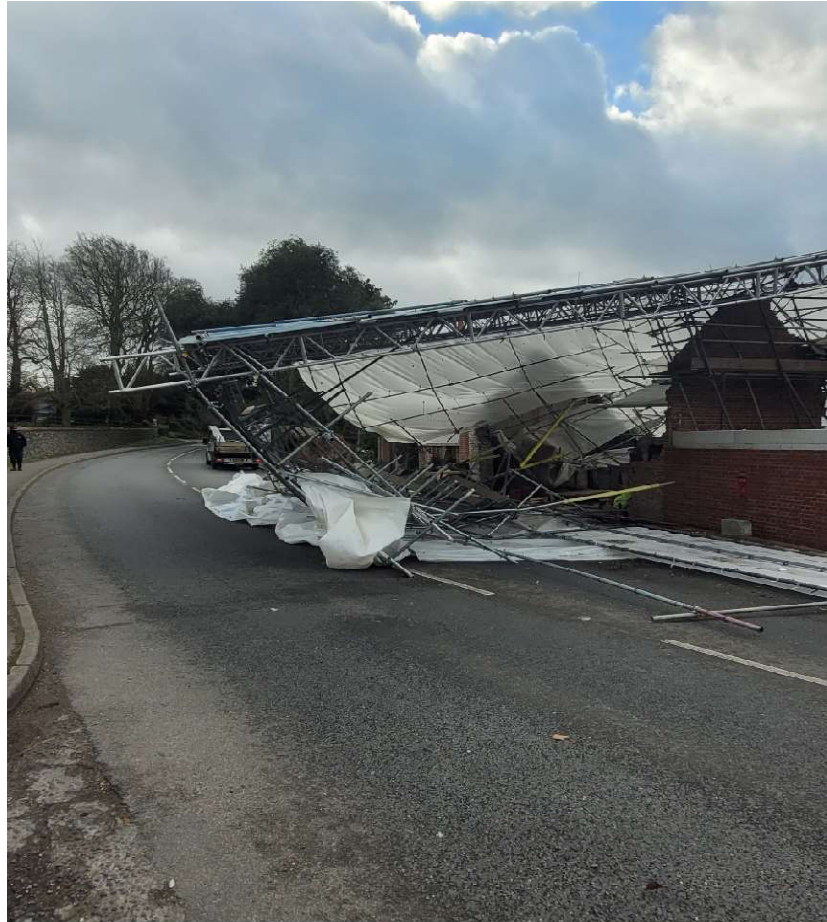
**Scaffold Collapse Front**

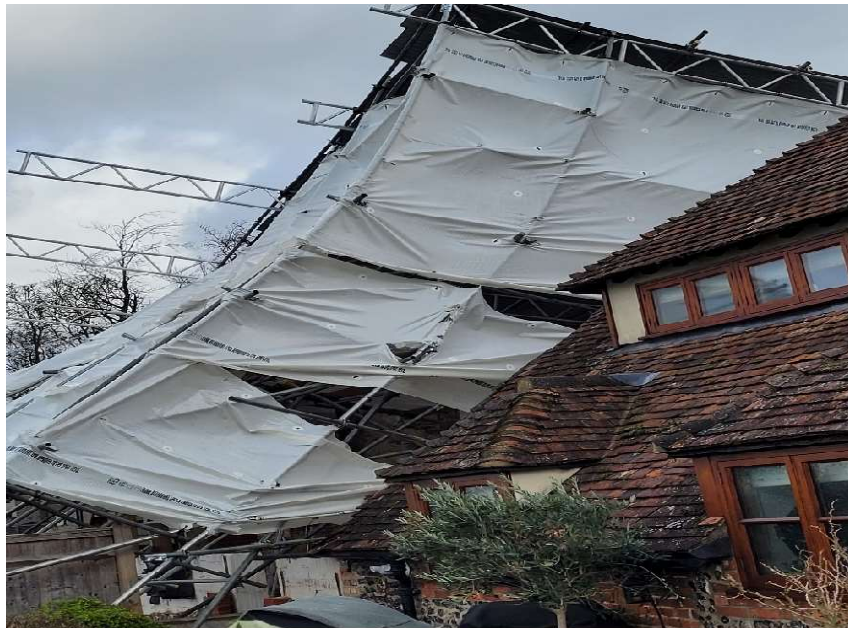
**Scaffold Collapse Rear**

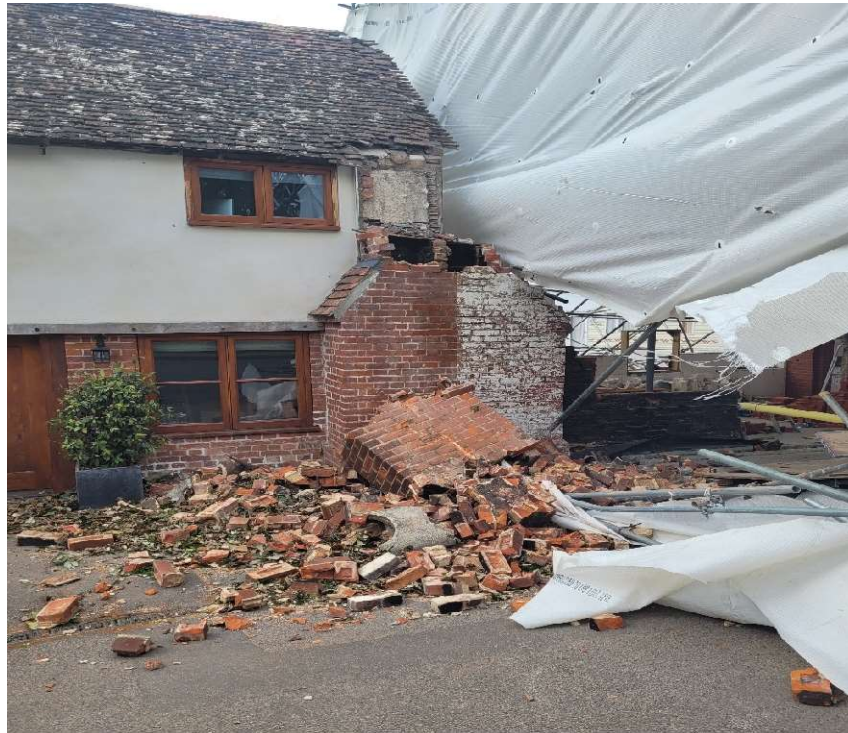
**Front Chimney Damage**

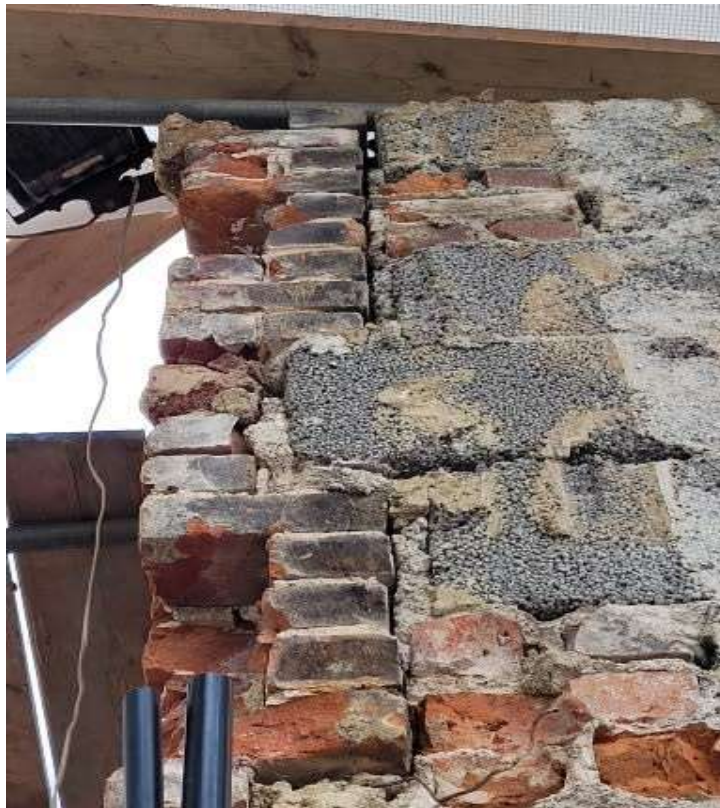
**Gable End Wall Damage**
