## 5.0 RECORD OF IMPLIMENTED WORK

5.0 RECORD OF IMPLEMENTED WORK

5.1 Appraisal of Exterior Materials & Finishes

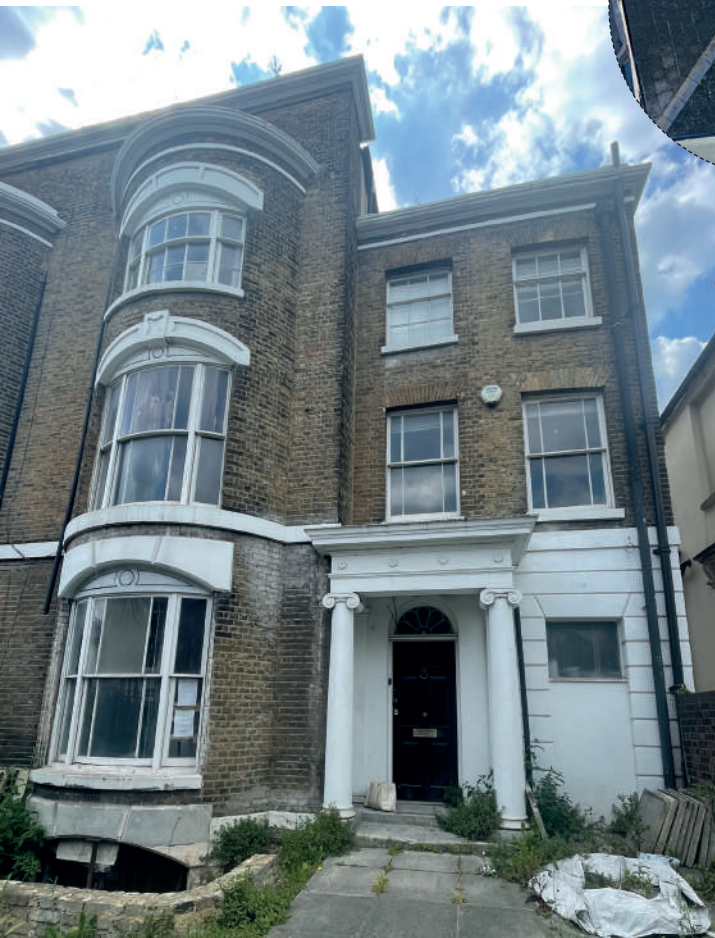
Fig 17 Site photo Front Elevation by JCA Oct 2025:  
Evidencing later side wing brick colour change,  
side aperture no external works having been carried out

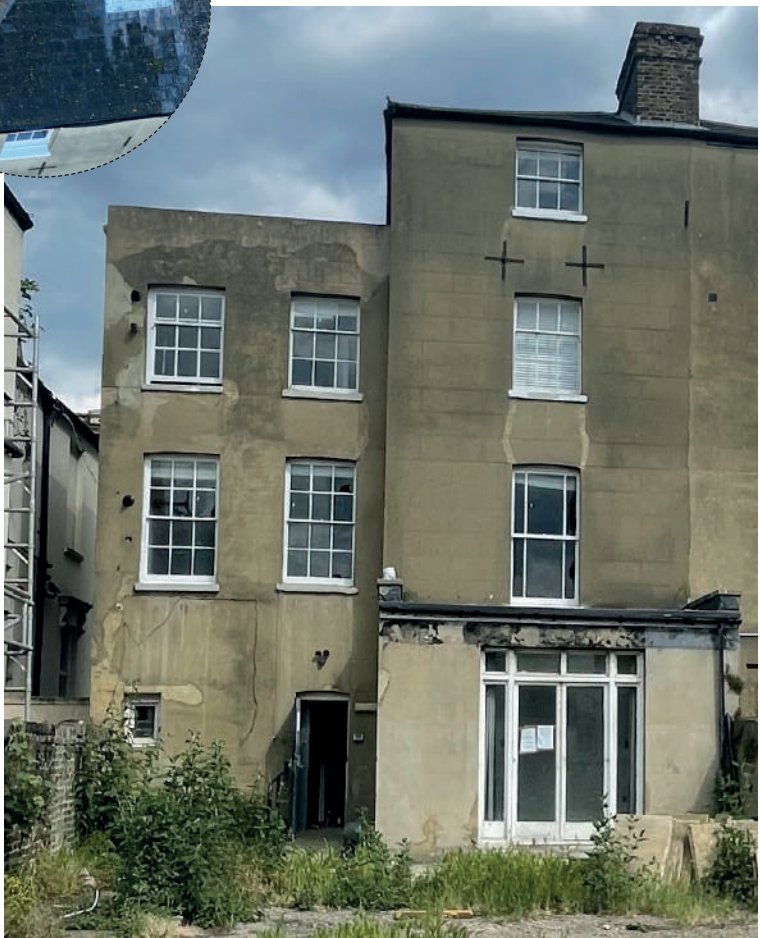
Fig 18 Site photo Rear Elevation by JCA Oct 2025:  
Evidencing no external works having been carried out

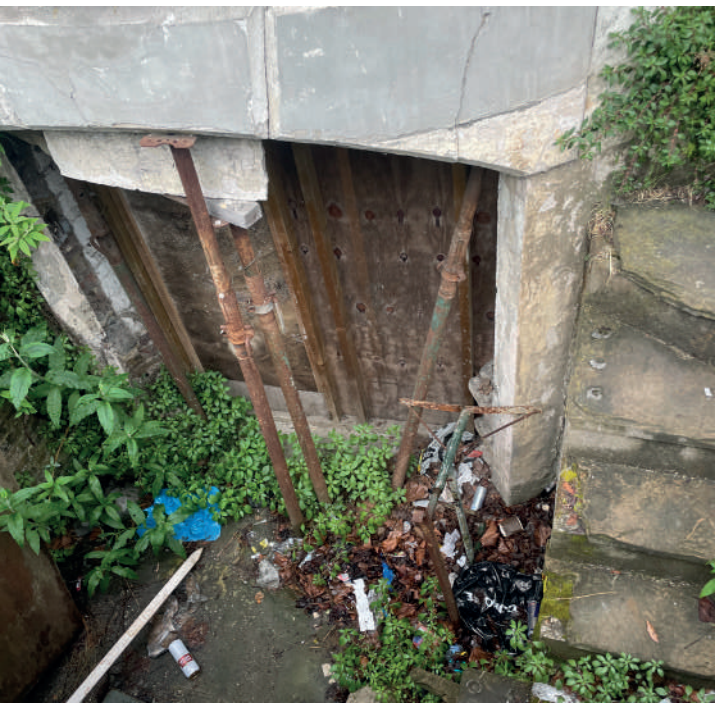
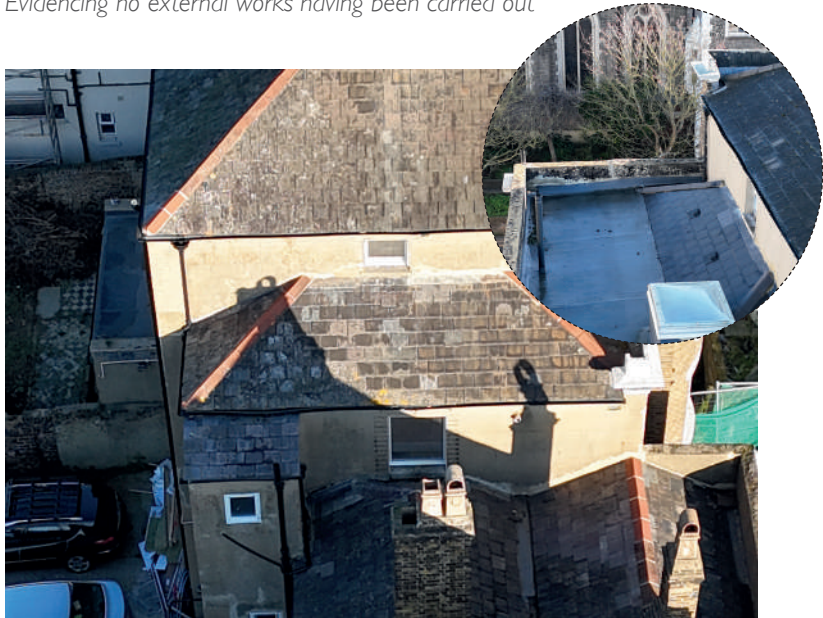
Fig 19 Left: Site photo by JCA Oct 2025: Evidence of aborted work and temporary structural measures to Lower Ground Floor bay;; Fig 14b (callout) light-well wall upstand construction; 14c right: Drone footage by JCA Oct 2025: Evidencing original hipped slate roof wing of no. 196 to which it is assumed no. 195 mirrored prior to the additional flat roof extension; 14d (callout) No. 195 slate roof remains, AOV inserted within)

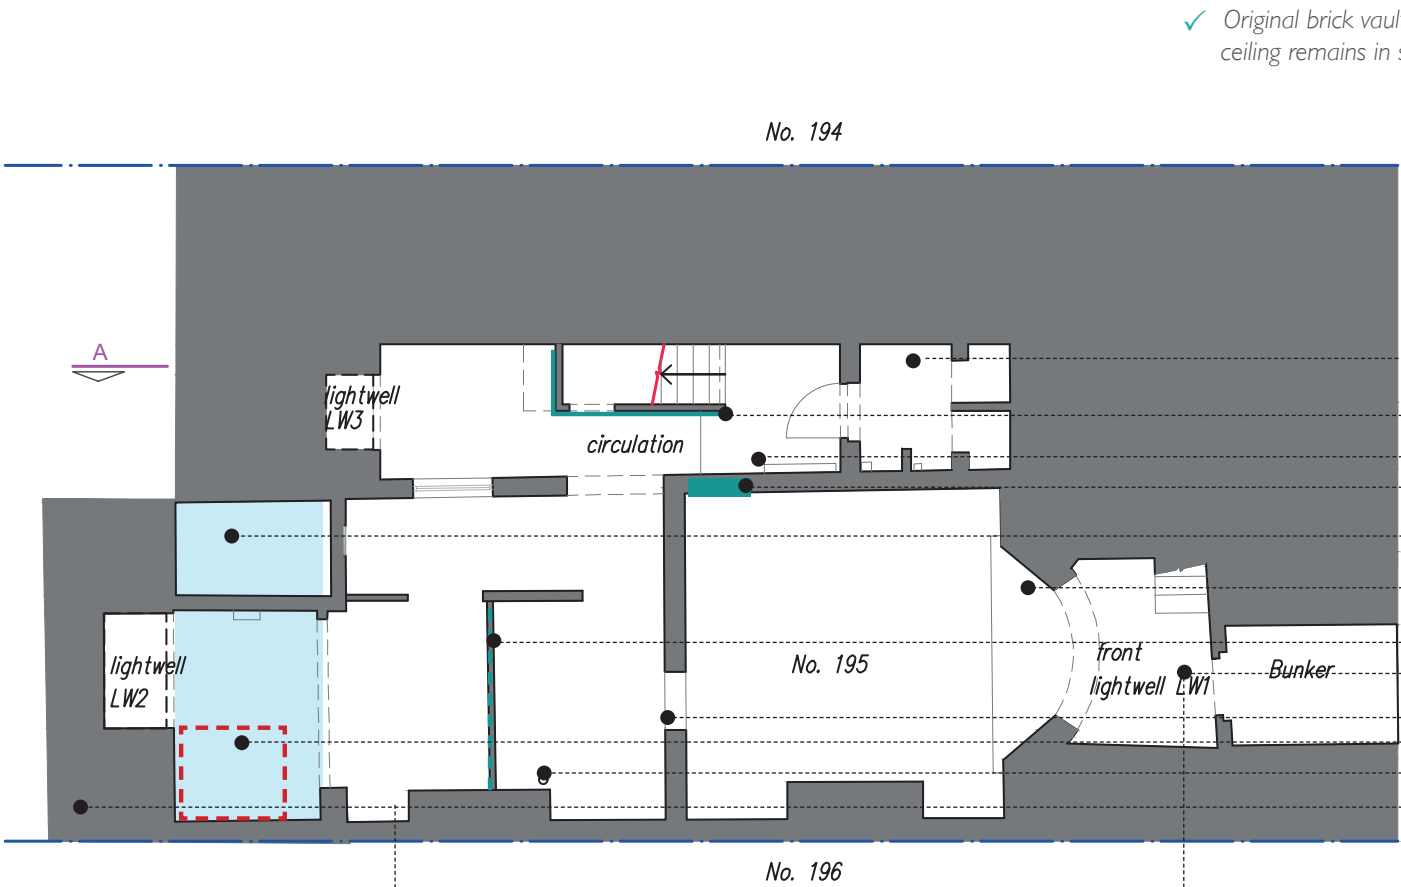
Fig. 20: Basement survey drawing by Direct Construction Surveyors & associated on site imagery 2025

- ✓ brick vaulted ceiling extant
- ✓ fire rated under-stairs cupboard
- ✓ stone slabs evident in situ
- ✓ previously in-filled door revealed, retained in situ
- ✗ area severed
- ✓ plasterboard lining removed
- ✓ later partition relocated
- ✓ lightwell area revealed
- ✗ door no longer evident
- ✓ hoist shaft removed
- ✗ rationale for new svp sought
- ✓ lifted stone slabs evident on site (stacked within rear yard)

general:  
✗ fenestration lost - possibly removed prior to un-lawful works when plasterboard was inserted internally to all walls.

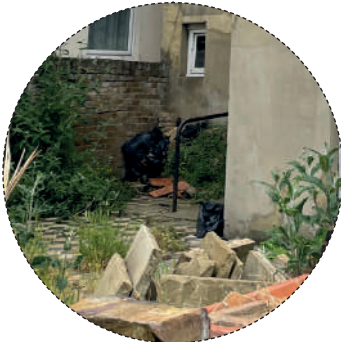
Stone slabs lifted, retained on site.

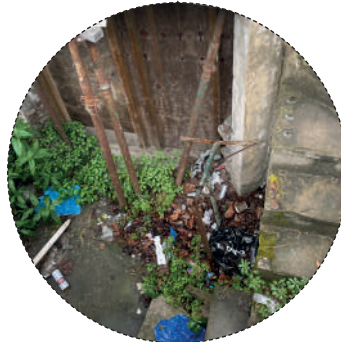
Previously in-filled light-well Opened up & revealed

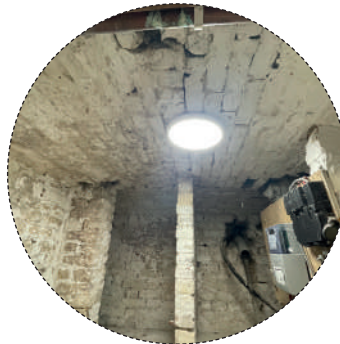
Original brick vaulted ceiling remains in situ.

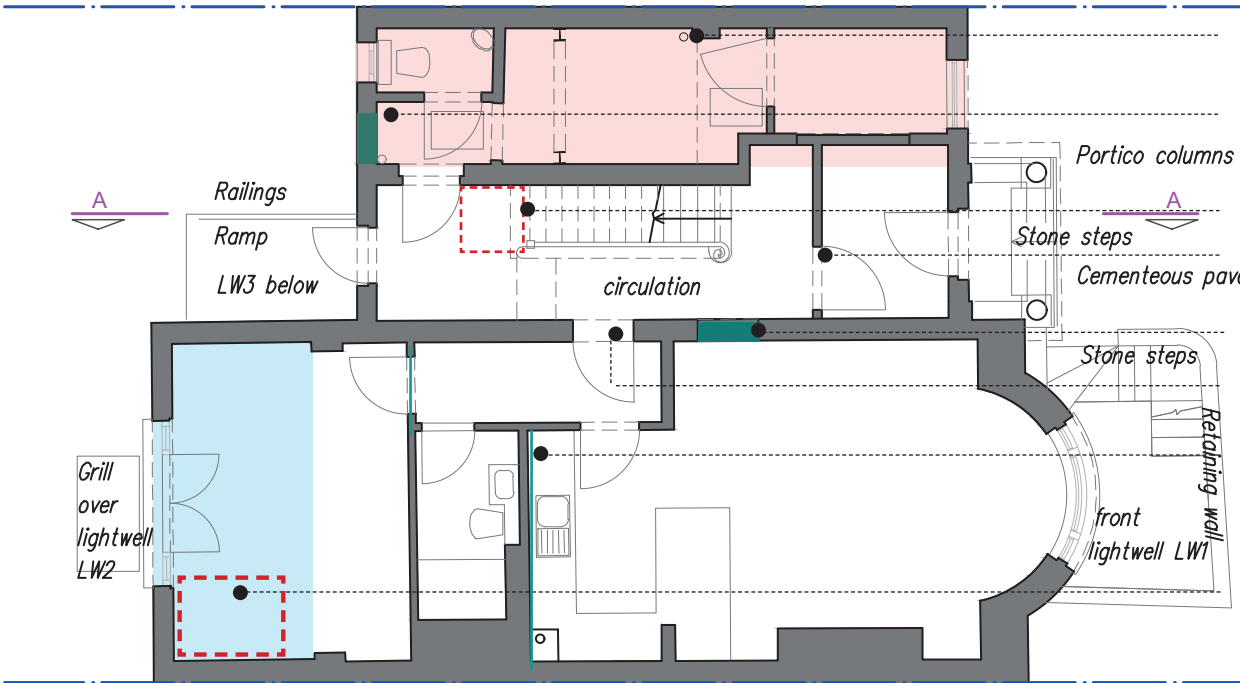
Fig. 21: GF survey drawing by Direct Construction Surveyors & associated on site imagery 2025

original svp location at time of extension  
pedestrian access aperture evident

extraction fan aperture  
night safe replaces door  
glazed partition and door  
aperture infilled  
staircase returned to straight flight  
hatching denotes partition  
formed, severing circulation

apertures formed/widened

no evidence of wc window approval  
window and panel replace night safe

no evidence of lgf lobby approval

- ✓ utilities generally located in west wing, as such reliant on original svp location
- ✗ window aperture filled new svp from basement
- ✓ lgf lobby removed
- ✓ partition pulled forward to give greater clearance to staircase
- ✓ in-filled - door location evident
- ✓ utilises door apertures
- ✓ less detrimental room division better reading of plan form
- ✓ hoist lift removed
- ✓ general ability to read original plan form
- ✓ keeps utilities in later wing

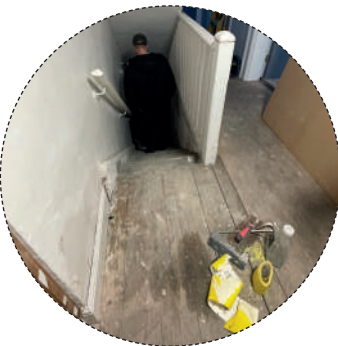
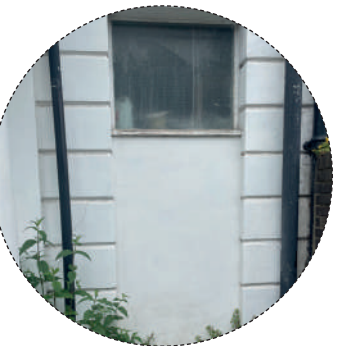
evidence of floor board, skirting infill and replacement where removed lgf lobby was formed.

side wing front service access night safe infill evident

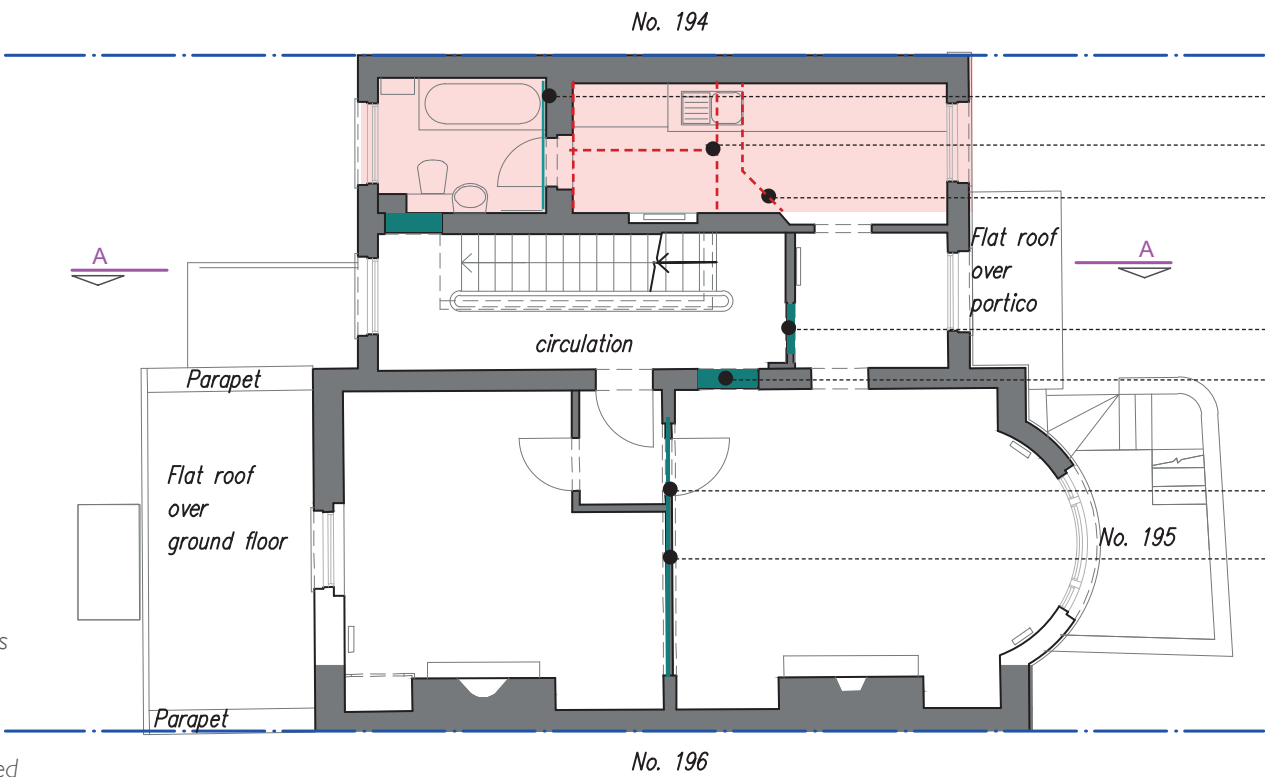
- ✗ partition installed (over steel-work below)
- ✓ wc partitions removed
- ✗ chimney removed
- ✓ door infill
- ✓ door infill
- ✓ lobby partition formed
- ✓ arch infill with shadow gap
- general:
  - ✓ arrangement retains original plan form
  - ✓ door infill's retain doors and decorative moulding features in situ
  - ✓ utilises existing openings for ventilation and flues

office wc's installed  
utilising residential  
bathroom

doors and apertures  
intact

dividing wall removed  
(nibs retained)

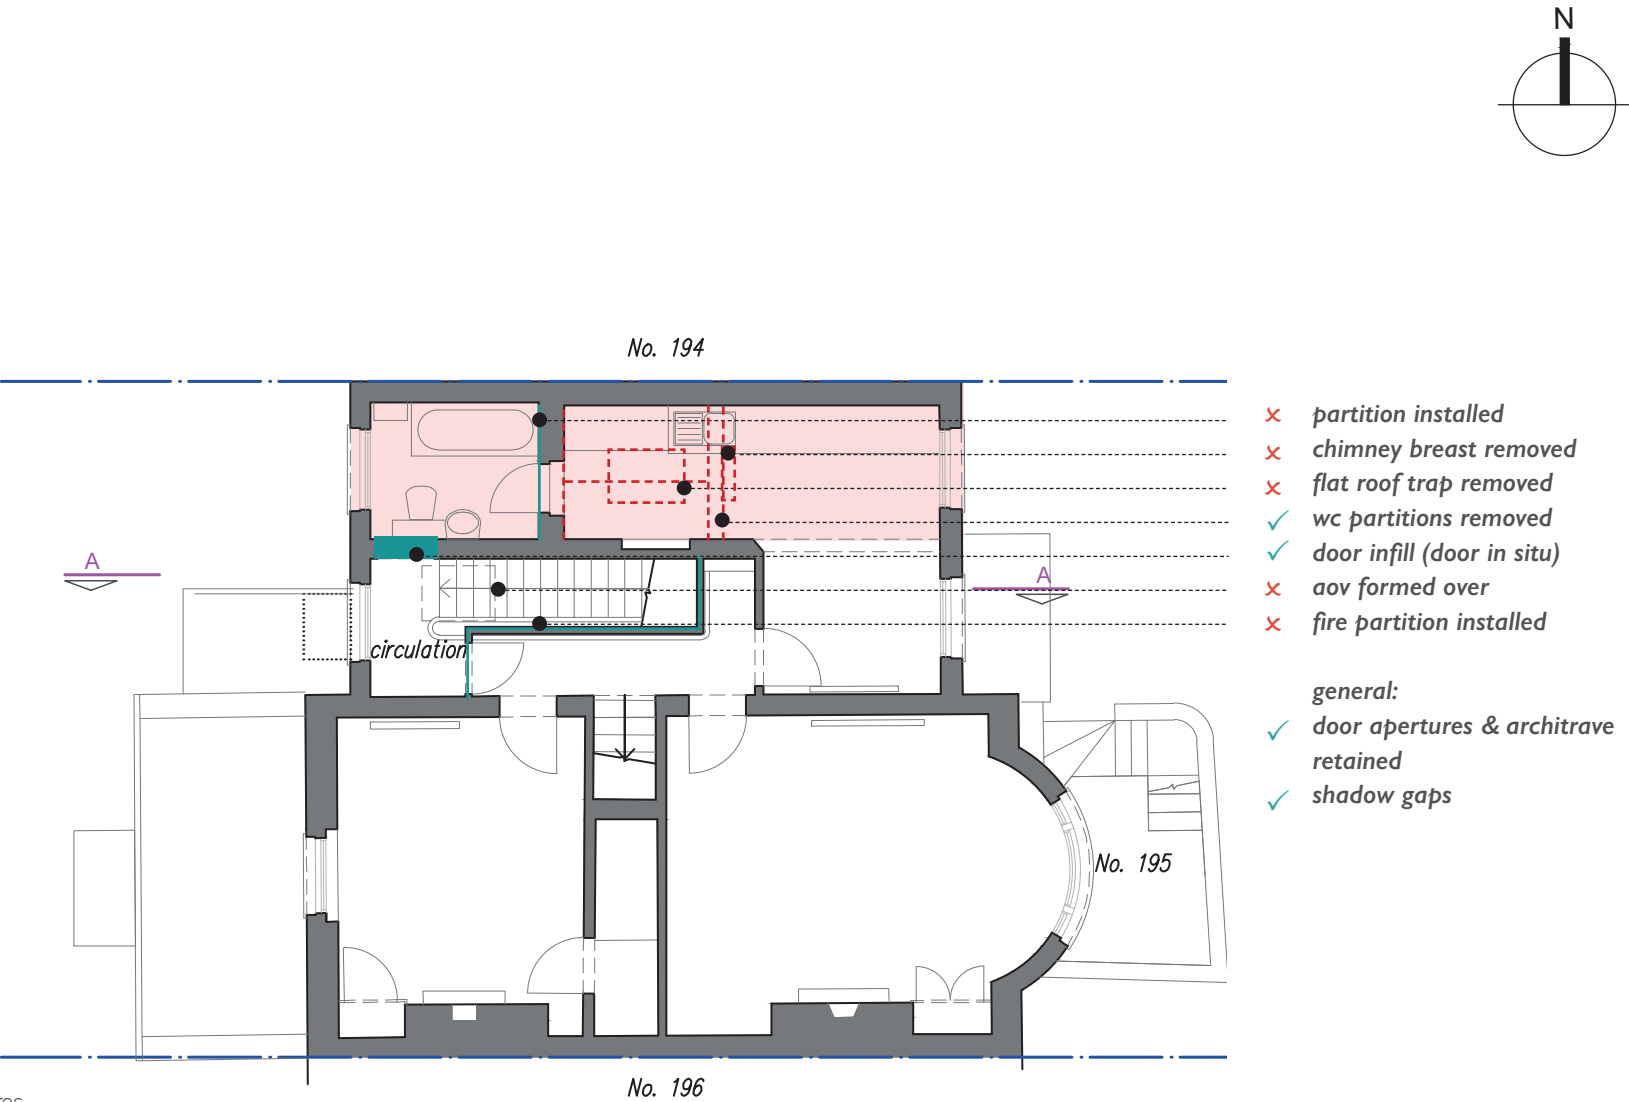
chimney breast evidenced

wc's located  
partition formed

original location of doors and apertures  
locations evident

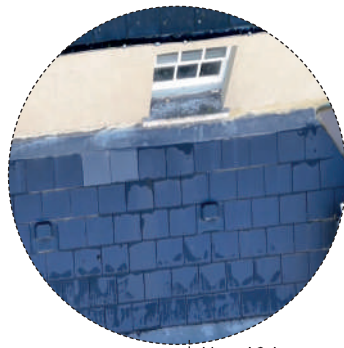
✓ Original slate hipped roof to side wing with tile vents revealed in drone footage, stairwell window over

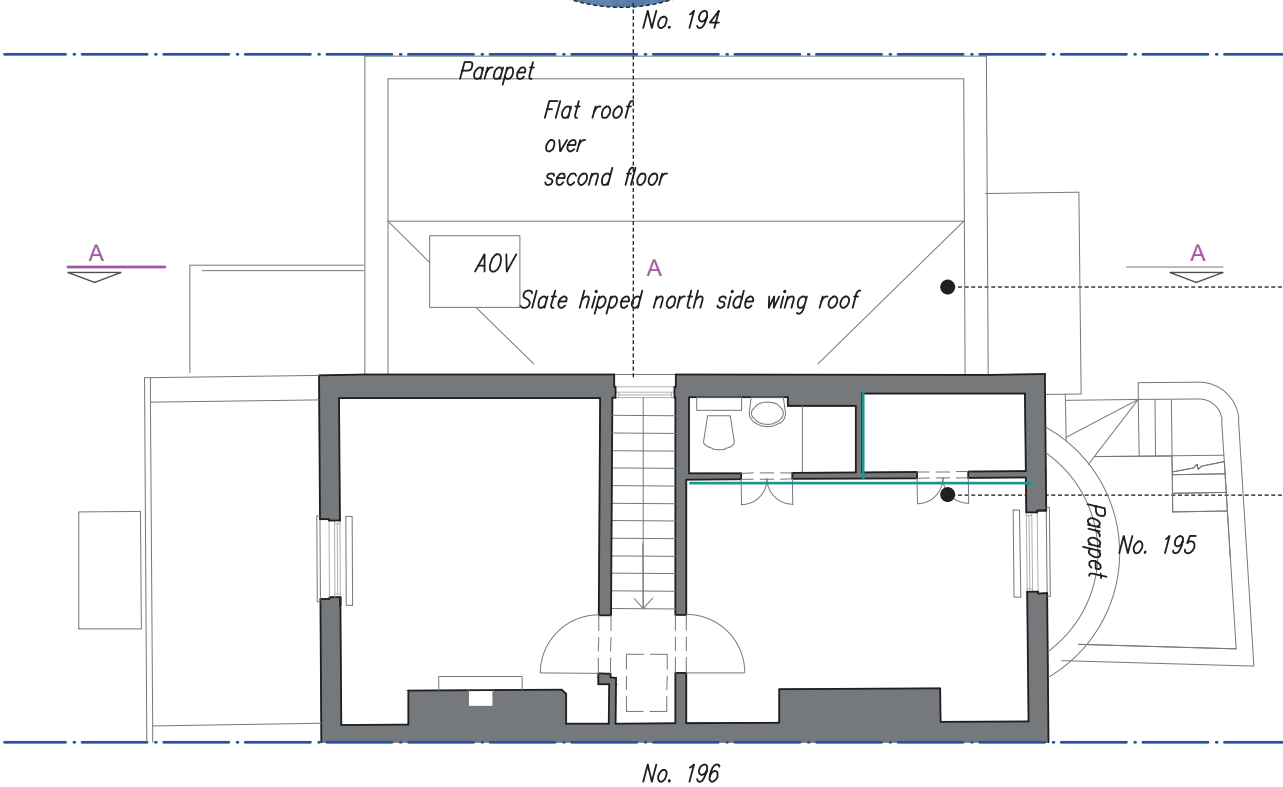
Fig. 24: 3F survey drawing by Direct Construction Surveyors & associated on site imagery 2025

✓ original slate hipped roof to side wing with tile vents revealed in drone footage,

✗ partitions formed

general:  
minimal intervention; reversible partitions to wc & store

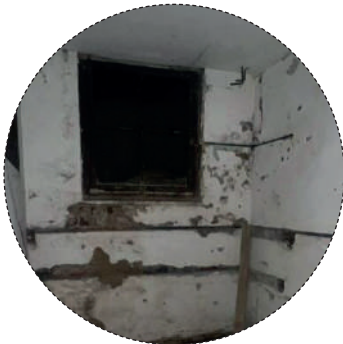
Light-well window remains in situ

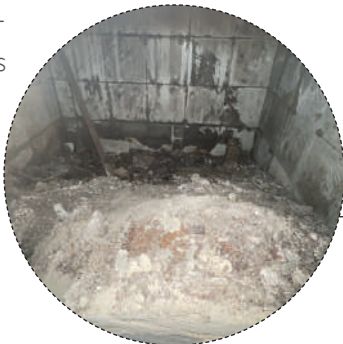
Light-well tiles remain in situ

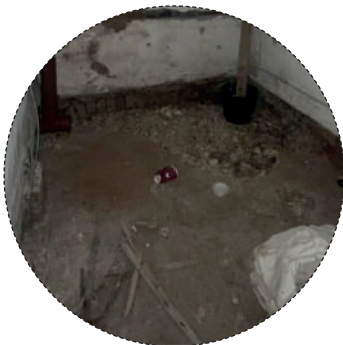
Stone flooring remains in situ

✓ Evidence lath and plaster in situ mesh protection below over fire rated gypsum plasterboard

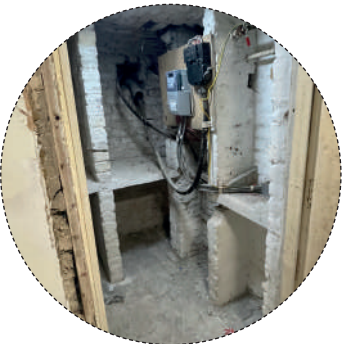
✓ Evidence of lath and plaster in situ, acoustic insulation over and plasterboard below

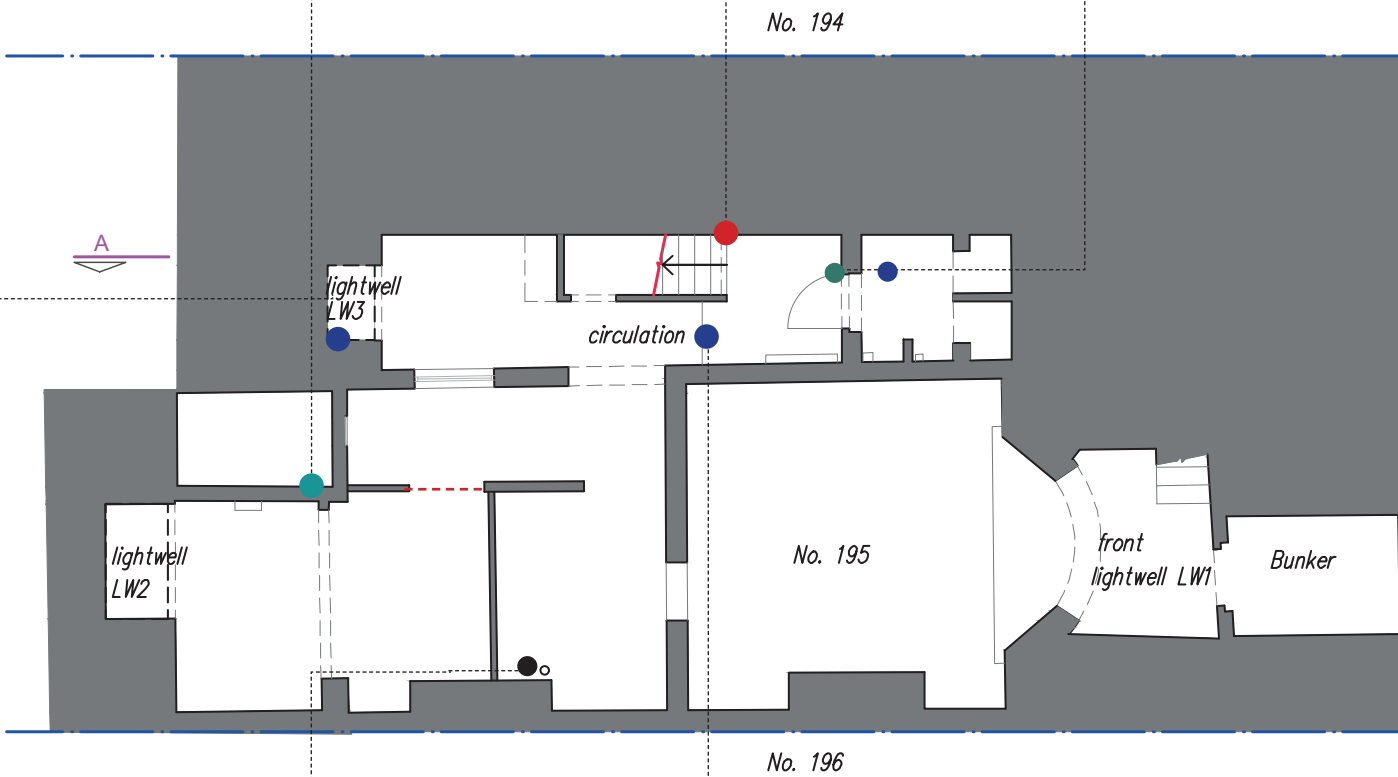
Fig. 25 LGF survey drawing by Direct Construction Surveyors & associated on site imagery 2025

Structural Engineer Inspection revealed no major movement or settle-ment was suspected, despite cracking through the stonework over the basement bay, brickwork was in reasonable conditions with no major cracking at low level and as such, However, the chimney revealed little or no foundation below and some vertical cracking was evident.

No cracking or movement was apparent to the front Bay brickwork internally

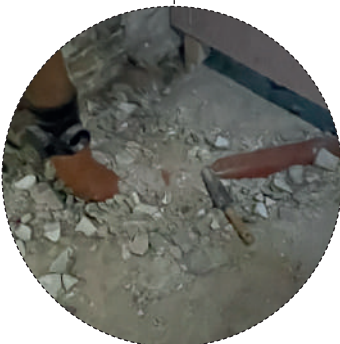
✗ New SVP Located

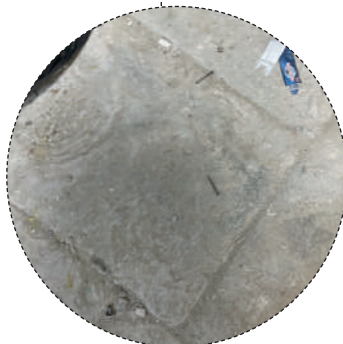
✓ Original stone slabs retained in situ.

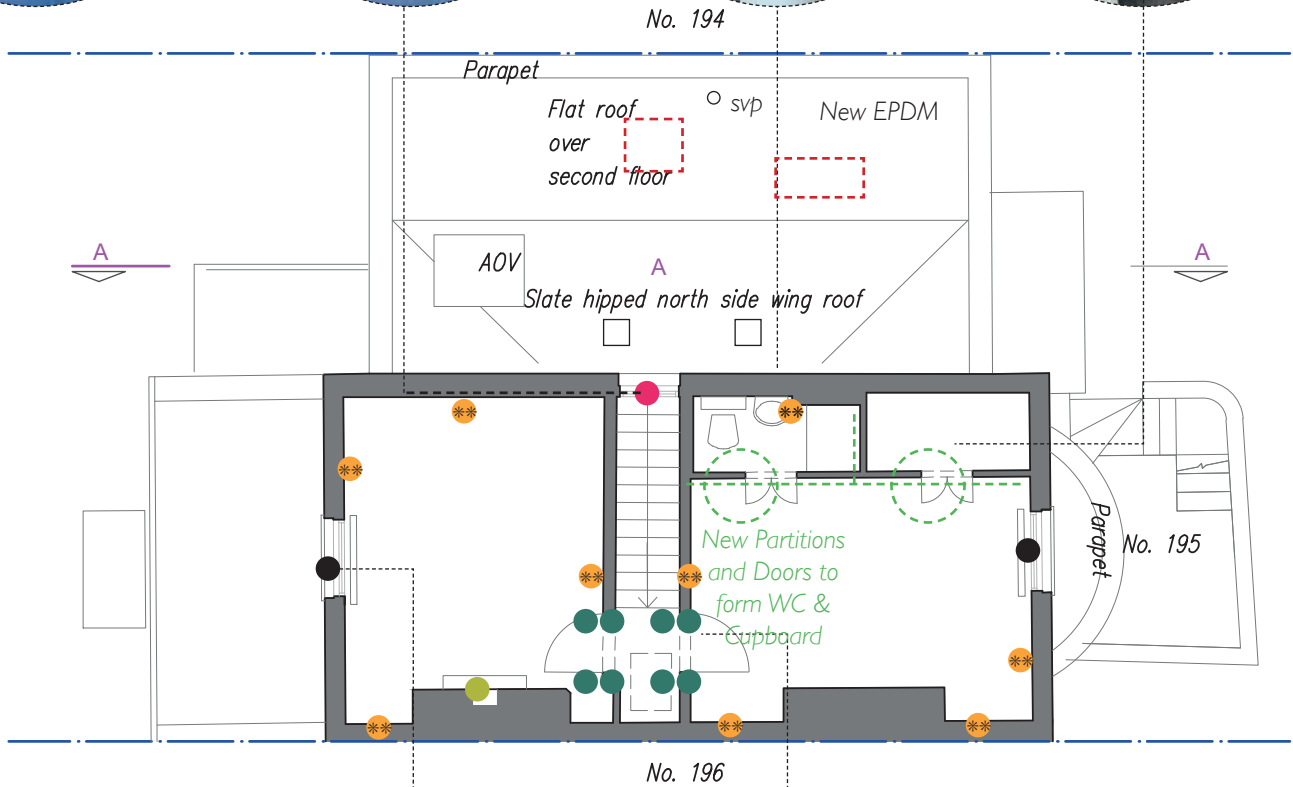
Fig. 29 3F survey drawing by Direct Construction Surveyors & associated on site imagery 2025

AOV formed

✓ Original slate hipped roof to side wing with tile vents revealed in drone footage, stairwell window over

✓ New partition evidenced in Square skirting type remains in-situ

New partitions and doors to frame en-suite and storage.

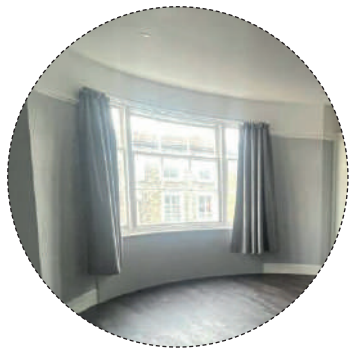
✓ Original bow window evidenced

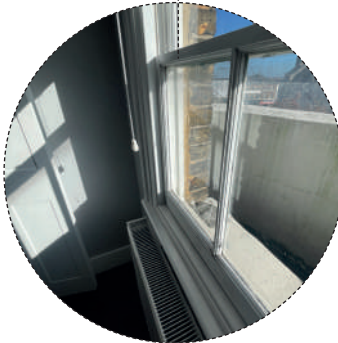
✓ Sash window in keeping with original

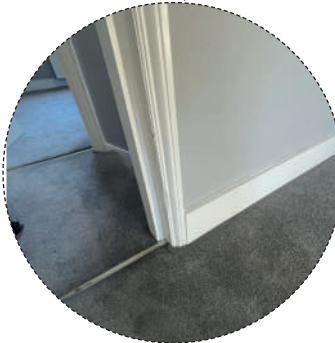
✓ Original architrave and skirting remains in-situ.
