# ARBORICULTURAL ASSESSMENT REPORT

| | <b>Risk Address:</b> | School Bungalow, Erskine Road, Vigo, Gravesend, Kent, DA13 0RL |
| <b>Refs:</b> | <b>PRI Ref:</b> | 122331 |

| <b>Arborist Name:</b> | Sarah MacKinnon | <b>Date:</b> | 12/02/2019 |

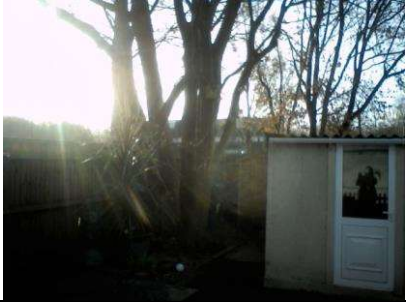
| TG1 - Hornbeam | T1 - Oak (English) |

| Tree No | Common Name | Age Class | Condition | Height (m) | Crown Spread (m) | Stem diam. (mm) | Dist to bldg. (m) | Roots Implicated | Pruning history | Recommendation | Tree work constraints | Notes | Owner address | Owner |
|---|---|---|---|---|---|---|---|---|---|---|---|---|---|---|
| TG1 | Hornbeam | Mature | Fair | 16.5 | 9.4 | 340 | 5.5 | Y | Subject to past reduction management. | Fell and treat stumps. | Located near school entrance gate. | | School Bungalow, Erskine Road, Vigo, Gravesend Kent DA13 0RL | Policyholder |

| Tree No: | Species | Works Required |
|---|---|---|
| TG1 | Hornbeam | Fell and treat stumps. |

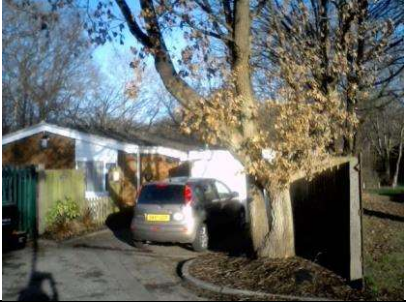
| Tree No | Common Name | Age Class | Condition | Height (m) | Crown Spread (m) | Stem diam. (mm) | Dist to bldg. (m) | Roots Implicated | Pruning history | Recommendation | Tree work constraints | Notes | Owner address | Owner |
|---|---|---|---|---|---|---|---|---|---|---|---|---|---|---|
| T1 | Oak (English) | Mature | Fair | 14.3 | 13.0 | 310 | 7.5 | N | No significant recent management. | No work required. | Adjacent school entry gate. | | School Bungalow, Erskine Road, Vigo, Gravesend Kent DA13 0RL | Policyholder |

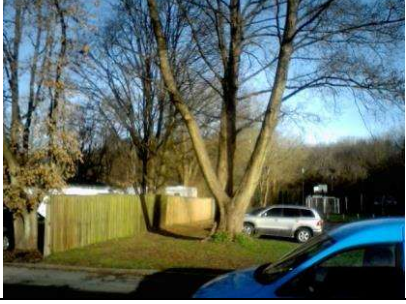
| T2 - Alder | T3 - Willow |

| Tree No | Common Name | Age Class | Condition | Height (m) | Crown Spread (m) | Stem diam. (mm) | Dist to bldg. (m) | Roots Implicated | Pruning history | Recommendation | Tree work constraints | Notes | Owner address | Owner |
|---|---|---|---|---|---|---|---|---|---|---|---|---|---|---|
| T2 | Alder | Mature | Fair | 20 | 16 | 590 | 11 | Y | Subject to past reduction management . | Fell and treat stump. | Adjacent school entry gates. | | | Local Authority |

| Tree No: | Species | Works Required |
|---|---|---|
| T2 | Alder | Fell and treat stump. |

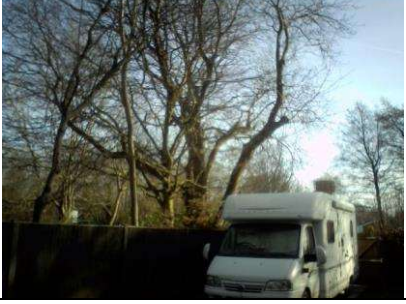
| T3 | Willow | Mature | Fair | 15.3 | 10 | 650* | 7.5 | N | No significant recent management. | No work required. | Potential/Identified bat habitat. | Given species and current size, considered likely potential future risk to property. | Local Authority |

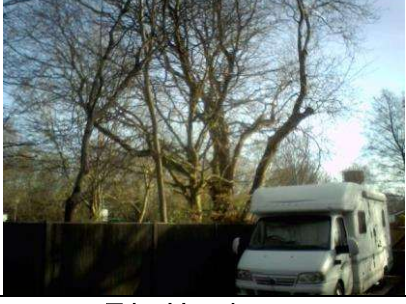
| T4 - Hornbeam | T5 - Ash |

| T4 | Hornbeam | Mature | Fair | 11 | 7.0 | 300 | 7.5 | N | No significant recent management. | No work required. | | | Local Authority |

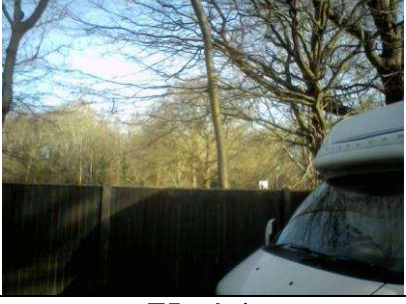
| T5 | Ash | Early Mature | Fair | 16 | 6 | 160 | 7.5 | N | No significant recent management. | No work required. | | | Local Authority |

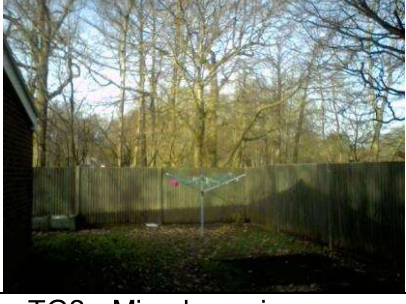
| TG2 - Mixed species group | |

| TG2 | Mixed species group | Early Mature | Fair | 11 | 5.0 | 200 | 6 | N | No significant recent management. | No work required. | | Primarily semi to early mature hornbeam with occasional semi mature willow. | Local Authority |
