**Ref: 4121/24**

## **PROPOSED REDEVELOPMENT AT MID KENT GOLF CLUB, SINGLEWELL ROAD, GRAVESEND, KENT DA11 7RB.**

### **PHASE I GEO ENVIRONMENTAL DESK STUDY AND PRELIMINARY RISK ASSESSMENT**

**February 2024**

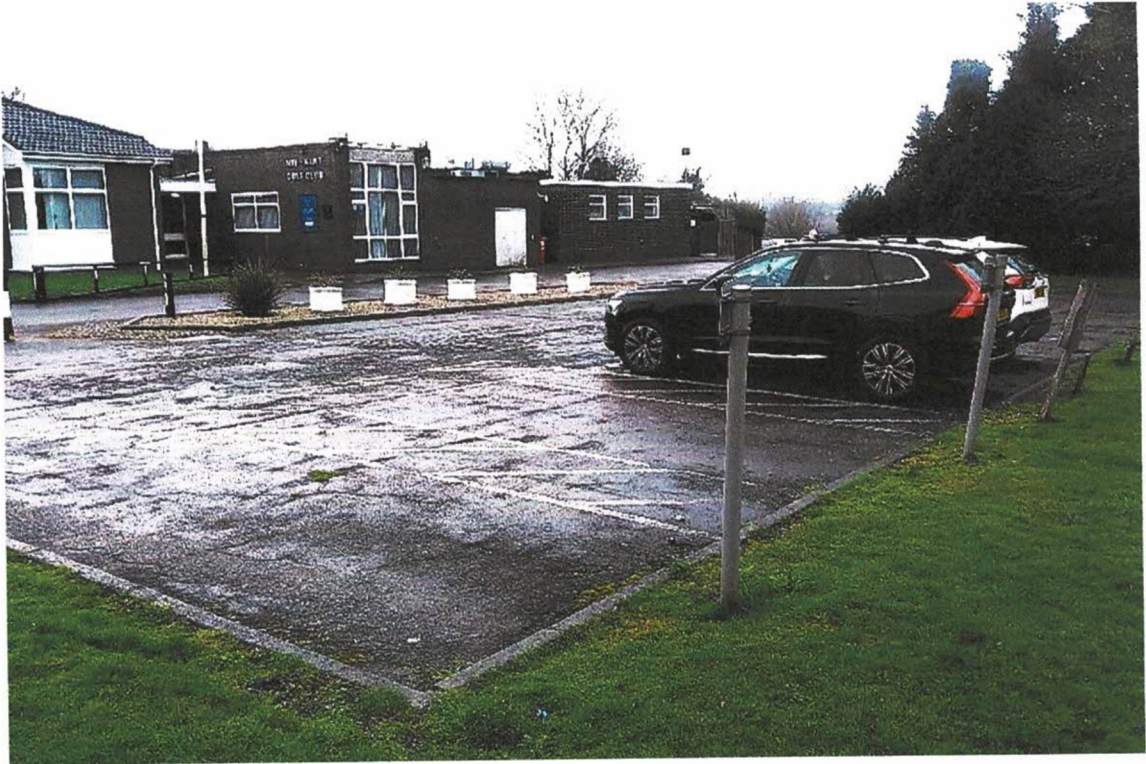
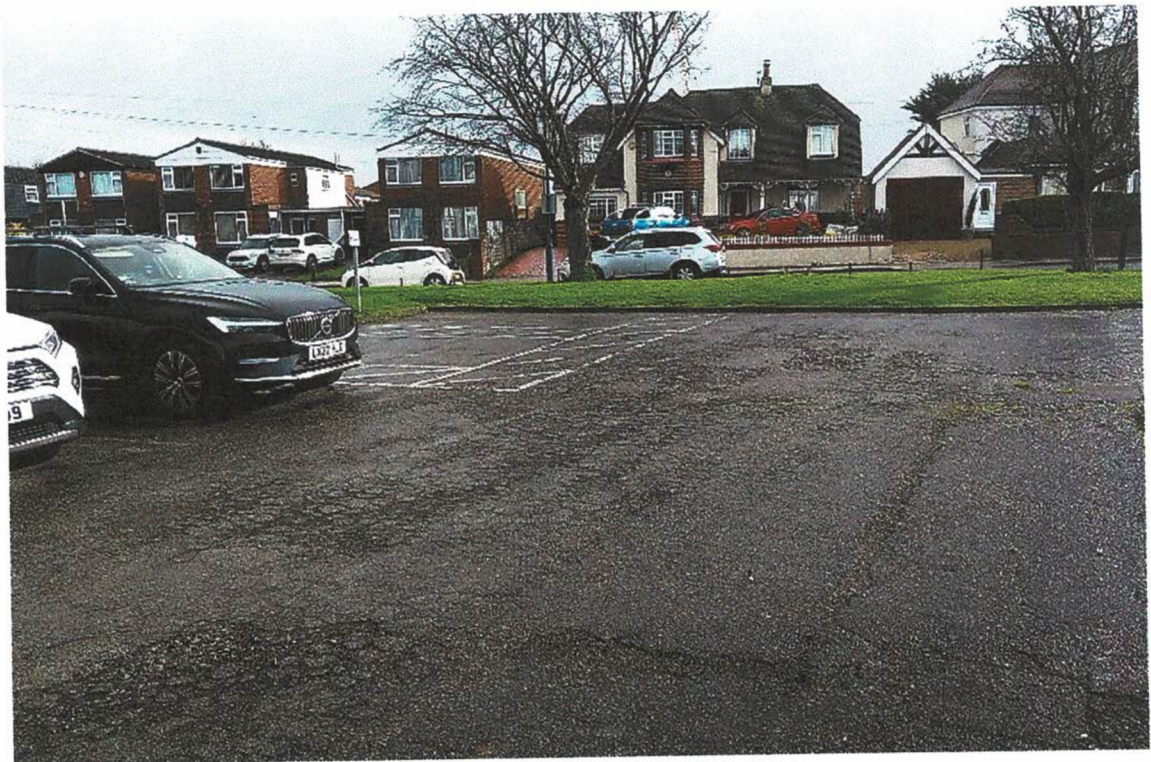
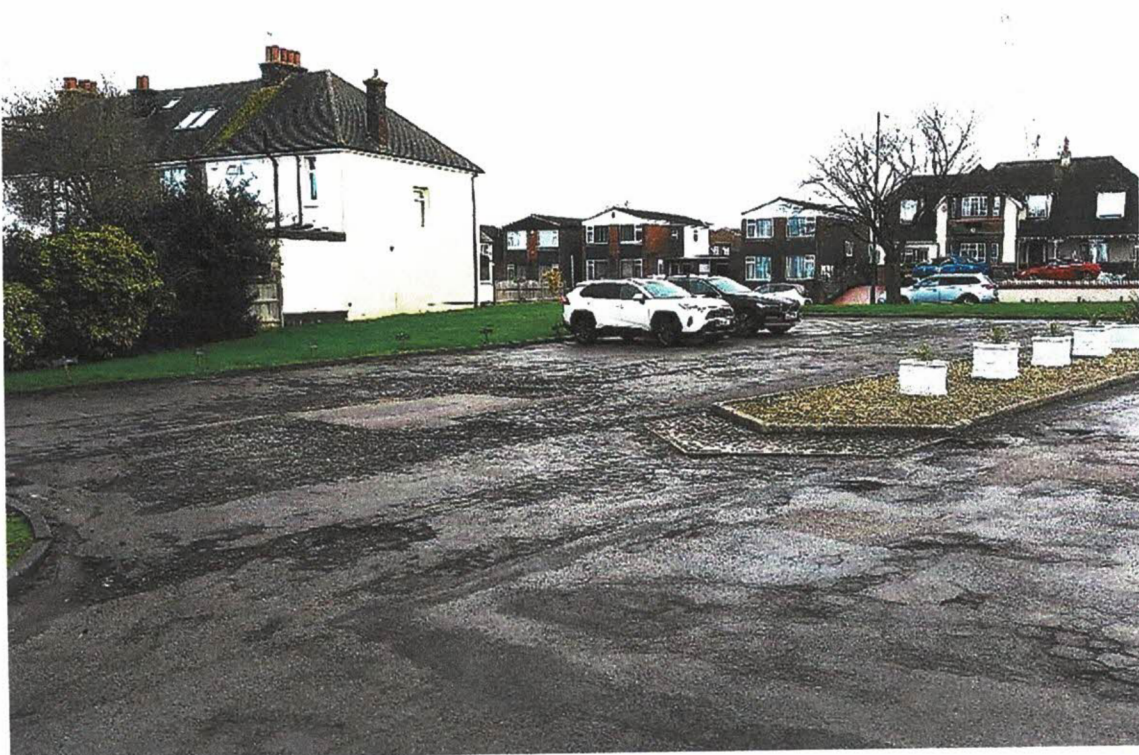
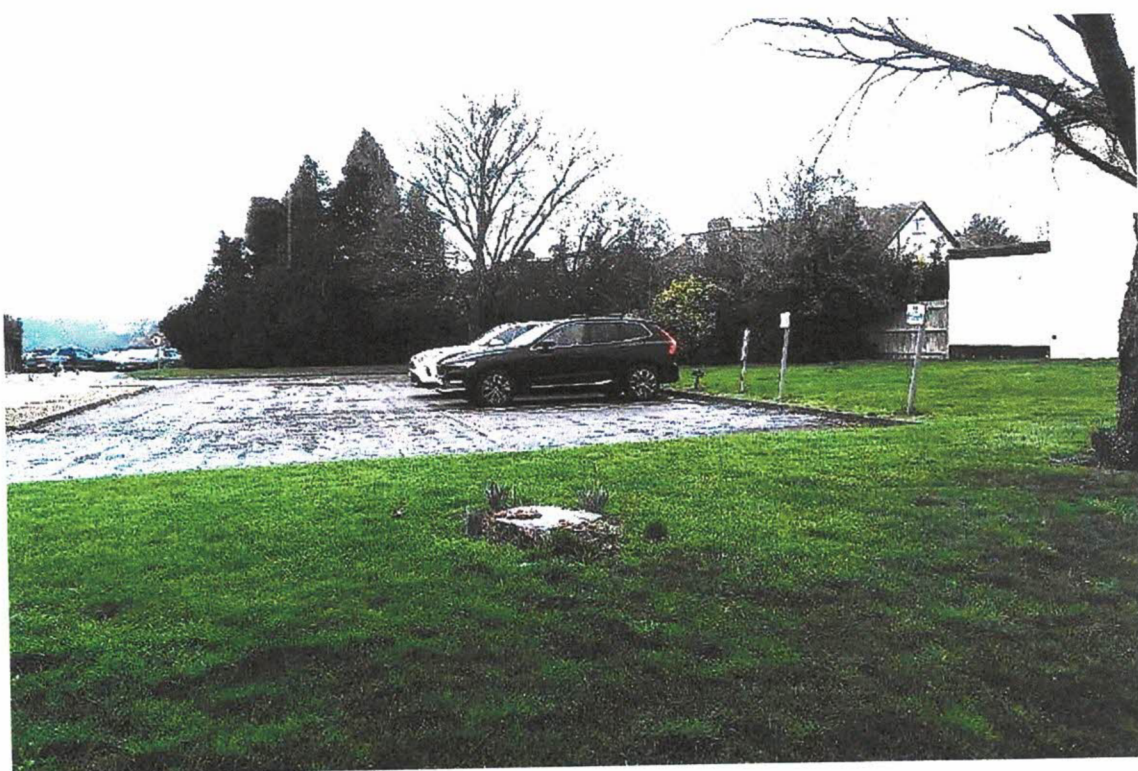
- 7.3 The site comprised a relatively small area of worn tarmac surfacing which currently functions as a car park for the golf club (Plates 1-4). Two vehicles were parked on the car park at the time of the inspection.

- 7.4 An elliptical area of granular surfacing supporting a row of ornamental horticultural tubs extended across the south end of the site, the north, east and west sides of the site comprising mown grass. Ornamental trees and shrubs were situated on the east and west sides of the site.

- 7.5 The public footpath along Singlewell Road formed the east boundary of the site, tarmac surfacing comprising the main entrance into the golf club from Singlewell Road extending alongside the site's south end. Additional vehicular parking for the golf club was situated beyond the west boundary of the site. The side elevation of a semi-detached dwelling and its associated garden fences formed the north boundary of the site.

- 7.6 No visual or olfactory evidence of contamination was observed on or around the site during the course of the inspection.
