# Drainage Report

**Kimberly Clark**  
**Northfleet Mill**  
**Gravesend**  
**Kent**  
**DA11 9AD**

## A60790 Kimberly Clark Northfleet Mill DA11 9AD - CCTV Survey Report : 28/07/23

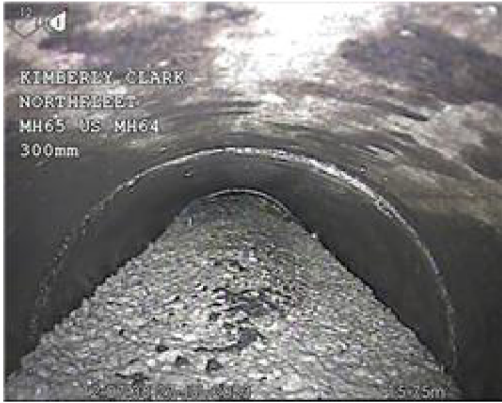
| <b>Section: 1</b><br><br><b>From: MH65</b><br><b>To: MH64</b> | <ul style="list-style-type: none"> <li>• Survey abandoned @ 15.75m due to concrete in line.</li> <li>• Line believed to be a redundant overflow no longer in use. Capped off with concrete.</li> </ul> | <b>DRB Grade: B</b><br><b>Pipe Size: 300</b><br><b>Material: Vitrified Clay (i.e. all clayware)</b><br><b>Use: Surface Water</b> |

| Pos | Video Ref | Code | Description | Image |
|---|---|---|---|---|
| 15.75m | 0:01:07 | OB | Other obstacles: 100% Cross sectional area loss - Severity 3 Concrete. | Image Provided - Ref: 0_2<br> |

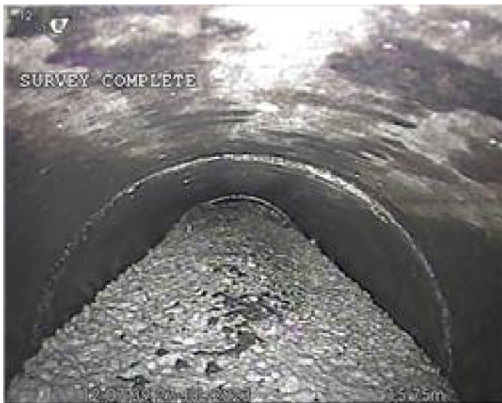
| Pos | Video Ref | Code | Description | Image |
|---|---|---|---|---|
| 15.75m | | SA | Survey abandoned<br>Survey abandoned due to concrete in line. | Image Provided - Ref: 0_9999<br> |

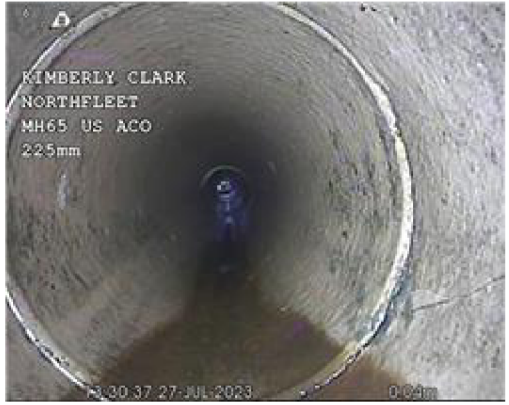
| Pos | Video Ref | Code | Description | Image |
|---|---|---|---|---|
| 00.00m | 0:00:07 | CLJ | Crack, longitudinal at 05 o'clock at joint - Severity 1 | Image Provided - Ref: 2_2<br> |

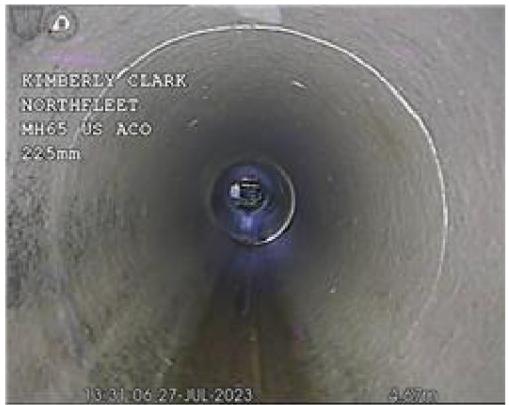
| Pos | Video Ref | Code | Description | Image |
|---|---|---|---|---|
| 04.67m | 0:00:37 | CC | Crack, circumferential from 12 o'clock to 12 o'clock - Severity 1 | Image Provided - Ref: 2_3<br> |

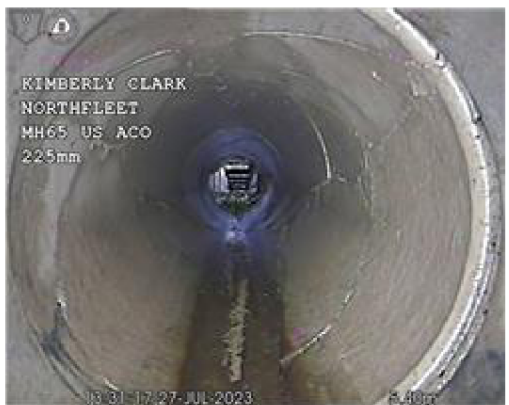
| Pos | Video Ref | Code | Description | Image |
|---|---|---|---|---|
| 05.40m | 0:00:43 | CMJ | Cracks, multiple from 12 o'clock to 12 o'clock at joint - Severity 2 | Image Provided - Ref: 2_4<br> |

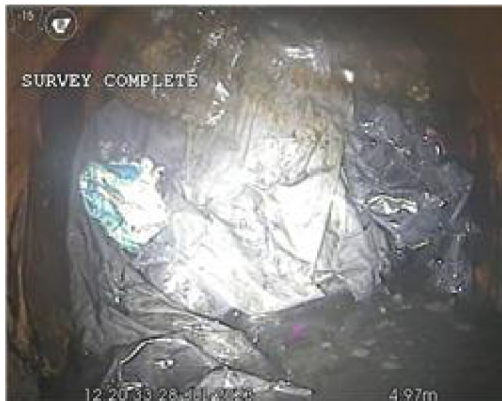
| Pos | Video Ref | Code | Description | Image |
|---|---|---|---|---|
| 04.97m | | SA | Survey abandoned<br>Possible redundant line. | <p>Image Provided - Ref: 12_9999</p> |

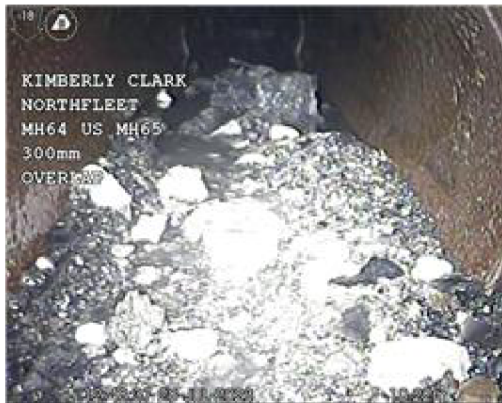
| Pos | Video Ref | Code | Description | Image |
|---|---|---|---|---|
| 10.22m | 0:00:51 | DER | Settled deposits coarse: 25%<br>Cross sectional area loss -<br>Severity 3 | Image Provided - Ref: 13_2<br> |

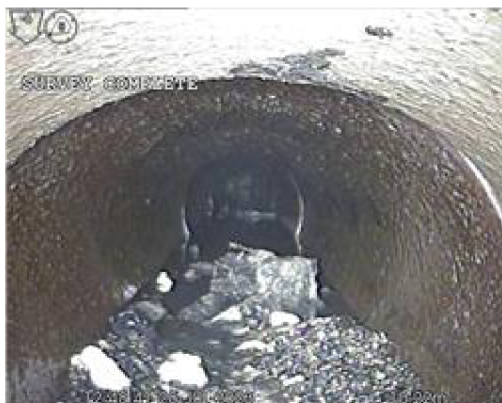
| <b>Section: 14</b><br><br><b>From: MH64</b><br><b>To: MH65</b> | <ul style="list-style-type: none"> <li>• Survey abandoned @ 10.22m due to rubble/debris.</li> <li>• Line believed to be a redundant overflow no longer in use. Capped off further D/S.</li> </ul> | <b>DRB Grade: B</b><br><b>Pipe Size: 300</b><br><b>Material: Vitrified Clay (i.e. all clayware)</b><br><b>Use: Surface Water</b> |

| Pos | Video Ref | Code | Description | Image |
|---|---|---|---|---|
| 10.22m | | SA | Survey abandoned<br>Unable to complete survey due<br>to rubble/debris. | Image Provided - Ref: 13_9999<br> |
