## ASBESTOS SURVEY RE-INSPECTION REPORT

REFERENCE No. J429635

LND & BLDG FRONTING DARNLEY RD, Gravesend, GRV008AA, DA11 0RY

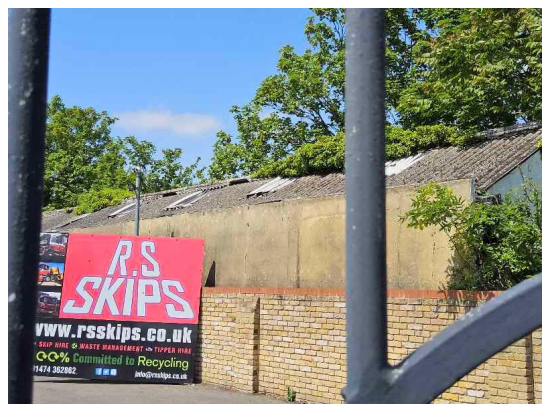
Inspection Number : 1  
 Inspection Date : 09/04/2026  
 Inspection Type : Visual Inspection  
 Level of Identification : Asbestos Presumed  
Material Location:  
 Building Name / No : Breeze Block Building  
 Floor Level : External  
 Area / Room : External  
 Item Description : Cement Corrugated Roof Sheet

Product Description : Corrugated Sheet  
 Estimated Quantity : > 100 m<sup>2</sup>  
 Likelihood of Disturbance : Usually inaccessible or unlikely to be disturbed  
 Sample Number : N/A  
 Sample Analysis : N/A

| Factors | Assessment Description | Score |
|---|---|---|
| Damage/Deterioration | Low Damage | 1 |

Material Risk Assessment Category as per HSG264 & HSG227: Very Low

Action : Inspect at Intervals & Update Register  
 Quantity : N/A  
 (Extent of material requiring treatment works)  
 Priority : Very Low  
 (Priority based on material and priority risk assessment)  
 Next Inspection Due : In accordance with the current Control of Asbestos Regulations

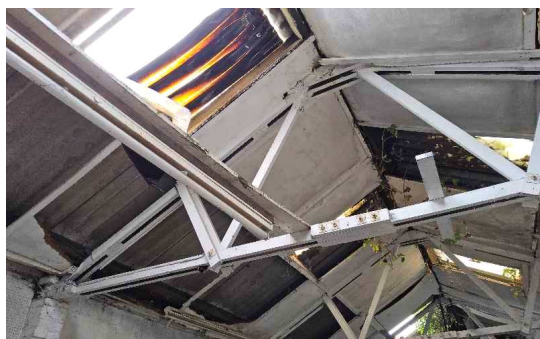
Inspection Number : 2  
 Inspection Date : 09/04/2026  
 Inspection Type : Visual Inspection  
 Level of Identification : Asbestos Presumed

Building Name / No : Breeze Block Building  
 Floor Level : Ground Floor  
 Area / Room : Internal  
 Item Description : Cement Corrugated Roof Sheets

Product Description : Corrugated Sheet  
 Estimated Quantity : < 100 m<sup>2</sup>  
 Likelihood of Disturbance : Usually inaccessible or unlikely to be disturbed  
 Sample Number : N/A  
 Sample Analysis : N/A

| Factors | Assessment Description | Score |
|---|---|---|
| Damage/Deterioration | Low Damage | 1 |

Material Risk Assessment Category as per HSG264 & HSG227: Very Low

Action : Inspect at Intervals & Update Register  
 Quantity : N/A  
 (Extent of material requiring treatment works)  
 Priority : Very Low  
 (Priority based on material and priority risk assessment)  
 Next Inspection Due : In accordance with the current Control of Asbestos Regulations

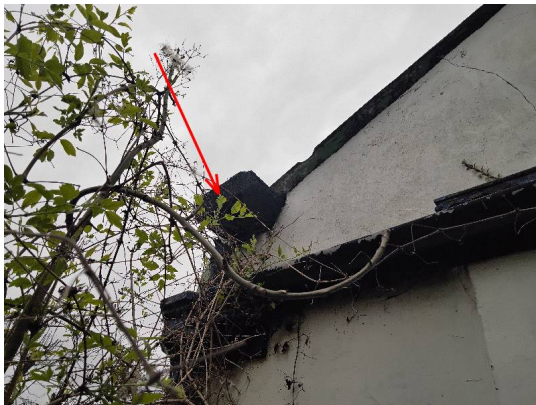
| Inspection No | Sample Reference Number | Building Name/No | Floor/Level | Area/Room | Item Description | Product Description | Damage/Deterioration | Estimated Quantity | Level of Identification | Inspection Status |
|---|---|---|---|---|---|---|---|---|---|---|
| 3 | - | Breeze Block Building | External | External | Felt to Gully | Roof Felt | Low Damage | <50lm | Asbestos Presumed | Previous photo best, overgrown vegetation makes it hard to acm - No Change |

Inspection Number : 3  
 Inspection Date : 09/04/2026  
 Inspection Type : Visual Inspection  
 Level of Identification : Asbestos Presumed

Product Description : Roof Felt  
 Estimated Quantity : < 50 lm  
 Likelihood of Disturbance : Usually inaccessible or unlikely to be disturbed  
 Sample Number : N/A  
 Sample Analysis : N/A

| Factors | Assessment Description | Score |
|---|---|---|
| Damage/Deterioration | Low Damage | 1 |

#### Recommended Action:

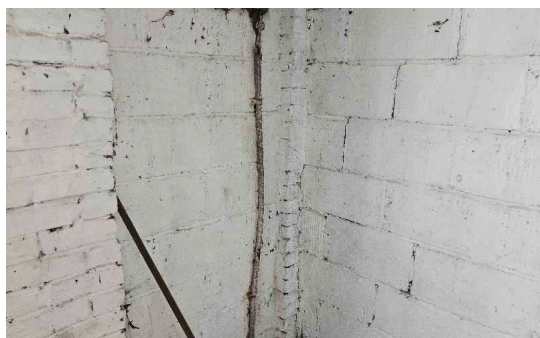
| Inspection No | Sample Reference Number | Building Name/No | Floor/Level | Area/Room | Item Description | Product Description | Damage/Deterioration | Estimated Quantity | Level of Identification | Inspection Status |
|---|---|---|---|---|---|---|---|---|---|---|
| 4 | - | Breeze Block Building | Ground Floor | Internal | Woven cable wrap | Wrap | Low Damage | 2lm | Asbestos Presumed | No Change |

Product Description : Wrap  
 Estimated Quantity : 2 lm  
 Likelihood of Disturbance : Usually inaccessible or unlikely to be disturbed  
 Sample Number : N/A  
 Sample Analysis : N/A

| Factors | Assessment Description | Score |
|---|---|---|
| Damage/Deterioration | Low Damage | 1 |

#### Recommended Action:

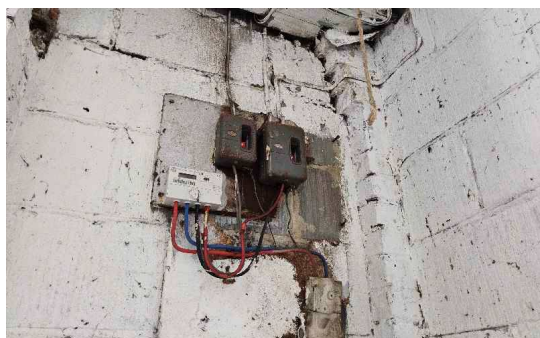
| Inspection No | Sample Reference Number | Building Name/No | Floor/Level | Area/Room | Item Description | Product Description | Damage/Deterioration | Estimated Quantity | Level of Identification | Inspection Status |
|---|---|---|---|---|---|---|---|---|---|---|
| 5 | - | Breeze Block Building | Ground Floor | Internal | Flash guards | Fuse Pads | Low Damage | Small amounts | Asbestos Presumed | No Change |

Product Description : Fuse Pads  
 Estimated Quantity : Small amounts  
 Likelihood of Disturbance : Usually inaccessible or unlikely to be disturbed  
 Sample Number : N/A  
 Sample Analysis : N/A

| Factors | Assessment Description | Score |
|---|---|---|
| Damage/Deterioration | Low Damage | 1 |

### Recommended Action:
