LOGGIA DEFECTS:

**Summary** - The loggia (timber pergola) is in a severely deteriorated condition, with a substantial section having already collapsed and the remaining structure considered close to failure. The principal 150 x 150mm timber beams are affected by significant rot, resulting in a marked reduction in structural capacity and excessive deflection under load. The original beam sizing is relatively modest for the span and has proven inadequate to support the mature wisteria and grape vine growth, contributing to overstressing and progressive failure. In addition, earlier iron brackets built into the adjacent garden wall to support the timber plate have corroded, causing corrosion jacking to the top course of brickwork and the formation of a pronounced horizontal crack. The continued presence of these embedded ferrous elements poses an ongoing risk of further masonry damage.

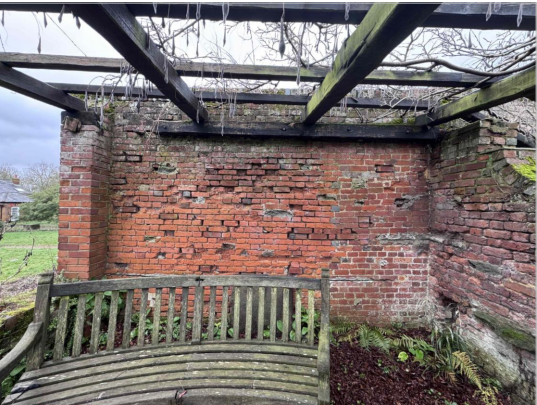
1. VIEW SHOWING CONDITION OF BRICK SPINE WALL

**Spalled brickwork** - There are significant areas of spalled brickwork along the spine wall, primarily attributable to previous repairs undertaken using dense cementitious mortars. These impermeable repairs are incompatible with the original, softer historic brick and lime mortar construction. The cement mortar prevents the natural migration and evaporation of moisture through the joints, forcing moisture to dissipate through the brick faces instead. During freeze-thaw cycles, trapped moisture expands, resulting in surface delamination and loss of the brick face. This mechanism of decay not only erodes the historic fabric but, where extensive, has implications for the long-term durability and structural performance of the wall.

**Incorrect mortar repairs** - A substantial proportion of the spine wall has been subject to inappropriate cement-based patch repairs, including the infilling of missing bricks with cementitious material. These interventions are visually intrusive and materially incompatible with the original lime-based construction. The rigidity and low permeability of the cement repairs disrupt the wall's intended moisture management strategy, creating localised stress and accelerating brick decay. Such repairs undermine both the material authenticity and the functional performance of the masonry.

**Cracks in brickwork** - Numerous cracks are present within both mortar joints and brick units. These fissures are likely associated with structural movement, differential loading, and the cumulative effects of moisture-related deterioration. In addition to their structural implications, the cracks create pathways for water ingress, further exacerbating decay within the wall fabric.

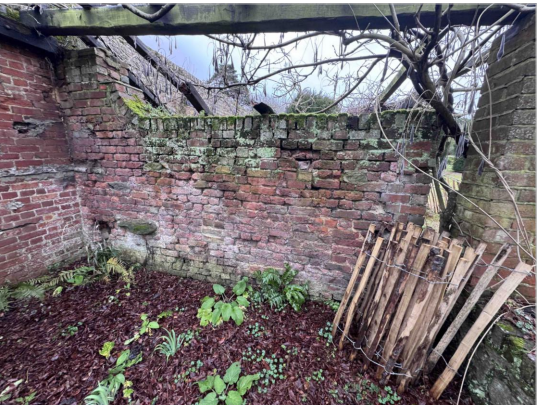
2. VIEW OF CENTRAL BRICK DIVIDING WALL
