POTTING SHED DEFECTS:

| <b>PROJECT:</b><br>PROPOSED OUTBUILDINGS REPAIR / REPLACEMENT AT OWLETT'S MANSION, COBHAM | <b>CLIENT:</b><br>NATIONAL TRUST | <b>DRAWING TITLE:</b><br>EXISTING ELEVATIONS<br>POTTING SHED | <b>DRAWN BY:</b><br>NF | <b>SCALE:</b><br>1:50 @ A3 | <b>REV</b><br>P1 - 06.03.2026 -<br>Final issue | <b>DEFECTS KEY:</b><br>Cracks in masonry<br>Spalling or missing brickwork / mortar<br>Rotten or unstable timber structure | Improper mortar repairs<br>Areas covered by vegetation - to be further investigated<br>Water Damage, Damp, Mould |

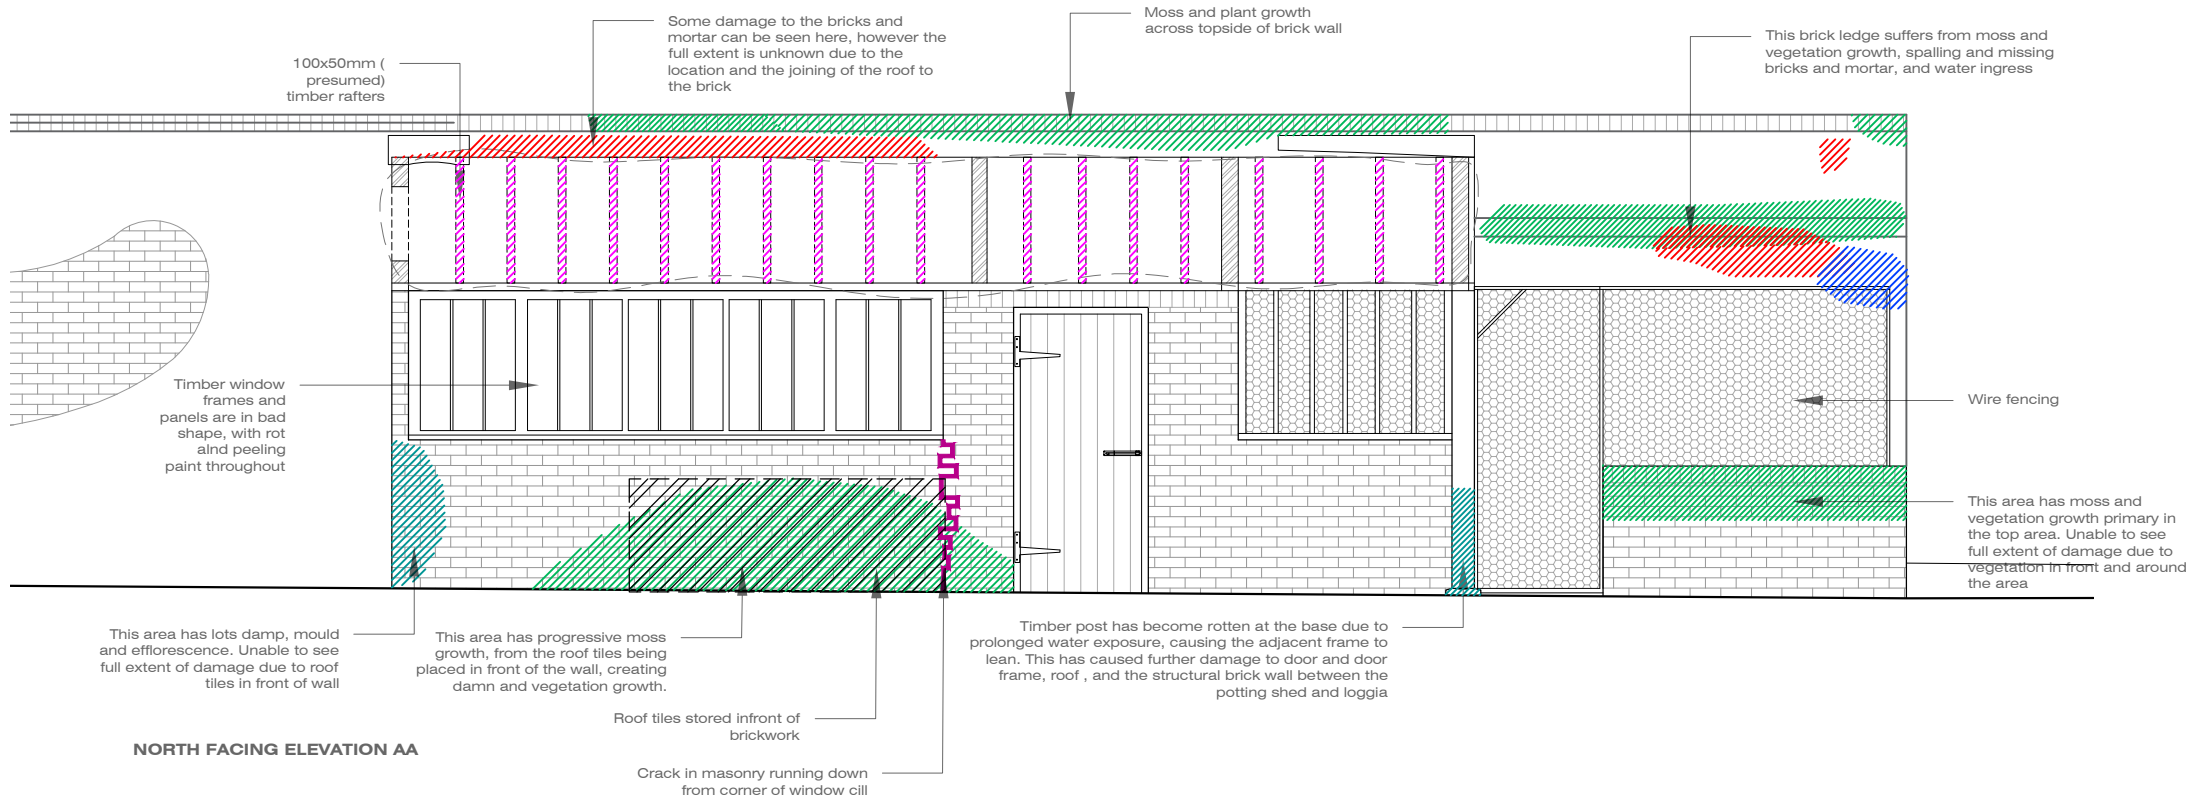
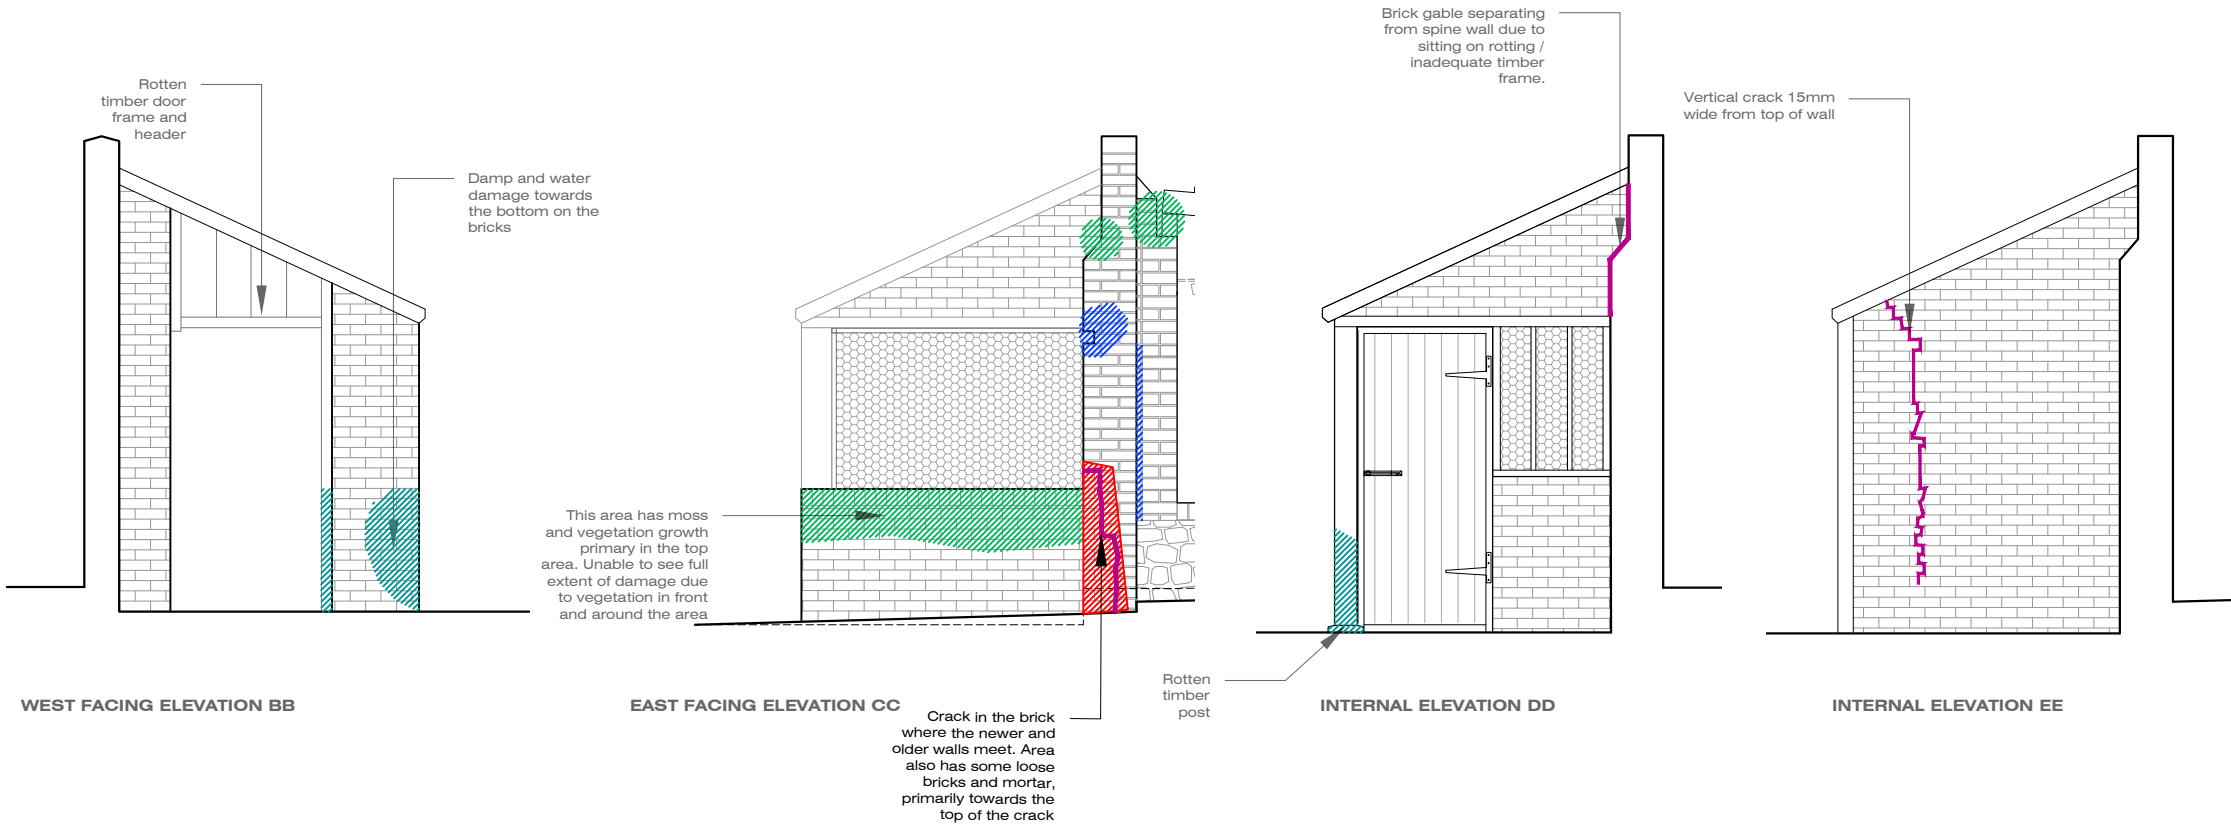
**Summary** - The Potting Shed is in an advanced state of deterioration, principally due to prolonged water ingress, timber decay and associated structural movement. The failure of the roof covering has allowed persistent moisture penetration, resulting in widespread wet rot and beetle infestation to the timber rafters. Loss of structural integrity at rafter bearings has led to roof spread and outward thrust on the masonry walls, causing displacement and cracking. Localised structural failure at the northwest corner, caused by decay of a supporting timber post, has resulted in differential movement between the end wall and the principal spine wall. The cumulative effect of timber decay, masonry cracking, and inappropriate past interventions has compromised both the structural stability and the material integrity of the building. The defects are interrelated, with moisture ingress acting as the primary driver of decay and structural movement.

The mono-pitch roof structure is beyond repair. The original softwood rafters (100 x 50mm at approximately 380mm centres) exhibit extensive wet rot and significant beetle infestation. The absence of a waterproof roof covering has left the timbers exposed, accelerating deterioration.

At the junction with the spine wall, rafter bearings have decayed, leading to loss of effective support. This has caused the roof to drop and exert lateral thrust on the supporting masonry. In several locations, rafters no longer adequately bear onto their supports due to geometric distortion caused by structural movement. The roof structure can no longer be considered structurally reliable.

The timber support conditions at the head of the masonry wall have failed due to prolonged moisture exposure. Decay at these interfaces has reduced load transfer capacity and contributed to roof spread. At the northwest corner, the end wall is supported in part by a timber post bearing onto a saddle stone. The base of this post has rotted, resulting in vertical displacement and differential settlement. This has caused separation between the end wall and the main brick wall.

The northwest end wall, constructed in half-brick thickness and largely reliant on a timber frame for stability, has dropped relative to the adjoining structure. A pronounced movement joint has opened between this wall and the spine wall as a result of settlement and timber decay.

Internally, a cross wall exhibits a significant vertical crack, approximately 20mm wide at its head and tapering toward its base. This is consistent with roof spread resulting from loss of bearing at the top of the main wall. The crack compromises both structural stability and weather resistance.

Localised brick deterioration is also present around the former flue opening, and areas of masonry require repointing.

The absence of a functioning roof covering has exposed the structure to prolonged moisture ingress. This has been the principal catalyst for timber rot, beetle infestation, and masonry movement. Persistent damp conditions have undermined the durability of both structural timber and brickwork, accelerating the rate of decay. Unless the source of water penetration is addressed, further deterioration will continue.
