PROPOSED OUTBUILDINGS REPAIR /  
REPLACEMENT AT OWLETT'S MANSION,  
COBHAM

NATIONAL TRUST

GREENHOUSE - EXISTING  
ELEVATIONS

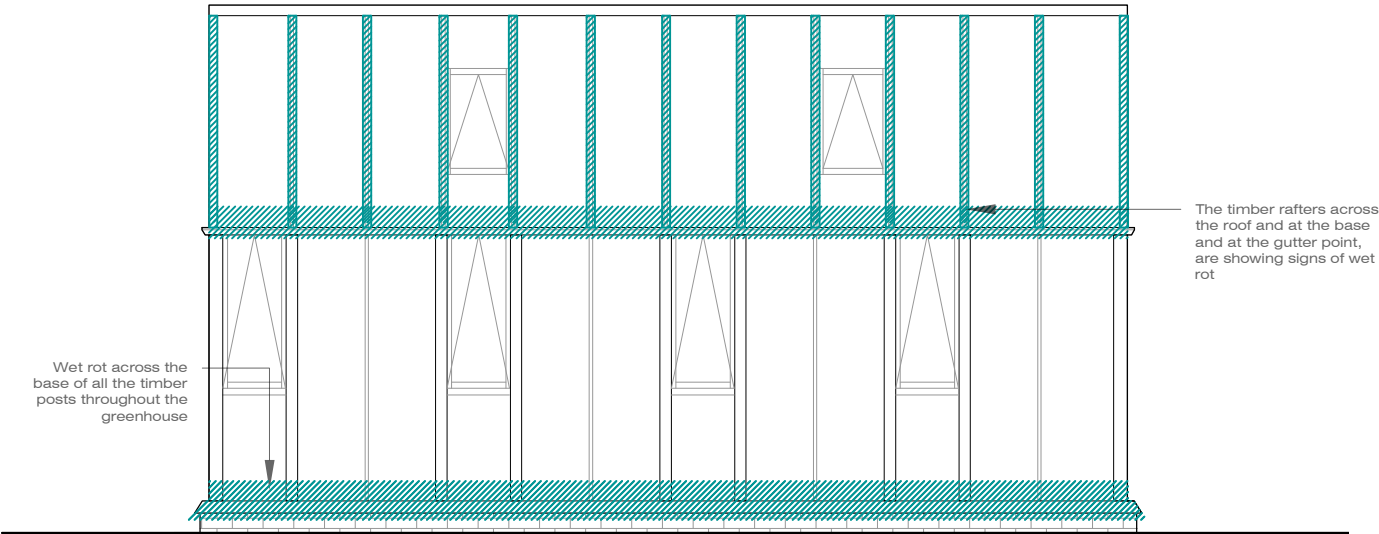
NORTH EAST ELEVATION

The timber rafters across  
the roof and at the base  
and at the gutter point,  
are showing signs of wet  
rot

The rafters forming the vaulted roof also show signs of rot along their upper surfaces, caused by ongoing water ingress. While steel tie rods brace the roof structure, they do not address the deterioration of the timber members themselves.

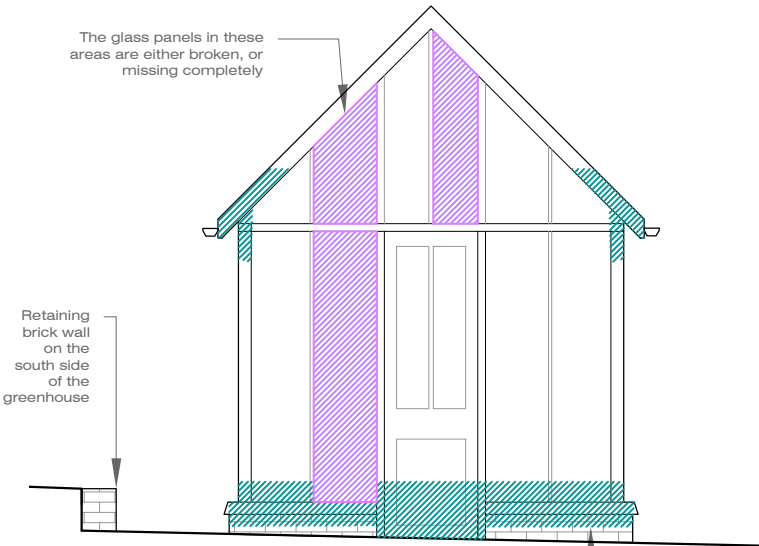
SOUTH EAST ELEVATION

Wet rot across the  
base of all the timber  
posts throughout the  
greenhouse

Wet rot is present at the base of the vertical posts and within the lower wall plate, where prolonged moisture exposure has caused advanced decay. This has reduced the structural capacity of the frame.

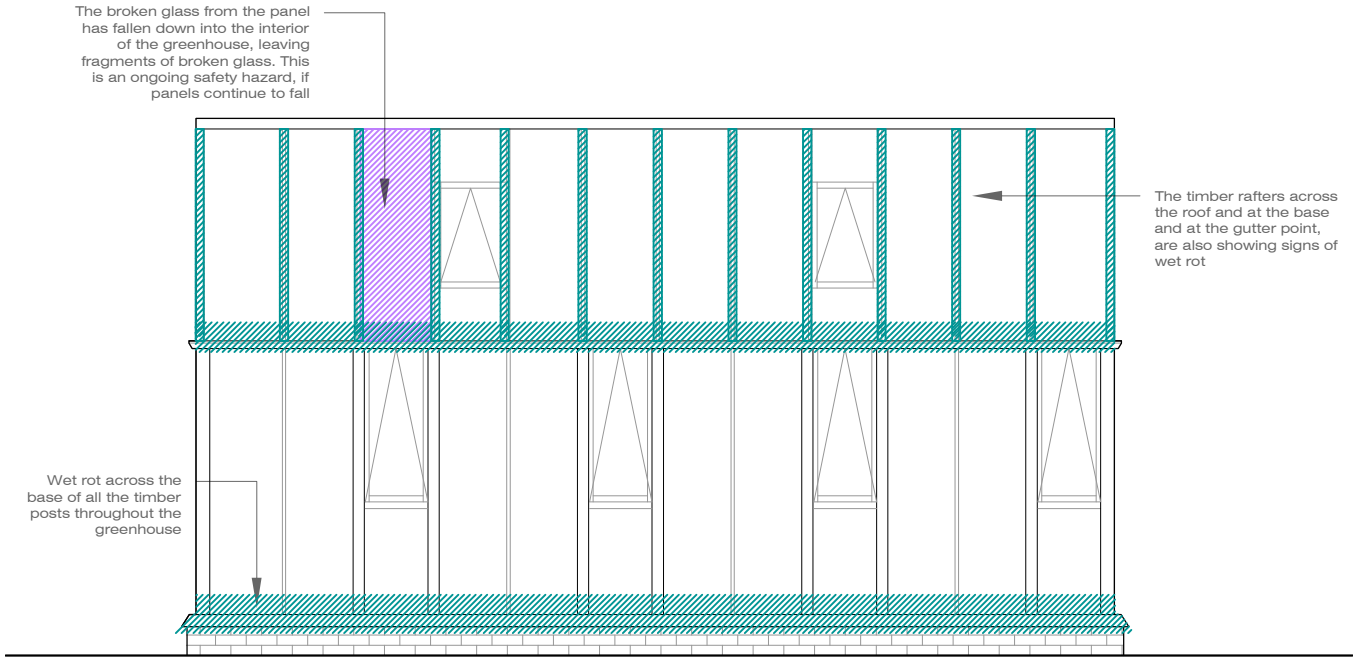
NORTH WEST ELEVATION

The broken glass from the panel  
has fallen down into the interior  
of the greenhouse, leaving  
fragments of broken glass. This  
is an ongoing safety hazard, if  
panels continue to fall

The timber rafters across  
the roof and at the base  
and at the gutter point,  
are also showing signs of  
wet rot

The greenhouse is fitted with single glazing. Several panes are broken or missing due to the use of non-reinforced glass, which has shattered under impact and weather exposure.

Broken glazing and decayed framing present a clear safety risk.

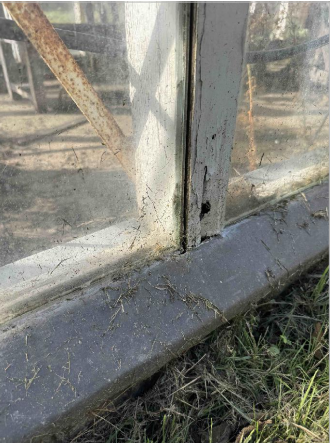
The timber frame sits on a brick plinth that is poorly detailed. Lead flashing has been installed around the base, but it is not properly formed and is allowing water to enter the timber wall plate and lower frame.

This detail does not provide effective drainage or separation between brick and timber. As a result, moisture is retained at the base of the structure, which has directly contributed to the rot in the posts and wall plate. The plinth detail is inadequate and would need to be redesigned to prevent further decay.

8. CLOSE UP OF LEADED BRICK  
PLINTH AND ROTTEN TIMBER WALL  
PLATE
